**Cause of Concrete Pier Cap Deterioration
on the I-75 Bridge over River Rouge
(B01 of 82194) in Detroit,
and Effectiveness of Repair Methods**

Final Report

Michigan Department of Transportation

Research and Technology Section
Materials and Technology Division
Research Report No. RC-1346

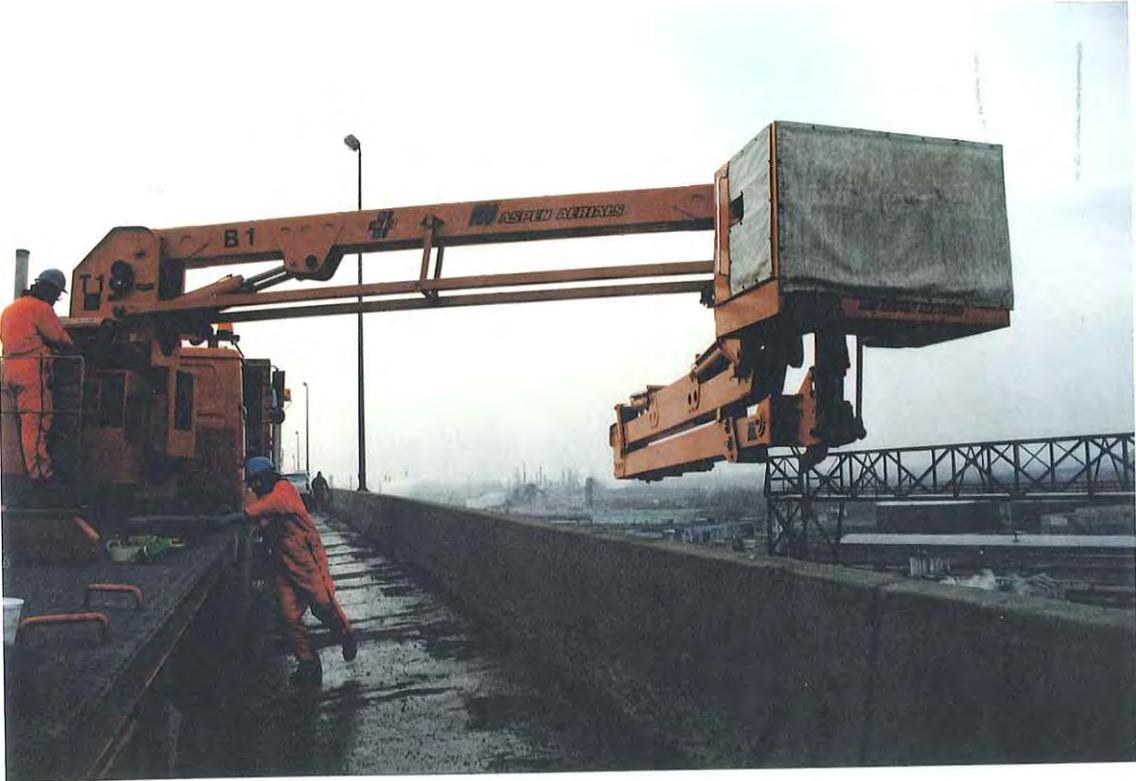
Figure 3. A reach-all provided access to the bridge piers for observation and coring.

span of the bridge, showing the piers in question is seen in Figure 2. The team accessed portions of Pier Caps 38 and 39 north-bound from the ground, and from above using a reach-all (Figure 3) provided by the Michigan Department of Transportation (MDOT). Coring of samples from Piers 38 and 39 was conducted by MDOT and under the direction of the project team on December 11-15, 1995.

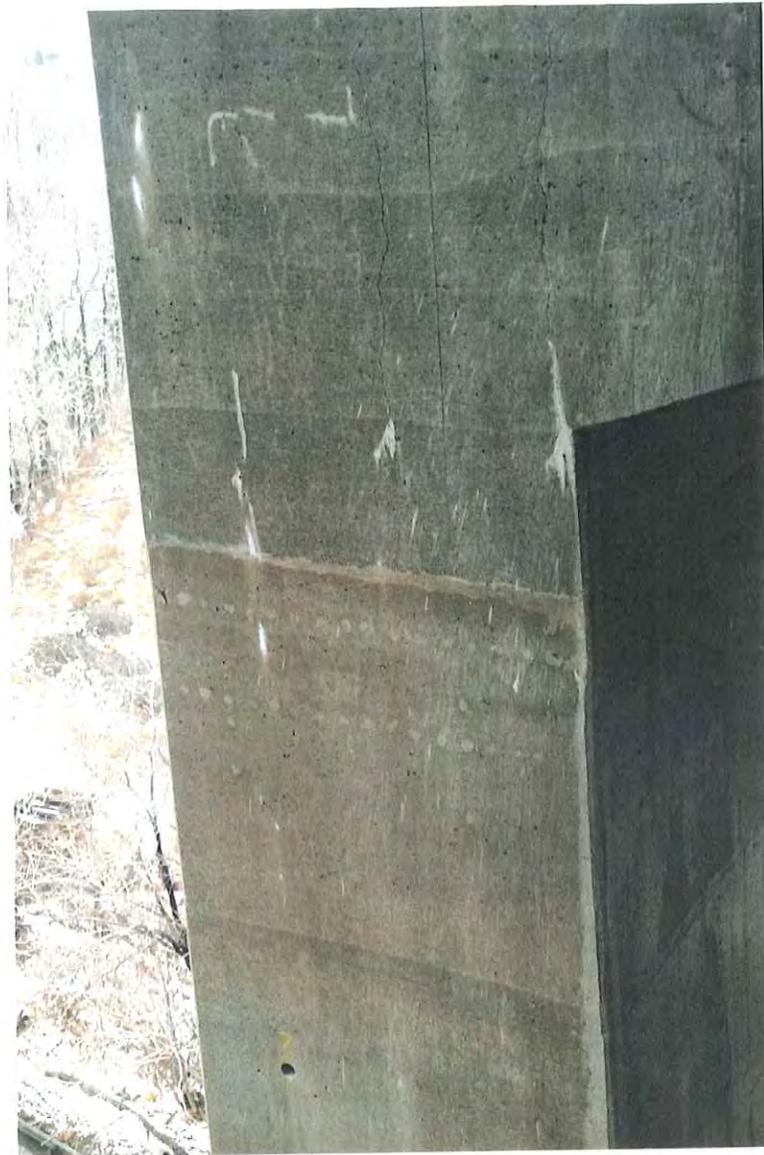
Figure 4. North face of Pier 38 north-bound and outer column. Note the difference in color between the pier cap and column.

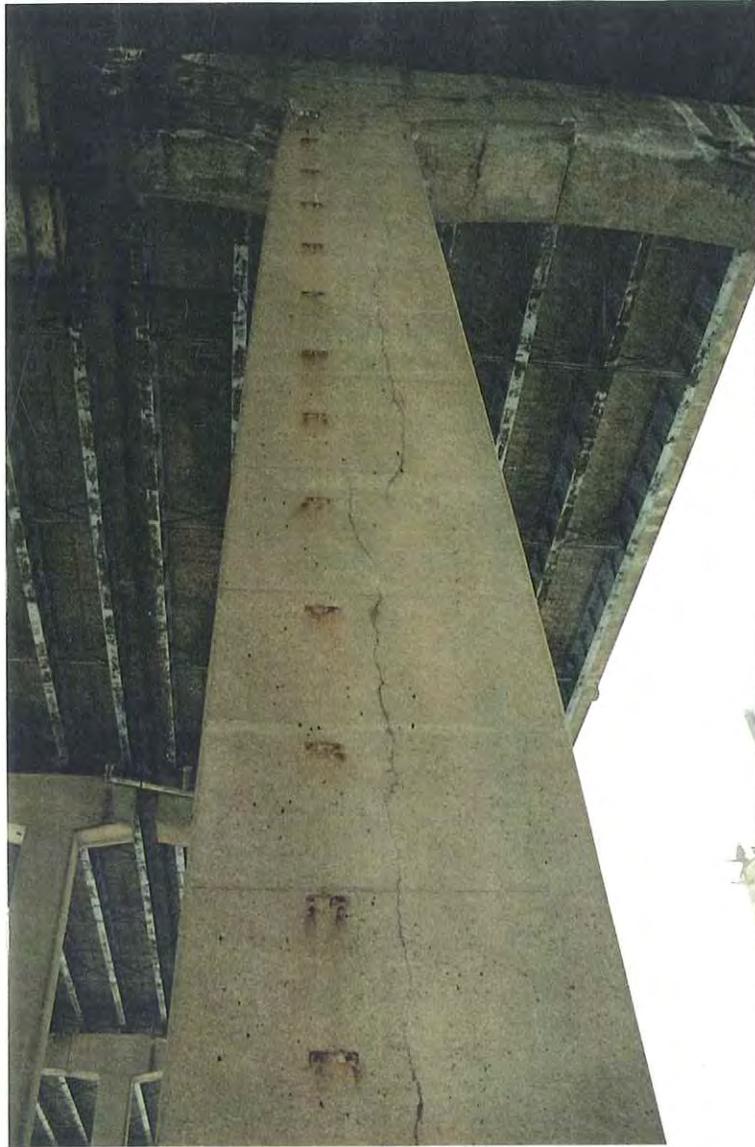
Figure 5. Vertical cracks approximately centered in the width of the column were typical of the crack pattern in the columns. This column supports Pier 40 north-bound.

Cracking in pier columns varied. In general, a relatively fine vertical crack was observable at pier columns, approximately centered in the width of the column. Figure 5 shows a column from Pier 40 north-bound exhibiting this type of crack pattern. However, in some areas the cracking was more extensive and pronounced. For example, in Pier 38 north-bound one column exhibited significantly more extensive cracking at the top column section than at lower sections; concrete color in the more extensively cracked section was gray while the remainder of the column was buff.

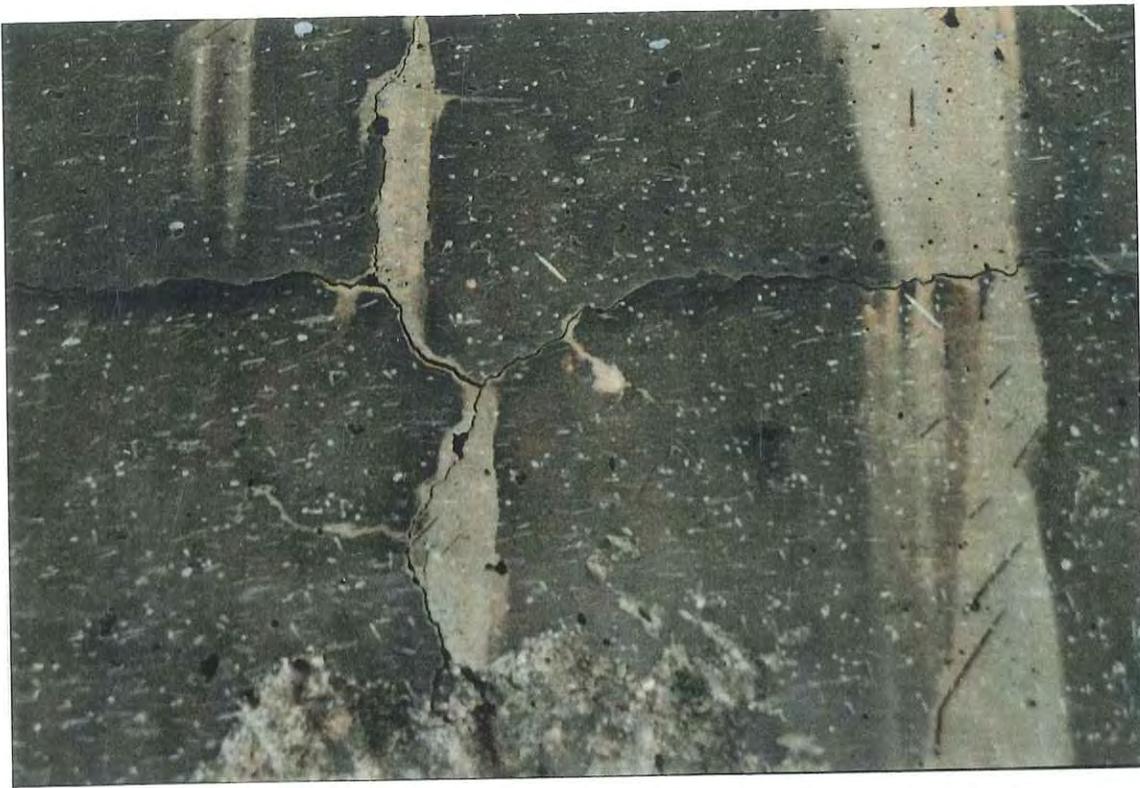
Figure 6. Close-up of south face of Pier 39 north-bound showing the typical pattern cracking seen on the pier caps.

Extensive pattern cracking was observed at all of the pier caps in Piers 37 to 40. Figure 6 shows a close-up of the typical pattern cracking. Some cracks at the north face of Pier 38 north-bound measured wider than 1/8 in. In general, no delamination was detected when surfaces adjacent to cracks were sounded with a hammer. However, surfaces at the exterior (west) face of the pier cap were delaminated.

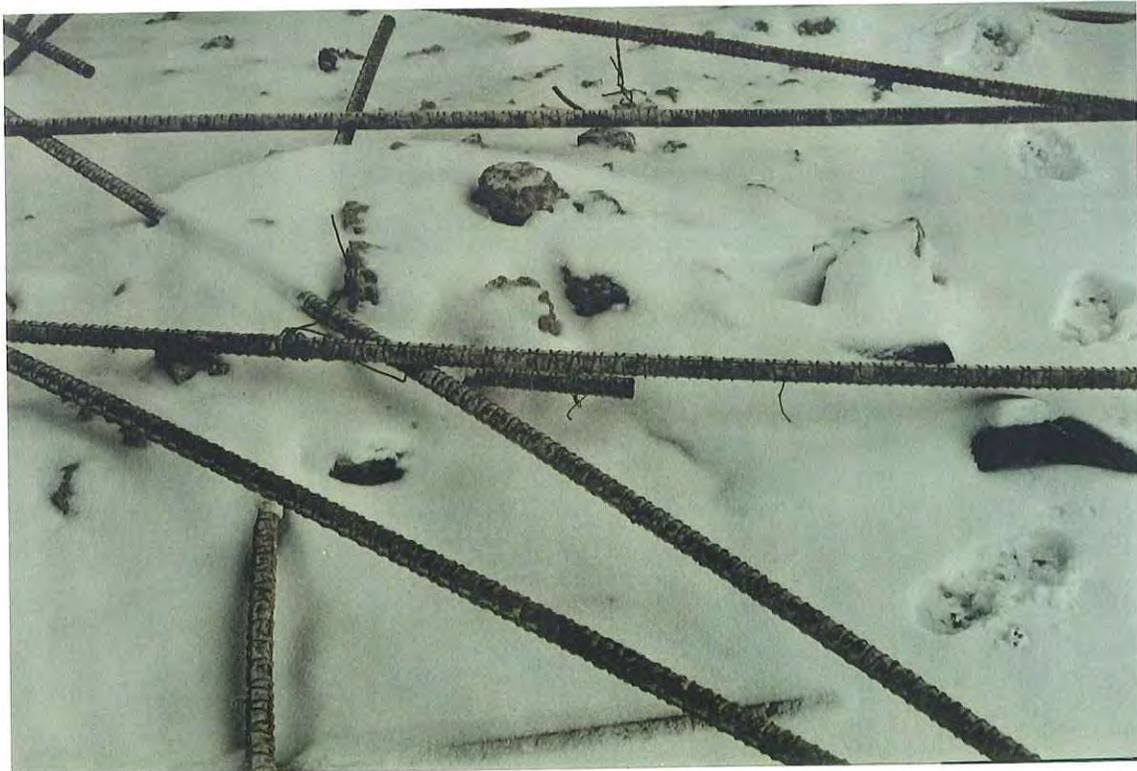
Figure 7. Reinforcing steel presumably taken from Pier 40 during demolition. Note that very little corrosion has taken place; the rust visible on the surface of the bars could have been present at construction or could have occurred after demolition.

The pier cap at Pier 40 south-bound had been demolished in preparation for replacement. Reinforcing steel presumably removed from the pier cap was observed adjacent to the base of the pier, as shown in Figure 7. Corrosion observed on the steel was not considered severe since no substantial pitting or rust pack was observed and reinforcing steel deformations were generally clearly present. Reportedly, concrete was easily demolished at this pier cap.

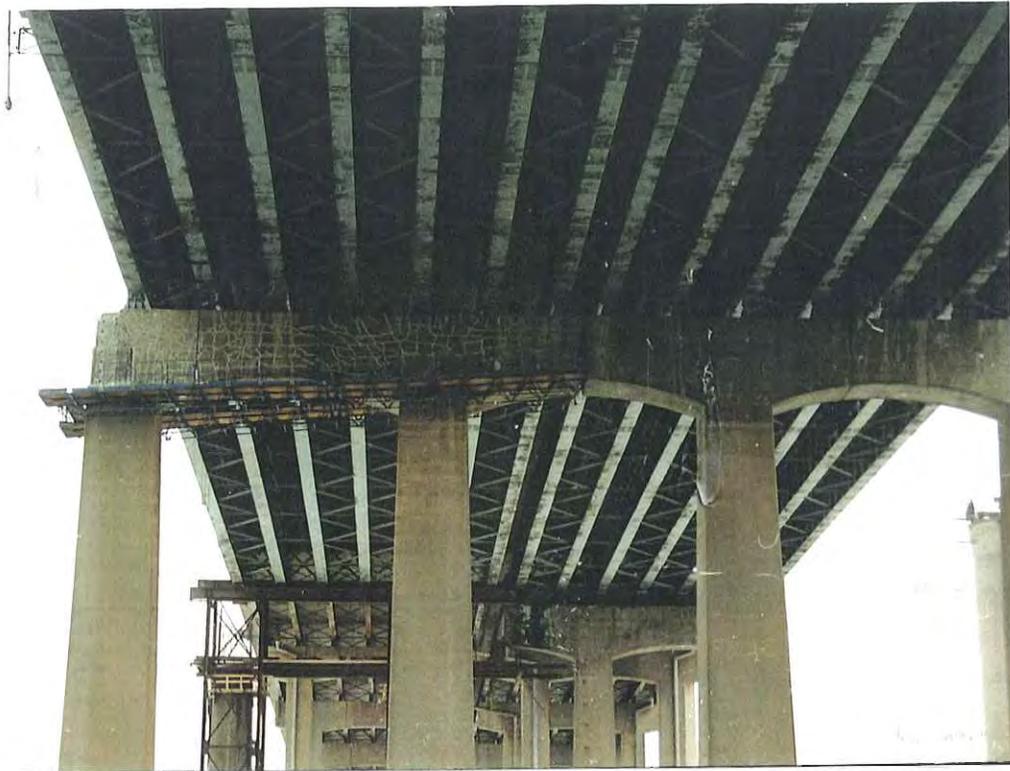
Figure 8. South face of Pier 39 south-bound. The cracks have been injected with epoxy as part of the repair procedure. The left end of the pier cap has been prepared for post-tensioning.

Cracks in the pier cap at Pier 39 south-bound had been epoxy injected as part of repairs in progress, as shown in Figures 8 and 9. Figures 9 and 10 show the locations of the cores taken in the north face of the pier cap for this project.

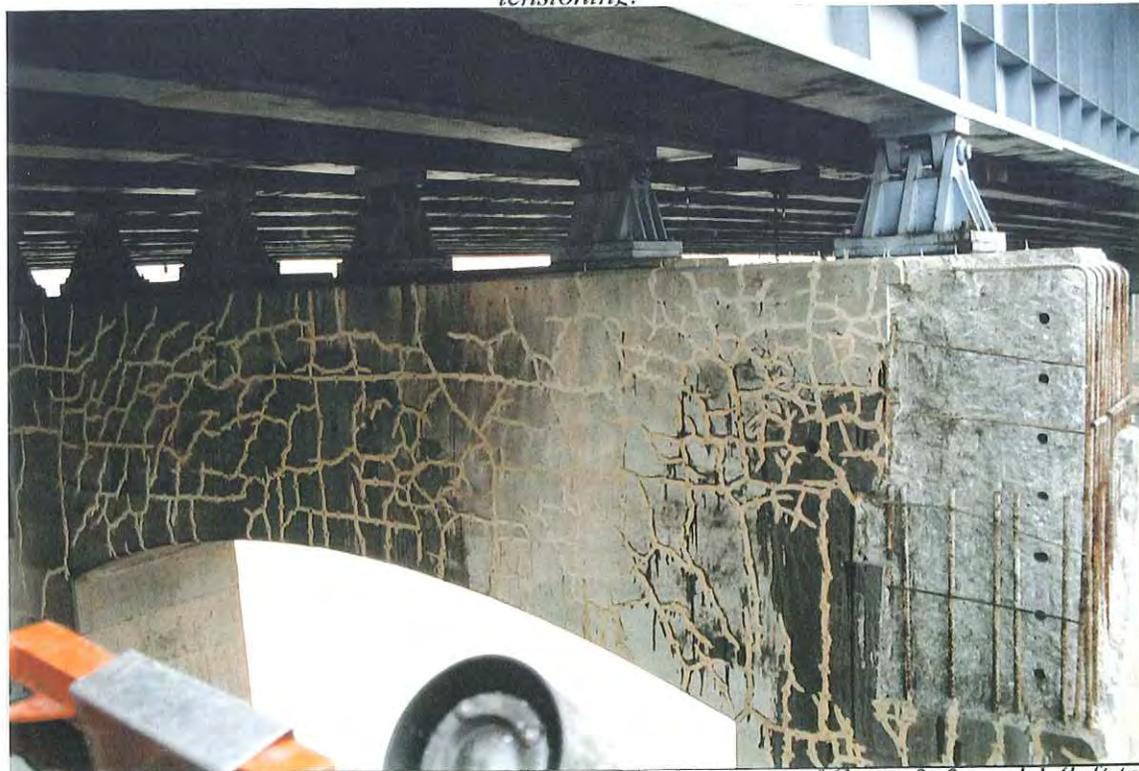
Figure 9. North face of Pier 39 south-bound. The locations of Cores 3, 2, and 1 (left to right) are shown, along with a closer view of the area prepared for post-tensioning.

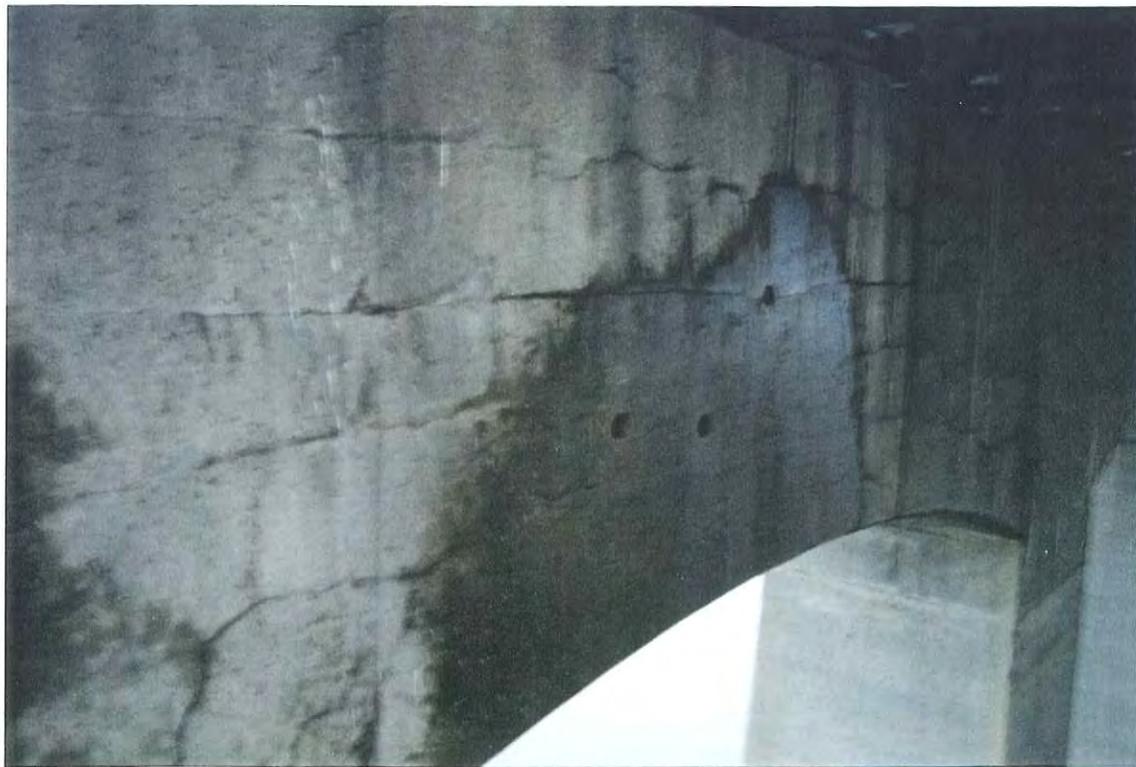
Figure 13. South Face of Pier 38 south-bound, showing all three cores.

Figures 11, 12 and 13 show the project's remaining core locations on Pier 39 north-bound, south face, Pier 38 north-bound north face, and Pier 38 south-bound south face respectively.

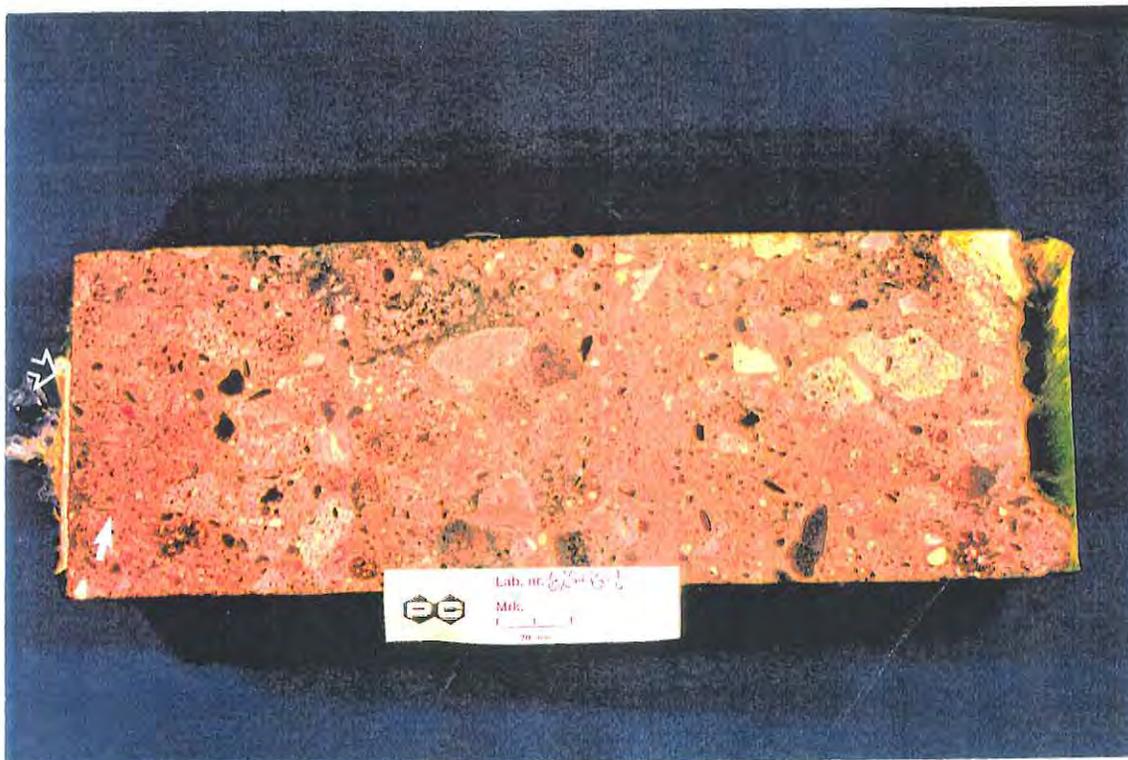
The epoxy in the two cores that were taken from injected areas did not penetrate the cracks. It should be noted that the cracks in the cored specimens were very small. It is not known how effective the injection was in the larger cracks. Figure 19 shows a pier cap sample from an epoxy injected region in Pier 39. The photo shows that there is little or no penetration of the epoxy into the small surface crack.

Figure 19. Photo of Pier 39 sample with epoxy layer present at the surface (see open arrow). The layer does not penetrate the concrete. A surface crack is present (see closed arrow).
