Appendix A.

Petrographic Reports

RE: Addendum to Petrographic Report for Michigan Department of Transportation

The following comments are provided to address questions raised in response to our previous report on the cracking of the concrete pier caps, I-75 bridge over the River Rouge in Detroit, Michigan.

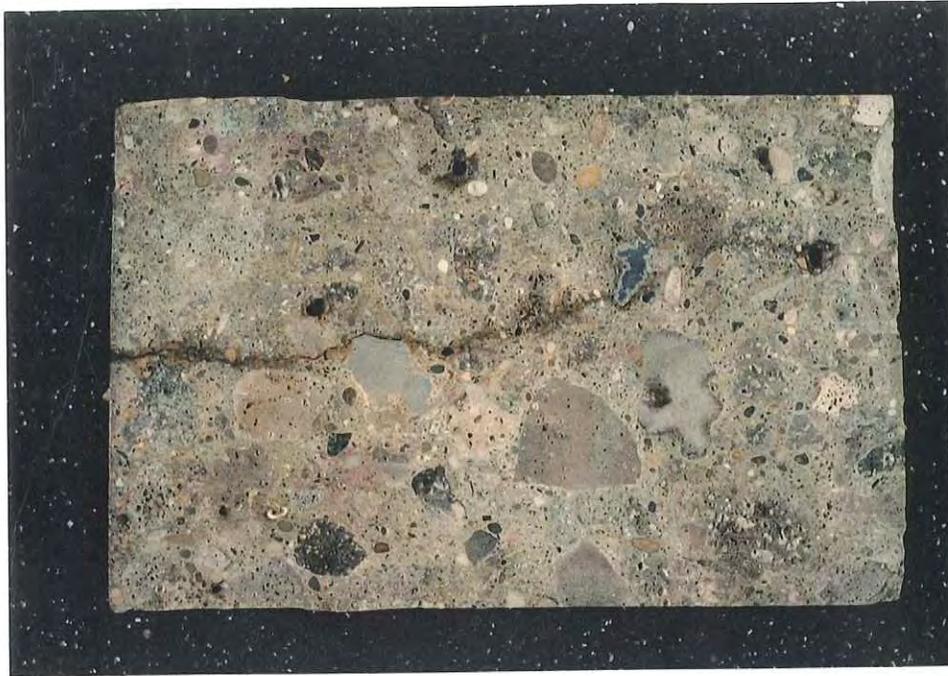
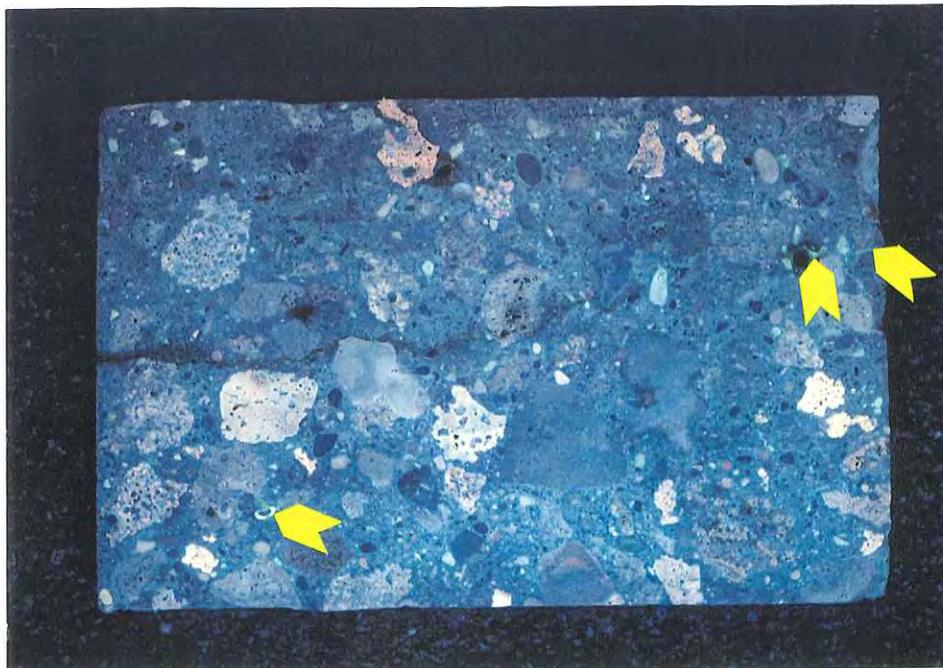
FIG. 1 PIER 39 #2 NB TREATED SAMPLE.

1a. Surface Photographed in Ordinary Light

1b. Surface Photographed in Ultraviolet Light

2. Photographs included in the August 7 report show representative lapped surfaces of longitudinally cut concrete cores treated with uranyl acetate. The method is used to screen cores for evidence of potential alkali-silica reaction products (gel). The arrows on the photographs show bright fluorescence attributed to alkali-silica gel. The amount of gel detected is very small.

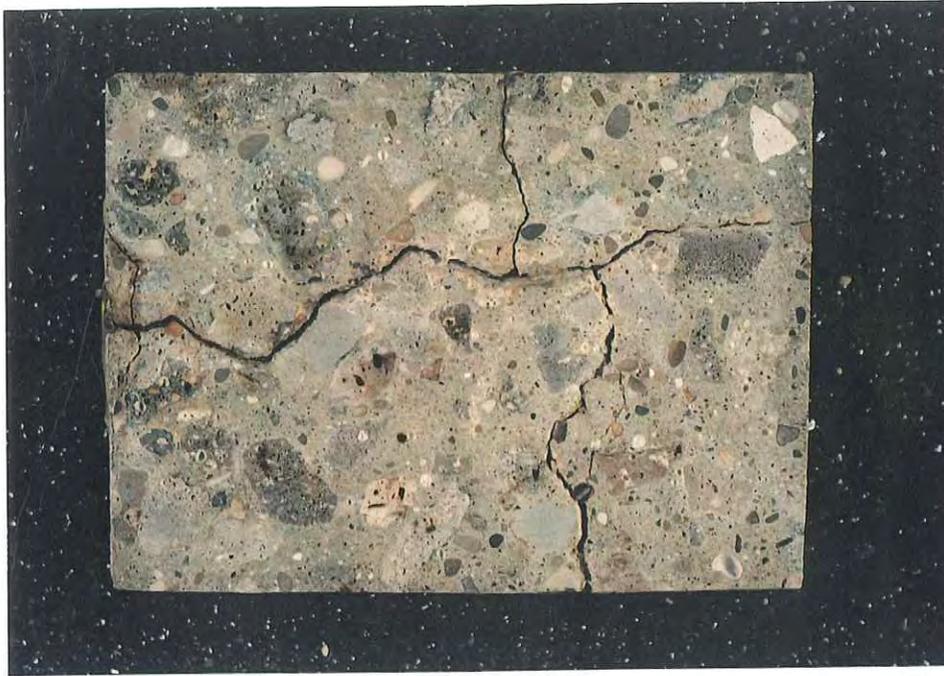
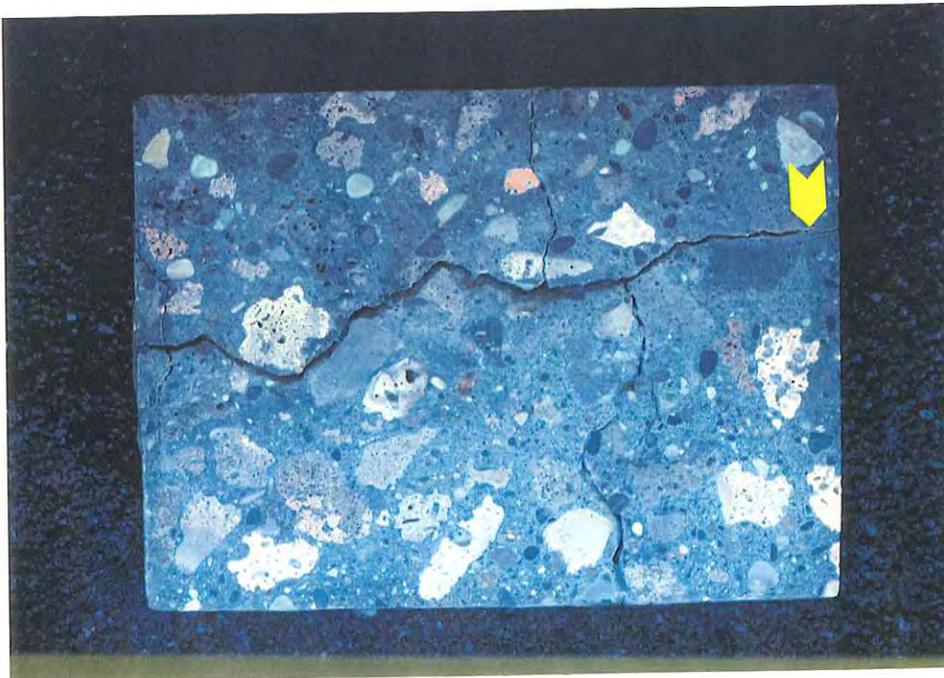
FIG. 3 PIER 38 #3 TREATED SAMPLE.

3a. Surface Photographed in Ordinary Light

3b. Surface Photographed in Ultraviolet Light

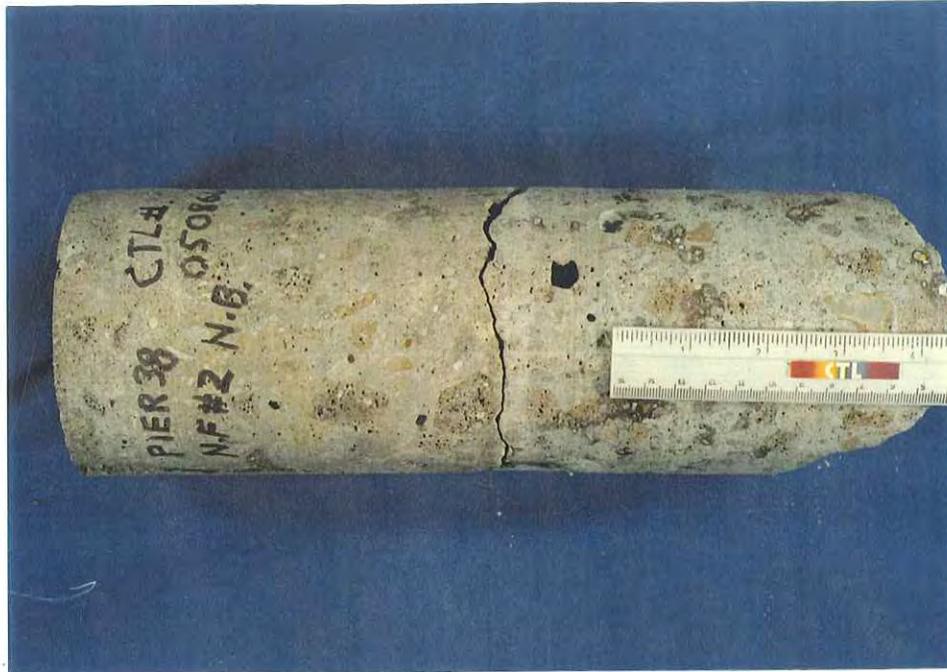
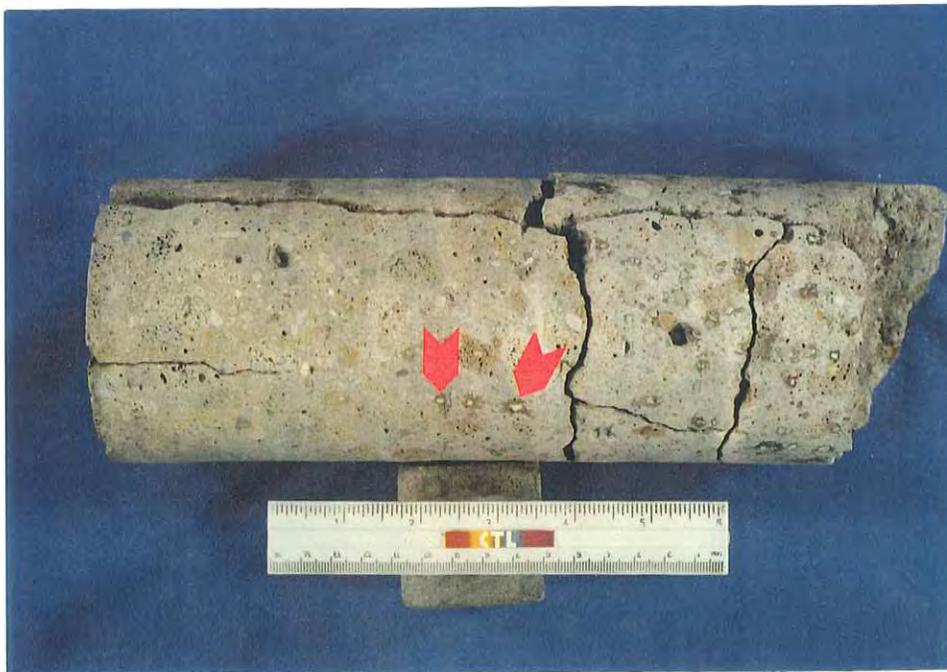
FIG. 3 TWO SIDE VIEWS OF CORE, AS RECEIVED. ARROWS SHOW FRESH ALKALI-SILICA GEL AROUND CHERT AGGREGATES.

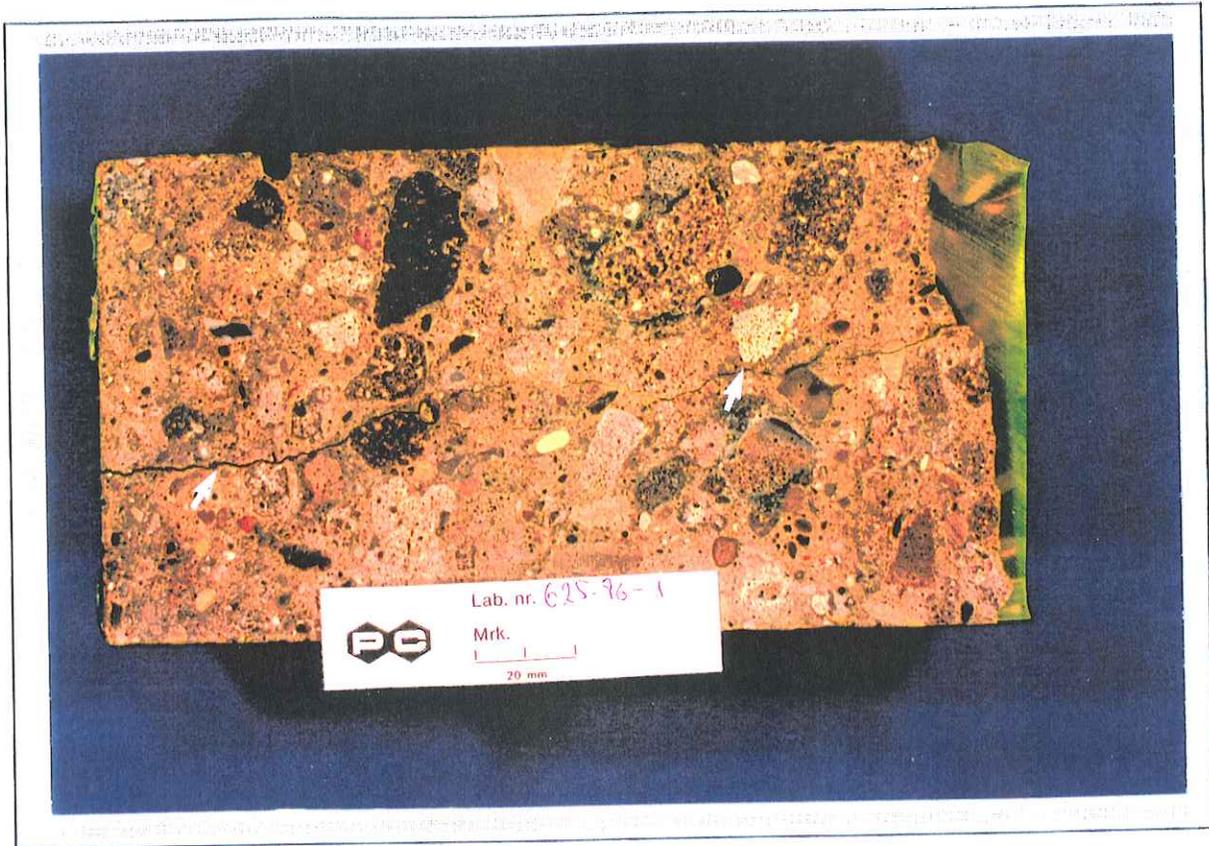
Photo 1. Macrofoto of sample 625-96-1. The concrete contains homogenous distributed slag particles in Portland cement paste. A macro crack penetrates the core perpendicular to surface.

The concrete core is penetrated by one major crack running perpendicular to the surface though sample section, see photo 1. The crack has a wide of approximately 0.5 mm at the upper approximately 50 mm and has a smooth run and do not penetrate aggregates. At lower level the cracks are narrower and aggregate grains are cut. In the fluorescence plan section the penetrating crack has a crack wide of approximately 0.5 mm through the hole section, see photo 3. In areas in upper section (marked with open arrows in photo 4) separation cracks/elongated airvoids are present. Partly cracked white particles are present (marked with closed arrows) and cracks are penetrating into the cementpaste. Coarse and fine cracks are detected in adhesion zone between aggregate and cementpaste (marked with small closed arrow). In areas slag particles are penetrated by cracks as well.

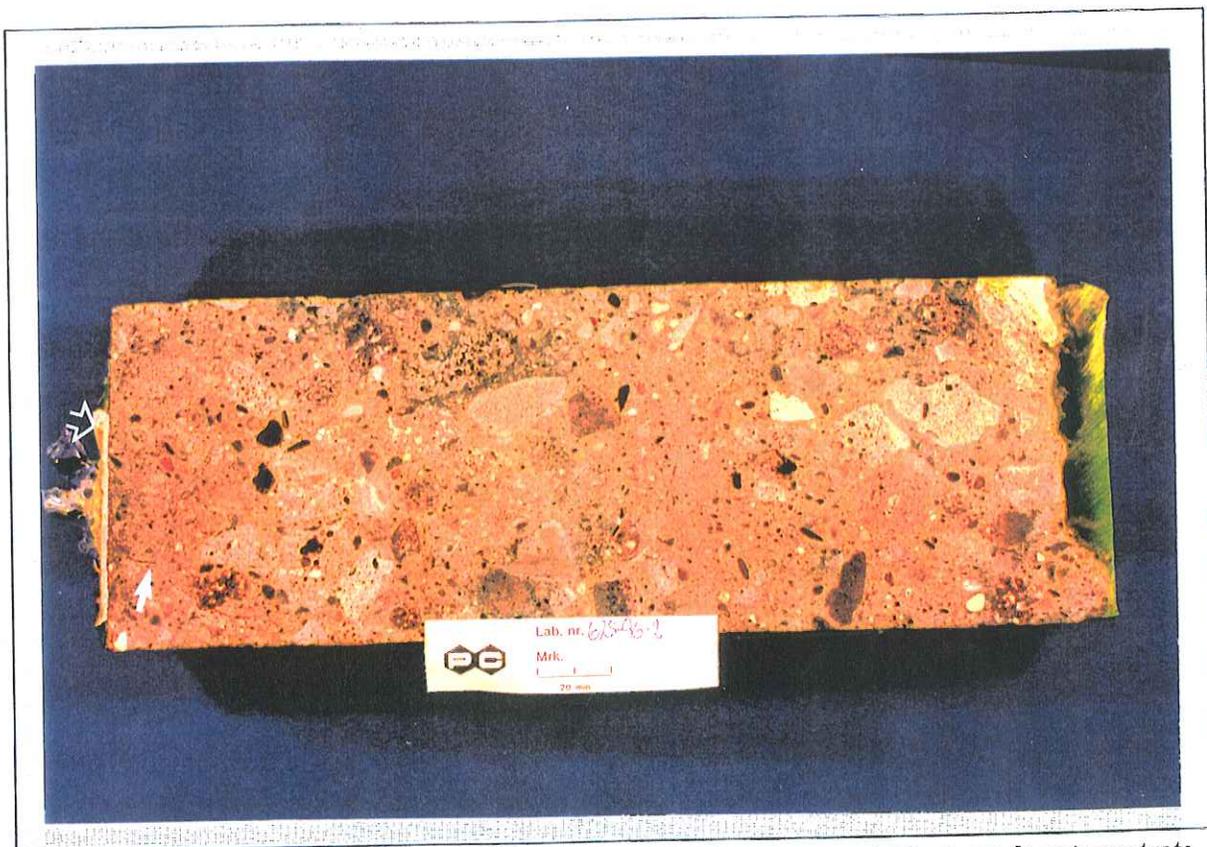
Photo 2. Macrofoto of sample 625-96-2. At surface grey epoxy layer is present. The layer do not penetrate the concrete. Surface crack is present, see arrow.

At upper surface a light approximately 2 mm thick layer is present. The layer is only present at surface and do not enter cracks at surface, see photo 2.

At concrete surface two cracks running perpendicular to the surface to a depth of approximately 40 - 50 mm, see photo 2. The cracks have a wide of approximately 0.2 mm and do cut some aggregates. In the fluorescence plan section only one crack at surface is detected, see photo 5. Fine cracks are detected in cement paste and in adhesion zone between aggregate and cementpaste.
