Appendix E
US23 SHRP Section 19 Core Site

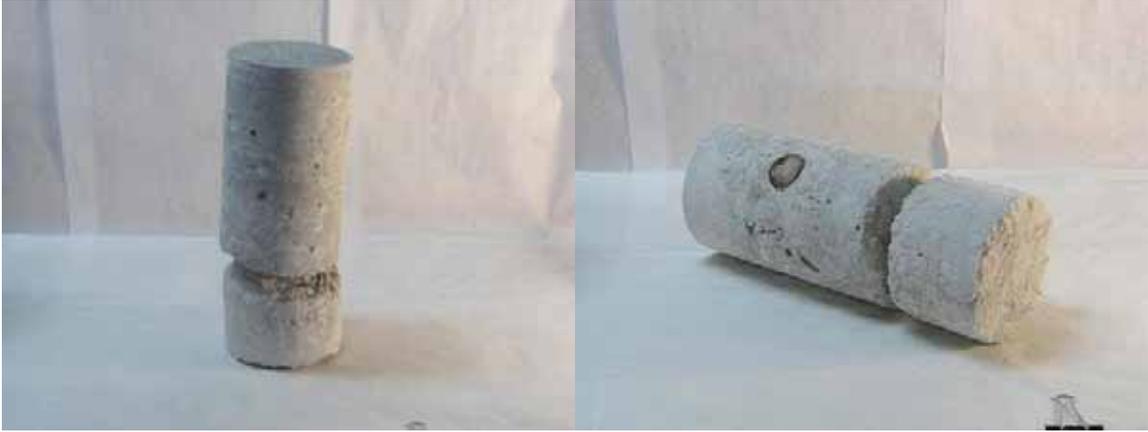
NB US23, section 19, station 341+00, at joint, (MTU ID US23-05).

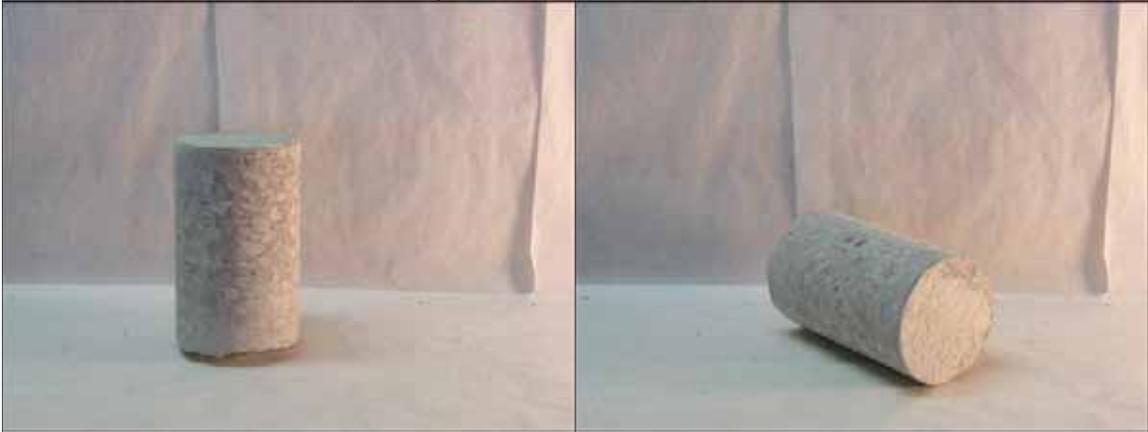
NB US23, section 19, station 341+15, "edge", (MTU ID US23-01).

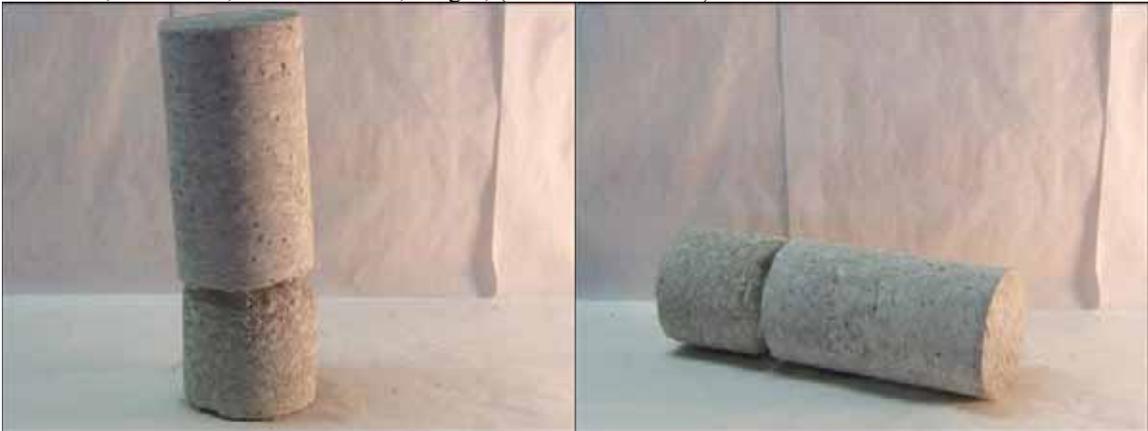
NB US23, section 19, station 341+09, "6 ft. from edge", (MTU ID US23-03).

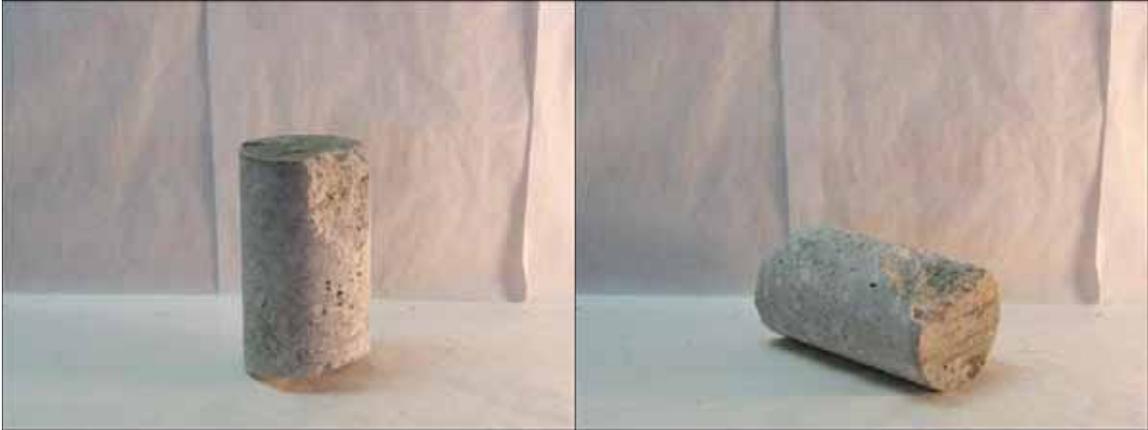
NB US23, section 19, station 341+15, "7 ft. from edge", (MTU ID US23-04).

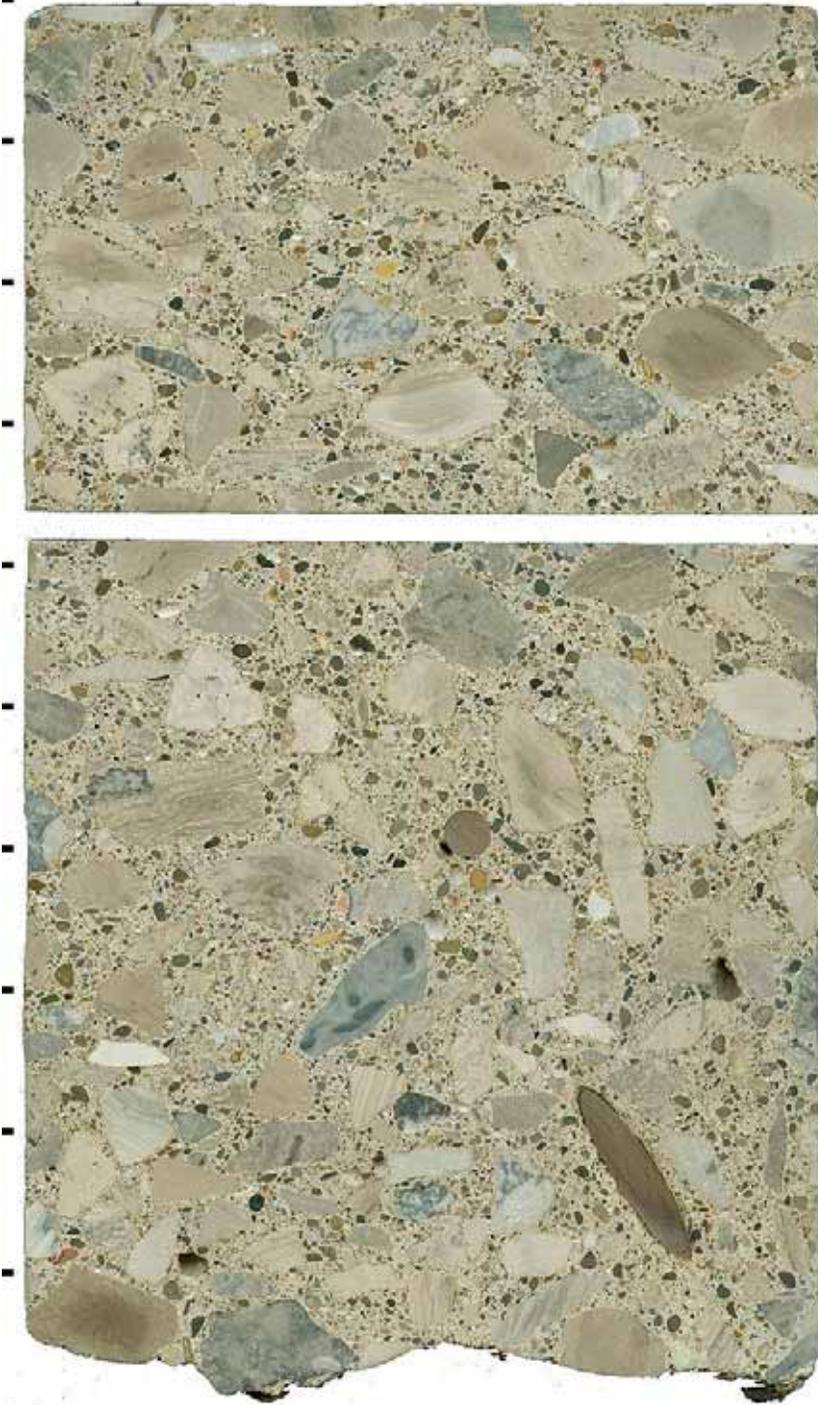
Slabs representing full cross section through pavement, as polished, NB US23, Section 19, constructed 1993, station 341+00, at transverse joint, MTU ID US23-05, tic marks every inch.

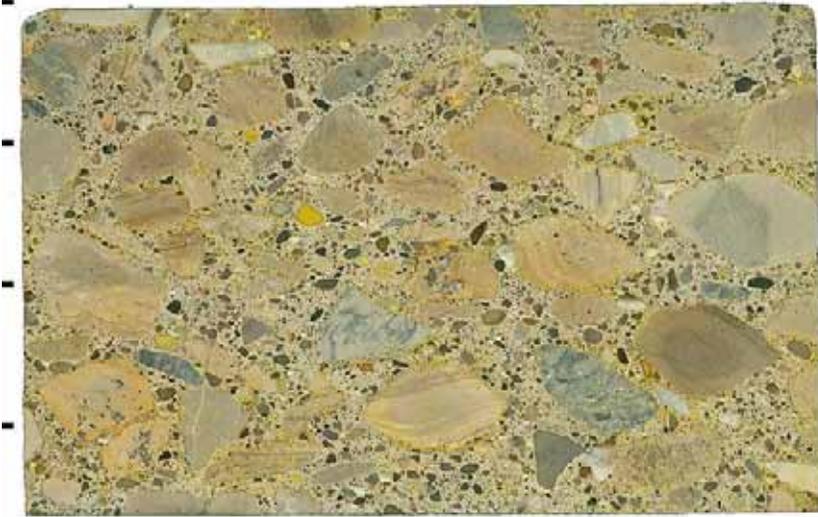
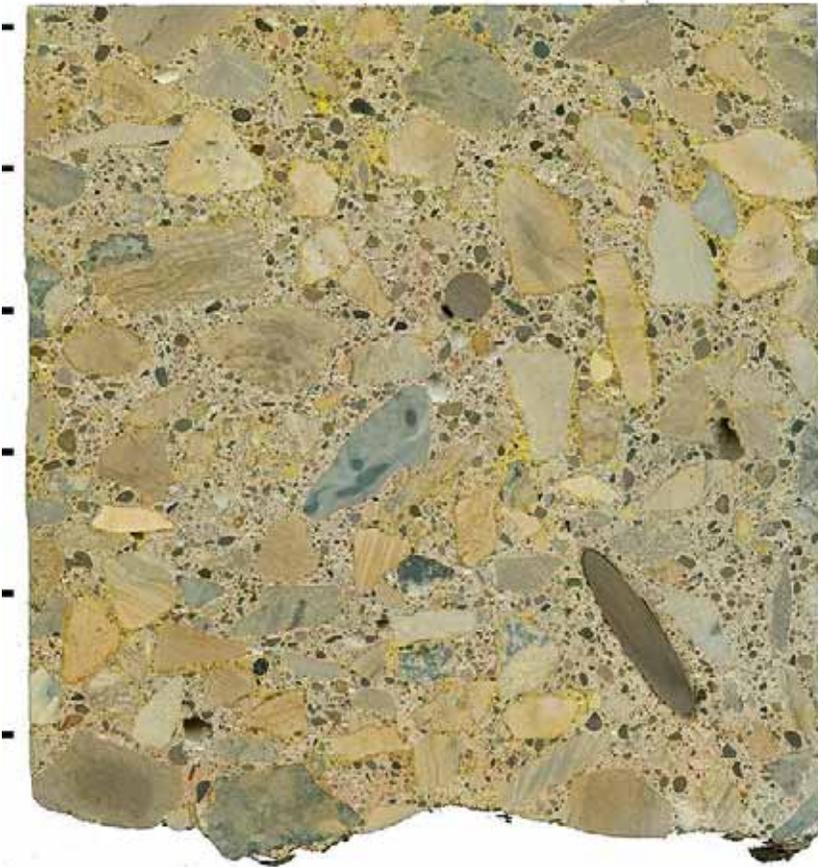
Slabs representing full cross section through pavement, after sodium cobaltinitrite stain, NB US23, Section 19, constructed 1993, station 341+00, at transverse joint, MTU ID US23-05, tic marks every inch.

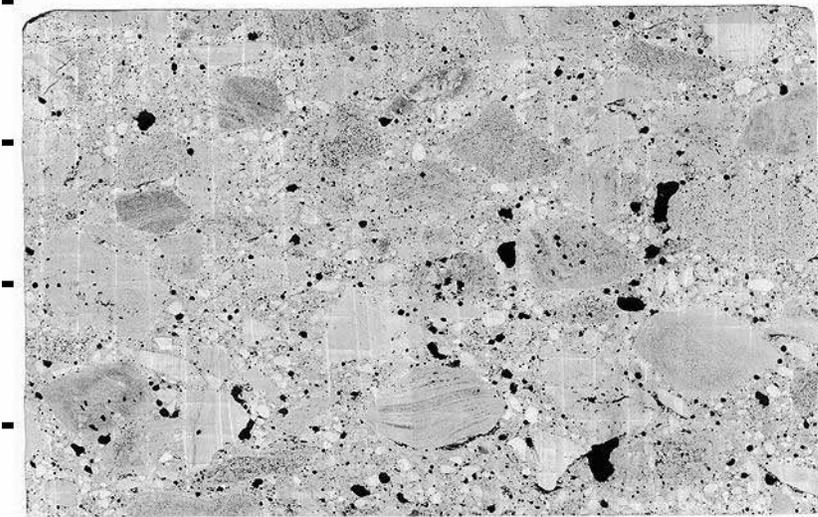
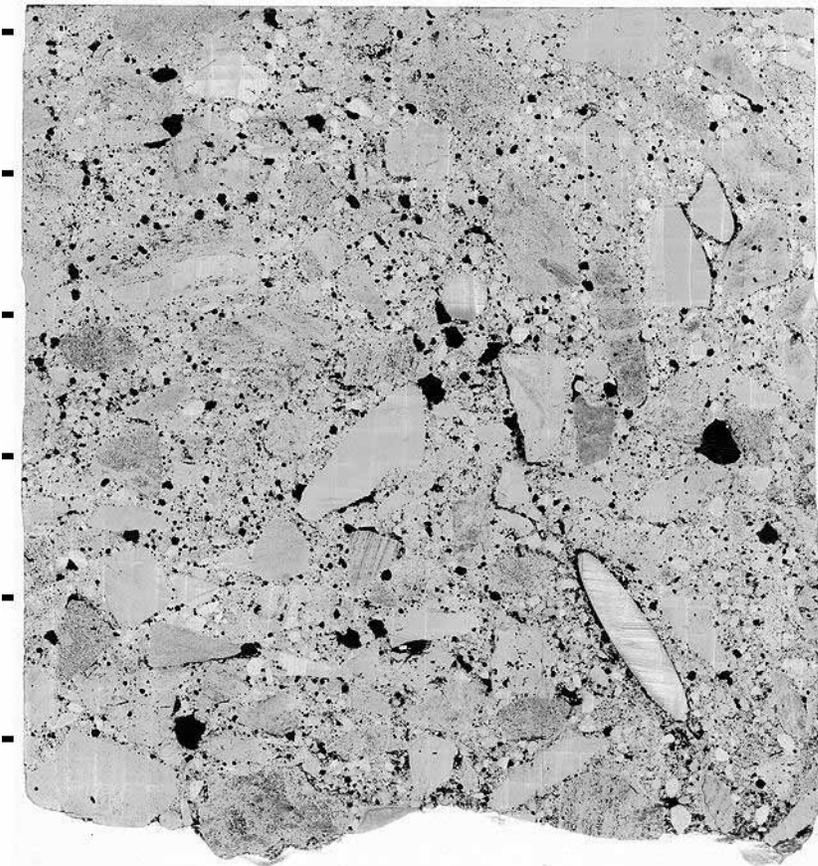
Slabs representing full cross section through pavement, after treatment to enhance air voids and cracks, NB US23, Section 19, constructed 1993, station 341+00, at transverse joint, MTU ID US23-05, tic marks every inch.

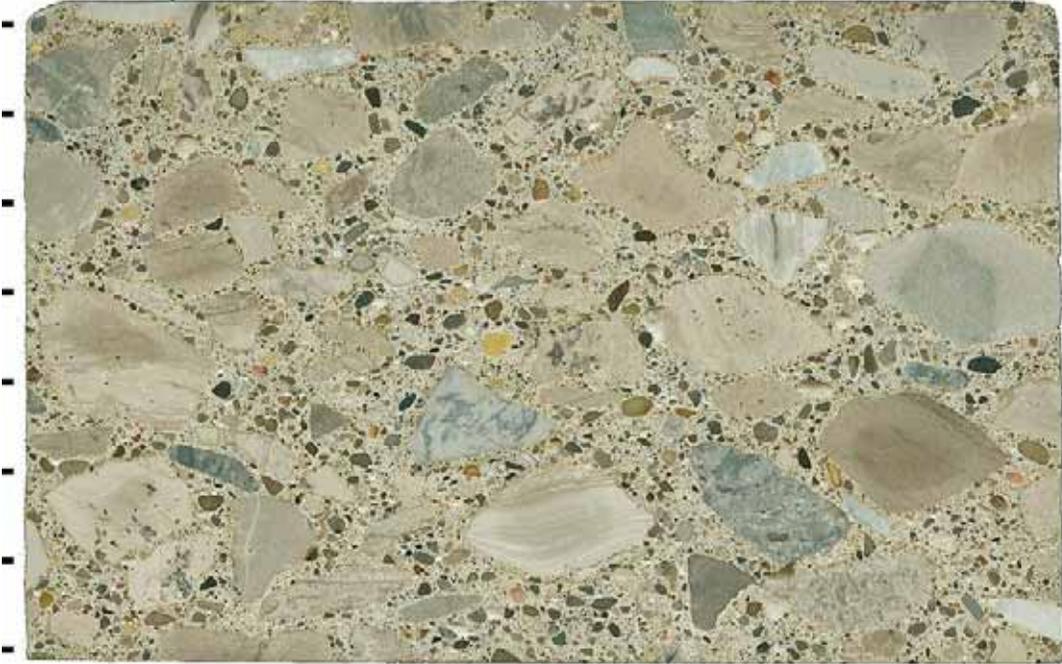
Slab representing cross section through top half of pavement, as polished, NB US23, Section 19, constructed 1993, station 341+00, at transverse joint, MTU ID US23-05, tic marks every half inch.

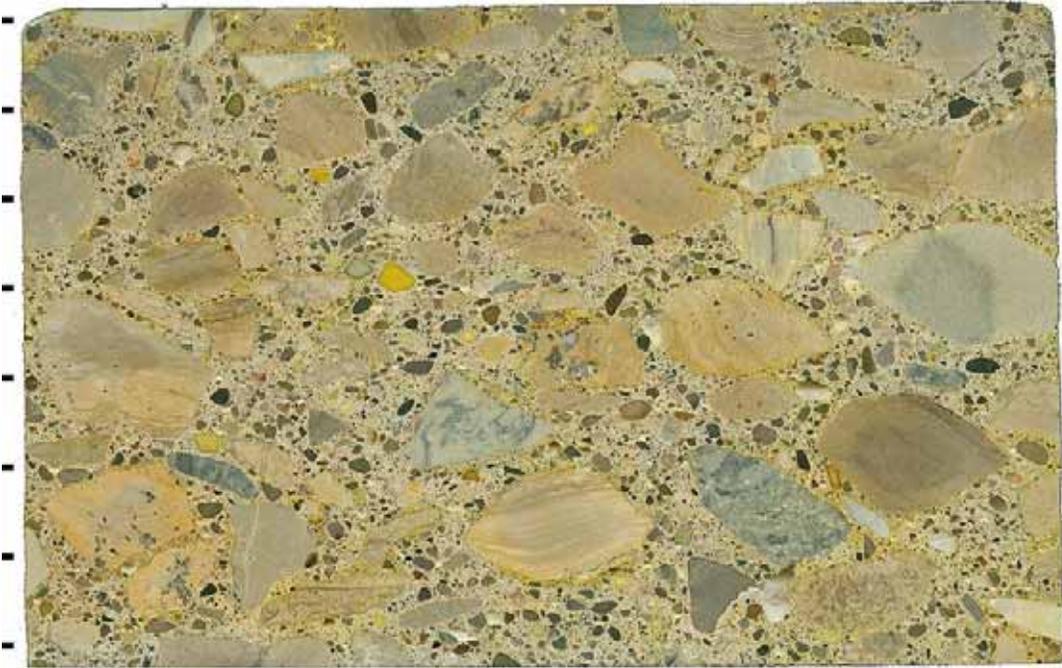
Slab representing cross section through top half of pavement, after sodium cobaltinitrite stain, NB US23, Section 19, constructed 1993, station 341+00, at transverse joint, MTU ID US23-05, tic marks every half inch.

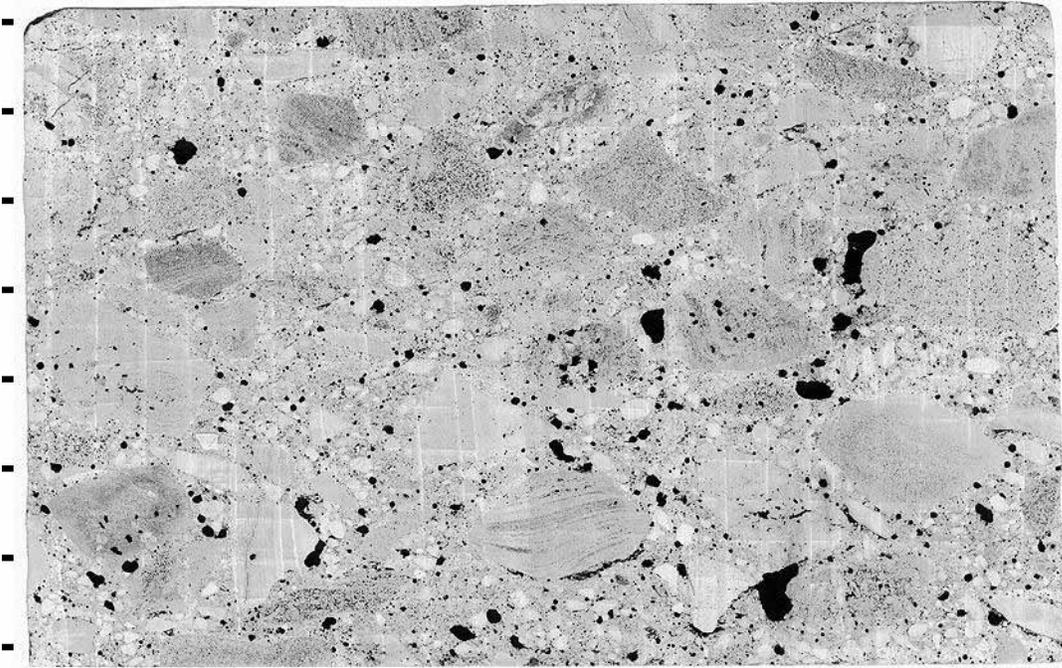
Slab representing cross section through top half of pavement, after treatment to enhance air voids and cracks, NB US23, Section 19, constructed 1993, station 341+00, at transverse joint, MTU ID US23-05, tic marks every half inch.

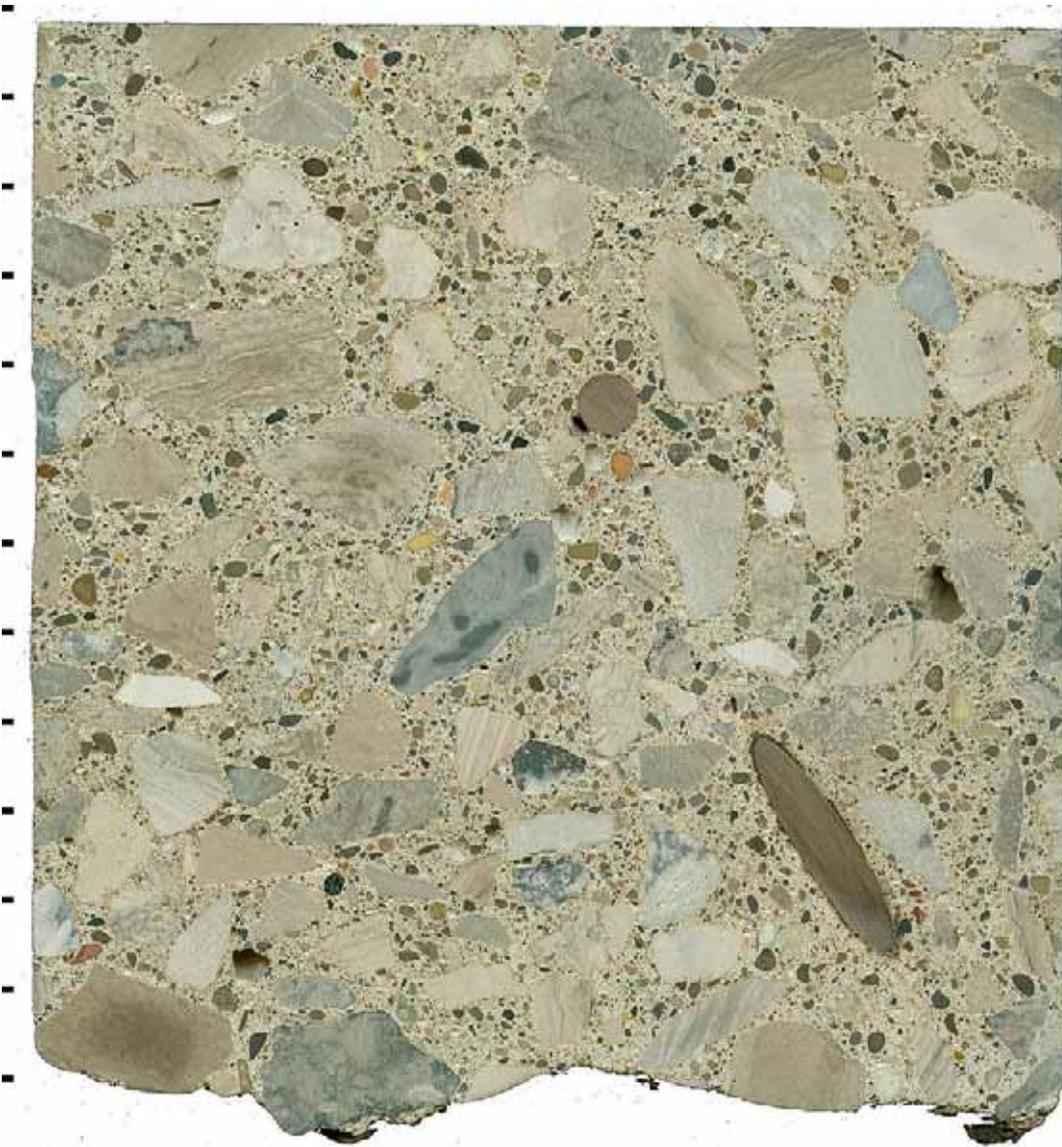
Slab representing cross section through bottom half of pavement, as polished, NB US23, Section 19, constructed 1993, station 341+00, at transverse joint, MTU ID US23-05, tic marks every half inch.

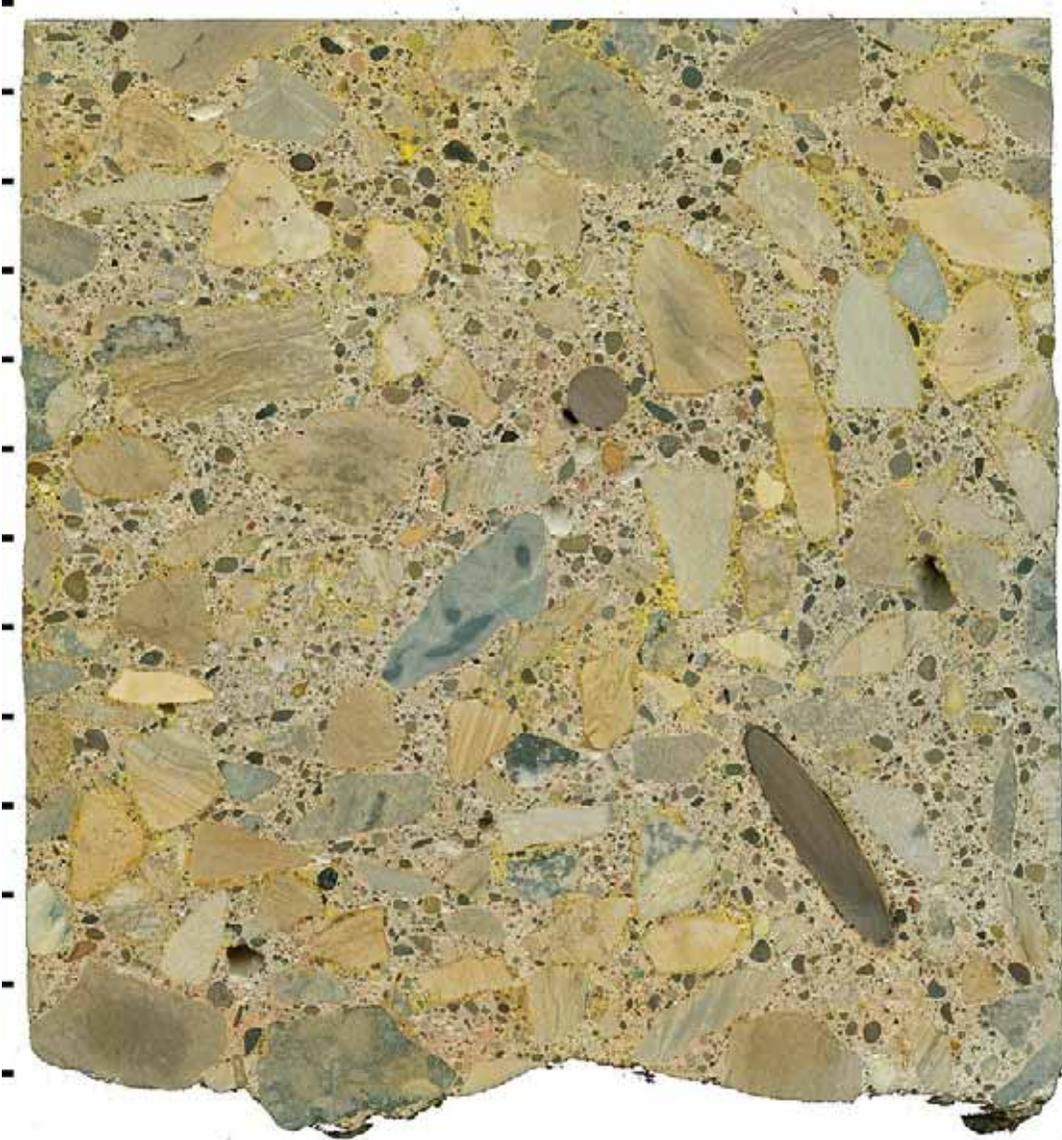
Slab representing cross section through top half of pavement, after sodium cobaltinitrite stain, NB US23, Section 19, constructed 1993, station 341+00, at transverse joint, MTU ID US23-05, tic marks every half inch.

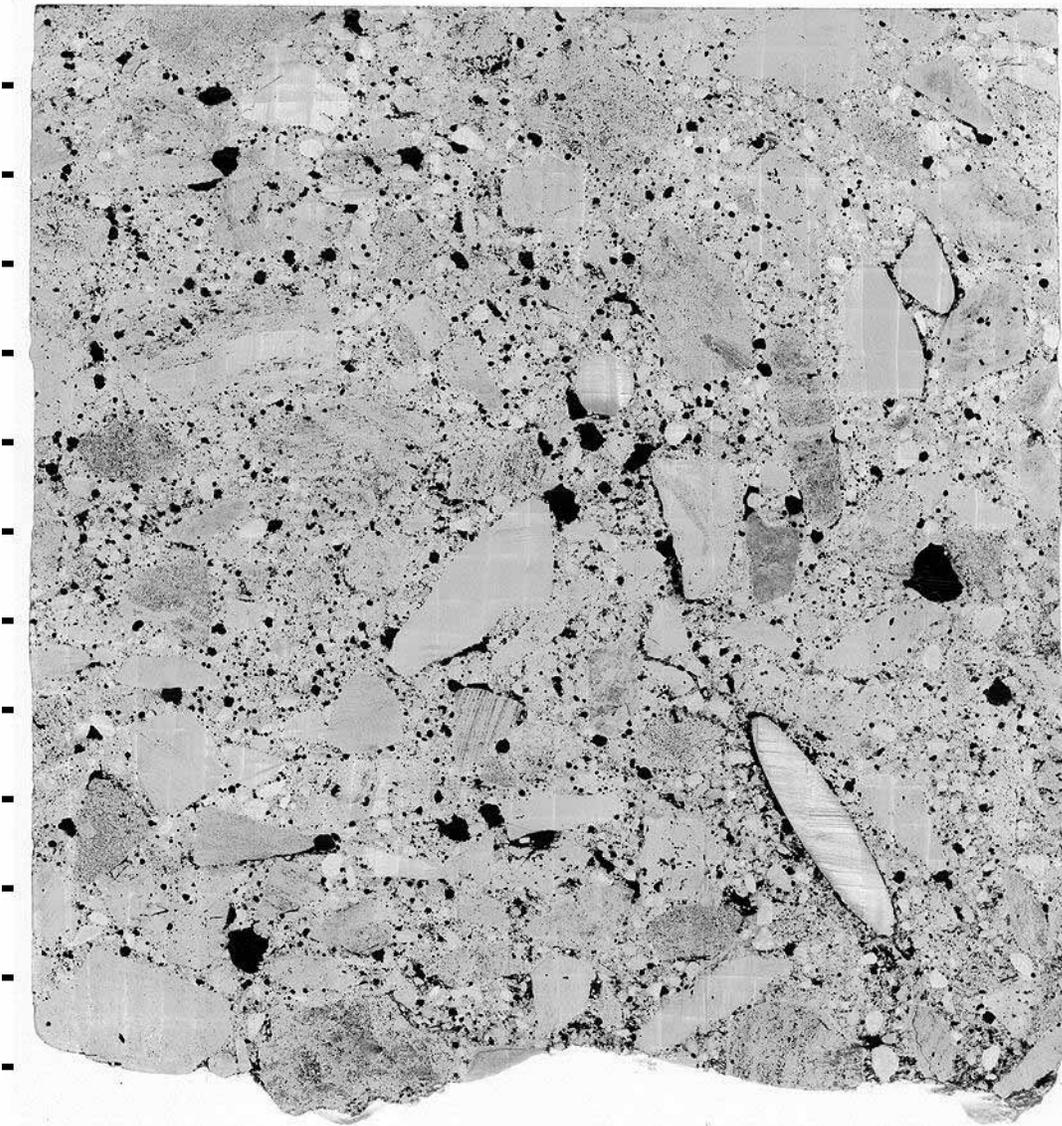
Slab representing cross section through top half of pavement, after treatment to enhance air voids and cracks, NB US23, Section 19, constructed 1993, station 341+00, at transverse joint, MTU ID US23-05, tic marks every half inch.

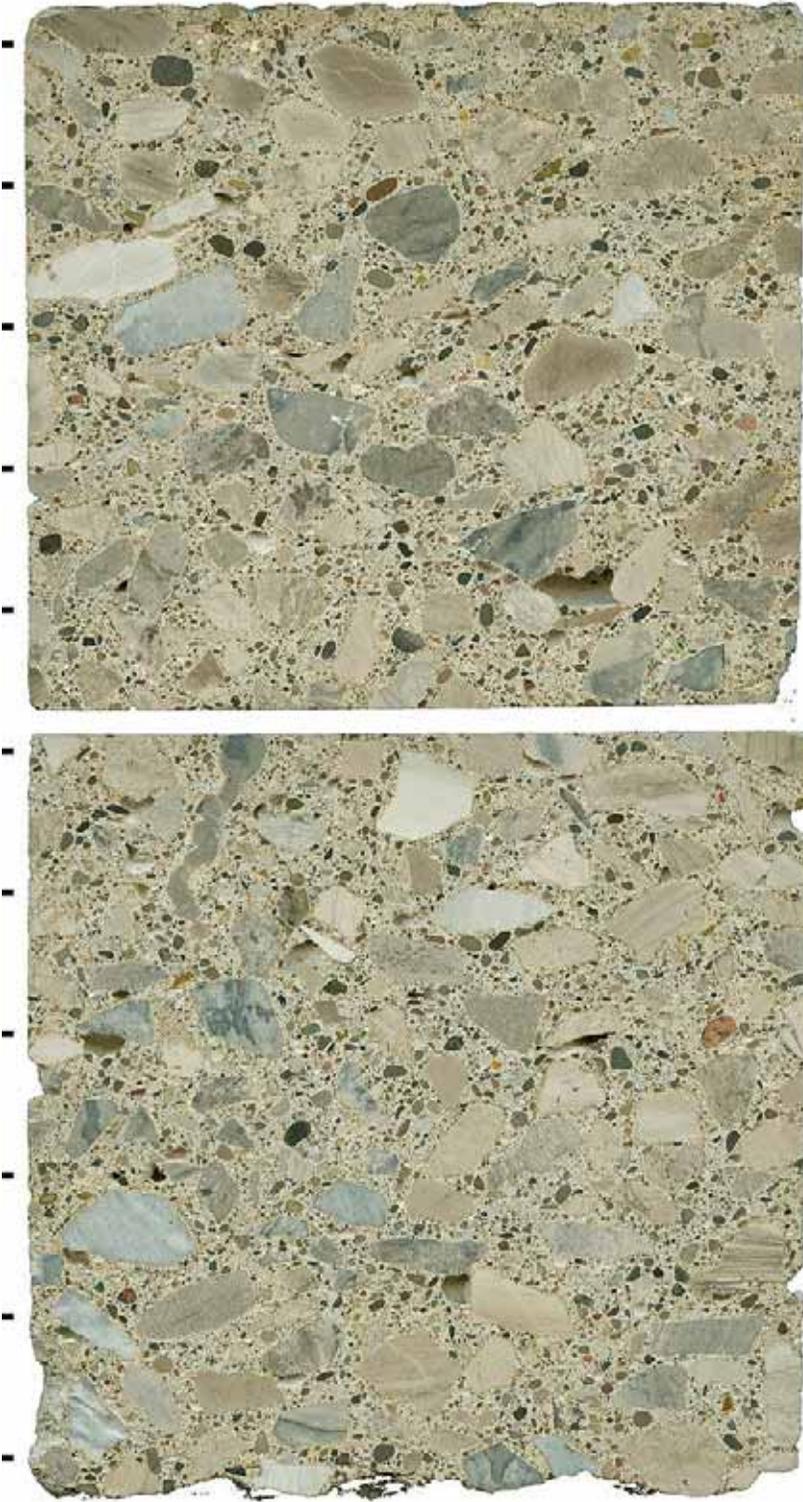
Slabs representing full cross section through pavement, as polished, NB US23, Section 19, constructed 1993, station 341+09, away from transverse joint, MTU ID US23-03, tic marks every inch.

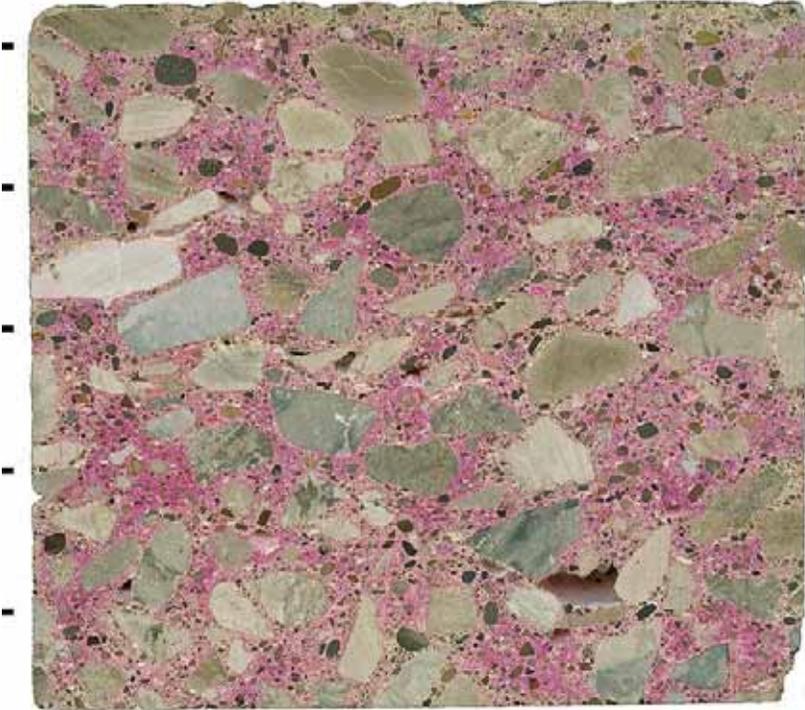
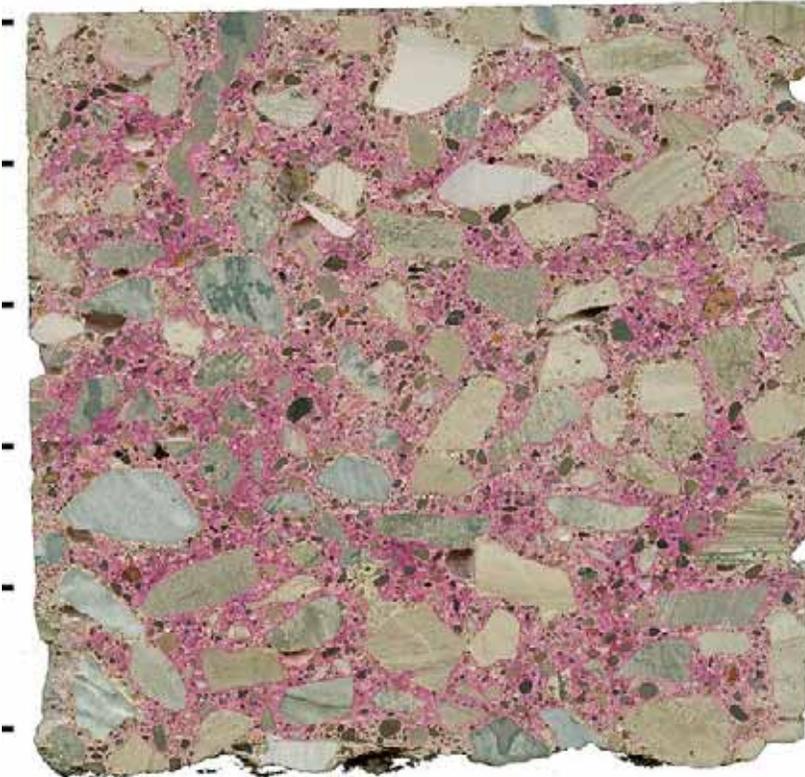
Slabs representing full cross section through pavement, after phenolphthalein stain, NB US23, Section 19, constructed 1993, station 341+09, away from transverse joint, MTU ID US23-03, tic marks every inch.

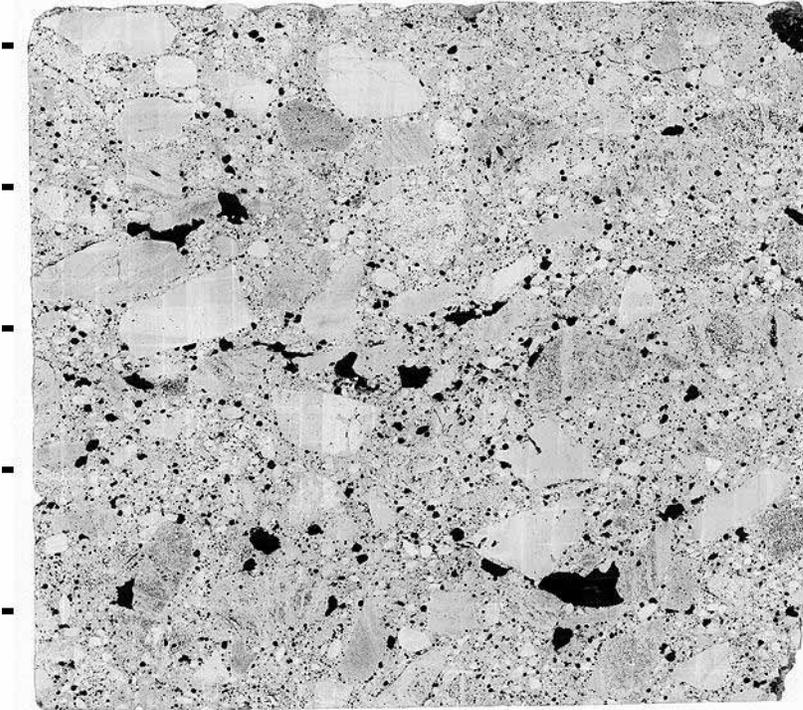
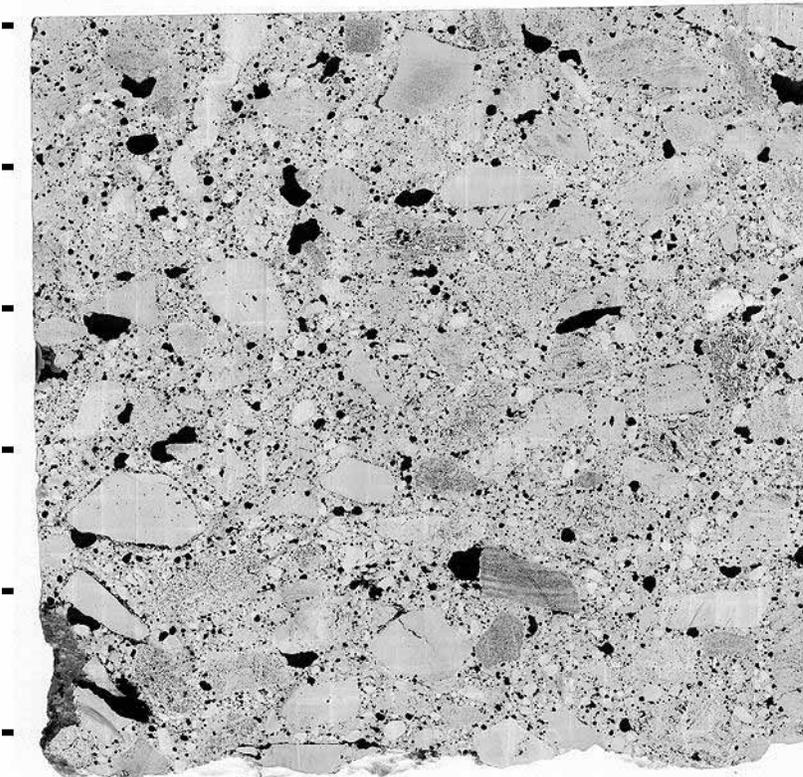
Slabs representing full cross section through pavement, after treatment to enhance air voids and cracks, NB US23, Section 19, constructed 1993, station 341+09, away from transverse joint, MTU ID US23-03, tic marks every inch.

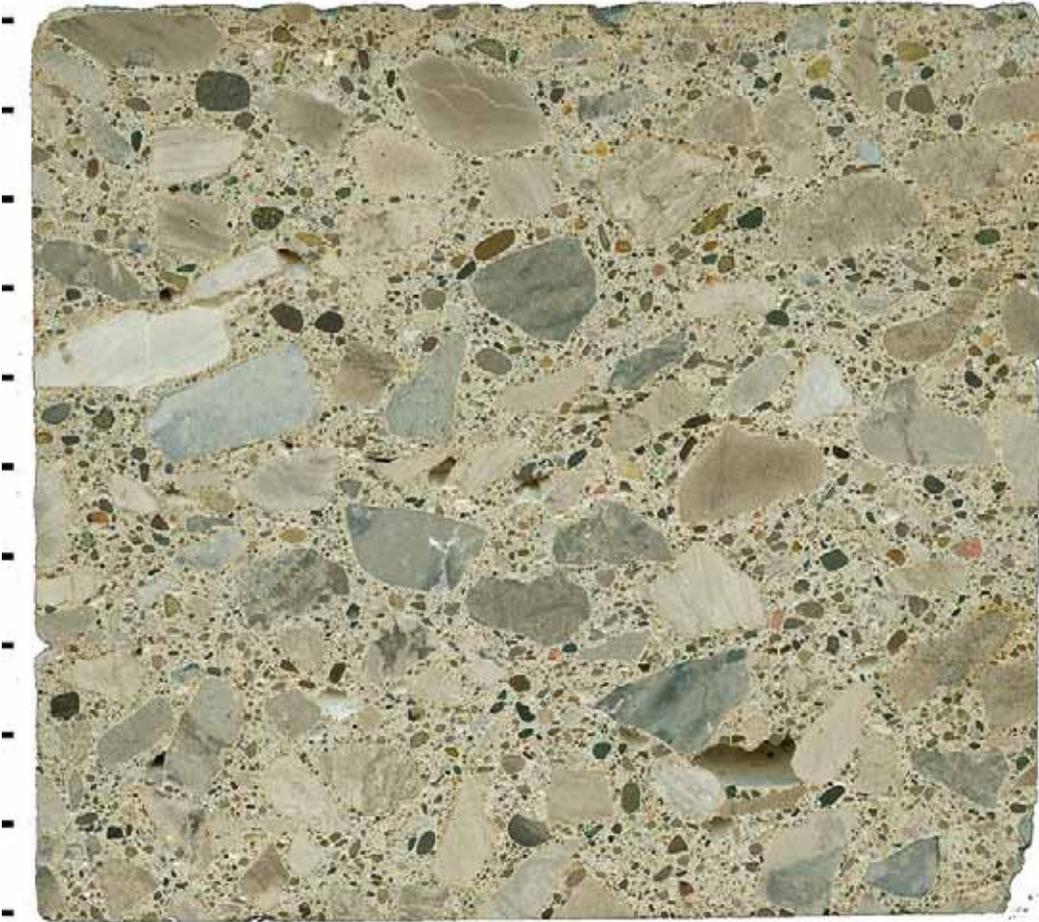
Slab representing cross section through top half of pavement, as polished, NB US23, Section 19, constructed 1993, station 341+09, away from transverse joint, MTU ID US23-03, tic marks every half inch.

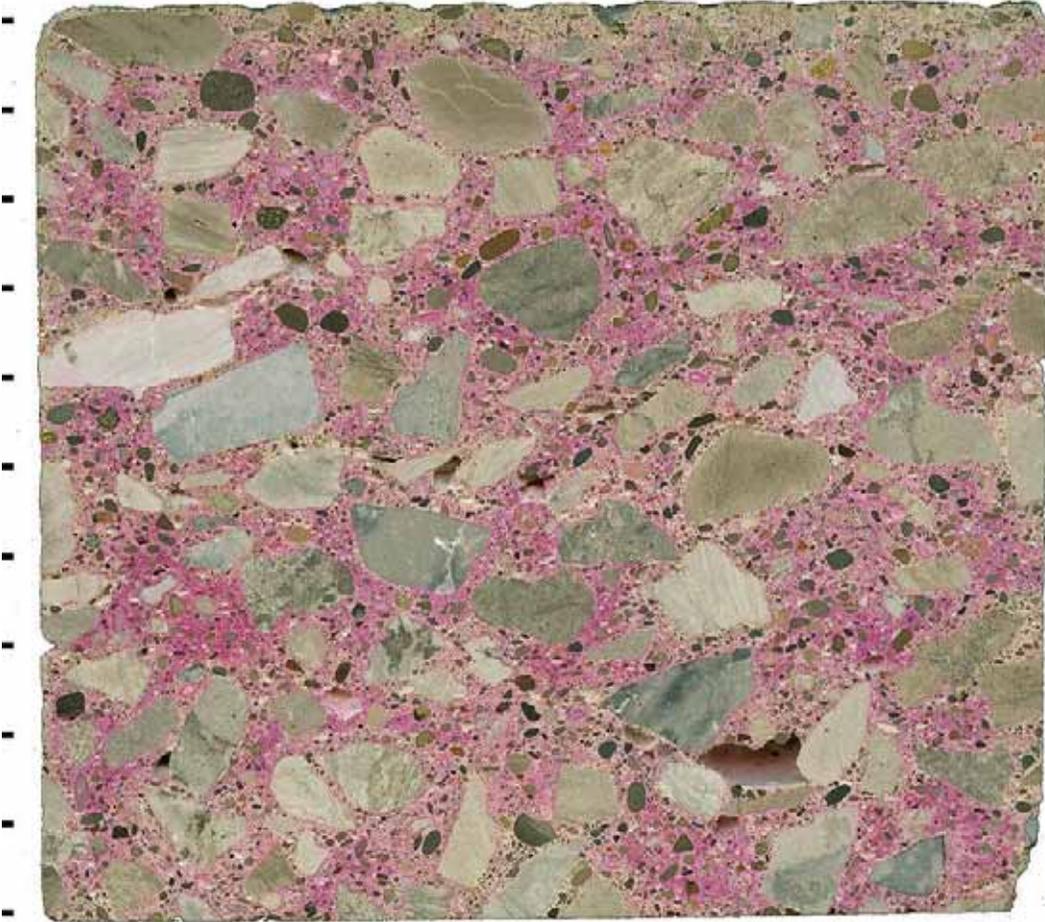
Slab representing cross section through top half of pavement, after phenolphthalein stain, NB US23, Section 19, constructed 1993, station 341+09, away from transverse joint, MTU ID US23-03, tic marks every half inch.

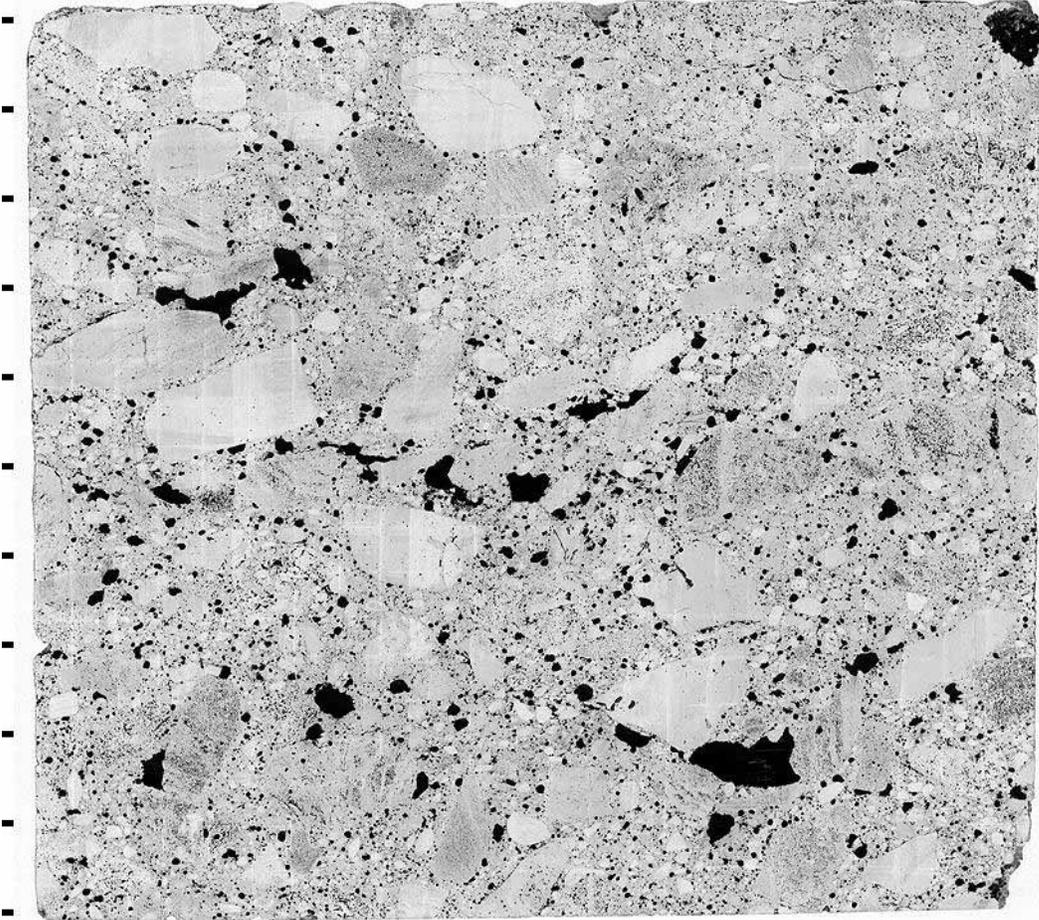
Slab representing cross section through top half of pavement, after treatment to enhance air voids and cracks, NB US23, Section 19, constructed 1993, station 341+09, away from transverse joint, MTU ID US23-03, tic marks every half inch.

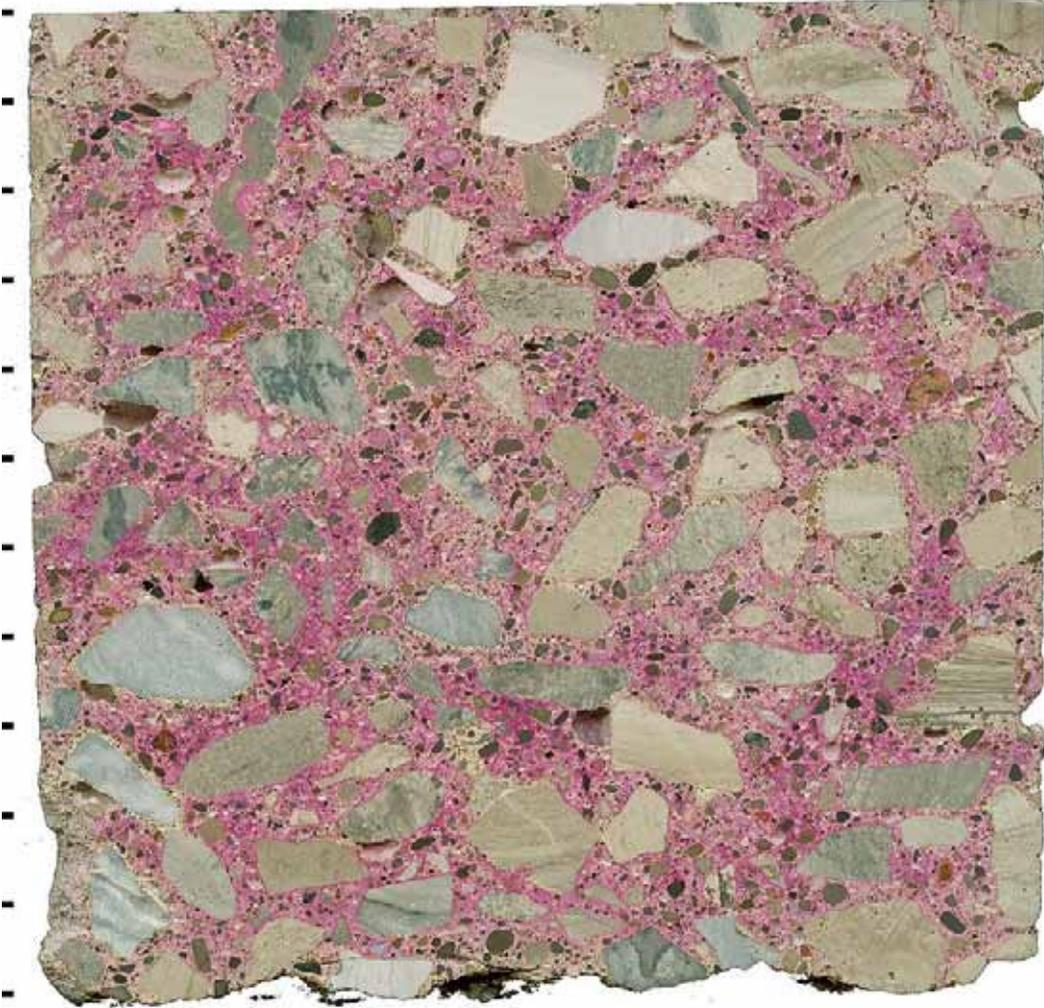
Slab representing cross section through top half of pavement, after phenolphthalein stain, NB US23, Section 19, constructed 1993, station 341+09, away from transverse joint, MTU ID US23-03, tic marks every half inch.

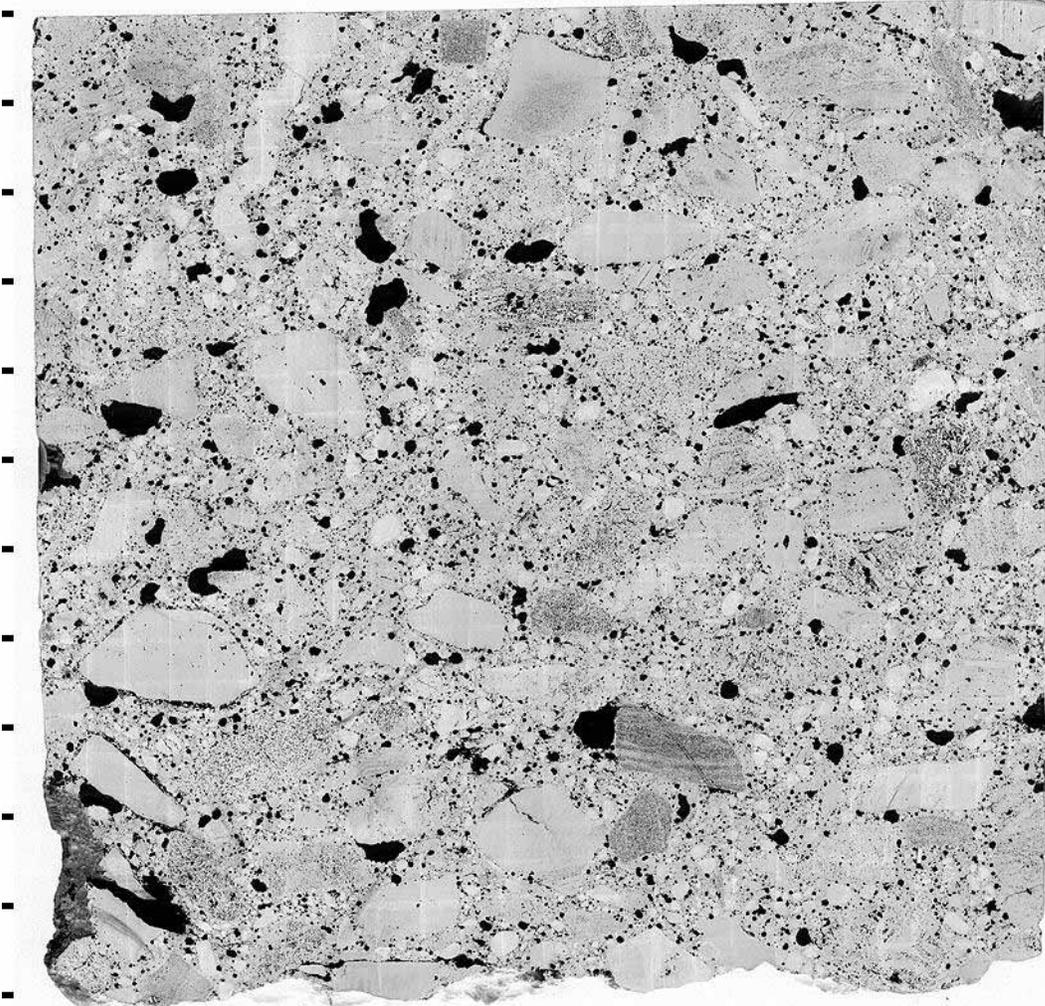
Slab representing cross section through top half of pavement, after treatment to enhance air voids and cracks, NB US23, Section 19, constructed 1993, station 341+09, away from transverse joint, MTU ID US23-03, tic marks every half inch.

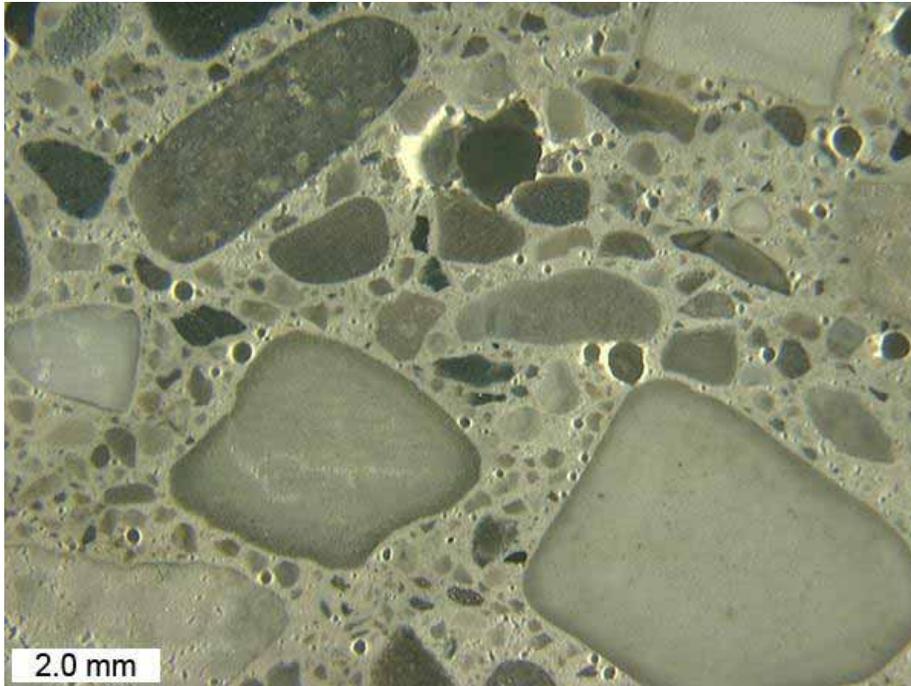
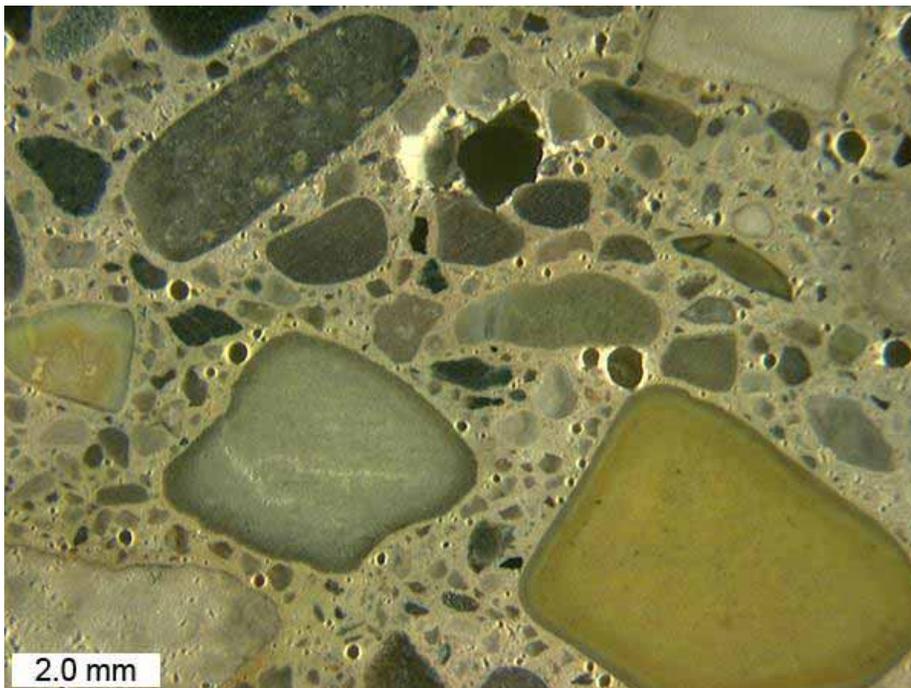
Fine aggregate particles with darkened rims in contact with the cement paste, before and after sodium cobaltinitrite stain, polished slab from NB US23, Section 19, constructed 1993, at transverse joint, top half of core, MTU ID US23-05.
