Appendix E
US23 SHRP Section 19 Core Site

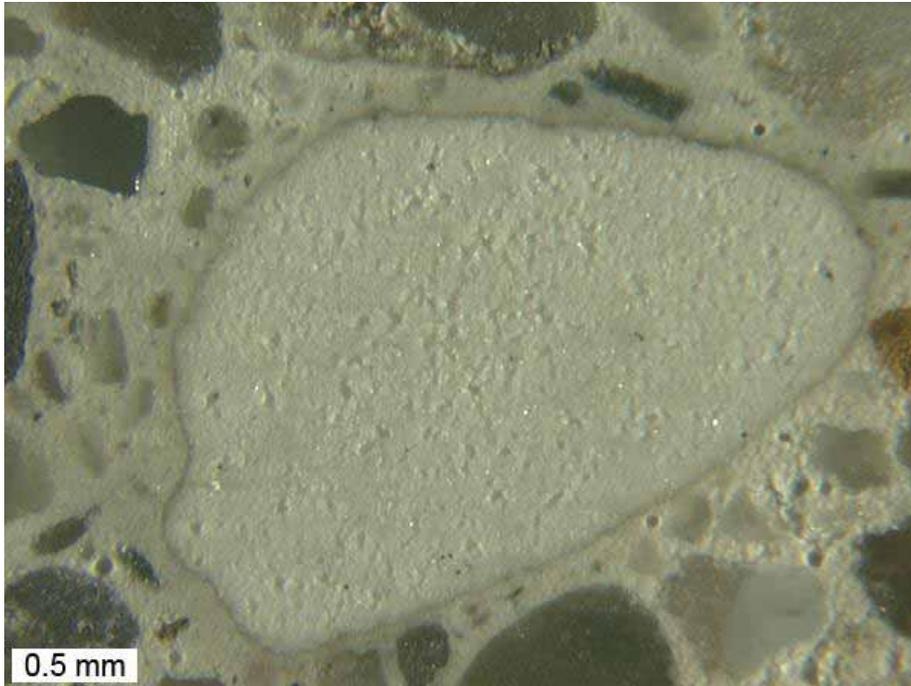
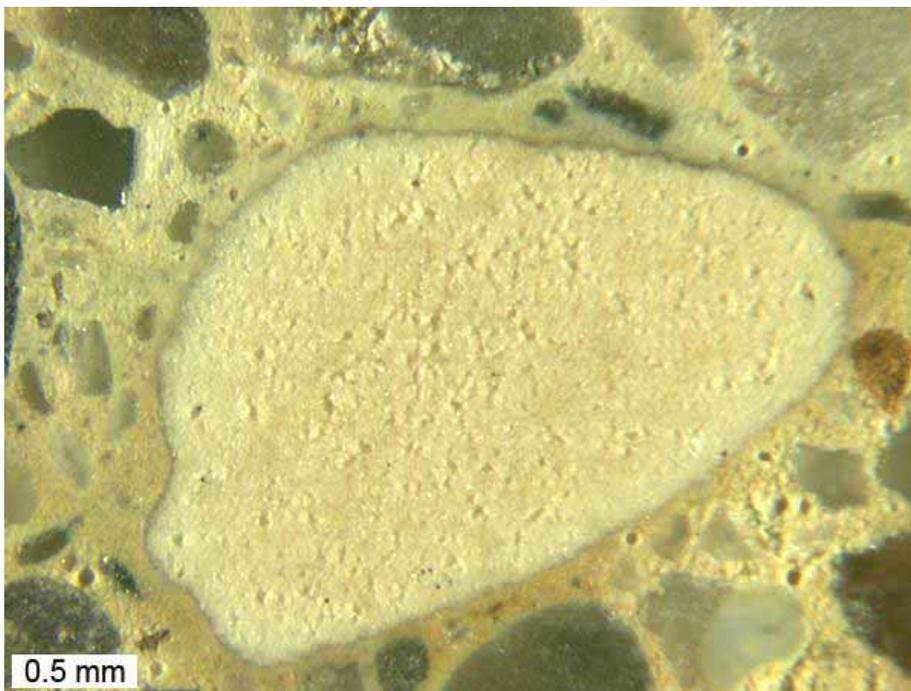
Coarse aggregate particle with darkened rim in contact with the cement paste, without cracking, before and after sodium cobaltinitrite stain, polished slab from NB US23, Section 19, constructed 1993, at transverse joint, top half of core, MTU ID US23-05.

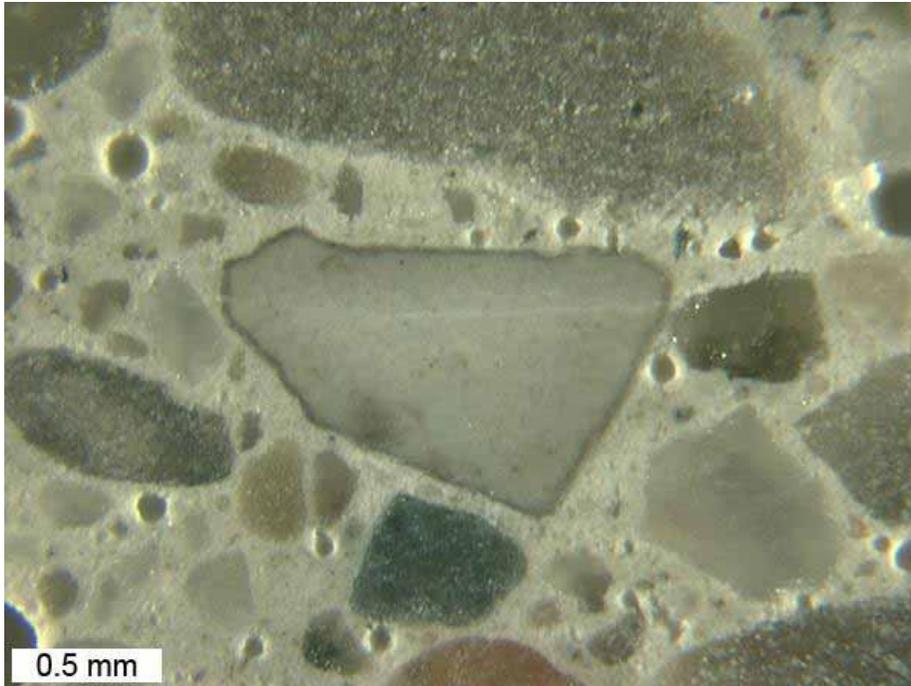
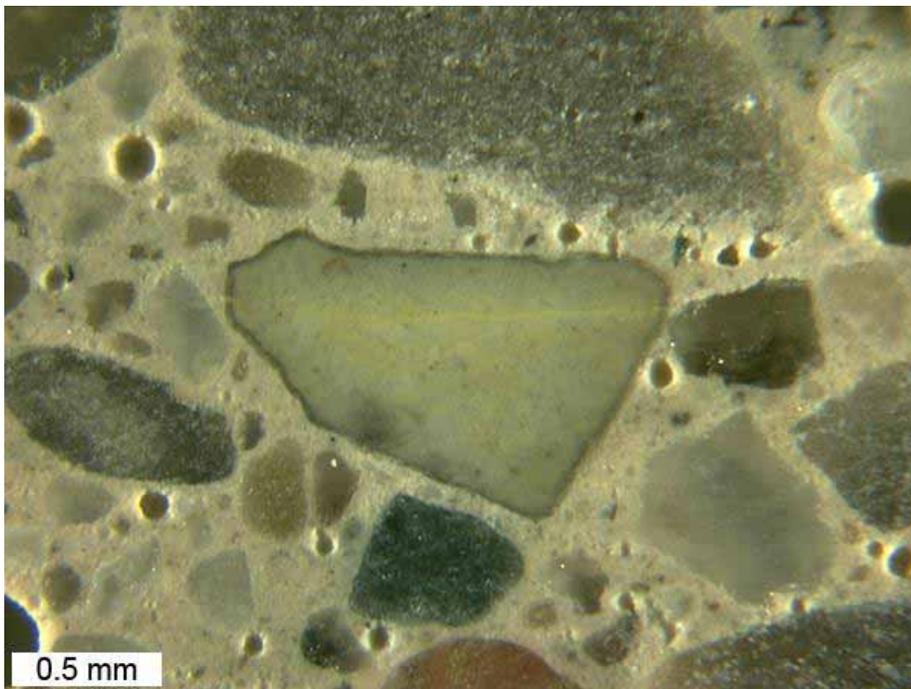
Fine aggregate particle with darkened rim in contact with the cement paste, with cracking, before and after sodium cobaltinitrite stain, polished slab from NB US23, Section 19, constructed 1993, at transverse joint, top half of core, MTU ID US23-05.

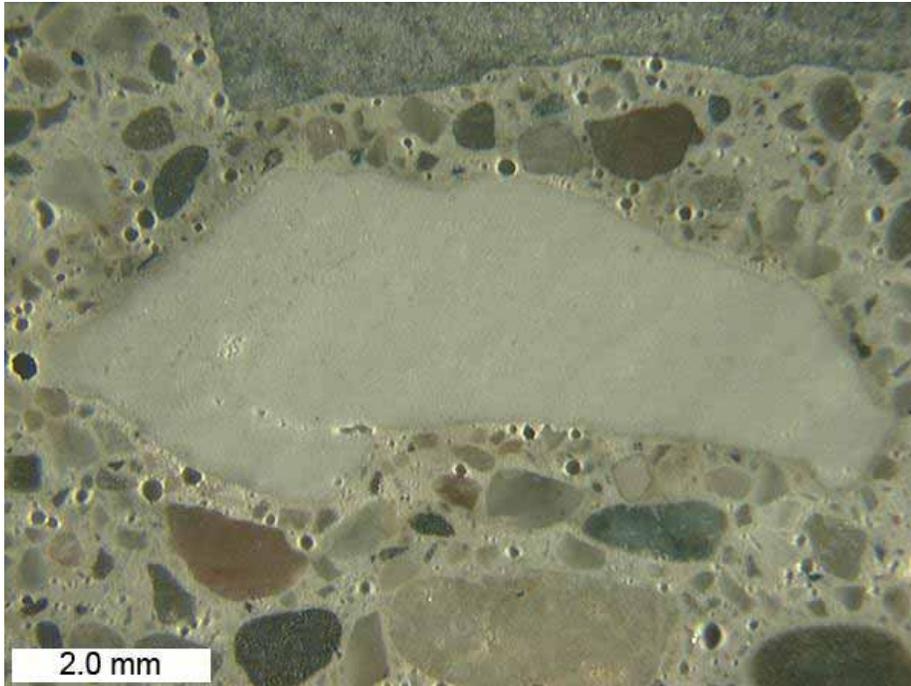
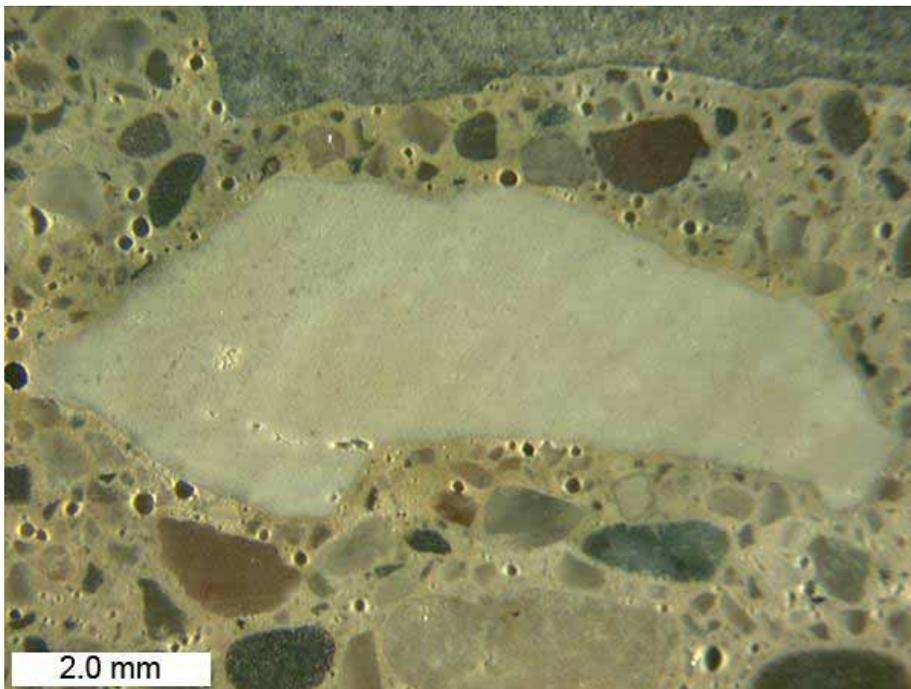
Coarse aggregate particle with darkened rim in contact with the cement paste, without cracking, before and after sodium cobaltinitrite stain, polished slab from NB US23, Section 19, constructed 1993, at transverse joint, top half of core, MTU ID US23-05.

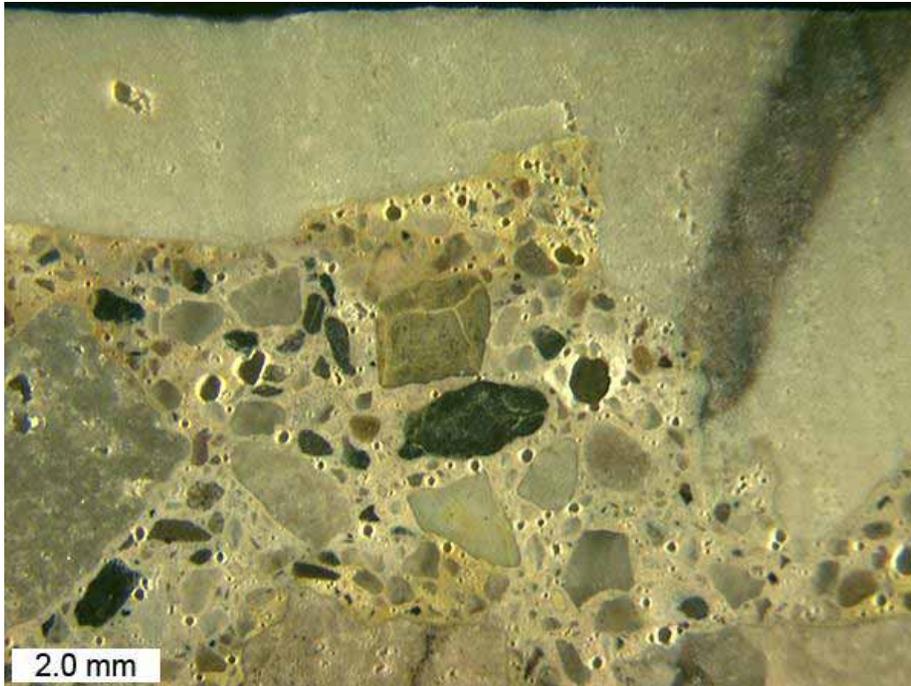
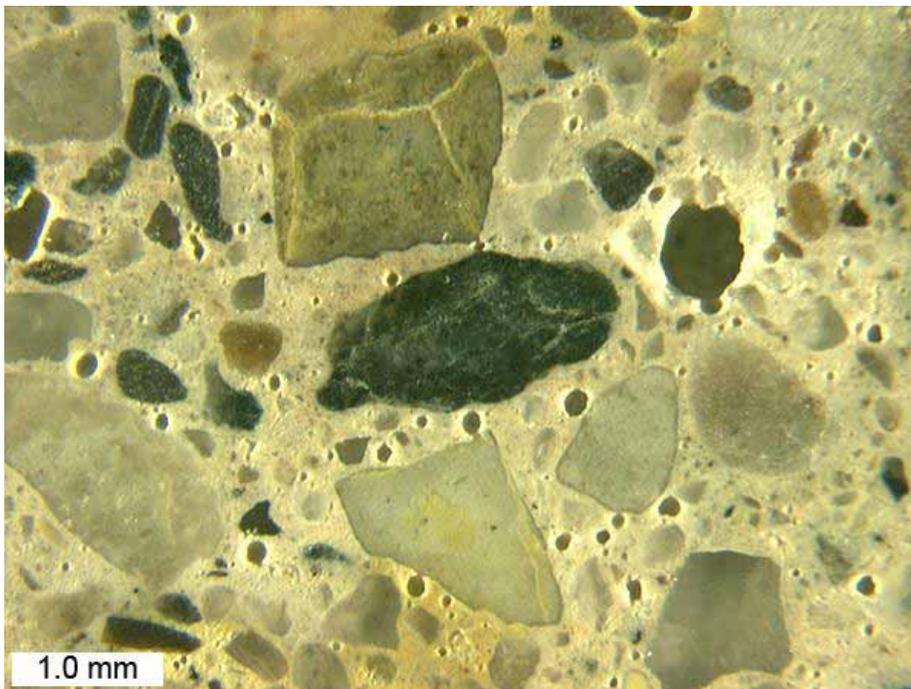
Successively close-up images of fine aggregate particles near pavement surface exhibiting alkali silica reactivity with associated cracks, after sodium cobaltinitrite stain, polished slab from NB US23, Section 19, constructed 1993, at transverse joint, top half of core, MTU ID US23-05.

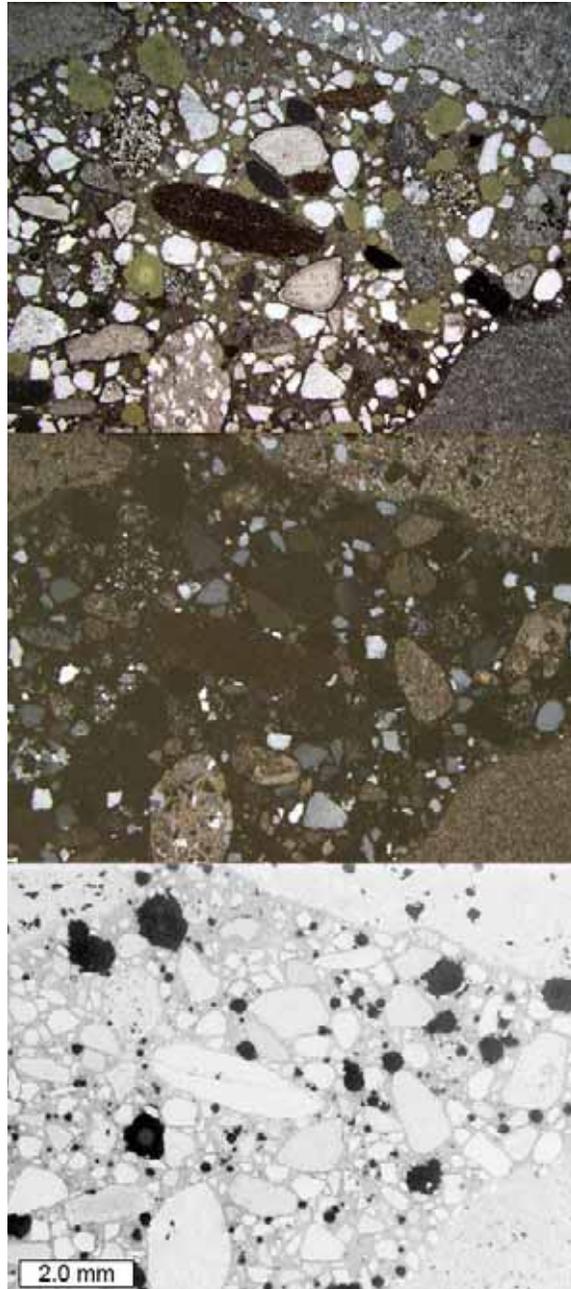
Example of chert particle, and brown siltstone particle, both with minor cracking associated with alkali-silica reaction, from thin section prepared from core from US23, Section 19, away from joint, MTU ID US23-03. From top to bottom: transmitted light, crossed-polars, and epifluorescent mode images.

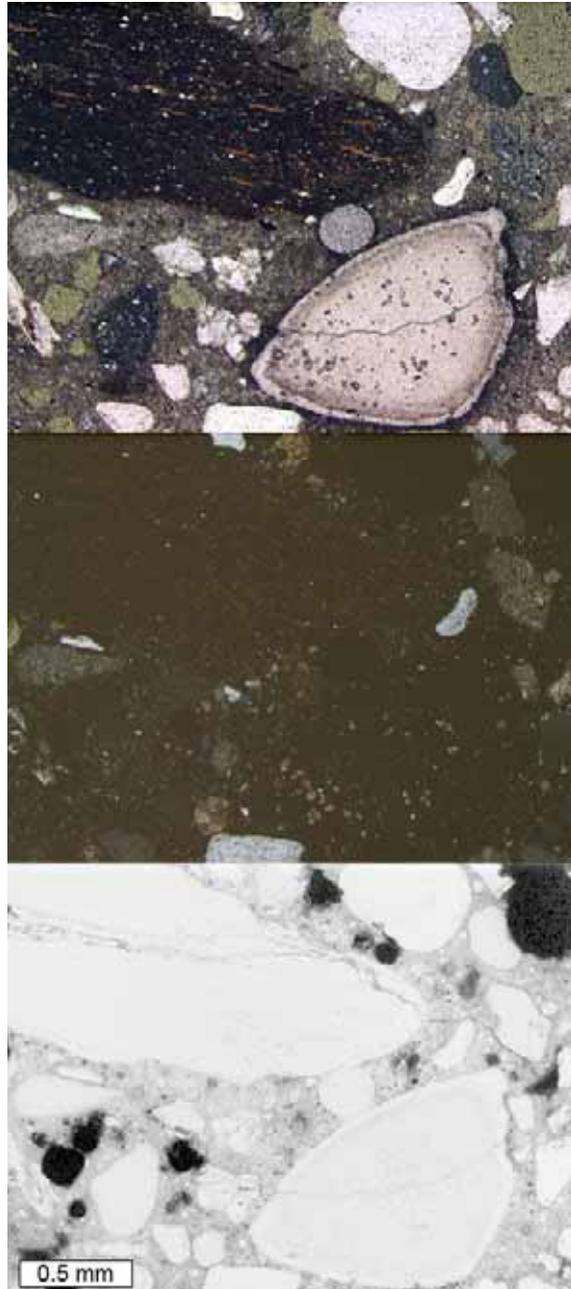
Close-up example of chert particle, and brown siltstone particle from previous figure, both with minor cracking associated with alkali-silica reaction, from thin section prepared from core from US23, Section 19, away from joint, MTU ID US23-03. From top to bottom: transmitted light, crossed-polars, and epifluorescent mode images.

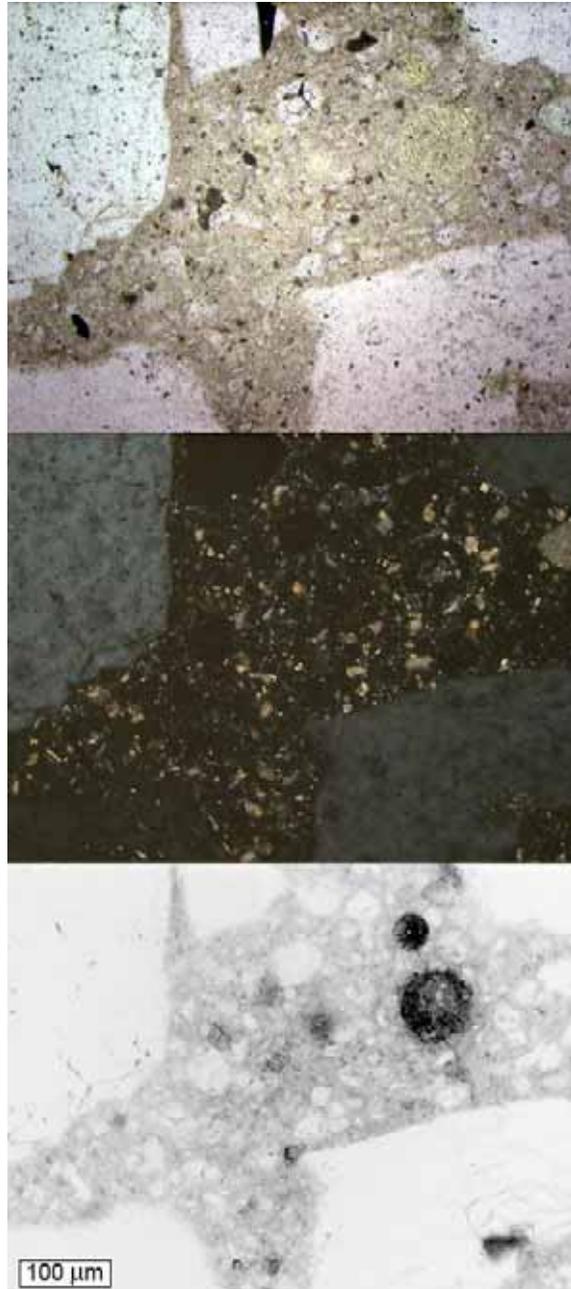
Carbonate dust in cement paste fraction in thin section prepared from core from US23, Section 19, away from joint, MTU ID US23-03. From top to bottom: transmitted light, crossed-polars, and epifluorescent mode images.

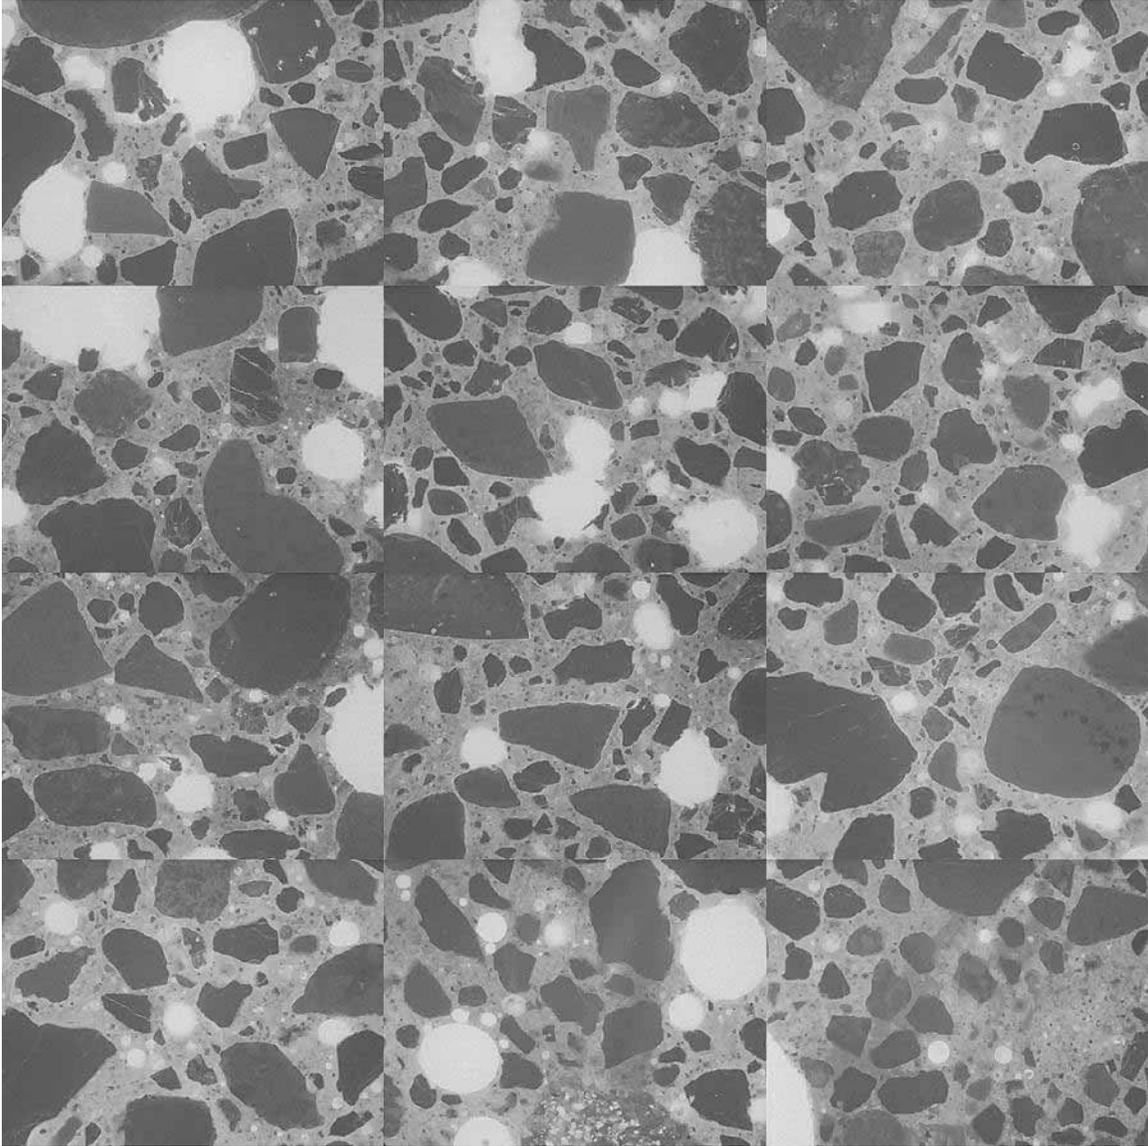
Mosaic of 12 epifluorescent mode images collected from thin sections prepared from core from US23, Section 19, away from transverse joint, MTU ID US23-03 (each individual frame measures 2.612 x 1.959 mm).

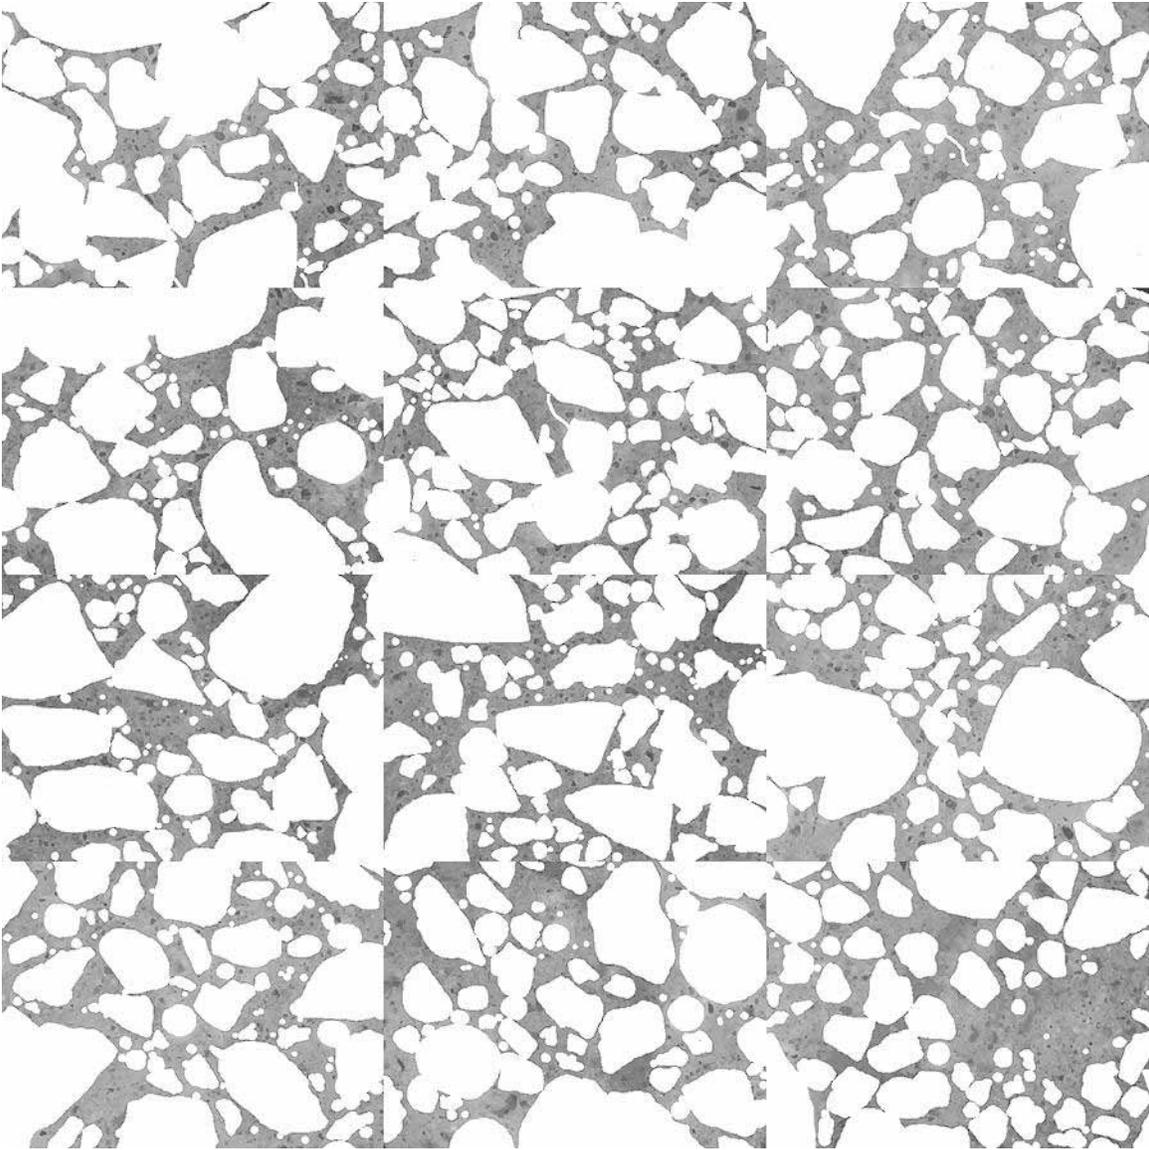
Mosaic of 12 epifluorescent mode images collected from thin sections prepared from core US23, Section 19, away from transverse joint, MTU ID US23-03, after masking out air voids and fine aggregate to isolate cement paste (each individual frame measures 2.612 x 1.959 mm).

Average cement paste pixel intensities per frame, and equivalent w/c values (as compared to 28-day moist cured mortar samples) from thin section prepared from core from US23, Section 19, away from transverse joint, MTU ID US23-03.

cement paste pixel fluorescence measurements (average intensity per frame)			
96	98	111	84
91	99	83	85
111	111	100	97
equivalent w/c ($y = 0.0044x + 0.0329$)			
0.46	0.45	0.46	0.52
0.40	0.43	0.46	0.40
0.41	0.52	0.52	0.47
