**Technical Report Documentation Page**

<b>1. Report No.</b> RC-1551	<b>2. Government Accession No.</b>	<b>3. MDOT Project Manager</b> Adnan Iftikhar	
<b>4. Title and Subtitle</b> Extending the Life of Asphalt Pavements (OR09-086A)		<b>5. Report Date</b> May 2011	
		<b>6. Performing Organization Code</b> 000510	
<b>7. Author(s)</b> Harold L. Von Quintus, P.E. and Rohan Perera, P.E.		<b>8. Performing Org. Report No.</b> 000510 – R5	
<b>9. Performing Organization Name and Address</b> Applied Research Associates, Inc. 100 Trade Centre Drive, Suite #200 Champaign, Illinois 61820		<b>10. Work Unit No. (TRAIS)</b>	
		<b>11. Contract No.</b> 2009-0670	
		<b>11(a). Authorization No.</b> Z1/R2	
<b>12. Sponsoring Agency Name and Address</b> Michigan Department of Transportation Office of Research and Best Practices 425 West Ottawa Street Lansing, Michigan 48933		<b>13. Type of Report &amp; Period Covered</b> Research Report Oct. 07, 2009 to April 30, 2011

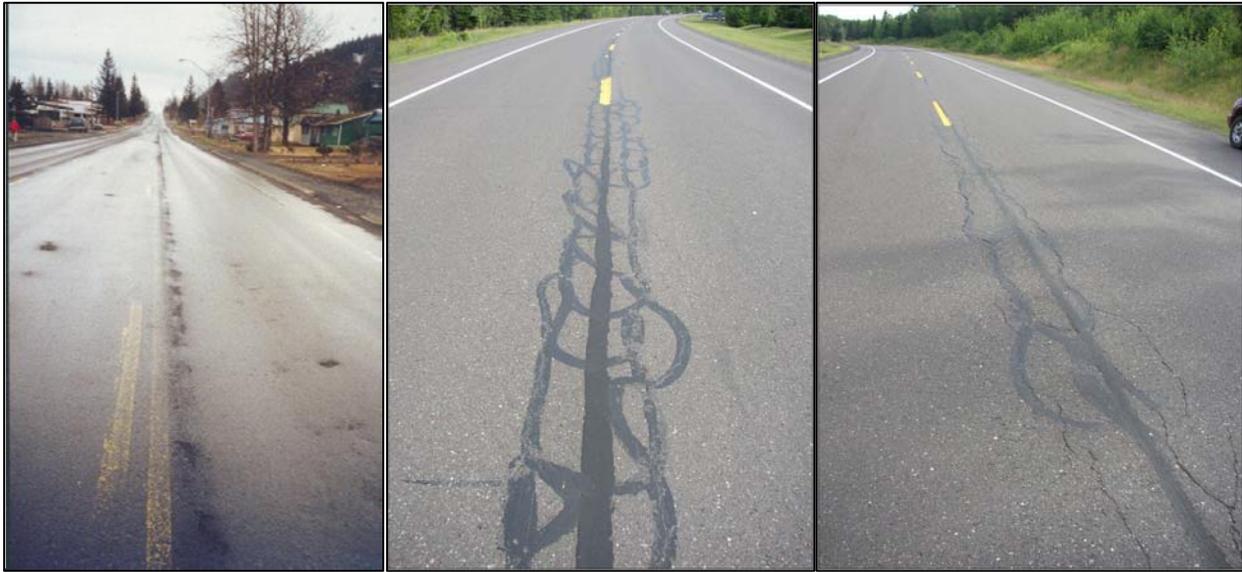
Figure 49. Cracking and Accelerated Deterioration Along Longitudinal Centerline Joints that were Inadequately Constructed

Longitudinal centerline cracking was recorded on 100 percent of the projects exhibiting poor and good performance (refer to Tables 21 and 22). Figure 49 is an example of excessive longitudinal cracking and deterioration along the centerline joint, which is directly related to the construction of the centerline joint. Figure 44 shows the amount of centerline cracking for projects with poor performance, while Figure 47 shows the amount of cracking for projects with good performance. The magnitude and severity of the centerline cracks are lower over an extended period of time for the asphalt pavements and overlays with good to exceptional performance with the exception of the mill and resurface pavement category.

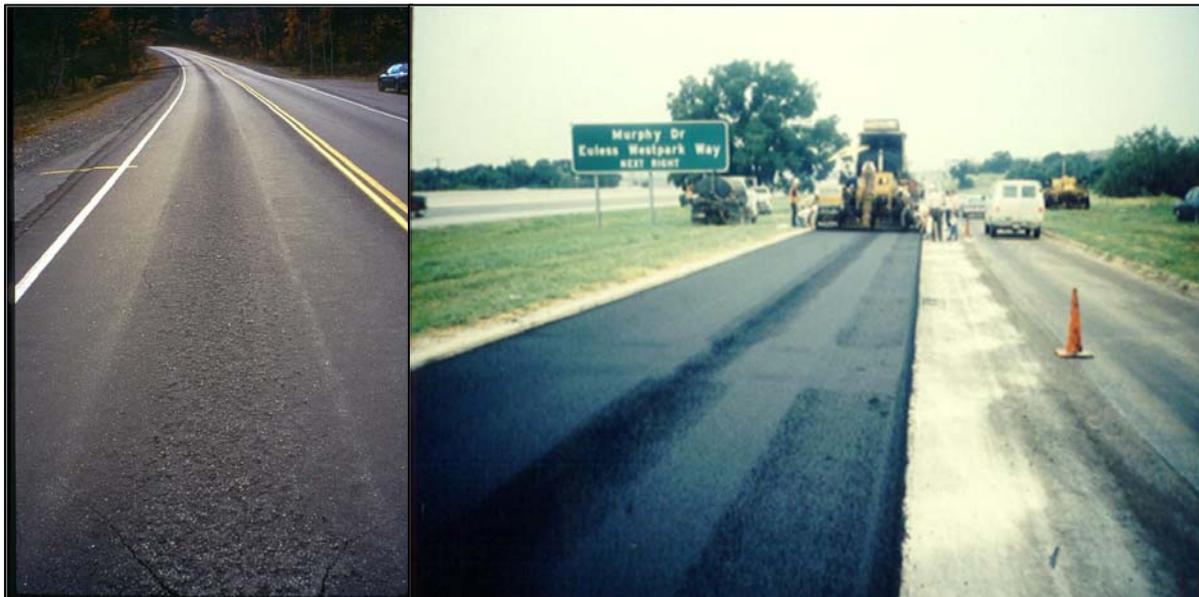
Figure 50. Cracking and Deterioration Along the Center of the Lane where the HMA was Improperly Placed
