IMPACT TESTS OF BREAKAWAY LIGHT POLES

Research Laboratory Division
Office of Testing and Research
Research Project 65 G-140
Research Report No. R-610

State of Michigan
Department of State Highways
Lansing, October 1966

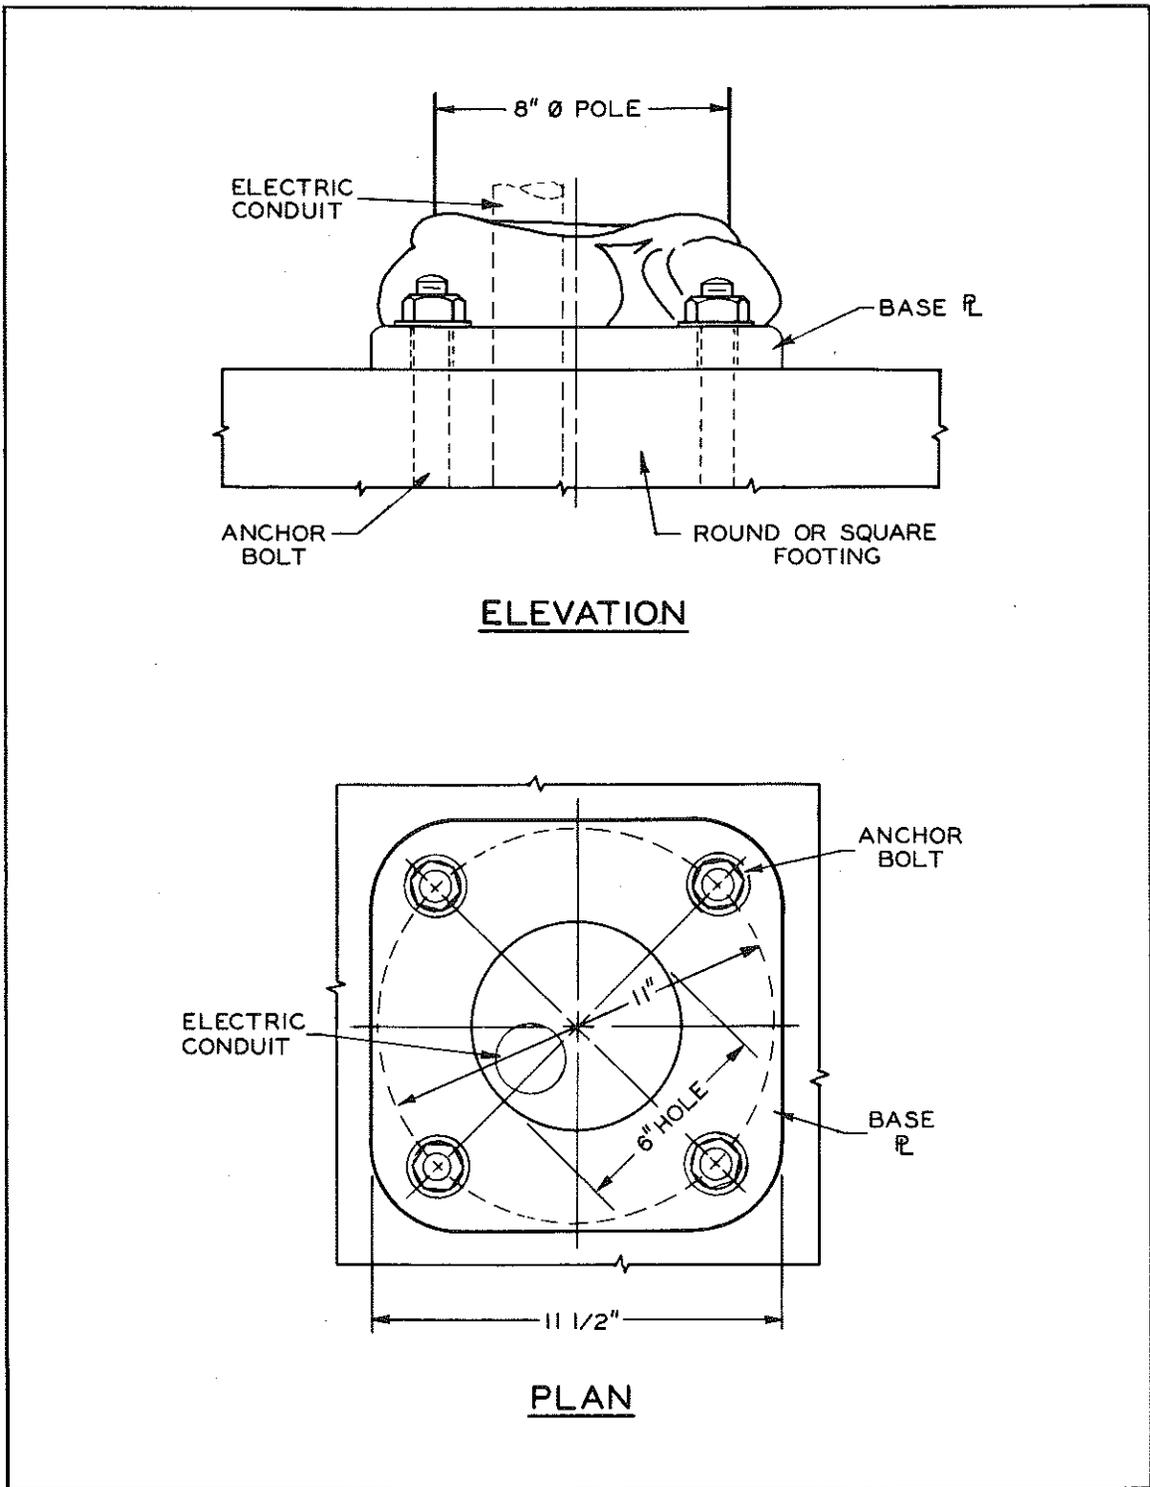
Figure 1. Michigan Department of State Highways conventional steel light pole anchorage design.

The conventional anchorage design for steel street light poles is shown in Figure 1. As can be seen, the pole is fastened to a concrete base with four 1-in. diam bolts through a steel base plate. The base telescopes over the butt of the pole and is connected to the pole with two continuous fillet welds--one on the inside at the bottom of the base and one on the outside at the top of the base.

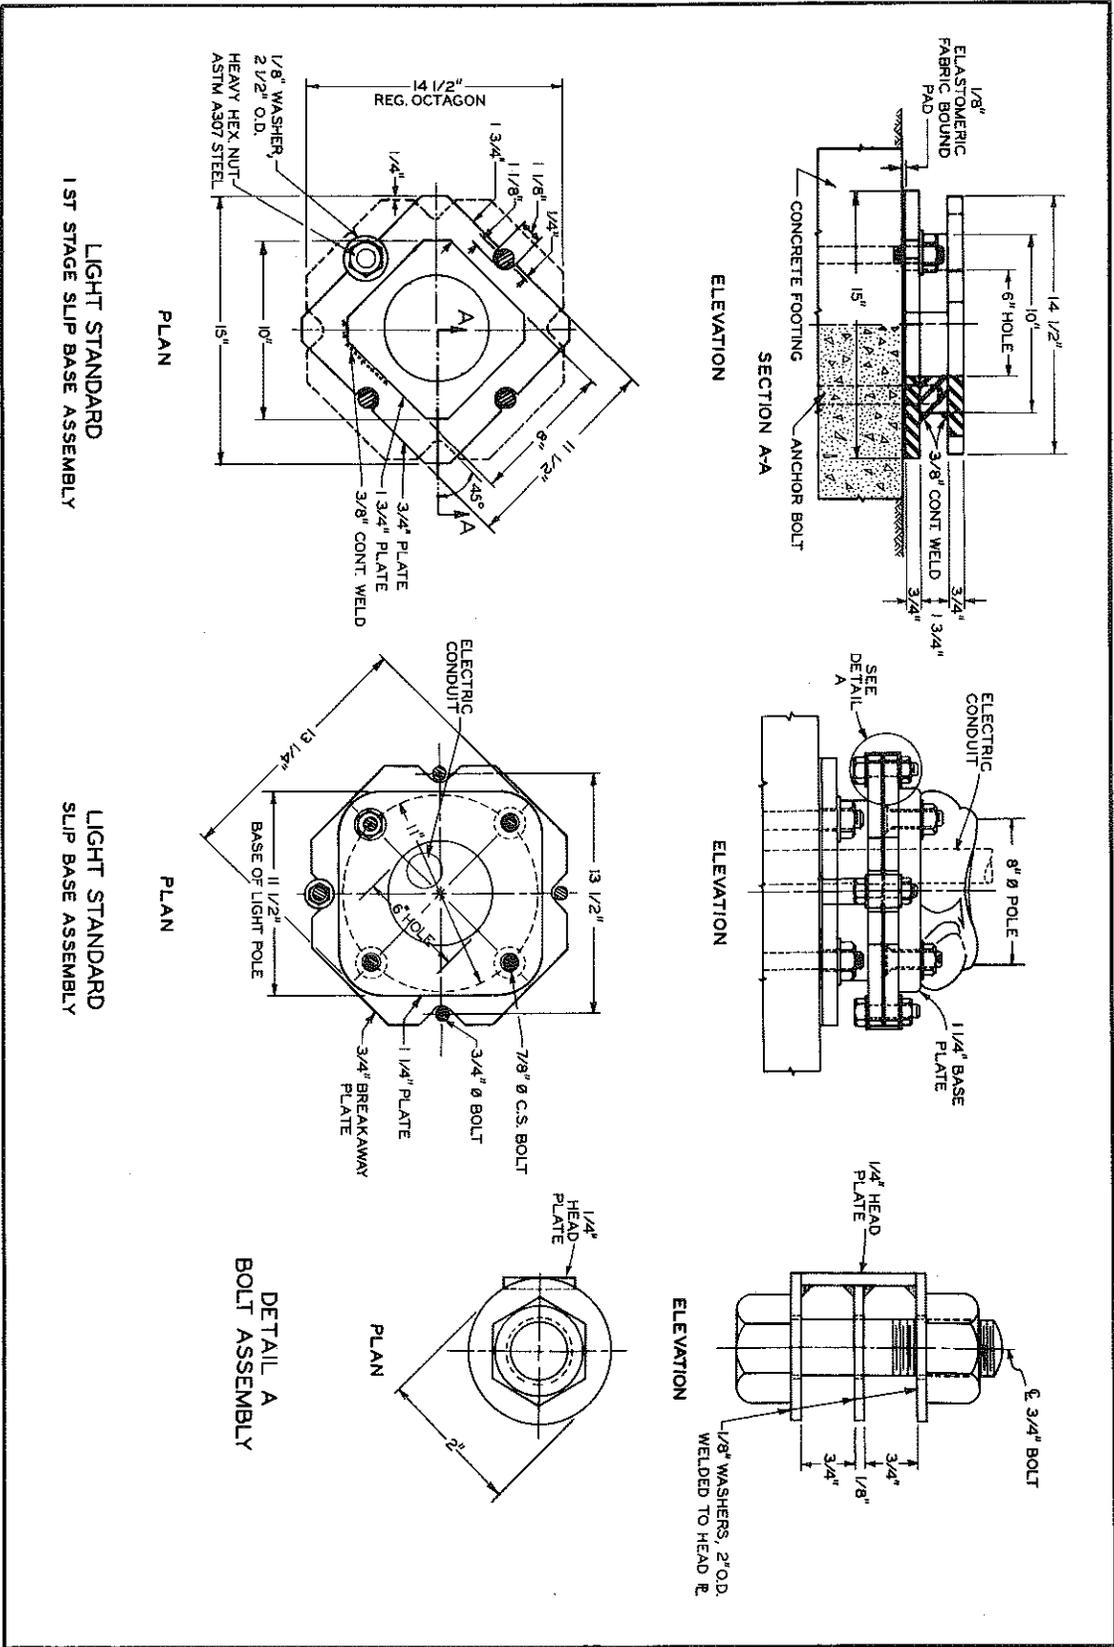
Figure 2. General Motors steel light pole with breakaway joint anchorage design.

The breakaway base joint connection (Fig. 2) consists of a 3/4-in. steel plate fastened to the concrete base with four 1-in. diam bolts and

a 3/4-in. thick "slip" plate attached to the pole base with four 7/8-in. diam countersunk head bolts. A 1-3/4 in. thick spacer plate is welded to the steel-to-concrete base plate at the bottom and to a 3/4-in. slip plate at the top. The pole is anchored by clamping the two slip plates together with four 3/4-in. diam bolts, one at each plate corner. The slip plates are notched so that the clamping bolts will slip out when a vehicle strikes the pole.

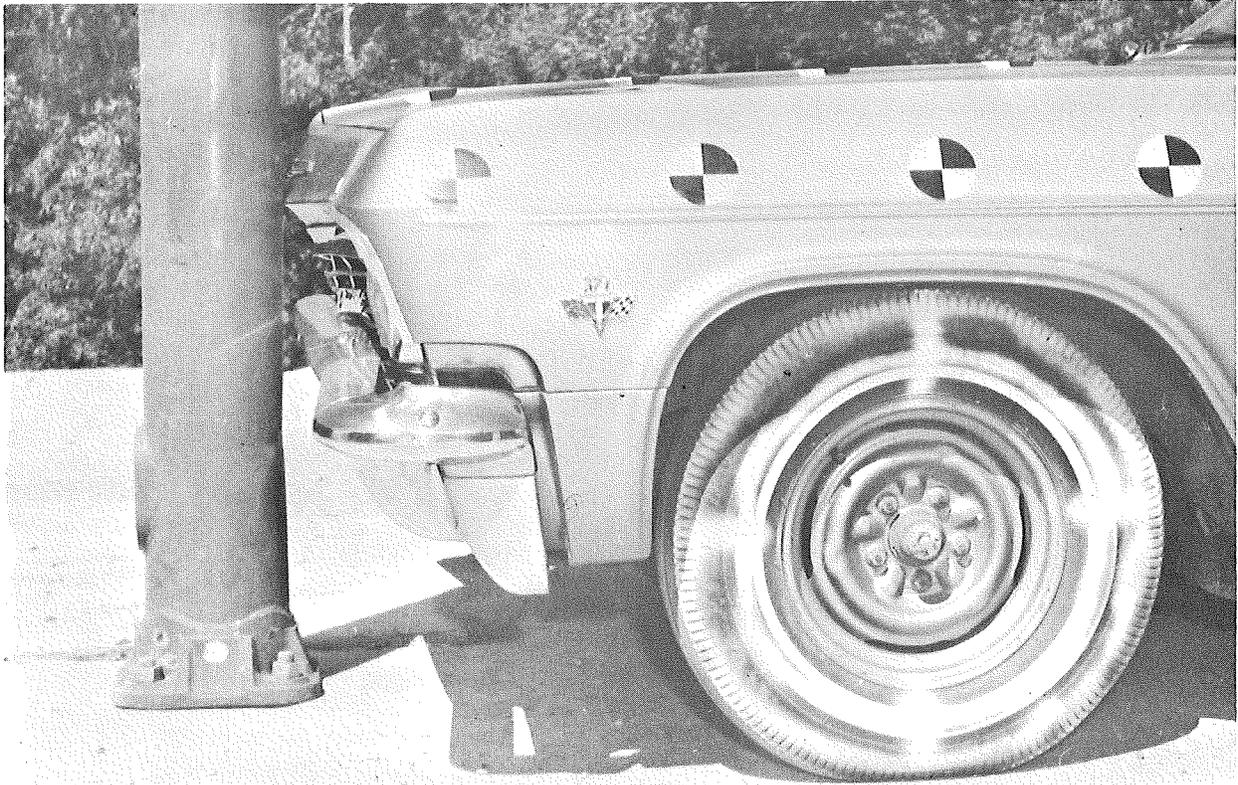
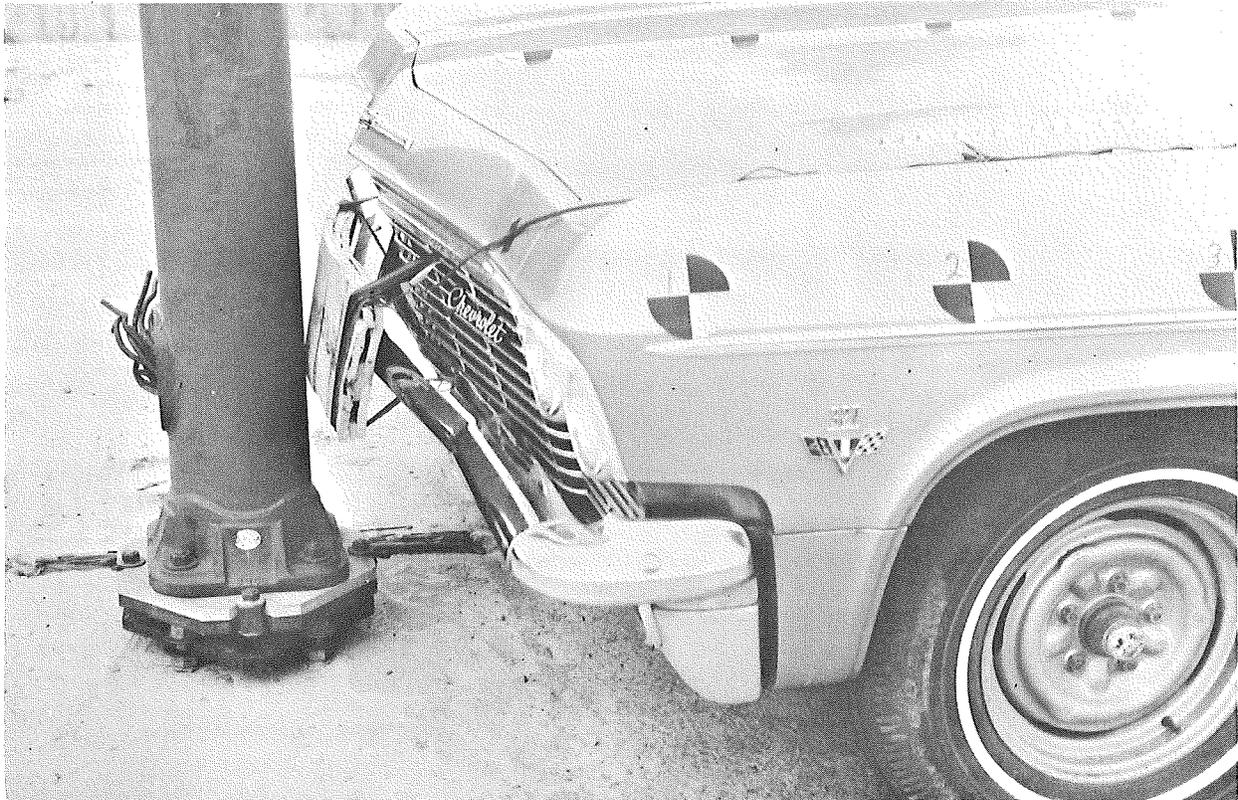
Figure 3. Poles with conventional and breakaway anchorages (above and below) showing approximate points of impact.

Poles with conventional and breakaway anchorages are shown before testing in Figure 3, with test vehicles illustrating the anticipated points of impact. The pole assemblies were shop-painted only. In the conventional anchorage, the bolts, nuts, and washers were hot-dip galvanized. The top slip plate, clamping bolts, and washers used in the breakaway joint base also were hot-dip galvanized. The bottom slip plate assembly and anchor bolts did not appear to have received any surface treatment. In both tests the top of the concrete footing was flush with the ground surface.

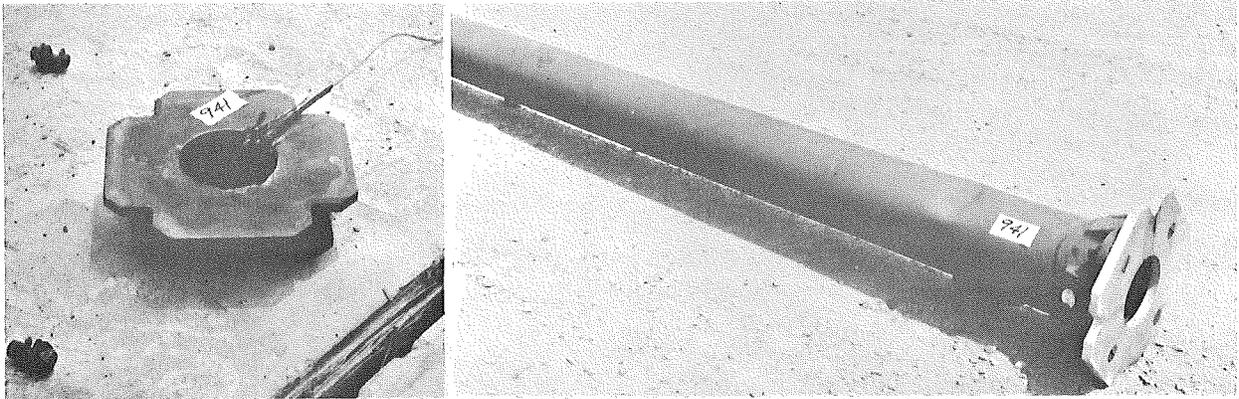
Figure 4. Bottom slip plate and severed wiring of breakaway anchorage after test impact (left), and damaged pole with top slip plate attached (right).

Breakaway Base Joint. At impact, the breakaway joint anchorage detached as intended in its design. The pole assembly was thrown into the air and as it descended the base struck the trunk lid of the car. The pole shaft was dented at the point of impact and the bracket arm deformed as it hit the ground. The pole assembly came to rest in line with the pre-collision vehicle path. The wiring was severed at the pole base. The anchorage, pole, and site are shown after test in Figures 4 and 5. The lap-belted dummy passenger remained in position without striking the instrument panel. The car was crushed approximately 3 in. in the front at the impact point and the trunk lid was slightly deformed and torn (Fig. 6).

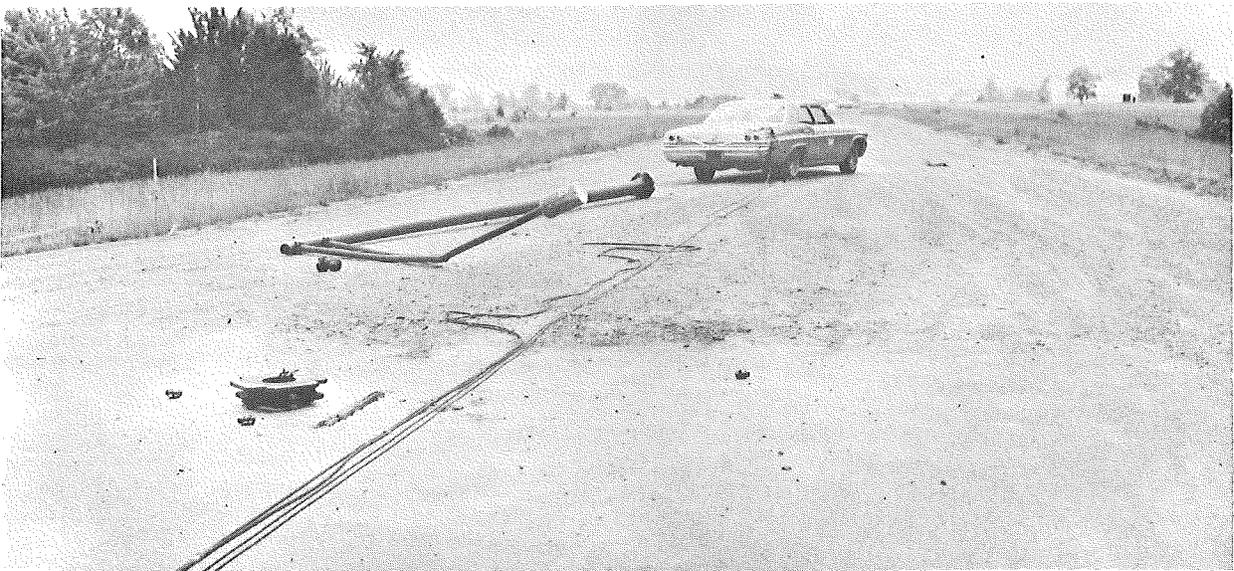
Figure 5. Test area after impact, showing breakaway anchorage, deformed bracket arm on pole, and test vehicle with remote control cables attached.

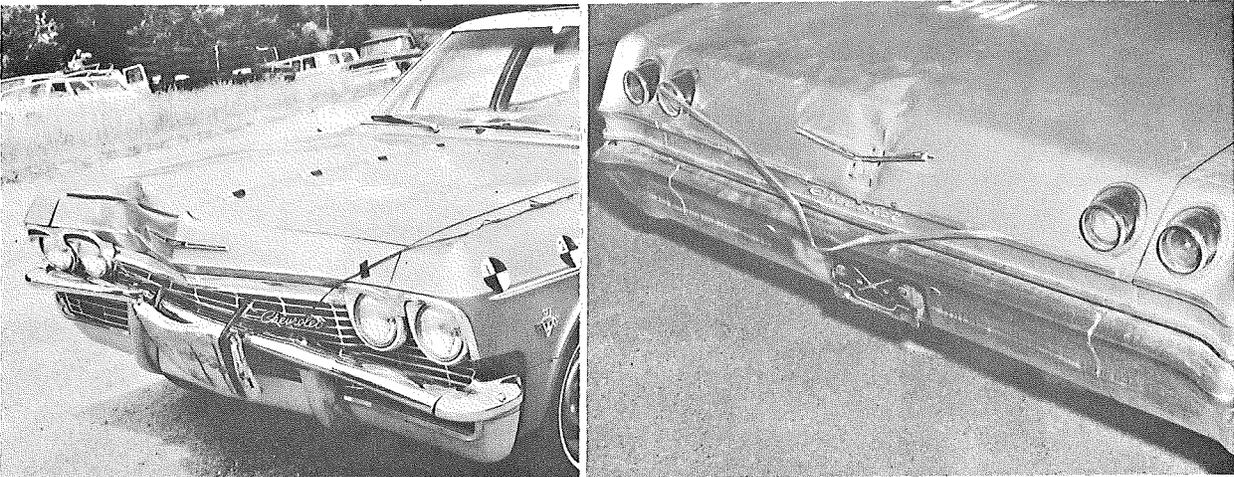
Figure 6. Damage from test impact with breakaway joint anchorage light pole.

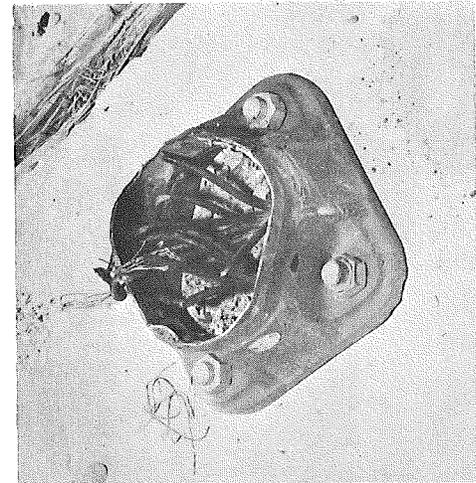
Figure 7. Conventional anchorage and severed wiring after impact.

Conventional Anchorage. The pole shaft fractured above the shaft-to-base fillet weld at the top of the base during impact, but all four of the anchor bolts remained intact (Fig. 7). The wiring was severed at the base. There was evidence that this fillet weld was cracked before the test. The pole assembly was thrown into the air and descended to the ground without striking the car. The shaft was severely damaged at the point of impact and the bracket arm connection broke as the pole hit the ground (Fig. 8). The pole assembly came to rest in line with the pre-collision vehicle path (Fig. 9). The lap-belted dummy passenger struck its right knee on the instrument panel. The car was crushed approximately 24 in. before the pole shaft fractured (Fig. 10).

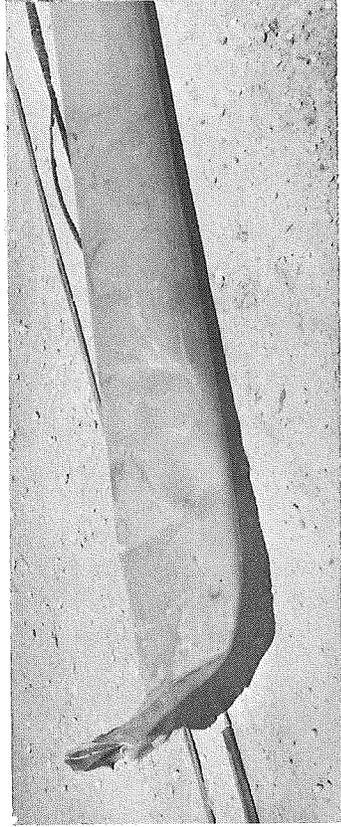
Figure 8. Damaged pole shaft and broken bracket arm connection after impact with conventional light pole.

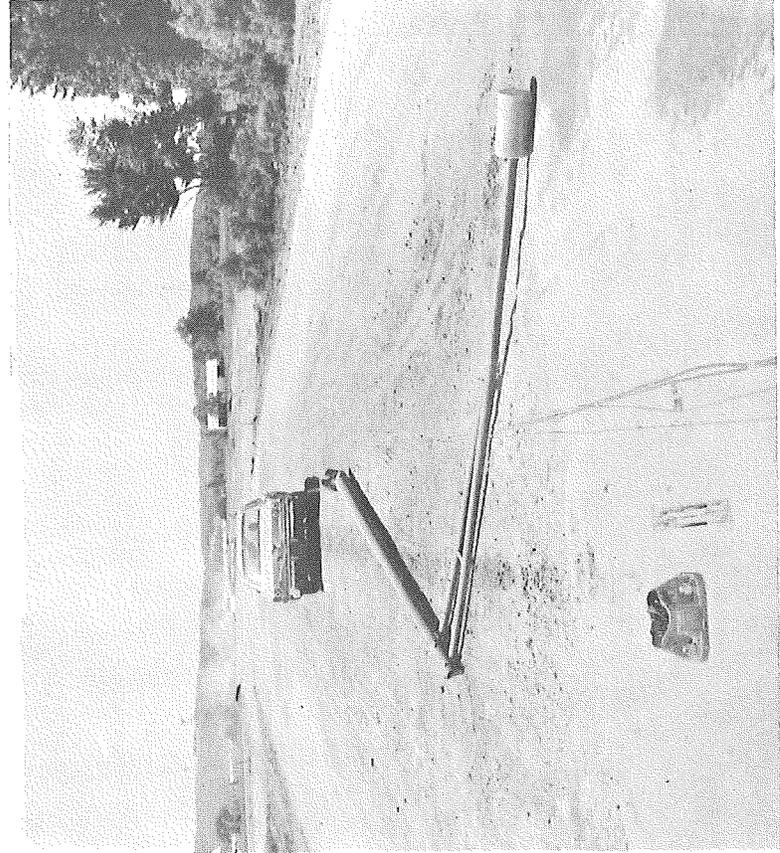
Figure 9. Test area after impact, showing conventional anchorage, damaged pole and bracket arm, and test vehicle with remote control cables attached.

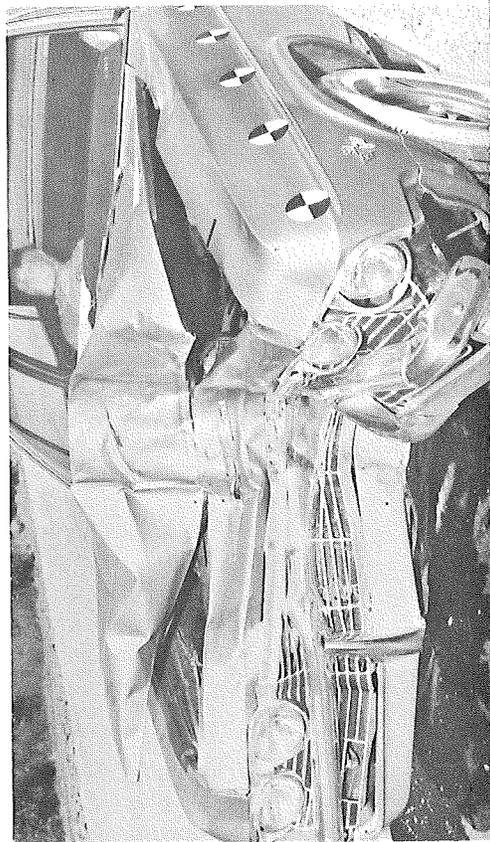
Figure 10. Damage from test impact with conventionally anchored pole.
