PERFORMANCE OF JOINT SEALANTS
USED IN 1964, 1965, AND 1966 MICHIGAN CONSTRUCTION

Research Laboratory Division
Office of Testing and Research
Research Project 62 G-116
Research Report No. R-625

State of Michigan
Department of State Highways
Lansing, March 1967

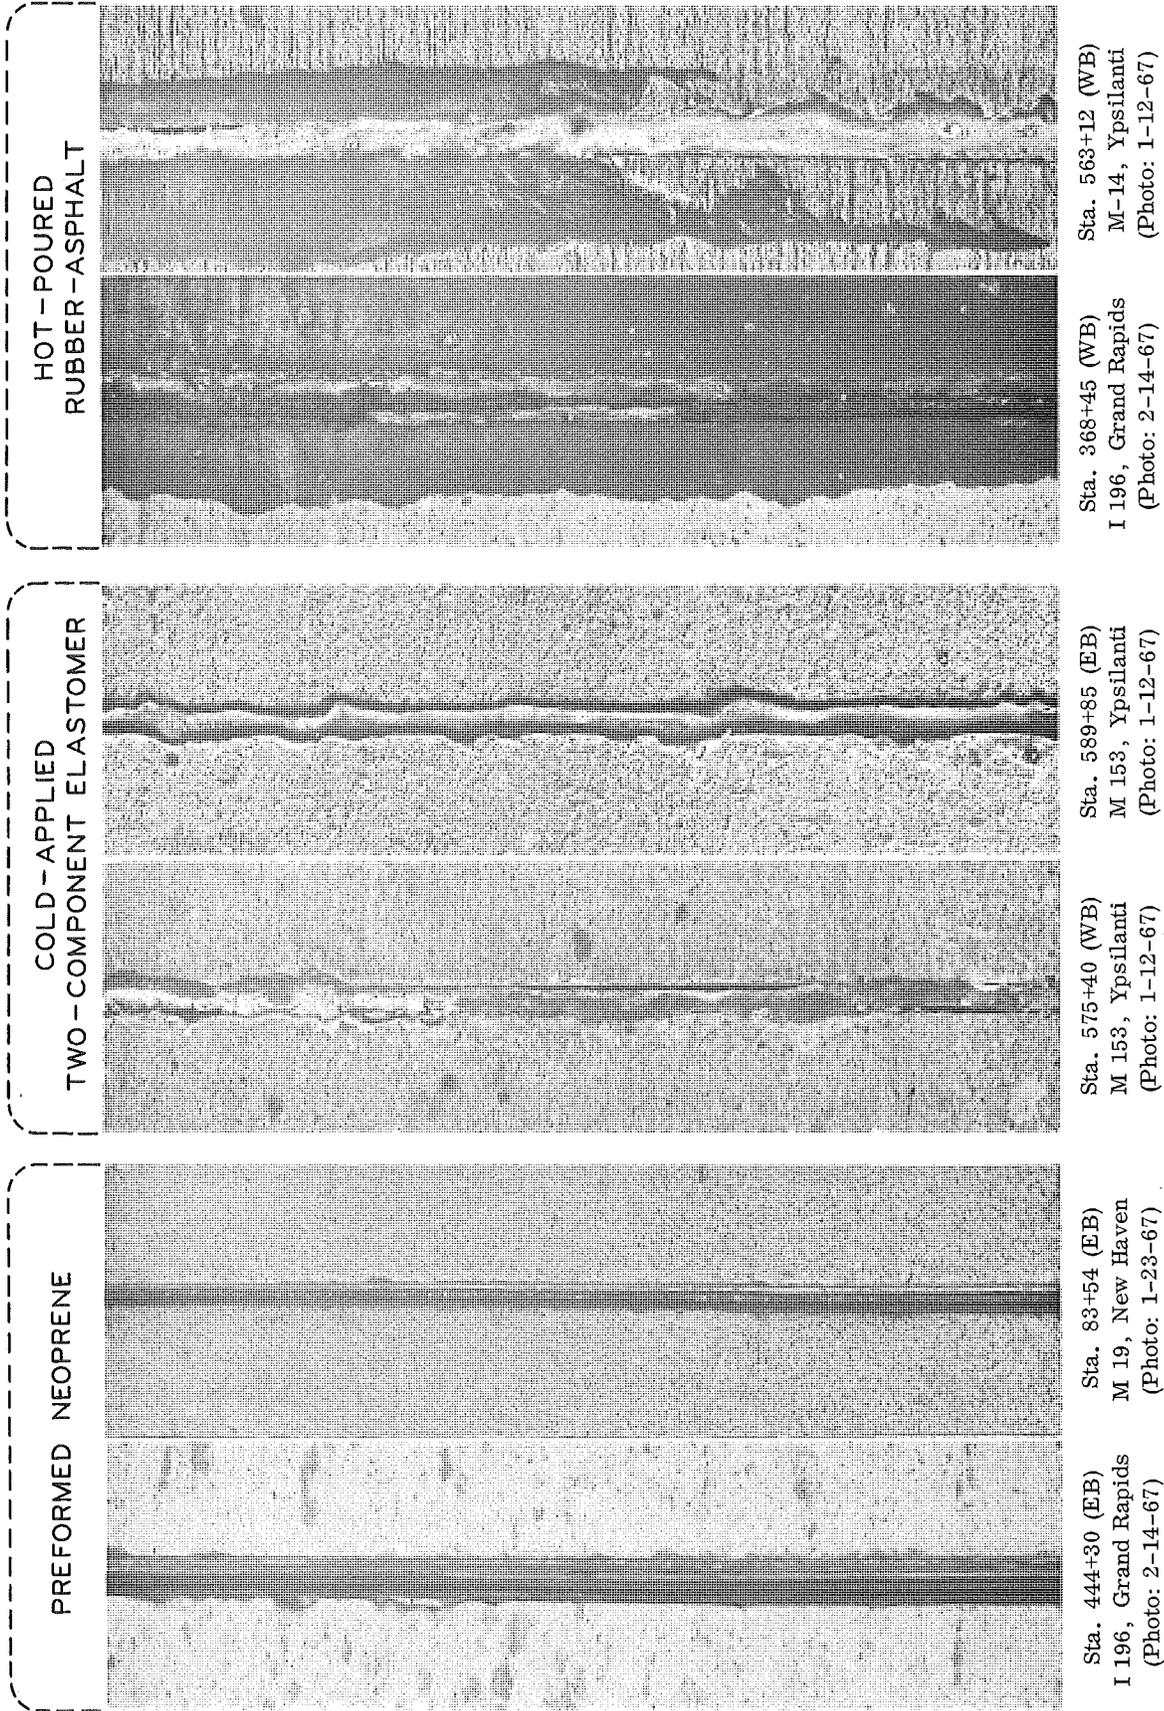
Preformed neoprene sealants with over 2 years of service are performing excellently. They appear to be satisfactorily tight, and no significant vertical movement is indicated by comparing latest seal depth with earlier measurements.

Performance data on cold-applied, two-component elastomeric sealers obtained during three successive winters show progressive adhesion failure. Typical joints have some adhesion failure extending to the bottom of the sealant, permitting intrusion of water and debris.

Data for hot-poured, rubber-asphalt sealer from one of two projects surveyed in 1965 (I 196, Grand Rapids) showed extensive cohesion failure of contraction joints. Less cohesion failure was apparent in 1967, but deep folds have developed in the upper surfaces of many seals, which are expected to collect debris that will be folded into the seal during the coming summer. The other project (M 14, Ypsilanti) showed 8.3-percent partial adhesion failure in 1965, which increased in quantity and depth in the 1967 survey.

Figure 1. Appearance of typical contraction joints sealed in 1964, after more than 2 years of service. Good performance of neoprene (left) contrasts with adhesion failure of cold-applied elastomer (center), and deep fold and adhesion failure of hot-poured rubber-asphalt (right).

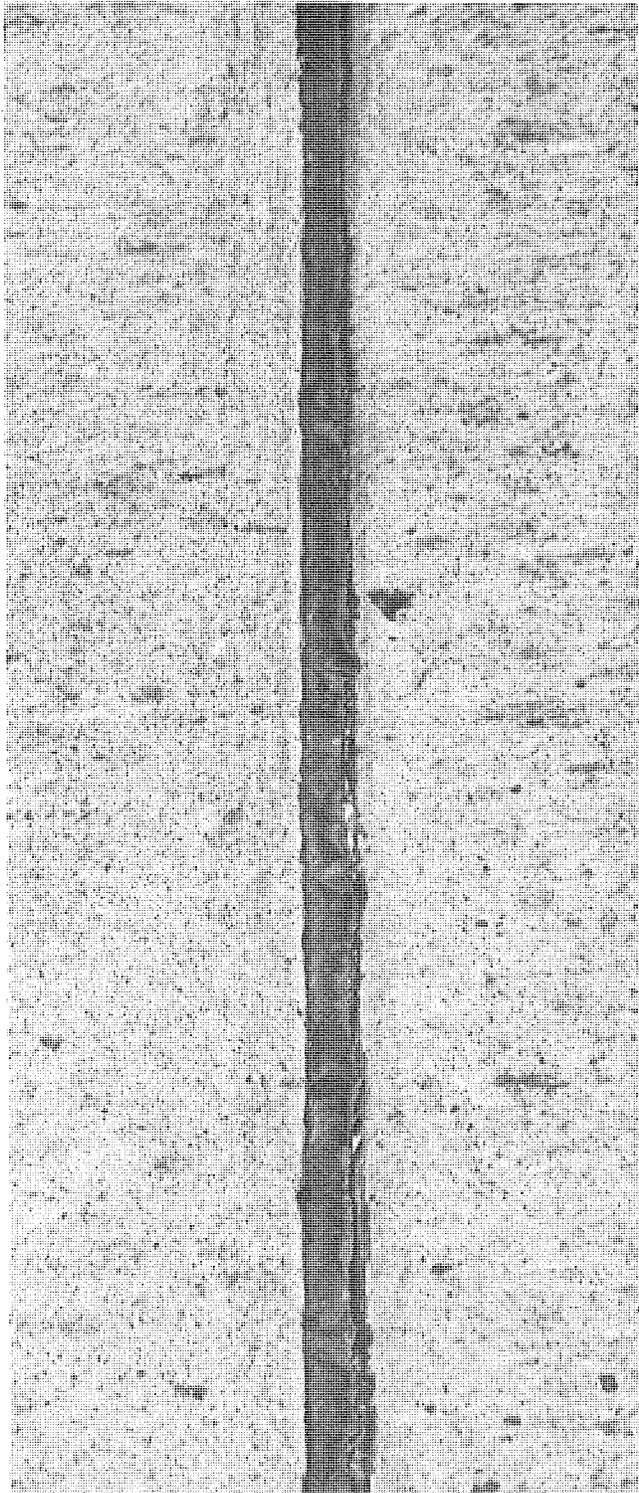
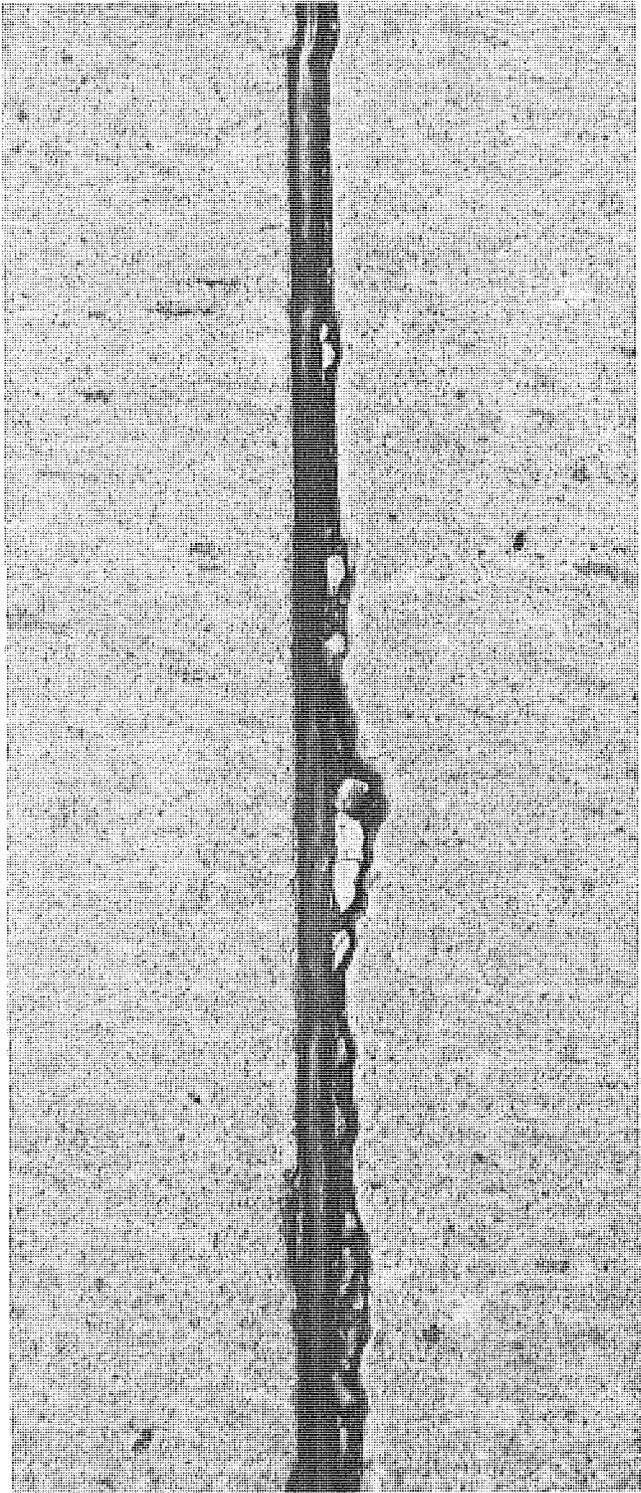
Small adhesion failures were found for cold-applied, two-component elastomeric sealer in the 1965 survey. The 1967 survey indicated adhesion failures ranging in depth from minimal to total along virtually 100 percent of the joint faces. Adhesion failure is expected to progress with time, as has occurred in older installations.

Sta. 860+79 (NB)
M 53, Utica
(Photo: 1-23-67)

Sta. 757+90 (NB)
M 53, Utica
(Photo: 1-23-67)

Figure 2. Typical two-component elastomeric sealer in contraction joints after 1 year of service, showing failure in adhesion.

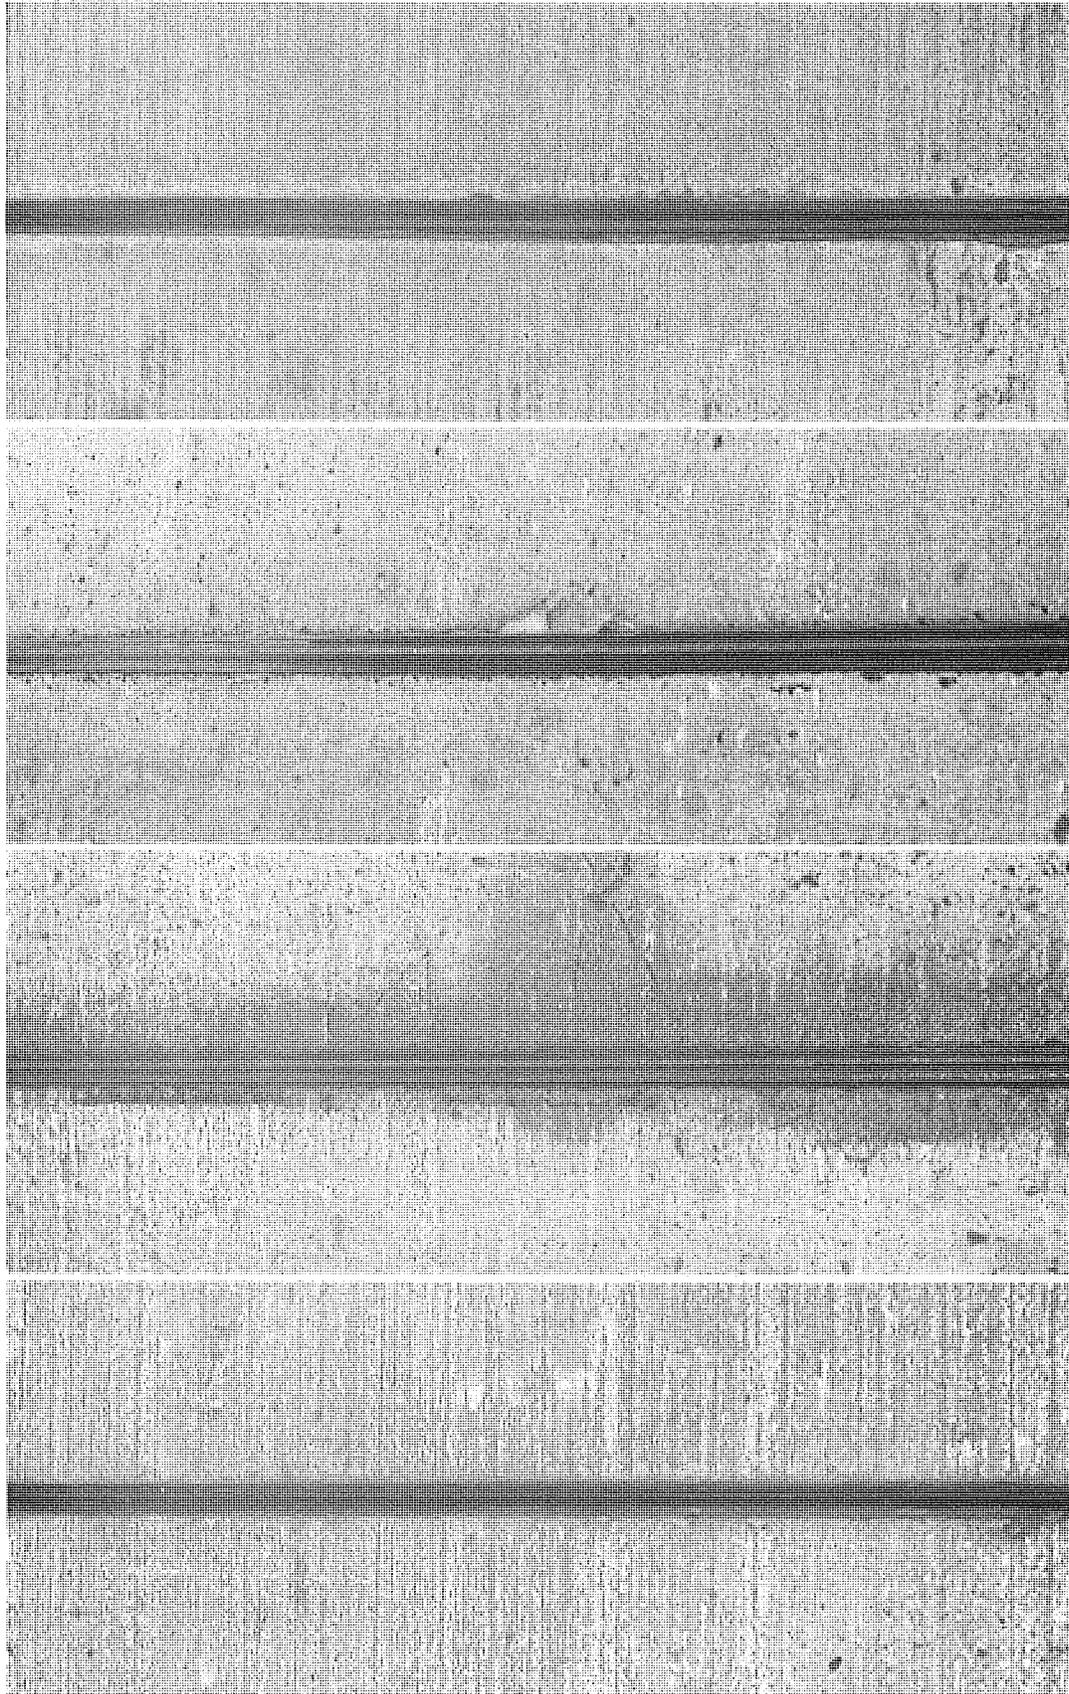
Sta. 121+28 (WB)
M 46, Kingston
(Photo: 1-24-67)

Sta. 351+50 (EB)
M 47, Saginaw
(Photo: 1-25-67)

Sta. 930+61 (NB)
US 131, Cadillac
(Photo: 1-26-67)

Sta. 555+20
US 127, Holt
(Photo: 1-18-67)

Figure 3. Typical neat appearing neoprene contraction joints sealed in 1966.

Field surveys show two apparent qualitative improvements for the 1966 projects as compared to earlier ones. There is much less twisting or tilting of sealer and its depth below the pavement surface appears more uniform. Quantitative measurements of sealer depth still show significant variation, however, and thus a need for further improvement in placement.

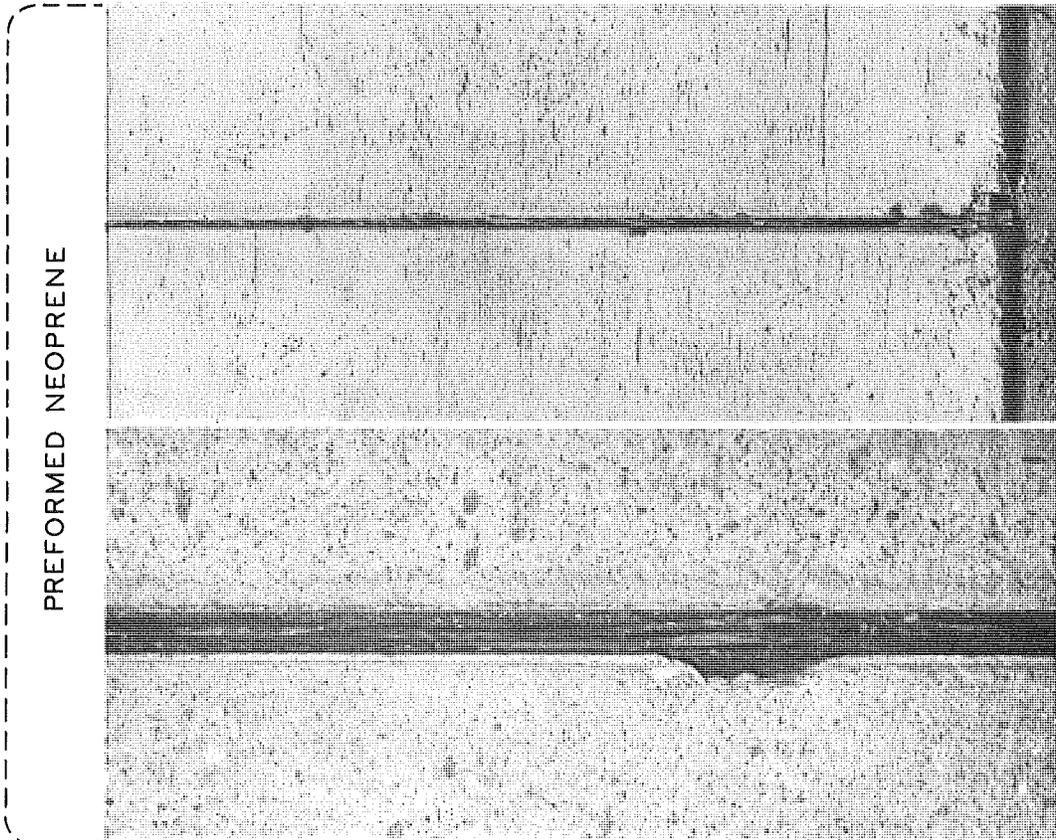
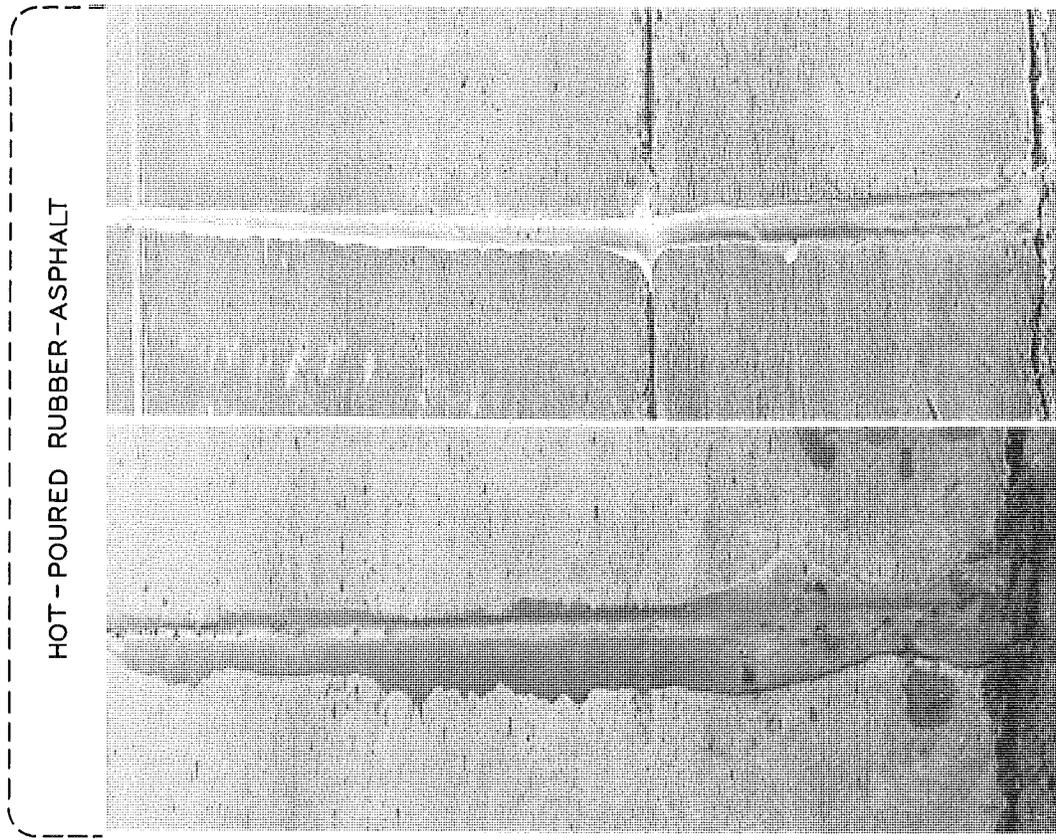
Joint grooves for the preformed neoprene sealant were formed to 1-in. widths, and in some cases close to 3/8-in. during hot weather. This condition prevails on the Grand Rapids project where most expansion seals, except at structures, have split longitudinally with the top portion expelled. These joints have not been repaired, since the remaining portion of the seal appears to be keeping out dirt and debris (Fig. 4). Expansion seals on the New Haven project are generally in good condition, although closer to the pavement surface than is now specified. For unknown reasons, one seal is entirely missing.

Sta. 445+47 (EB)
 I 196, Grand Rapids
 (Photo: 2-14-67)

Sta. 339+89
 I 196, Grand Rapids
 (Photo: 2-14-67)

Sta. 565+88
 M 14, Ypsilanti
 (Photo: 1-12-67)

Figure 4. Appearance of expansion joints sealed in 1964, after more than 2 years of service. Top portion of neoprene sealant (left) has split away and is missing, but remaining portion maintains effective seal. Hot-poured rubber-asphalt seals (right) are in good condition.

Generally good performance of hot-poured, rubber-asphalt seals was observed on two projects, although minor adhesion and cohesion failures were found.

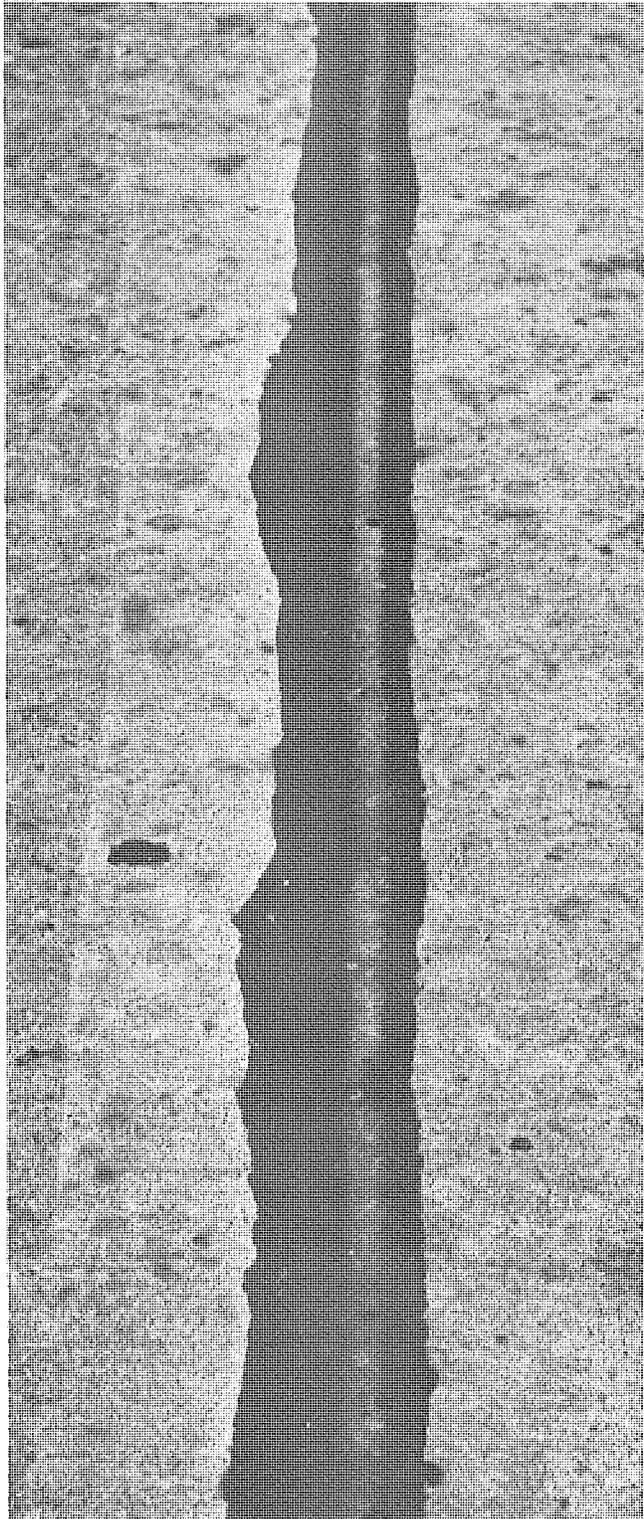
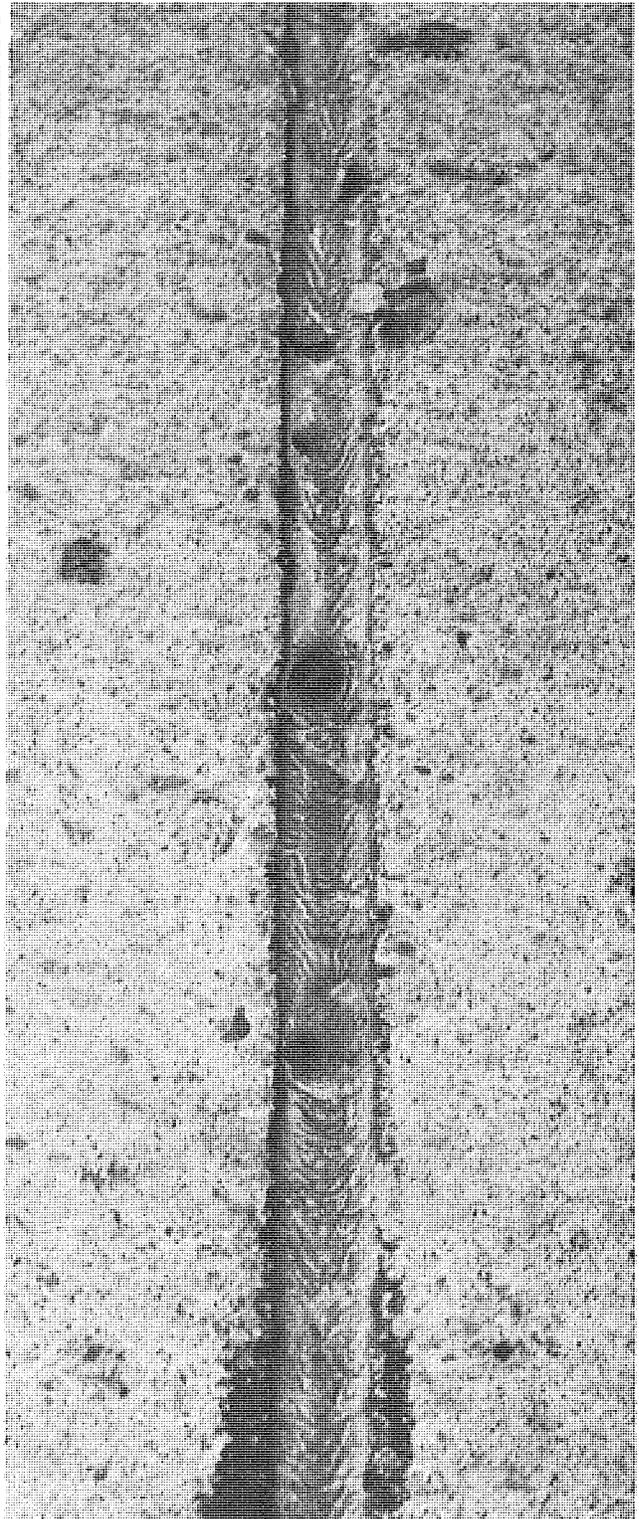
Sta. 61+96
M 14, Ann Arbor
(Photo: 1-12-67)

Sta. 939+54
M 53, Utica
(Photo: 1-23-67)

Figure 5. Hot-poured expansion joints sealed in 1965 and performing well.

The two 1965 projects surveyed had neoprene contraction joints and hot-poured rubber-asphalt expansion joints. They were paved during summer when only a few expansion joints were required, such as at structures, etc. Expansion joint grooves were formed with temporary fillers and were 1-in. wide. Surveys in 1965 and early 1967 show excellent performance.

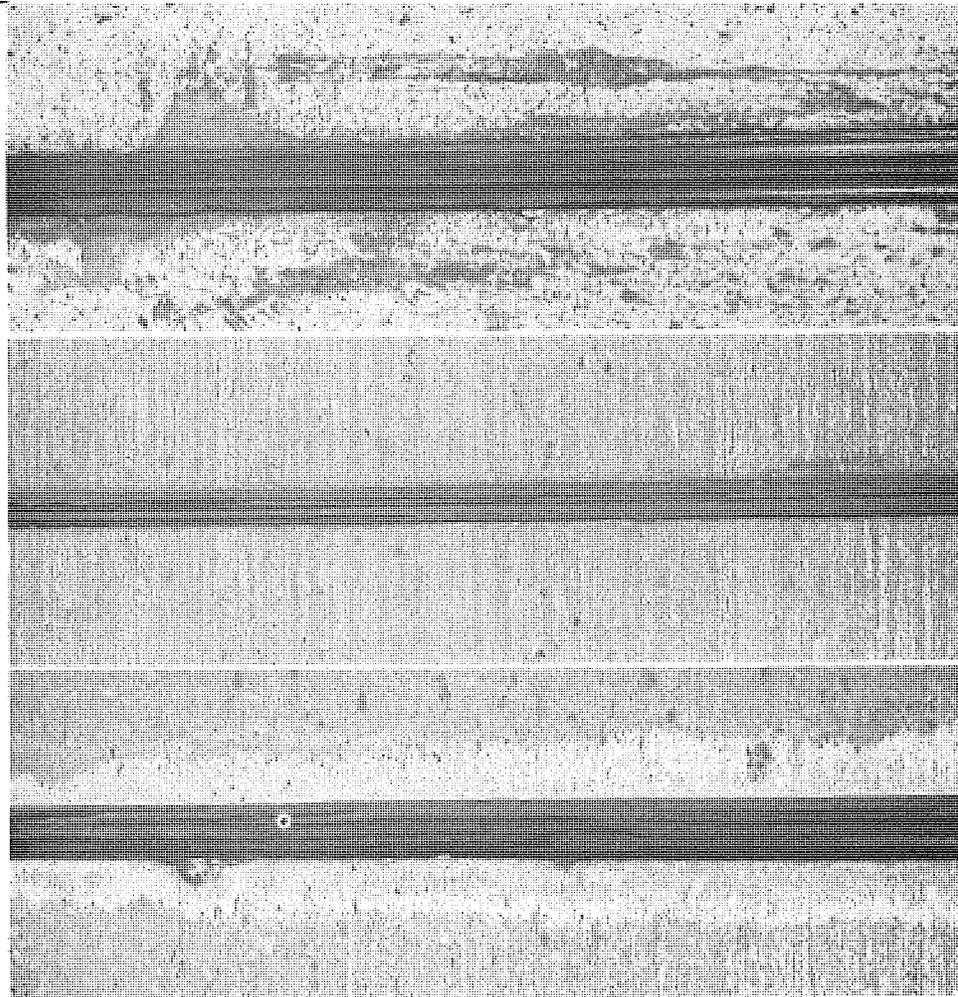
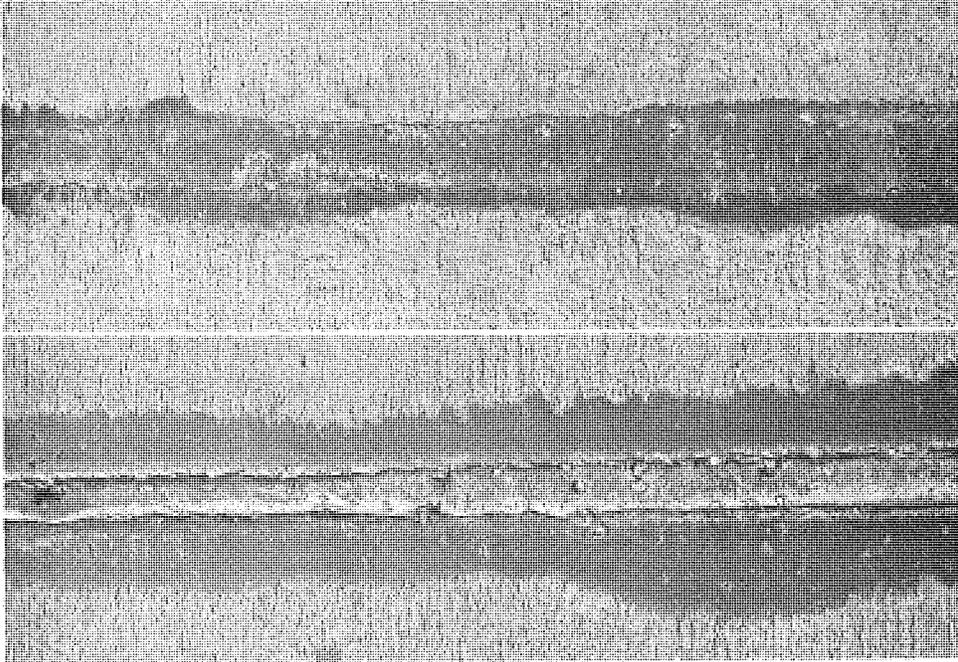
Sta. 178+60
Square Lake Rd., Pontiac
(Photo: 1-20-67)

Sta. 455+38
M 46, Kingston
(Photo: 1-24-67)

Sta. 367+39
M 47, Saginaw
(Photo: 1-25-67)

Sta. 432+05 (SB)
US 127, Holt
(Photo: 2-28-67)

Sta. 533+66 (NB)
US 127, Holt
(Photo: 2-28-67)

Figure 6. Appearance of expansion joints sealed in 1966, during their first winter of service. Typical neatly installed neoprene sealants are shown at left. Performance of hot-poured rubber-asphalt sealer was variable within the same project (right), with joint showing shallow adhesion failure adjacent to joint in good condition.

For preformed neoprene sealants, 1966 projects had expansion joint grooves sawed to 1-1/4 in. Sealers had theoretical compressions of 14 to 24 percent at the time of inspection. Prior studies show that expansion joints close progressively with years of service, so that the 1966-67 winter joint widths are maximums. Some measurements of sealer depth below pavement surface were greater than specified, although average depths are not considered excessive.

Expansion joints on one project were sealed with "up-graded" hot-poured rubber asphalt. This material's principal difference from Federal specification requirements is that it must pass a more severe bond extension test at 0 F. The February 1967 inspection shows varying behavior. Seven consecutive joints have considerable shallow adhesion failure along both joint faces with an unusual amount of embedded stone in the surface. The next four consecutive joints are excellent in appearance and have no adhesion failure. Laboratory examination of materials from these two groups of joints showed that the materials are identical in appearance, but that material from the poorer joints has a lower melting temperature. Flow tests show that both materials still meet specification requirements.

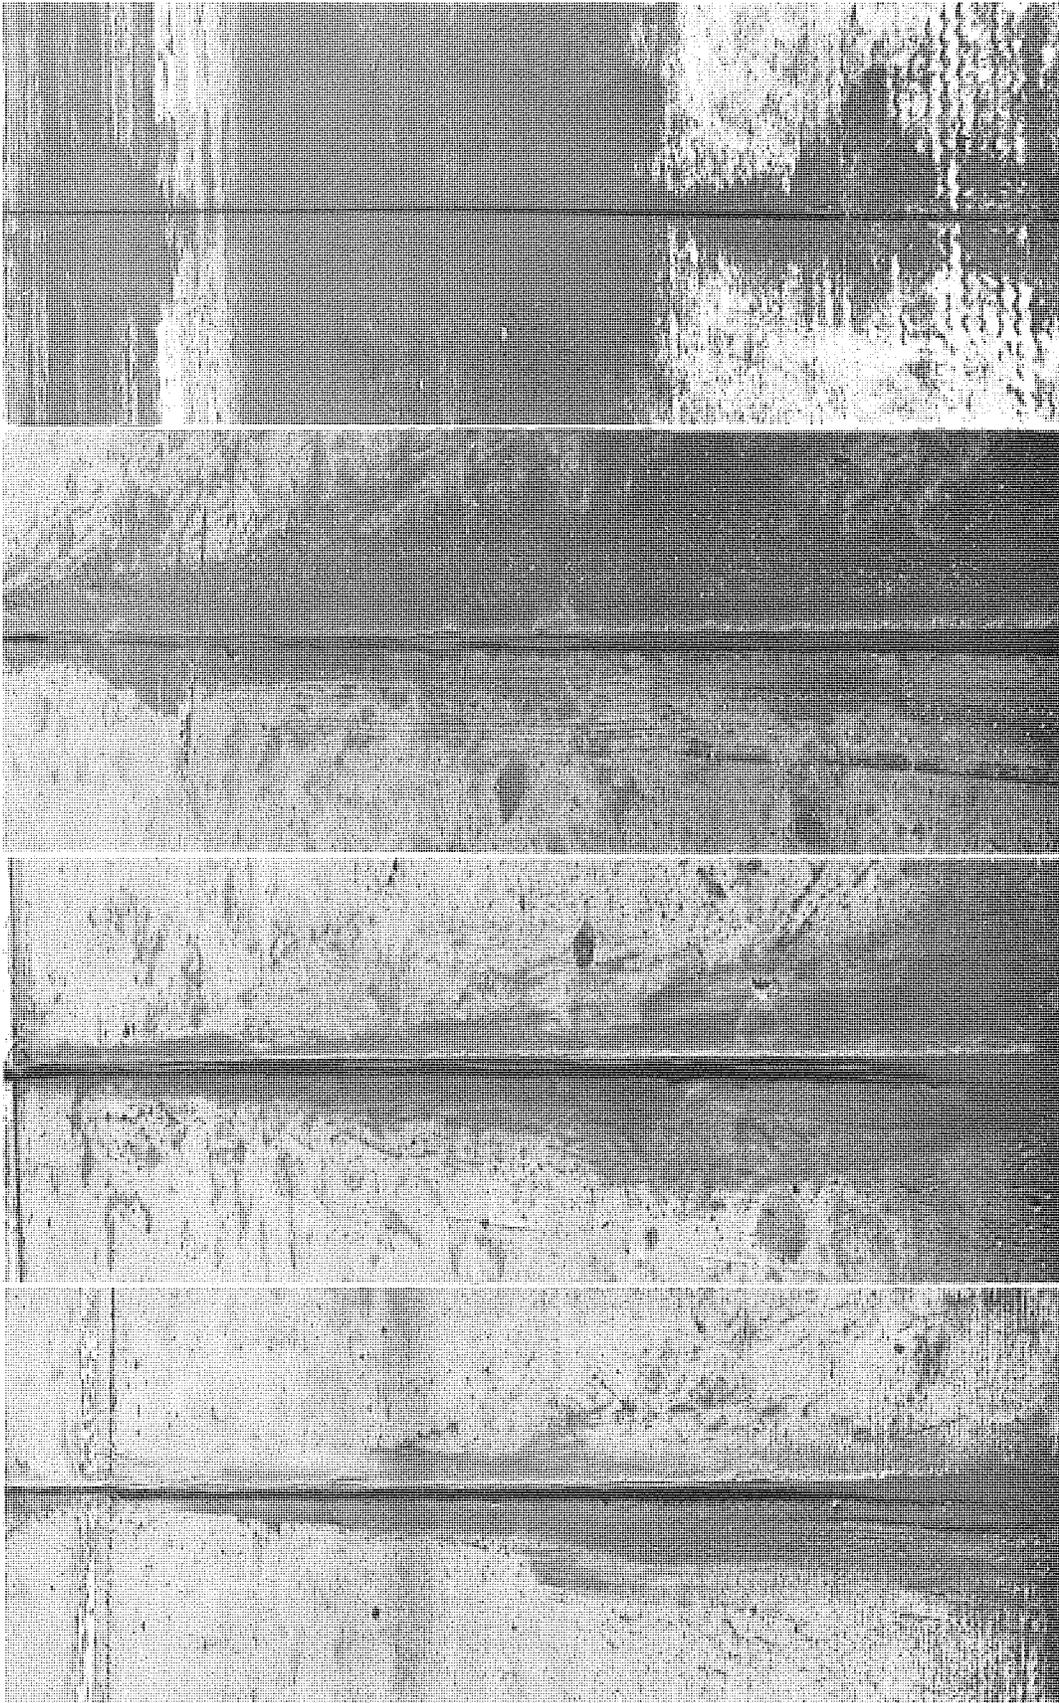
Group 1. Standard 1-in. grooves were sealed with 1-3/8-in. thin-wall neoprene, with the exception of one groove in which 1-1/2-in. thin-wall neoprene was used. This latter material had been submitted as 1-3/8-in. sealer, but was oversize and was designated as 1-1/2-in. nominal size.

Group 2. Standard 1-in. grooves were sawed to 1-1/4-in. and sealed with 1-5/8-in. thin-wall neoprene.

Group 3. Standard 1-in. grooves were sawed to 1-1/4-in. and sealed with 1-5/8-in. regular weight neoprene.

At Holt (Holt Road over US 127 and US 127 South of Holt Road to I 96), expansion joints were formed by sawing 1- by 2-1/4-in. grooves before uncontrolled cracking occurred. These were then sealed with 1-5/8-in. thin-wall neoprene. Upon inspection in early December 1965, shortly after completion of sealer installation, all expansion joints were neat in appearance, but all five different types of installation had isolated spots where sealer was low in the groove. The second winter inspection in January-February 1967 showed that the only group that had not moved downward significantly in the joint groove was Group 3 at Holland (Table 3). Typical installations of the different types are shown in Figure 7. The US 127 project was sealed in early 1966 and initial inspection in January 1967 showed that the seals were well placed and neat in appearance. The joints inspected in detail had no exceptionally low spots (Table 3), but a cursory inspection of other joints showed a few isolated spots where sealer depth was uneven. Inspection in the 1967-68 winter will be necessary to show whether the sealer will be pushed down, as was the case for the same type of installation on Holt Road over US 127.

Sta. 323+65
US 31BR, Holland
(Photo: 2-9-67)

Sta. 314+60
US 31BR, Holland
(Photo: 2-9-67)

Sta. 301+08
US 31BR, Holland
(Photo: 2-9-67)

Sta. 97+43
Holt Rd., Holt
(Photo: 1-10-67)

Figure 7. Experimental neoprene expansion joint installation after 1 year of service: 1-5/8-in. regular weight in 1-1/4-in. groove (left), 1-5/8-in. thin wall in 1-1/4-in. groove (left center), 1-3/8-in. thin wall in 1-in. groove, and 1-5/8-in. thin wall in 1-in. groove.
