AN EVALUATION OF
"EFFECTIVE AND DEPENDABLE" REFLECTORIZATION
FOR REGISTRATION PLATES

MICHIGAN DEPARTMENT OF STATE HIGHWAYS

Research Laboratory Section
Testing and Research Division
Research Project 69 G-172
Research Report No. R-741

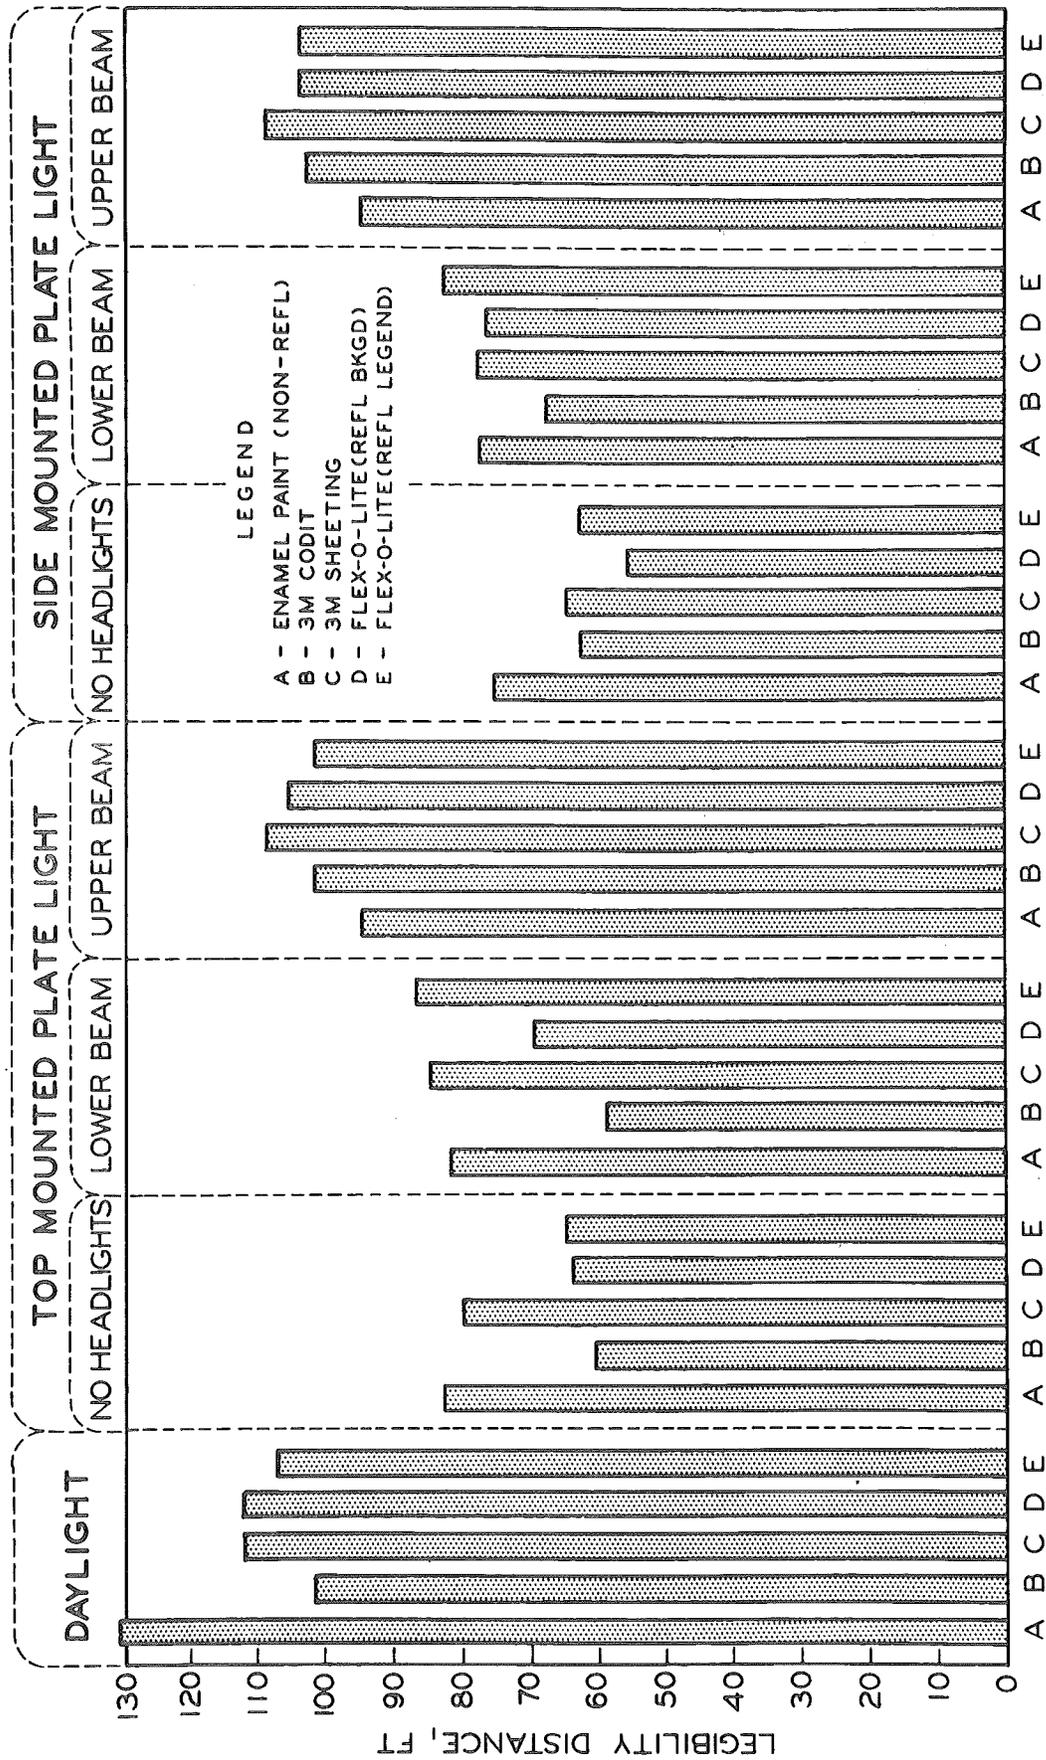
Figure 7. Effect of plate light illumination on legibility.

Without the assistance of headlights but using plate light illumination the non-reflectorized plate maintained the best legibility of all plates (Fig. 7).

In considering those lighting conditions which are most often encountered when reading a plate is necessary, daylight illumination, plate light illumination, and lower beam headlight along with plate light illumination, the observer data ranked performance of the various plates (Fig. 7) as follows:

- First: The non-reflectorized white on black plate, because it was best for two of the three lighting conditions.
- Second: The reflectorized legend plate because it was best for one of the three lighting conditions.
- Third: The non-reflectorized legend on a reflectorized background plate because they were never best and because of the following observation.

Legibility tests showed that under those lighting conditions which are most often encountered when reading a plate is necessary, a non-reflectorized white legend on black background plate and a reflectorized legend plate were the best. The non-reflectorized white on black plate was read at the greatest distances under daylight and plate light illumination conditions. While the reflectorized legend plate was read at the greatest distances under the combined illumination from lower beam headlights and plate lights. As mentioned earlier, plates with a white non-reflectorized legend on a gold reflectorized background show the poorest legibility performance because at night the gray appearing legend can easily blend into the background color.

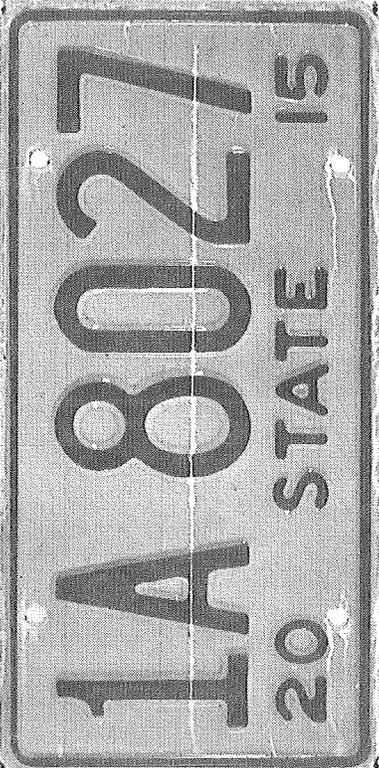
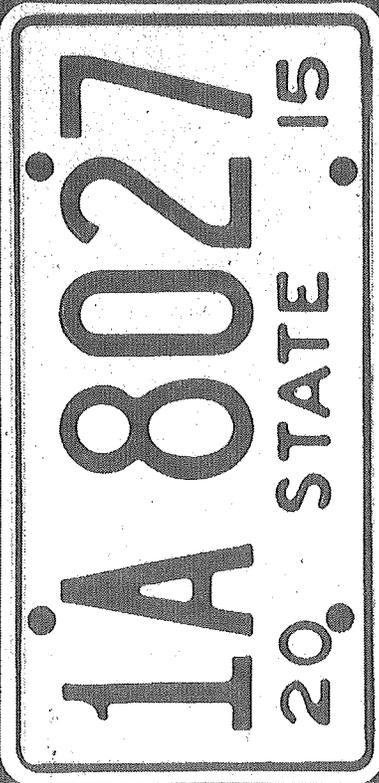
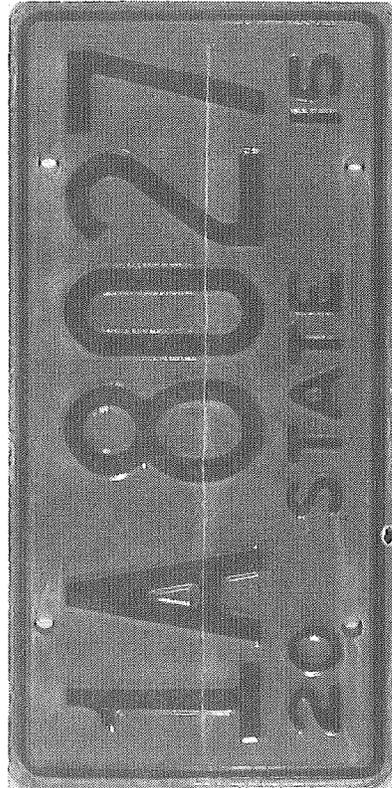
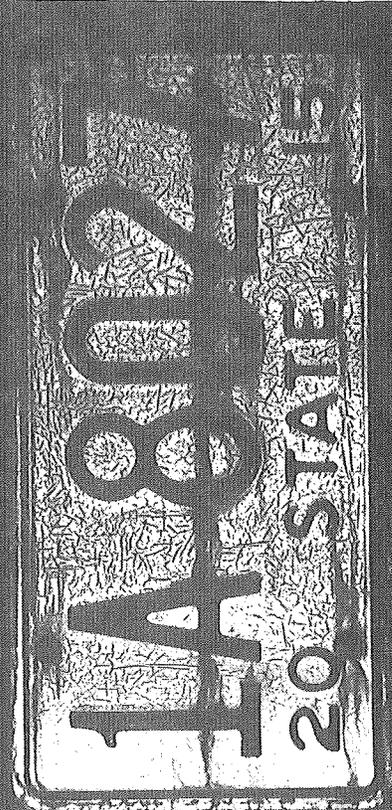
Figure 2. 3M sheeting, 1-year durability.

A. 200 hours Weathering - 100 hours Salt Spray

B. Appearance Prior to Testing

C. 800 hours Weathering - 200 hours Salt Spray

D. 800 hours Weathering - 200 hours Salt Spray

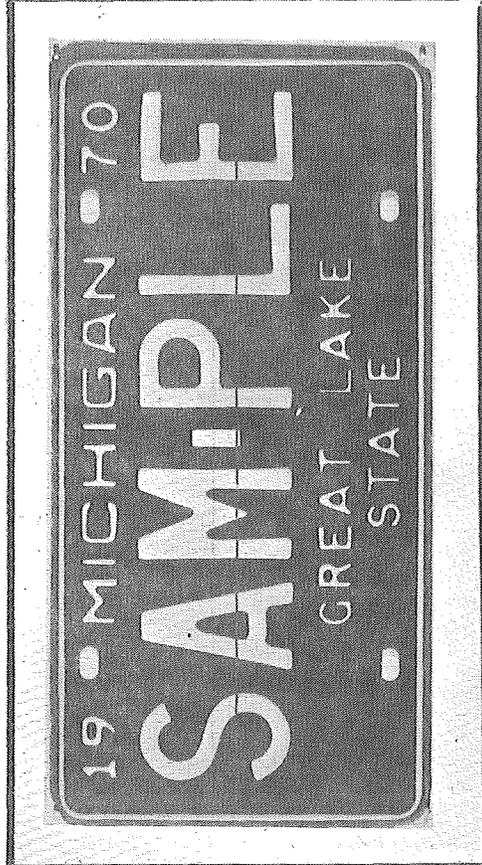
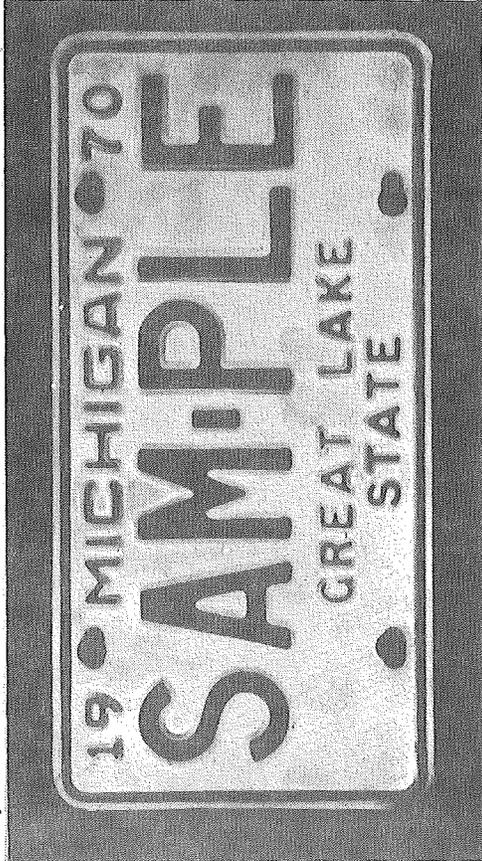
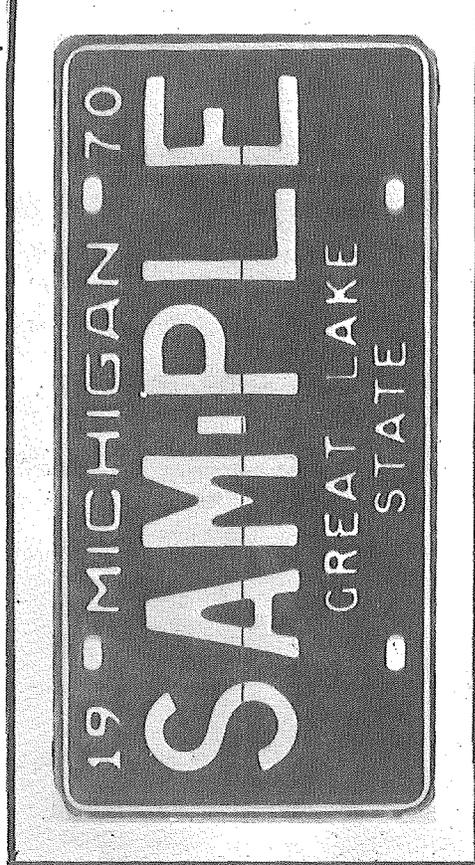
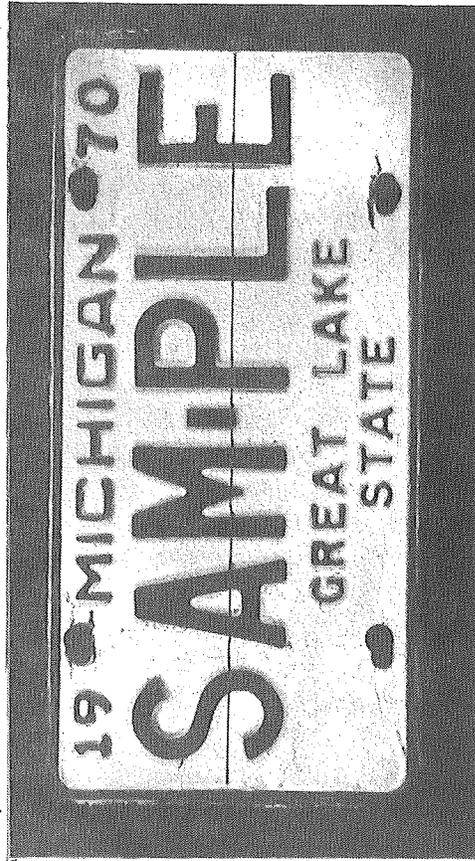
Figure 4. Flex-O-Lite, unknown durability.

Figure 4 shows Flex-O-Lite's plates 37B having a reflectorized background. Again the daylight to nighttime appearance change is obvious. Corrosion exposure and weathering had very little effect on this plate, however, losses about the perimeter of the plate are evident.

A. 200 hours Weathering - 100 hours Salt Spray

B. Appearance Prior to Testing

C. 800 hours Weathering - 200 hours Salt Spray

D. 800 hours Weathering - 200 hours Salt Spray

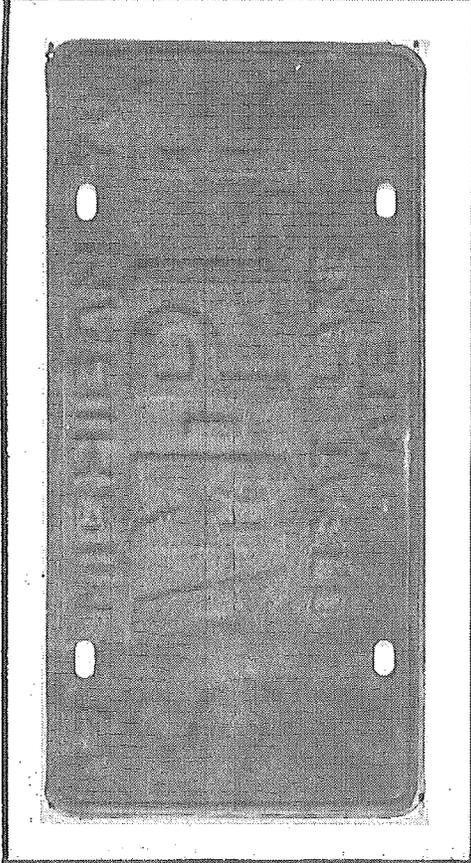
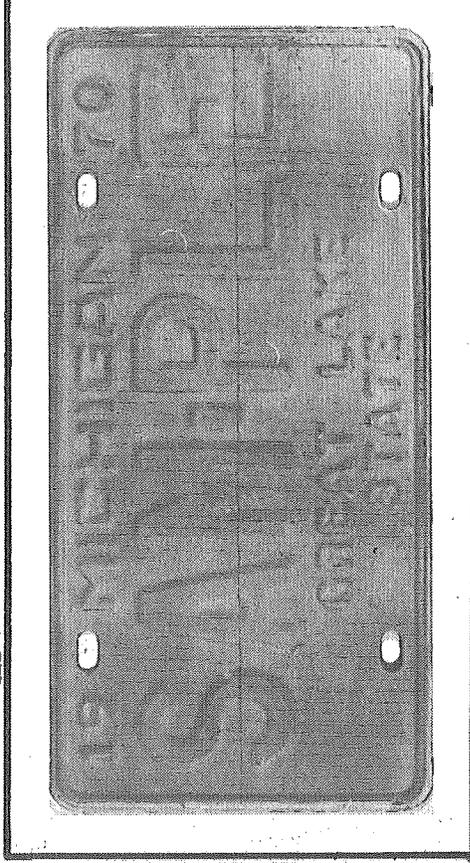
Figure 6. 3M Codit.

A plate made from 3M's Codit is shown in Figure 6. Weathering and corrosion had little effect but the poor uniformity of reflex performance is obvious.

A. 200 hours Weathering - 100 hours Salt Spray

B. Appearance Prior to Testing

C. 800 hours Weathering - 200 hours Salt Spray

D. 800 hours Weathering - 200 hours Salt Spray
