EFFECTIVENESS OF NEOPRENE SEALS
IN PREVENTING CONCRETE PAVEMENT
CONTRACTION JOINT DETERIORATION

F. J. Bashore
A. W. Price

A Highway Planning and Research Investigation
Conducted by the Michigan Department of Transportation
In Cooperation with the U. S. Department of Transportation,
Federal Highway Administration

Research Laboratory Section
Testing and Research Division
Research Project 73 G-195
Research Report No. R-1122

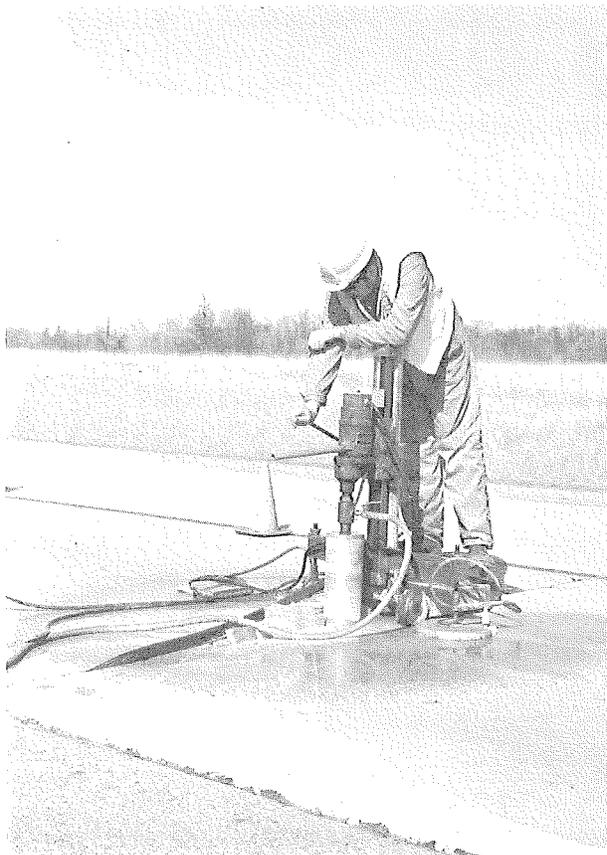
Figure 2. Cutting core with portable electric coring unit.

Cores were usually taken at the center of the traffic lane and the locations of the dowel bars were determined with a Pachometer so that the core could be taken between them. This was quite critical in slip-form paved projects where it was found that the location of the dowel bars was more variable than with formed paving. The cores were cut with a 6 in. (15.2 cm) diameter diamond-tipped hollow bit attached to an electric portable drill rig. The rig was held in position using two vacuum pads (Fig. 2).

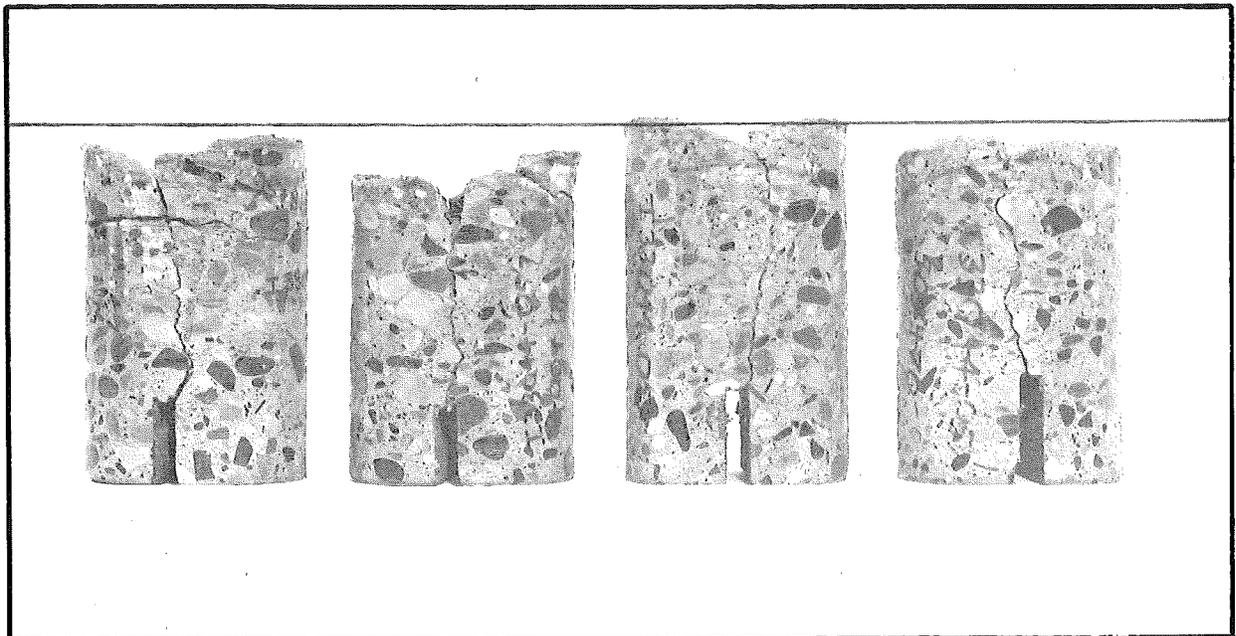
Figure 6. These four cores are from the same seven-year old pavement. The two on the left are from joints where the seal ended at the pavement edge and the two on the right are from joints which had the seal extending down the vertical edges. The line represents the average original depth of concrete. The cores are shown upside down.

joints. The core samples from the section where the seal was terminated at the pavement edge, consistently showed more deterioration (Fig. 6 and Table 6). It was also observed that much more silt was usually present in the contraction crack in this type of joint.

- 2) The neoprene seal should extend down the vertical edge of the pavement because no effective method has been found to seal the end of the joint when the seal is terminated at the horizontal end of the joint groove.

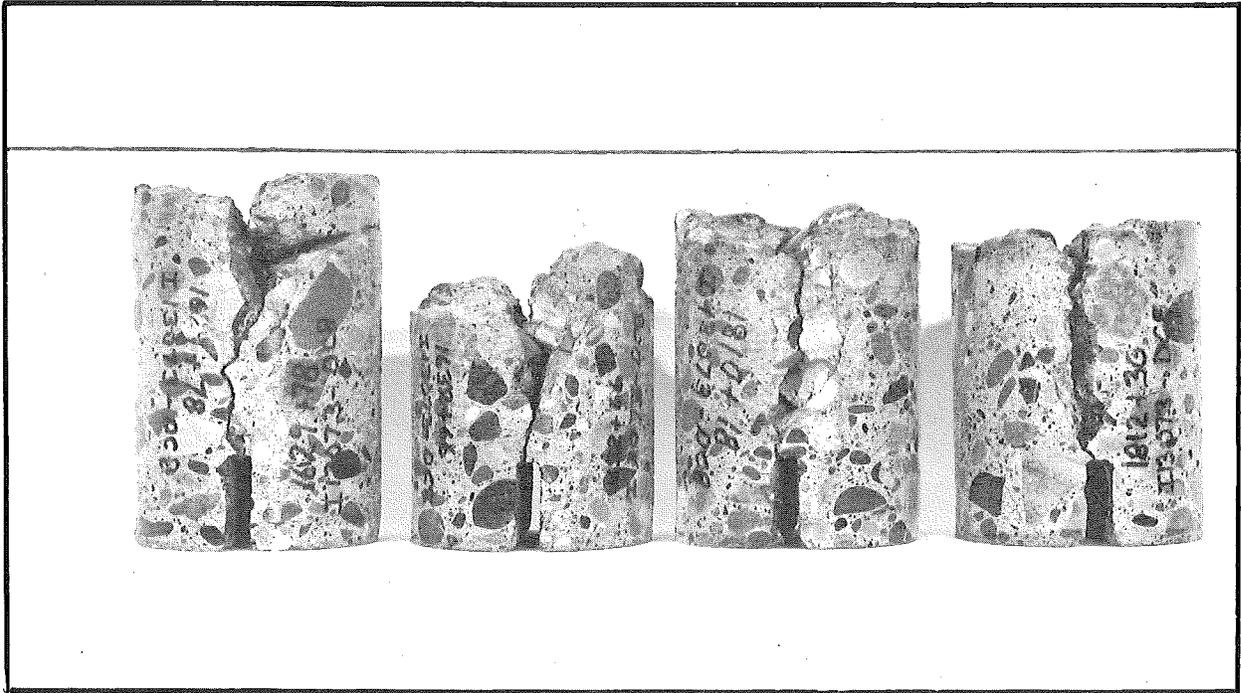
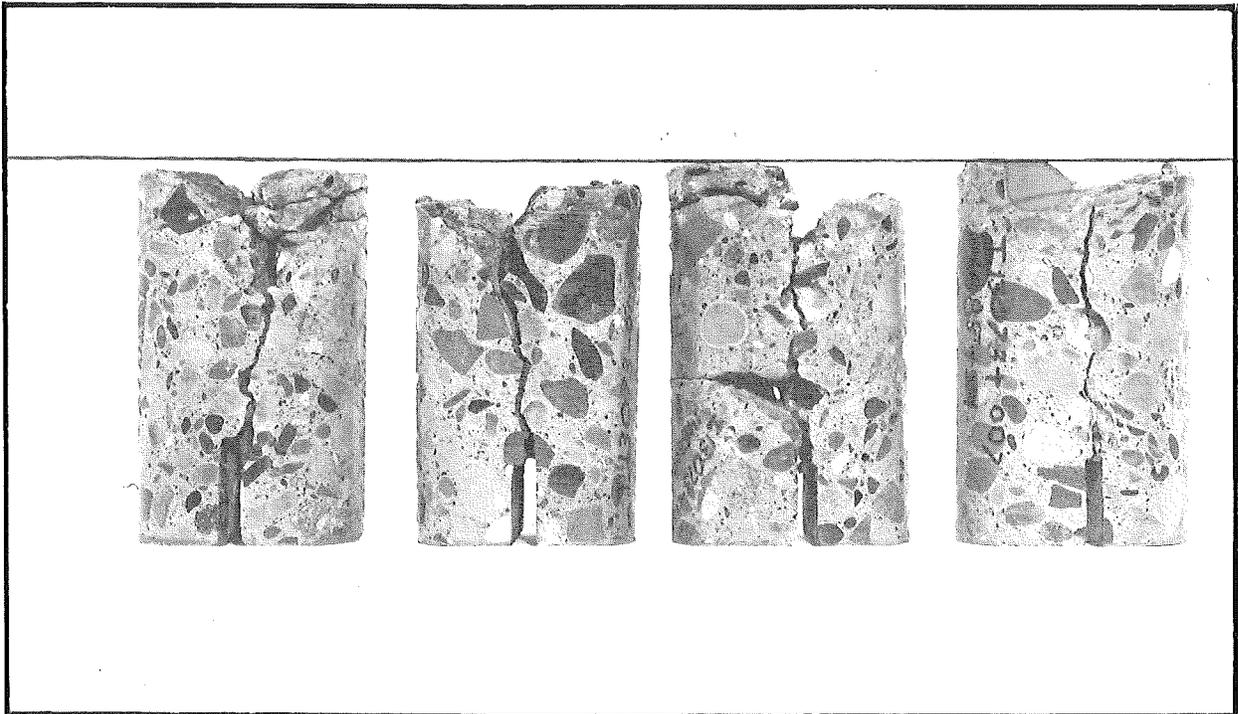
One project (I 13073D, C8) with steel baseplates under the joints was included in the study for the purpose of evaluating their effect on concrete deterioration below the joint groove. An adjacent project (I 13073-007) of the same age without baseplates was selected for comparison. Examination of the data shows that the project with baseplates had more deterioration than any of the other projects and significantly more than the adjacent project (Figs. 7 and 8).

Figure 8. Cores taken from adjacent projects when the pavement was seven years old. The group above represents the baseplate project and the group below is the non-baseplate project. The line in both photographs represents the average thickness of the pavement at the core location. The cores are shown upside down.
