FINAL REPORT ON  
JOINT LOAD TRANSFER TEST ROAD TO  
EVALUATE ACME LOAD TRANSFER ASSEMBLIES,  
PLASTIC COATED DOWELS AND END-OF-POUR  
CONSTRUCTION JOINT ASSEMBLIES

Research Laboratory Section  
Testing and Research Division  
Research Projects 67 F-95  
and 68 F-104  
Research Report No. R-1137

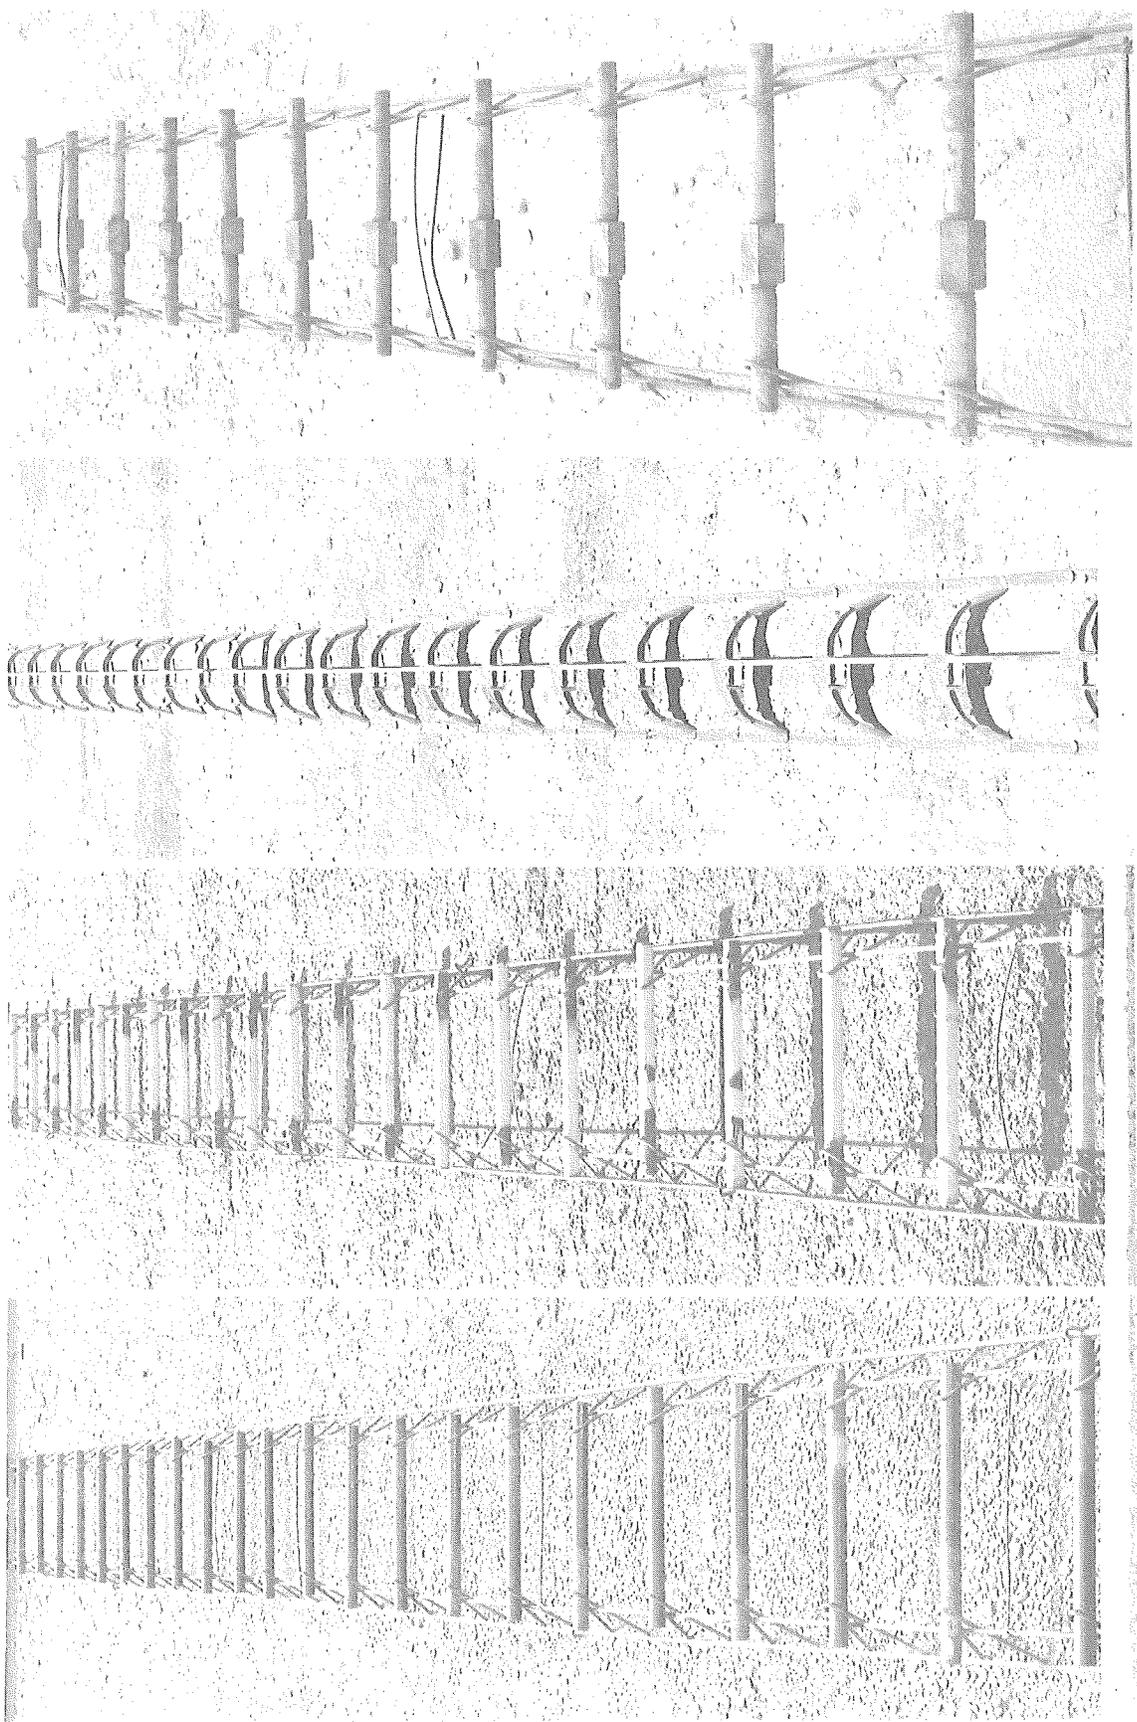
Figure 3. Standard MDOT and experimental load transfer assemblies.

Standard dowel bar assembly.      Assembly with plastic coated dowel bars.      Acme assembly.      End-of-pour assembly.

1) Michigan's Standard Assembly - Load transfer is accomplished using 1-1/4-in. diameter steel dowels 18 in. long. The dowels are held in a wire frame on 12-in. centers and at mid-depth of the slab. Alternate ends of the dowels are welded to the frame. The free dowel ends are sawed to maintain their roundness and thereby reduce restraint of movement. To prevent bonding of the concrete to the free dowel end, a coating of liquid asphalt RC-250 is applied for not less than 2/3 of the length of each dowel.

2) Assembly with Plastic Coated Dowels - This assembly is identical to the standard assembly except the dowels are coated with a plastic material. The coating consists of a 4-mil thick adhesive material overlaid by a 17-mil thick high density polyethylene material. The coating system is applied by an extrusion process before the dowels are sawed and welded into the wire frame. The plastic coating prevents bonding of the concrete to the dowels, thus eliminating application of a bond-breaker in the field. In addition to acting as a bond-breaker, the plastic coating also minimizes corrosion of the steel bar.

3) Acme Assembly - This assembly utilizes malleable iron castings to accomplish load transfer. Each individual transfer unit within a 12-ft assembly consists of a female and male casting which engage for a distance of 1-1/2 in. at the center of the assembly. The castings are straight in the engagement area but then curve down and outward and are fastened to sheet metal angles designed to support the assembly on the subbase. Spacing of the individual units at the center of the assembly is maintained by fastening to a metal plate. Assemblies are designed for load transfer at the mid-depth point of the slab. The assembly is held together during handling and installation by crimping the female casting, which is open on one side, onto the male casting. Because the sliding portion of the units is enclosed on three sides and is only 1-1/2 in. long, no bond breaker needs to be applied in the field before installation.

4) End-of-Pour Assembly - This assembly differs from a standard contraction joint assembly in two ways: first, the dowels consist of a 7-1/2-in. length of bar threaded into one end of a 3-in. long sleeve, and a 10-1/2-in. bar threaded into the other sleeve end, and; secondly, the plain ends of the shorter dowel pieces are welded to one assembly side frame; whereas, the other side frame is clipped onto the longer dowel pieces. This design permits the dowels to be supported independently of the bulkhead and allows removal and replacement of the half assembly extending into the second pour area.

Figure 3 illustrates an assembly of each type. Since the construction was performed in accordance with Standard Specifications the test sections contain expansion joints at intersections of other structures and at the PC's and PT's of curves.

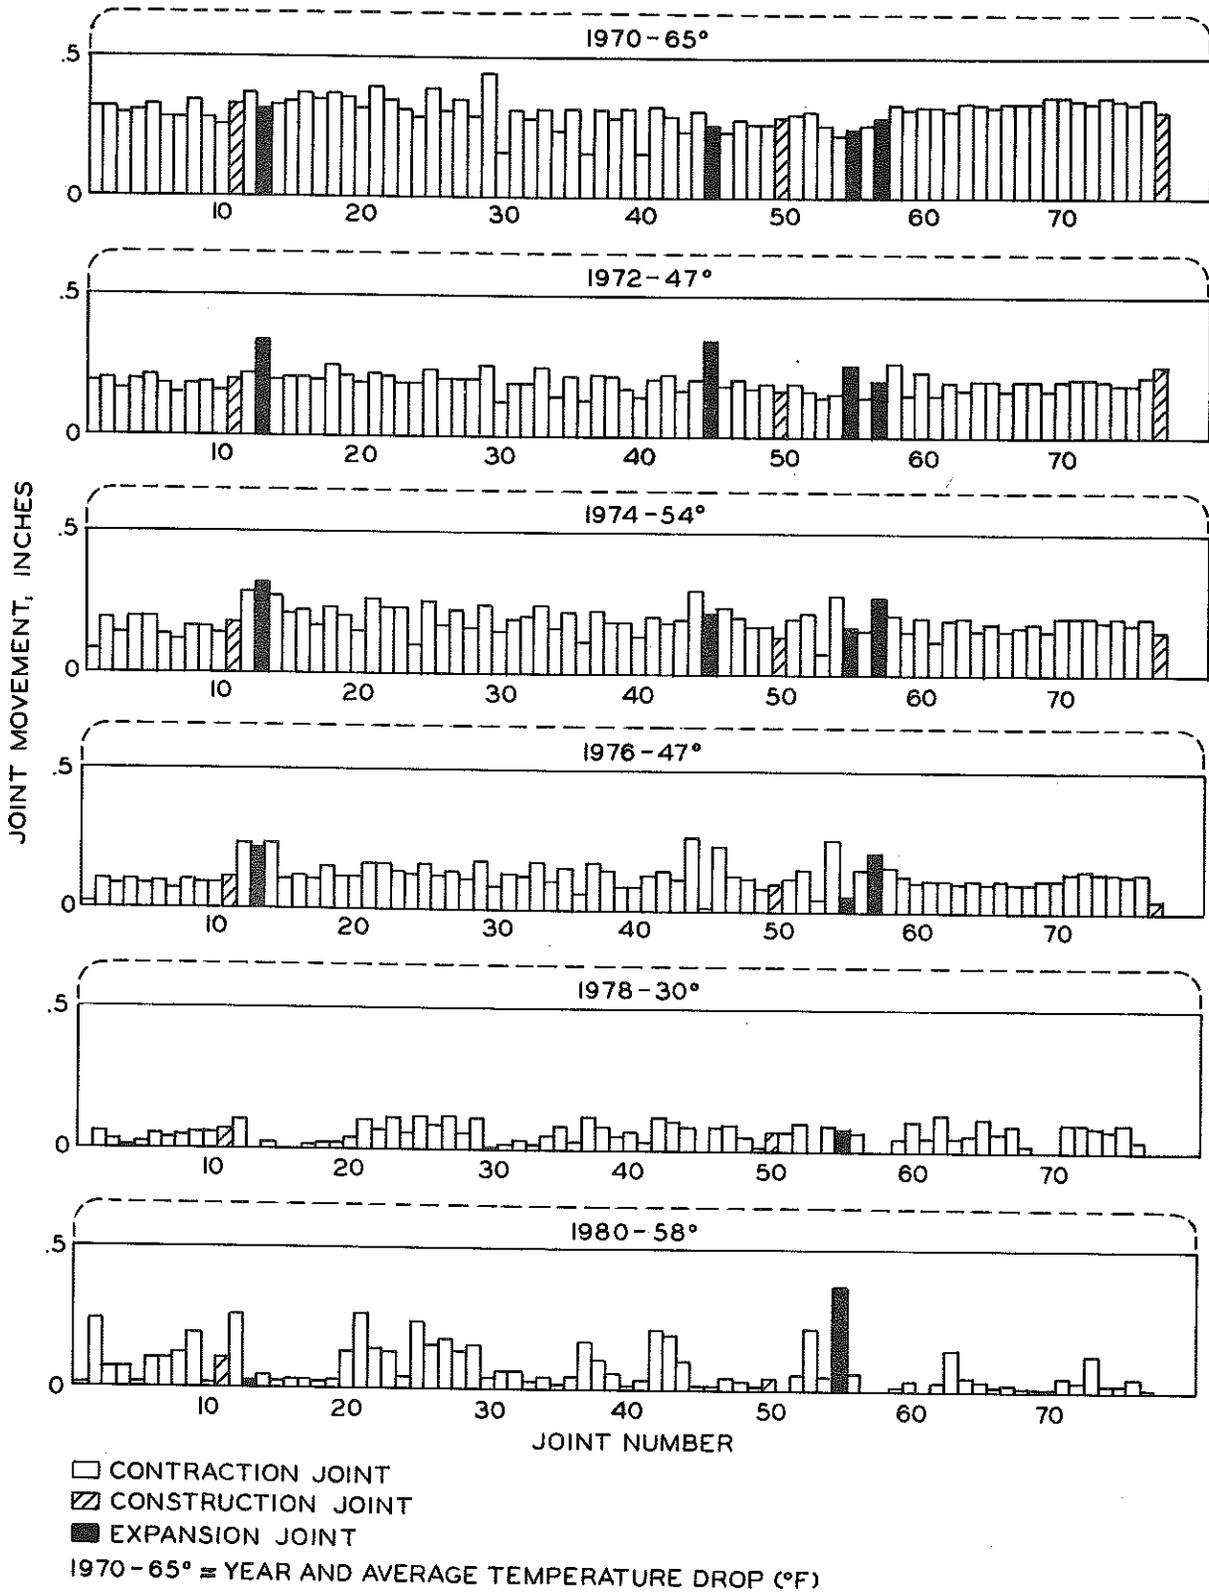
Figure 4. Ten-year period of semiannual joint movements (openings) for each joint caused by the temperature drops shown (standard steel dowels).

Joint Movements - In order for a pavement to perform satisfactorily for its design life it is necessary that the joints continue to open and close freely and to move a nearly uniform amount. However, under normal service conditions this is seldom the case, but rather joint movements vary considerably in amount especially with time, when some joints cease to move at all. To demonstrate the nonuniformity of joint movements (openings) over a 10-year period, semiannual movements of each joint for various temperature drops are shown in Figures 4, 5, and 6 for standard steel dowels, Acme dowels, and plastic coated dowels, respectively.

The amount of movement resulting from cooling the pavement depends on the magnitude of the temperature drop involved. This can be seen on the graphs by comparing the movements to the temperature change. For example, the amount of movements shown in 1970 for a 65 F change for the three joint types are much larger than those recorded in 1978 for a 30 F change.

On a given section of pavement there are several factors, such as dowel restraint, uniformity of concrete mix, curing conditions, pour temperature, and subgrade friction that influence the uniformity of joint movements. For the three sections involved on this project it appears that, in general, joints with 'small' movements the first year will continue to have small movement and similarly, joints with 'large' openings the first year show the same pattern of movement. This initial as well as subsequent non-uniformity from joint to joint can be noted on the graphs by observing the peaks and valleys of the bars representing the joint movements. Basically, the variation in movements stayed nearly the same through 1976 but by 1978 the movements are much more erratic, especially in the section containing standard steel dowels. By comparing the graphed movements, it is evident that the joints with plastic coated dowels moved more uniformly than the Acme or standard dowelled joints throughout the 10-year period.

The reason for the dramatic change in joint movement in the standard dowelled section in 1978 and even more noticeable in 1980 is that numerous imminent or complete steel fractures have occurred. Once the steel fractures or yields all or some of the movement occurs at the crack. The location of steel fractures and their effect on the 1980 joint movements are shown in Figure 7. As can be seen, the movements are affected more in the standard section than in the sections with Acme and plastic coated dowels. The reason for this is that the dowel restraint of Acme and plastic

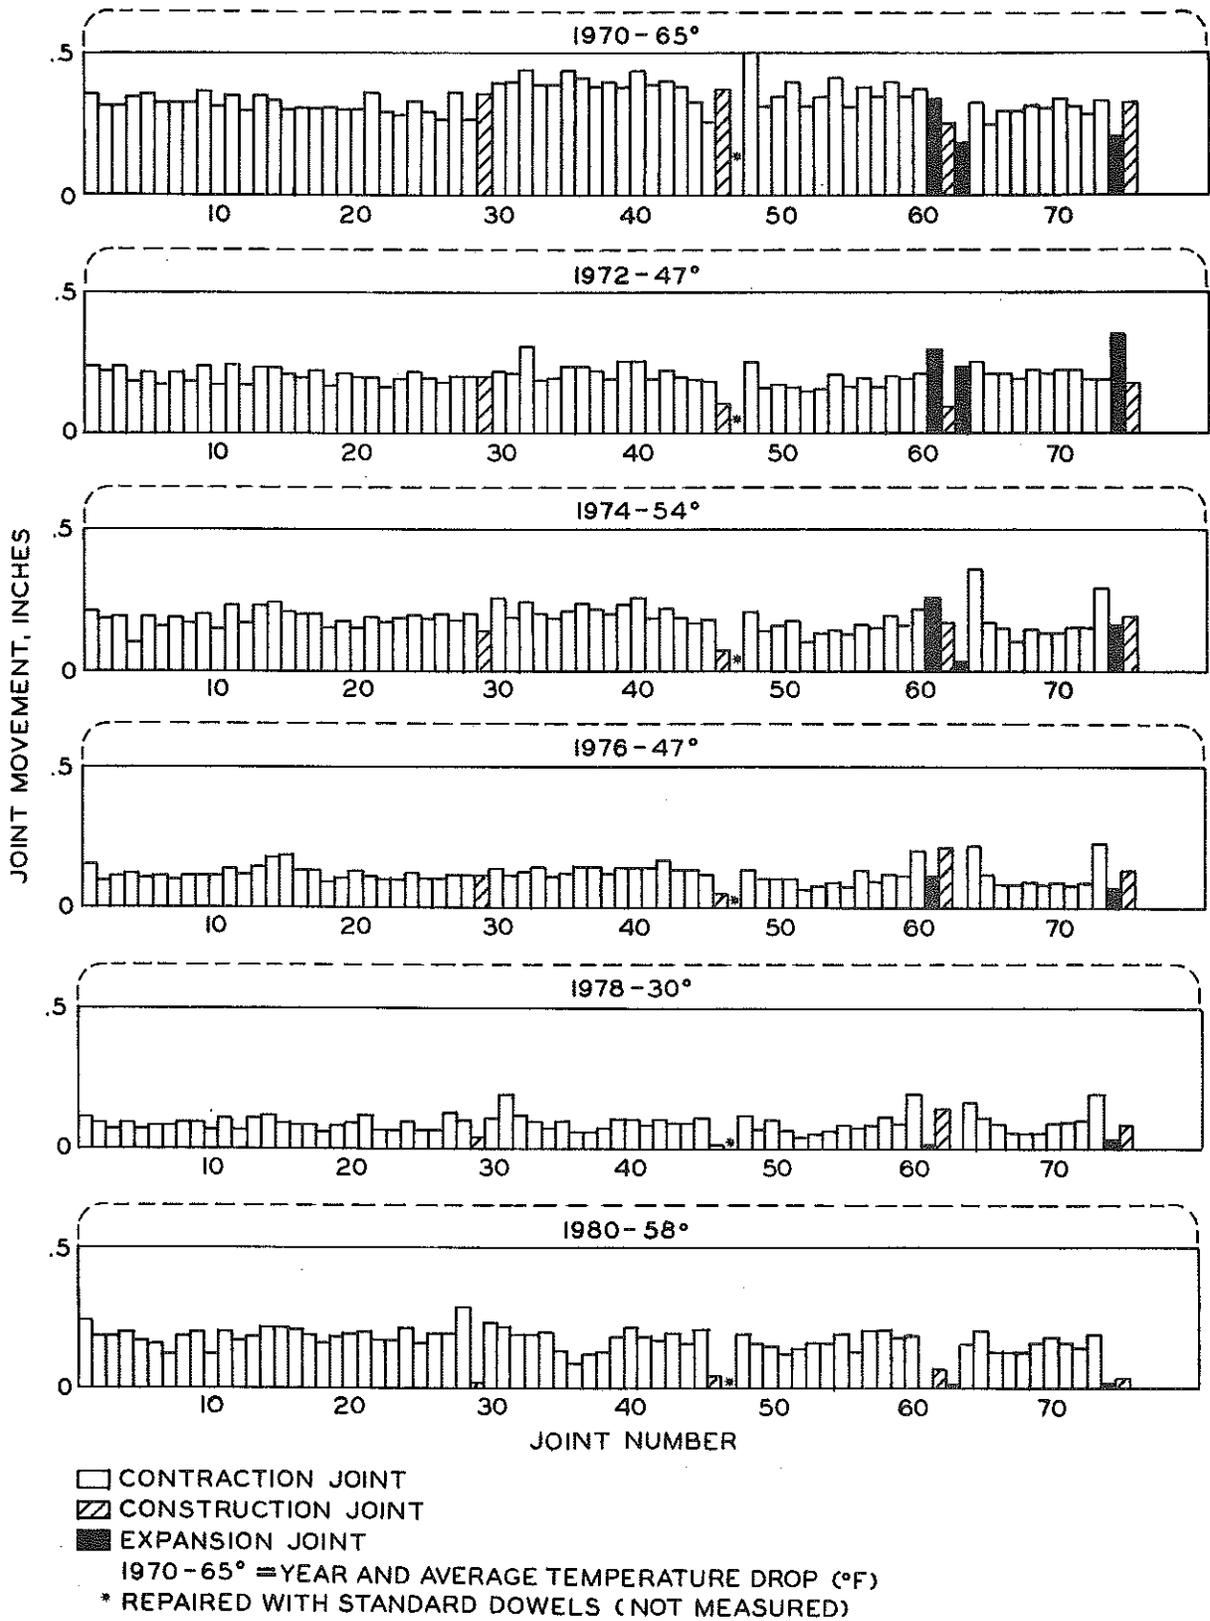
Figure 5. Ten-year period of semiannual joint movements (openings) for each joint caused by the temperature drops shown (Acme dowels).

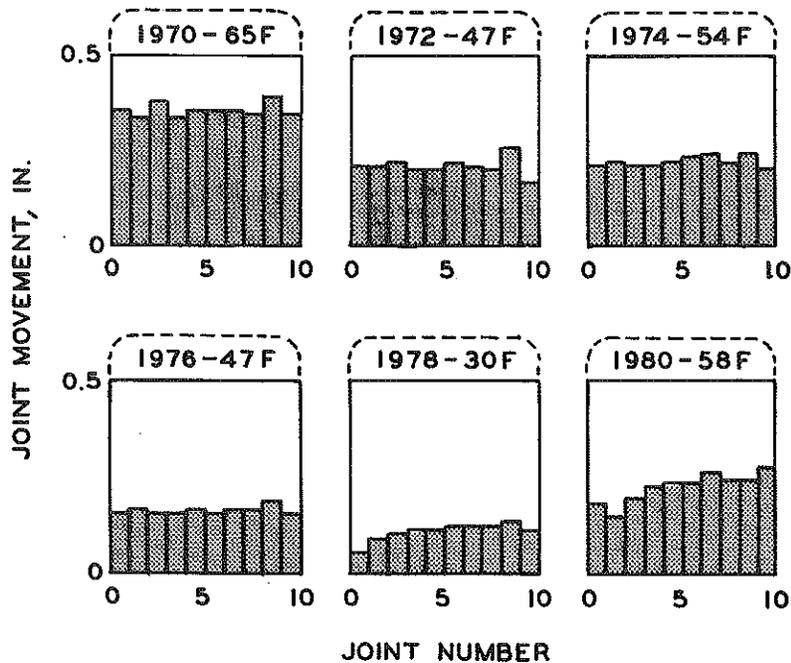
1970 - 65F = YEAR AND AVERAGE TEMP. DROP

Figure 6. Ten-year period of semiannual joint movements (openings) for each joint caused by the temperature drops shown (plastic coated dowels).

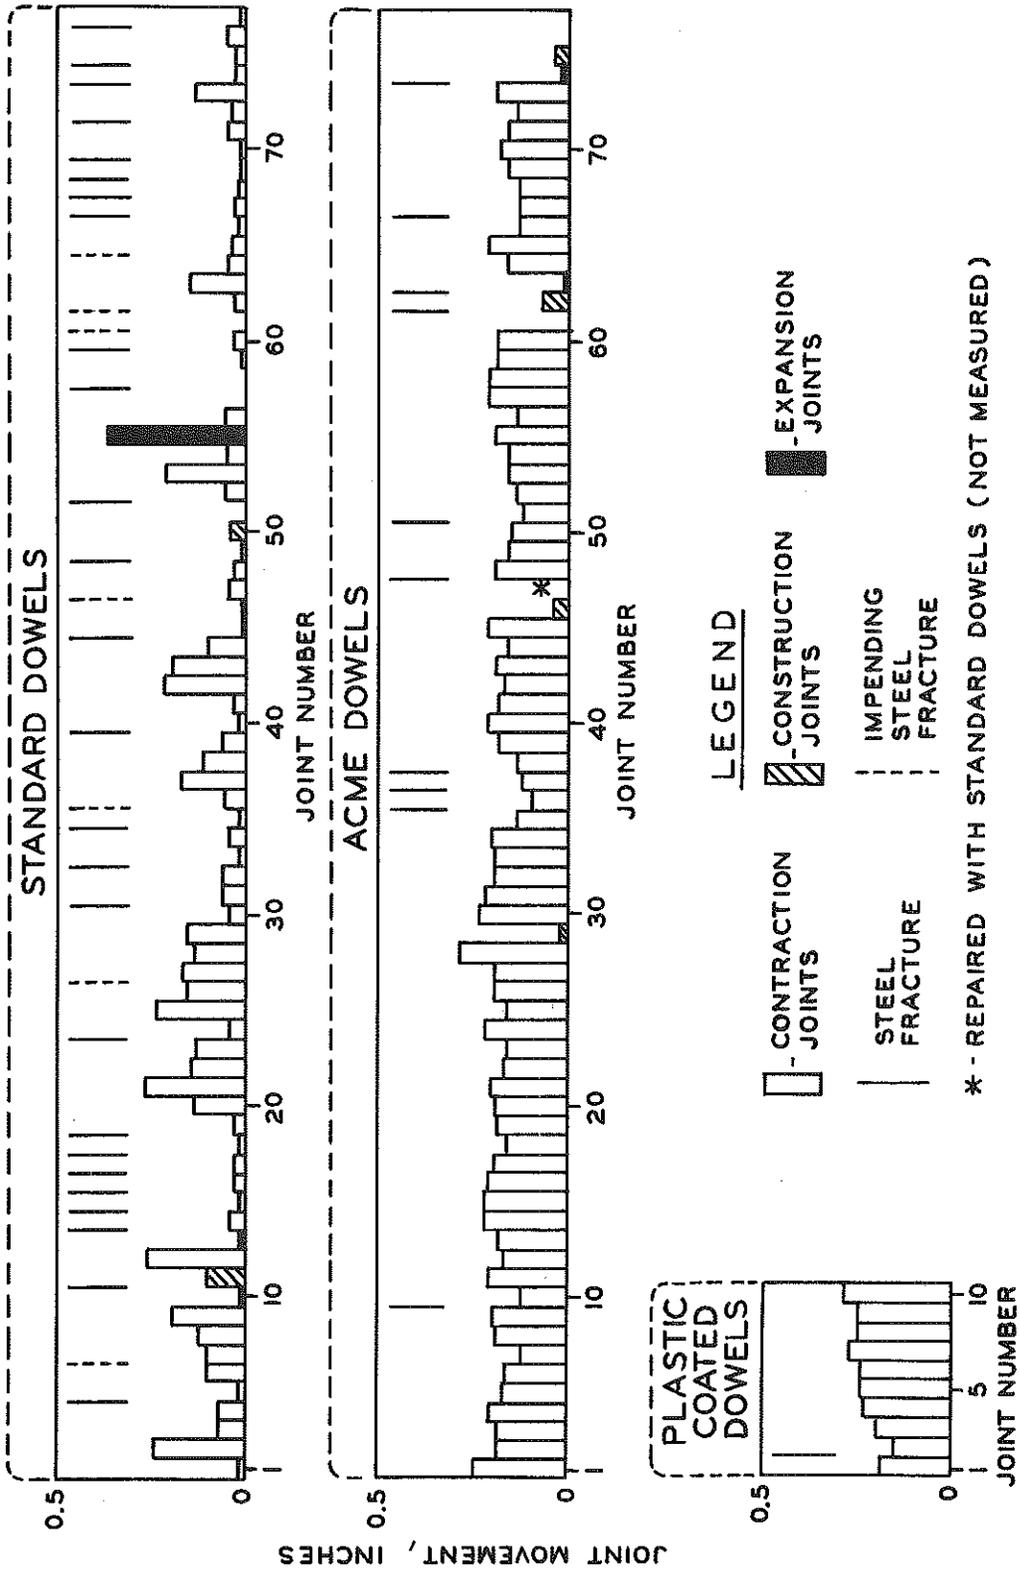
Figure 7. Effects of fractured steel on joint movements after 10 years of service.

coated dowels is low and the joints adjacent to the untied cracks continue to open an amount proportional to the new slab length; whereas, the restraint of the standard dowels is so great that nearly all the movement is transferred to the crack.

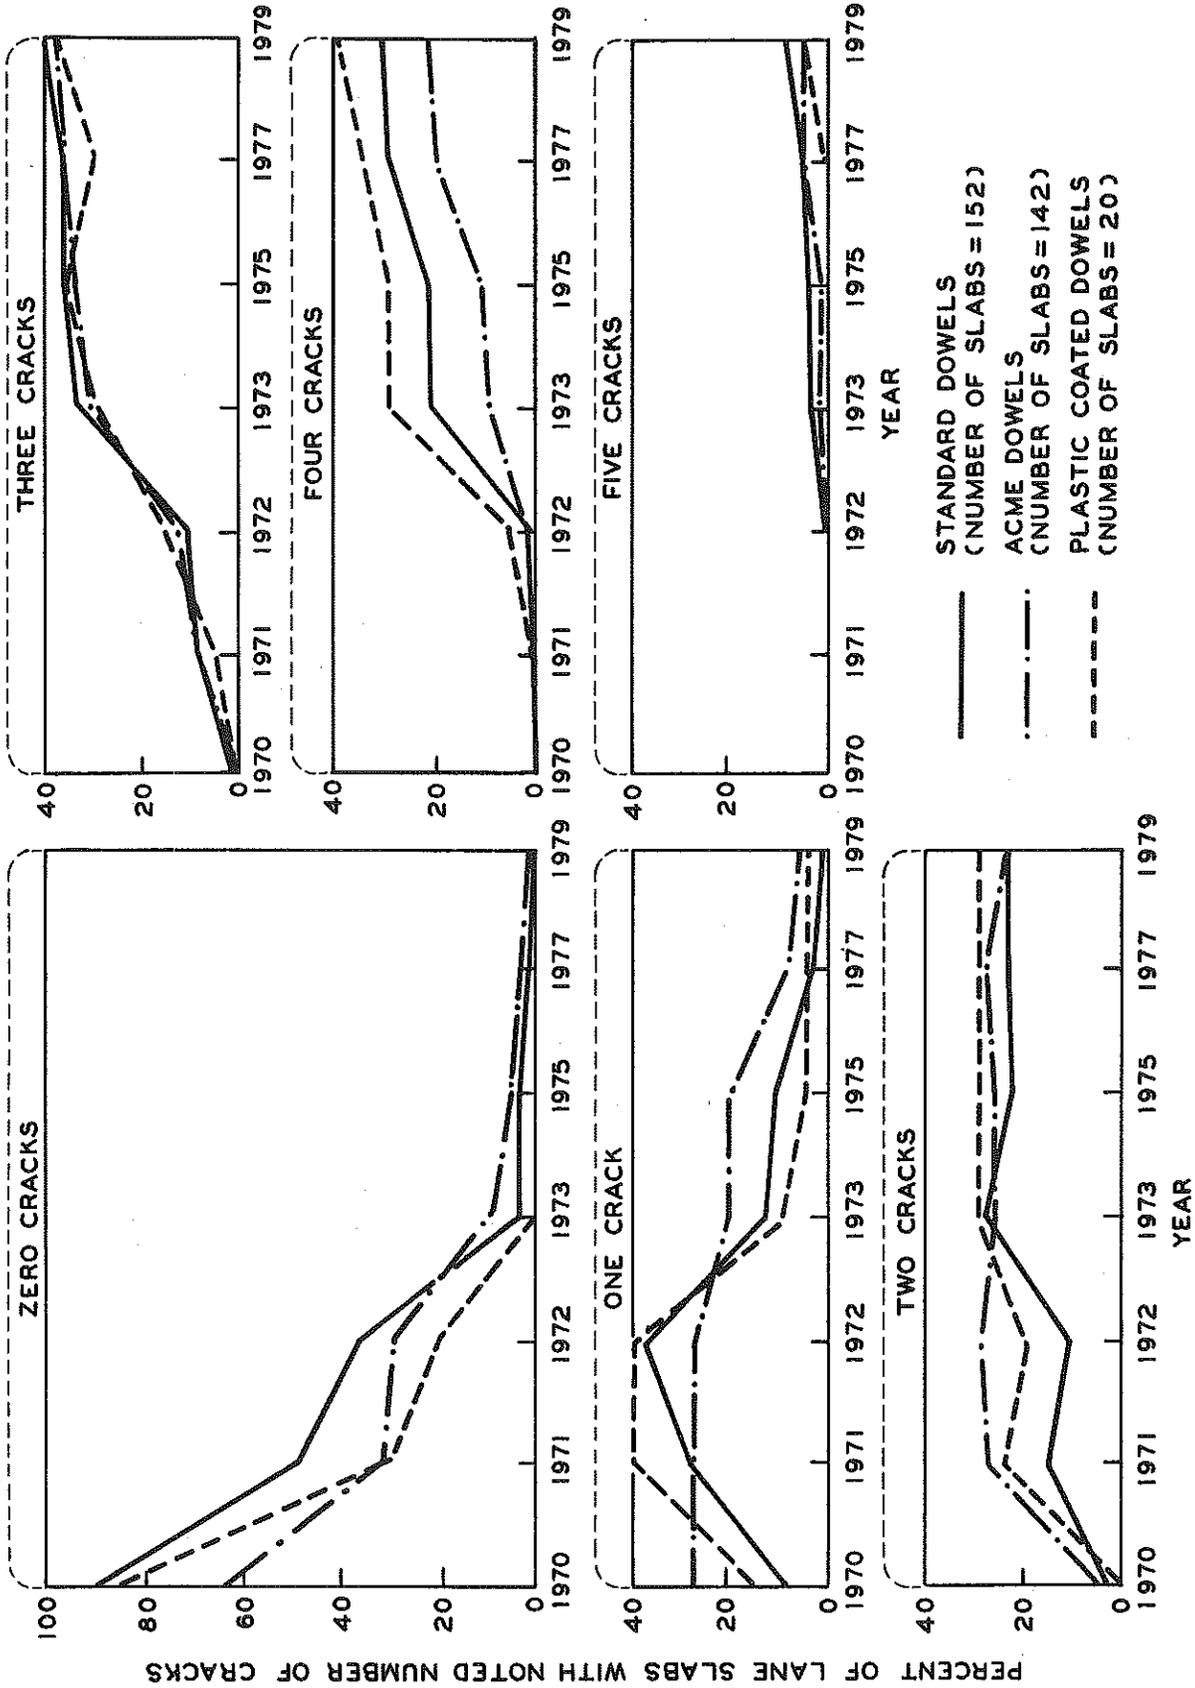
Figure 8. Percent of slabs in standard, Acme, and plastic coated dowel sections with zero to five cracks per slab at yearly intervals, 1970 through 1973, and then semiannually through 1979.

Figure 8 shows the frequency distributions of the number of cracks per lane slab in each of the three pavement sections being evaluated. The distributions are given at yearly intervals through 1973 and then every other year through 1979. Basically, the formation of cracks has followed the same pattern in each test section as can be seen on the graph by noting that the lines are only separated by a few percentage points. After four years of service the crack pattern was rather well established and by the end of 10 years nearly all slabs had cracked. Also, after 10 years, 90 percent or more of the slabs in each section had two or more cracks per slab.

As previously mentioned, the Acme dowels offer very little, if any, resistance to slab contraction, and plastic coated dowel restraint after four years embedment is only about one-fourth of that for standard steel dowels lubricated with asphalt. Apparently, for this pavement, dowel restraint has a minor effect on crack formation, but appears to have a significant relationship to steel fracture. For example, after 10 years' service the standard dowelled section contained 52 lane slabs with fractured steel, the Acme section had 20 lane slabs with steel fractures and 2 lane slabs in the plastic section had fractured steel (Fig. 7). It should be noted that eight of the fractures in the Acme section are in slabs joined by either a construction or expansion joint containing steel dowels. Eliminating these fractures, the percent of slabs fractured in the standard, plastic coated, and Acme dowelled sections are 34, 10, and 9, respectively. Table 2 lists the number of lane slabs with zero to six transverse cracks per slab and the number of these slabs with cracks containing fractured steel. As can be seen, steel fractures have occurred mostly in slabs with three or more transverse cracks. Also, the relatively large number of slabs with fractured steel in the section containing standard dowels would indicate that increased dowel

restraint induces more steel fractures. However, other factors are involved in the process leading to steel fractures, because the Acme dowels do not restrain slab contraction, yet six slabs have cracks with fractured steel. Nevertheless, the four to five time reduction in steel fractures experienced on the experimental sections certainly is significant and the use of load transfer devices that will function for years with little or no resistance to movement is of utmost importance.

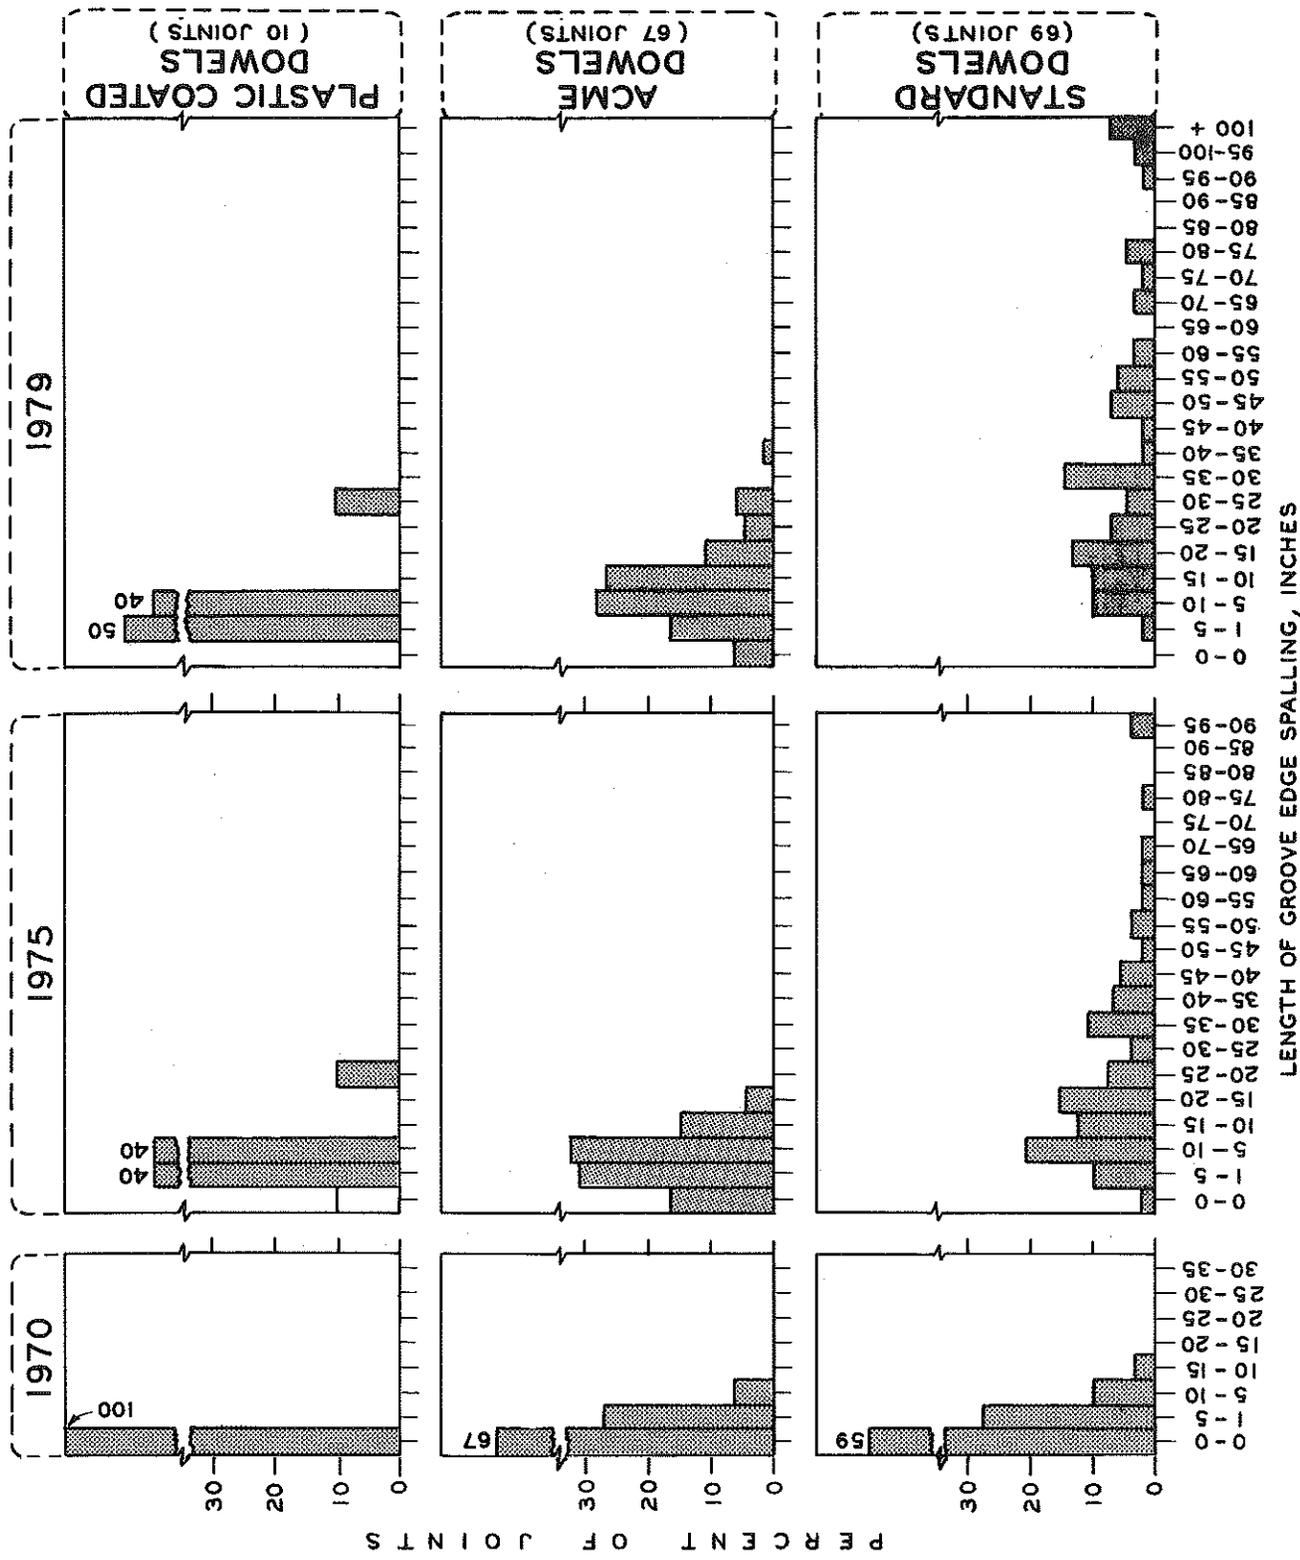
Figure 9. Histogram of contraction joint groove edge spalling in sections with the three different dowel types after 1, 5, and 10 years' service.

The length of groove edge spall on each contraction joint was estimated at yearly intervals. Spalls less than 1 in. wide were not included in the estimate. Figure 9 shows the distribution of the percent of joints with different amounts of spalls in each of the three pavement sections after 1, 5, and 10 years' service. After one year's service, 59, 67, and 100 percent

of the joints in the standard, Acme, and plastic coated dowelled sections, respectively, were without any spalls. After five years nearly all of the joints had spalled to some degree in the standard section. Thirty-six percent were spalled more than 25 in.; whereas, in the Acme and plastic coated dowelled sections all joints had spalled less than that amount. The 1979 graph shows that spalling in the standard section is still more severe than in the other two sections. In the plastic coated dowelled pavement, 90 percent of the joints had 10 in. or less of spall, while in the Acme dowelled section, 51 percent were spalled 10 in. or less. In the standard dowelled section, however, only 12 percent of the joints had spalls 10 in. or less in length. In all sections, most spalls were between 1 and 2 in. wide. The typical appearance of the spalls is shown in Figure 10.

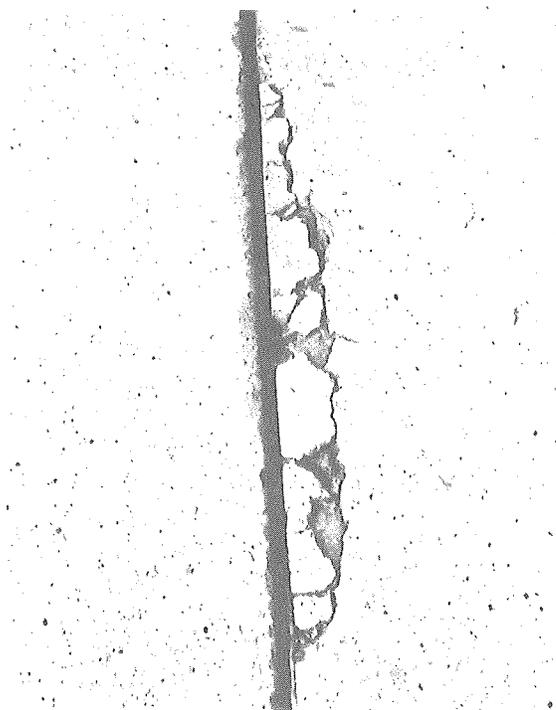
Figure 10. Condition of typical spall in neoprene sealed contraction joints; 10 years' service.

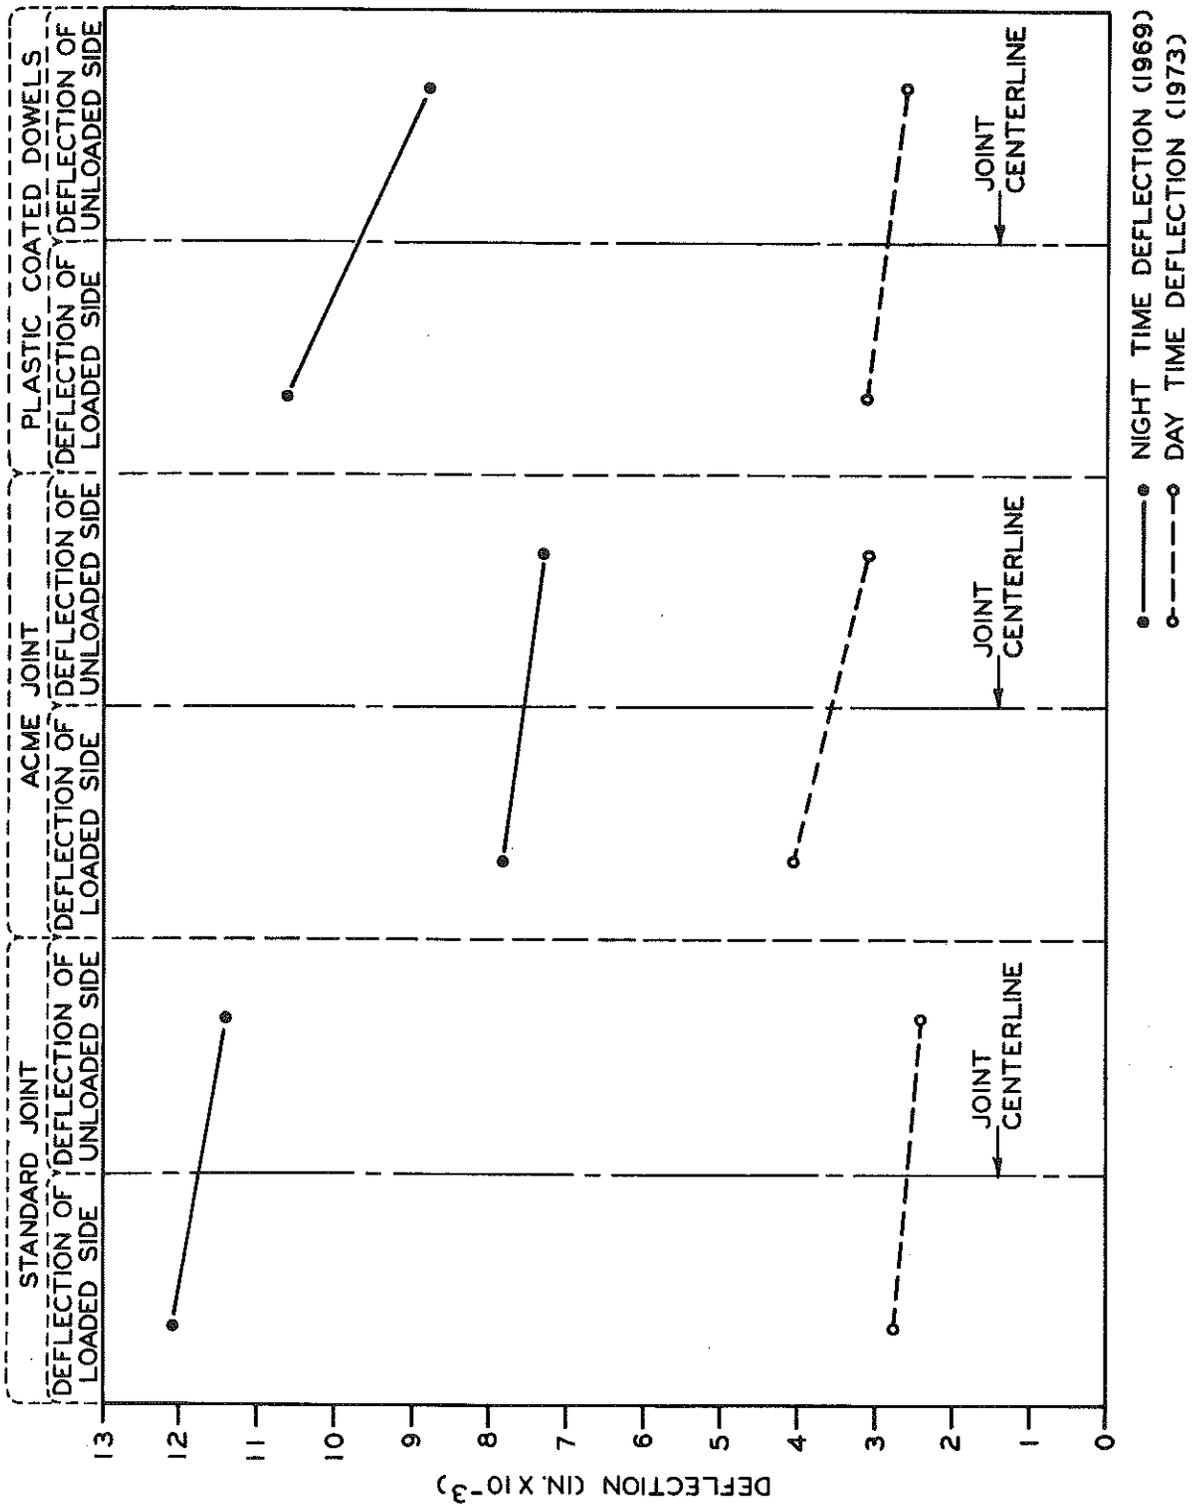
Figure 11. Deflection at joints in each test section.

The deflection measurements of the loaded and unloaded side obtained in each test section were averaged to obtain one value for each type of load transfer device. Figure 11 shows the average deflection across a joint of each type. The low values recorded for the daytime tests reflect the difference in warping condition of the pavement at the time the two tests were conducted.

The load-transfer effectiveness is defined as the ratio of the deflections of the unloaded side of the joint to the loaded side. As expected, and as can be seen in Figure 11, the unloaded side of the joints always deflected less than the loaded side which indicate none of the devices are 100 percent effective in transferring load. On the basis of the recorded deflections, the load transfer effectiveness of the standard assemblies was 94 percent in 1969 and 89 percent in 1973. The effectiveness of the Acme assemblies changed from 94 percent to 77 percent, whereas, for the plastic coated dowels there was no change from the 83 percent obtained in 1969. The results indicate that the standard and plastic coated dowels are performing better with respect to load transfer than the Acme units.

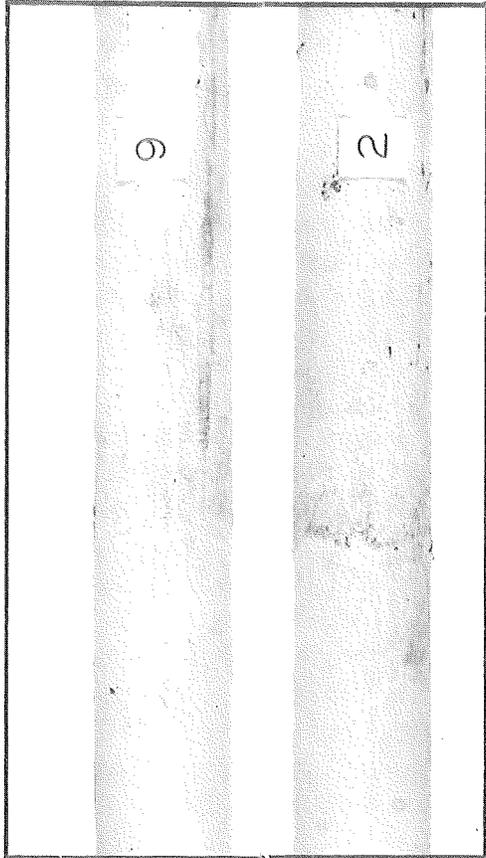
Figure 12. Corrosion of standard dowels after four years of service.

The dowels contained in the concrete blocks removed after four years' service were examined for corrosion. Figure 12 shows the condition of the standard dowels; as can be seen, rusting has commenced. The affected portion of the bars was at the joint centerline and is about 1 in. long. The deepest penetration, 1/8 in., was measured on bar No. 30. A depth of 1/16 in. was measured on both bar Nos. 22 and 26.

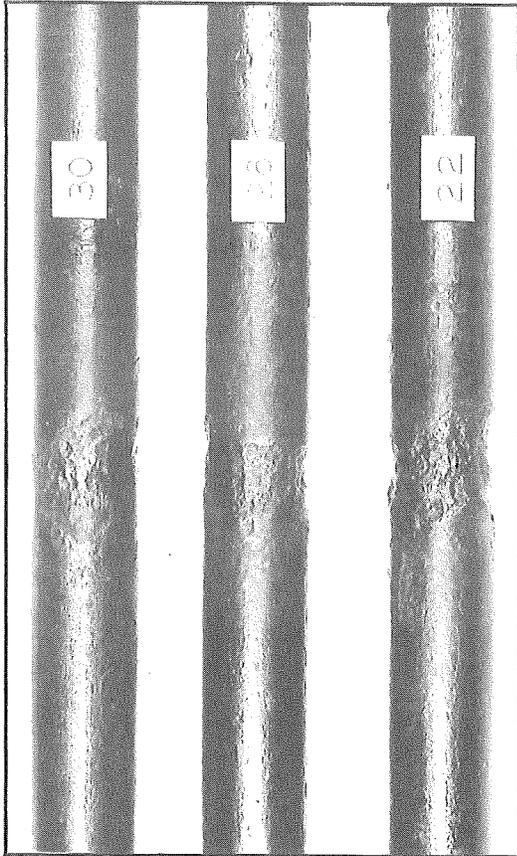
Figure 13. Plastic coated dowels after four years' service show no corrosion.

The plastic coated dowels removed from joint Nos. 2 and 9 did not exhibit any signs of corrosion (Fig. 13). The plastic coating was stained in the joint crack area but was without creases or cracks. Figure 14 shows the bar removed from joint No. 6, where as previously mentioned, the plastic coating had split prior to concrete pouring. As a result the bar had corroded in the joint crack area to a depth of 1/8 in.

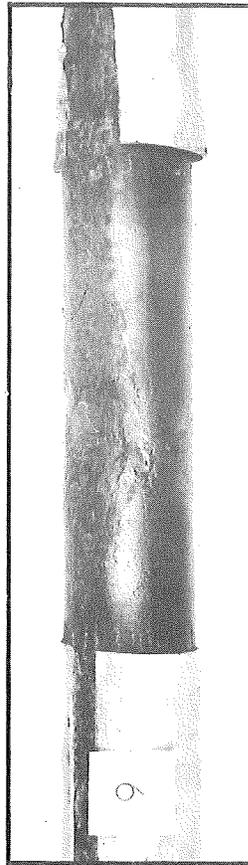
Figure 14. Plastic coated dowel with damaged coating shows corrosion in joint crack area.

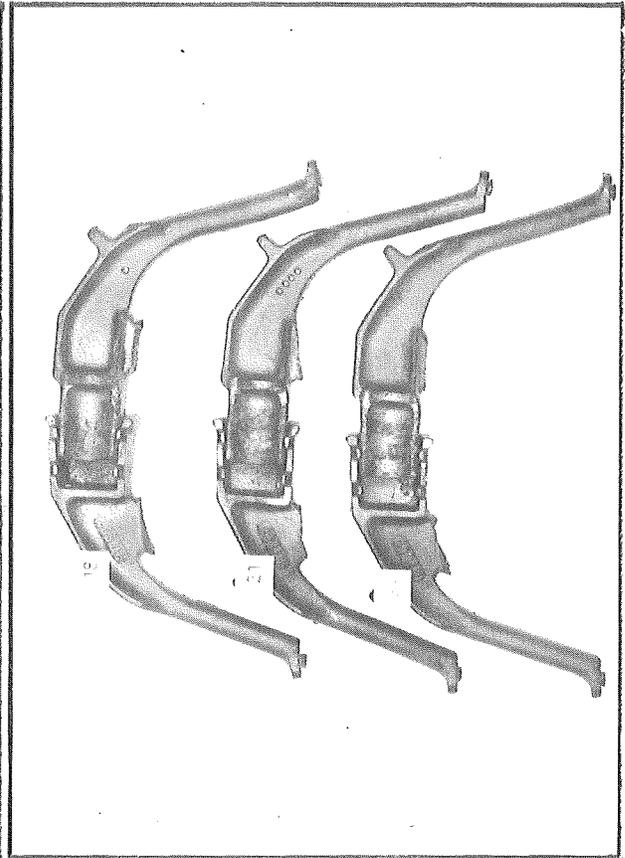
Figure 15. Acme dowel units show very little corrosion compared to standard dowels after equal length of service.

The three Acme units are shown in Figure 15. Although each unit showed signs of corrosion in the engagement area, the loss of metal by rusting was very small.

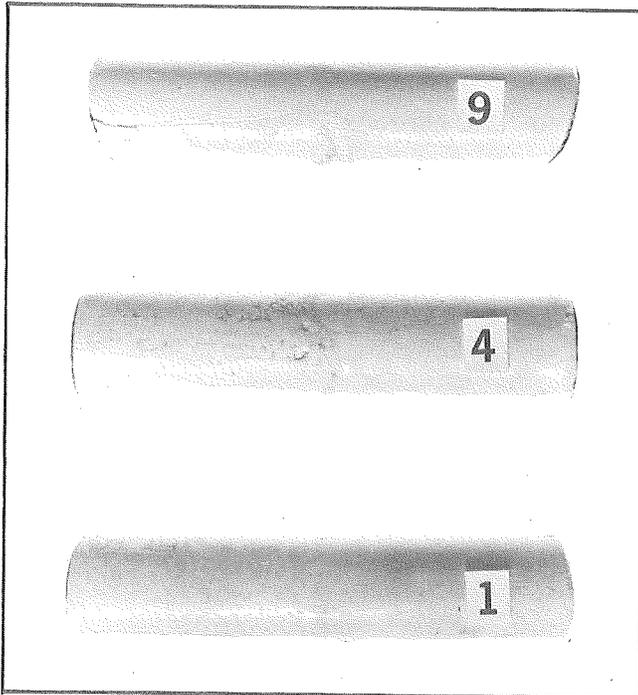
Figure 16. Corrosion-free plastic coated dowels; 10 years' service.

In 1979, after 10 years' service, three plastic coated dowel samples were removed by taking 6-in. diameter cores through the joints. These samples are shown in Figure 16. As can be noted, the dowels are free of any corrosion whatsoever. There are a few shallow indentations in the coating, but no breaks were found.
