**IDENTIFY CAUSES FOR UNDER
PERFORMING RUBBLIZED
CONCRETE PAVEMENT PROJECTS**

PHASE II

**FINAL REPORT
VOLUME I**

**TESTING AND RESEARCH SECTION
CONSTRUCTION AND TECHNOLOGY DIVISION
RC - 1416 - VOLUME I**

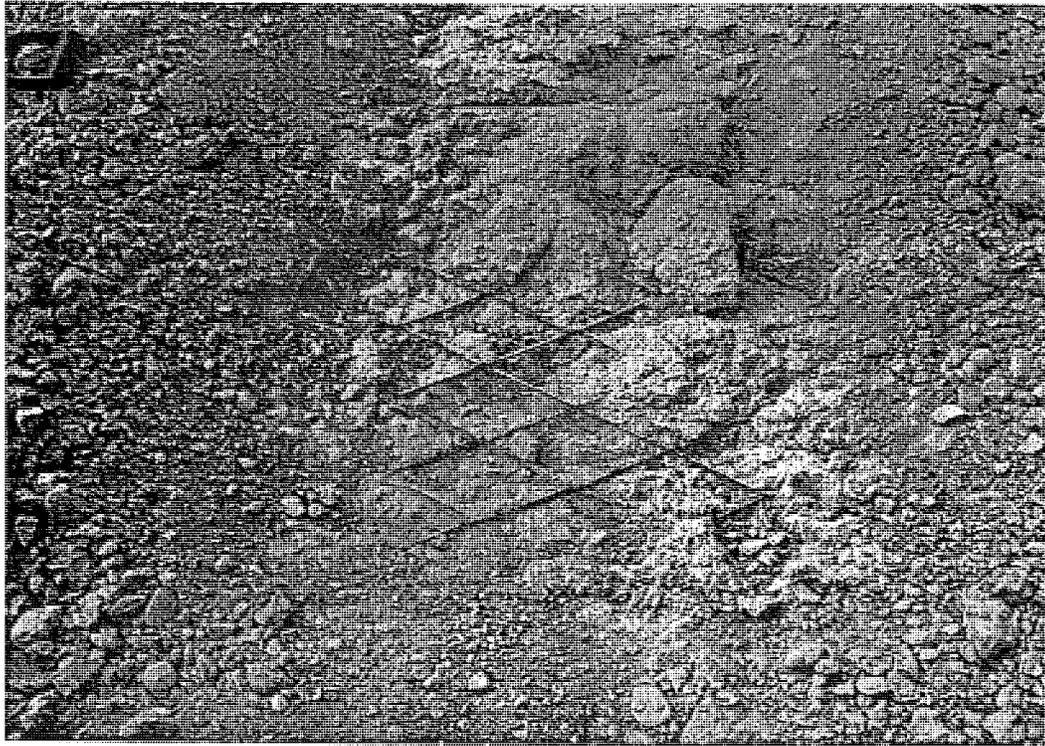
Figure 3.3 Partial debonding of the temperature steel (M21)

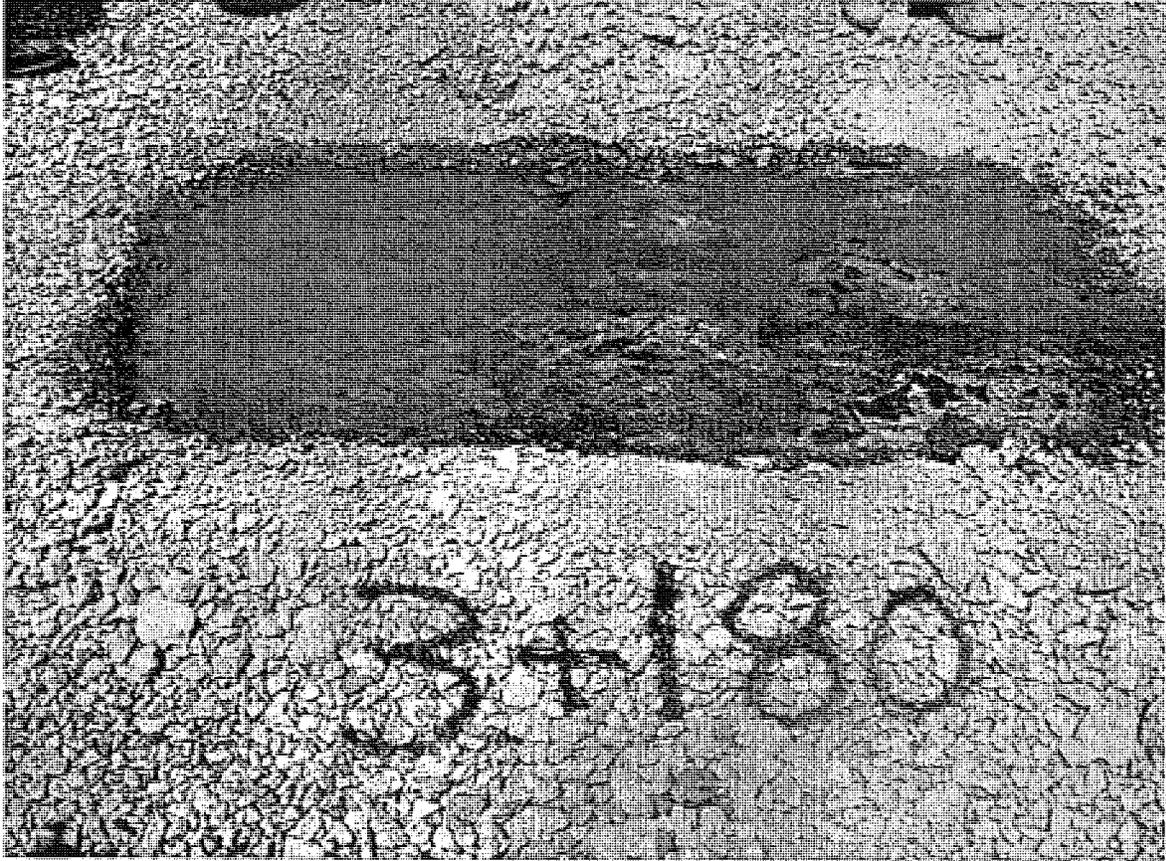
Figure 3.5 Trapped water above the fractured concrete in a trench (M-18)

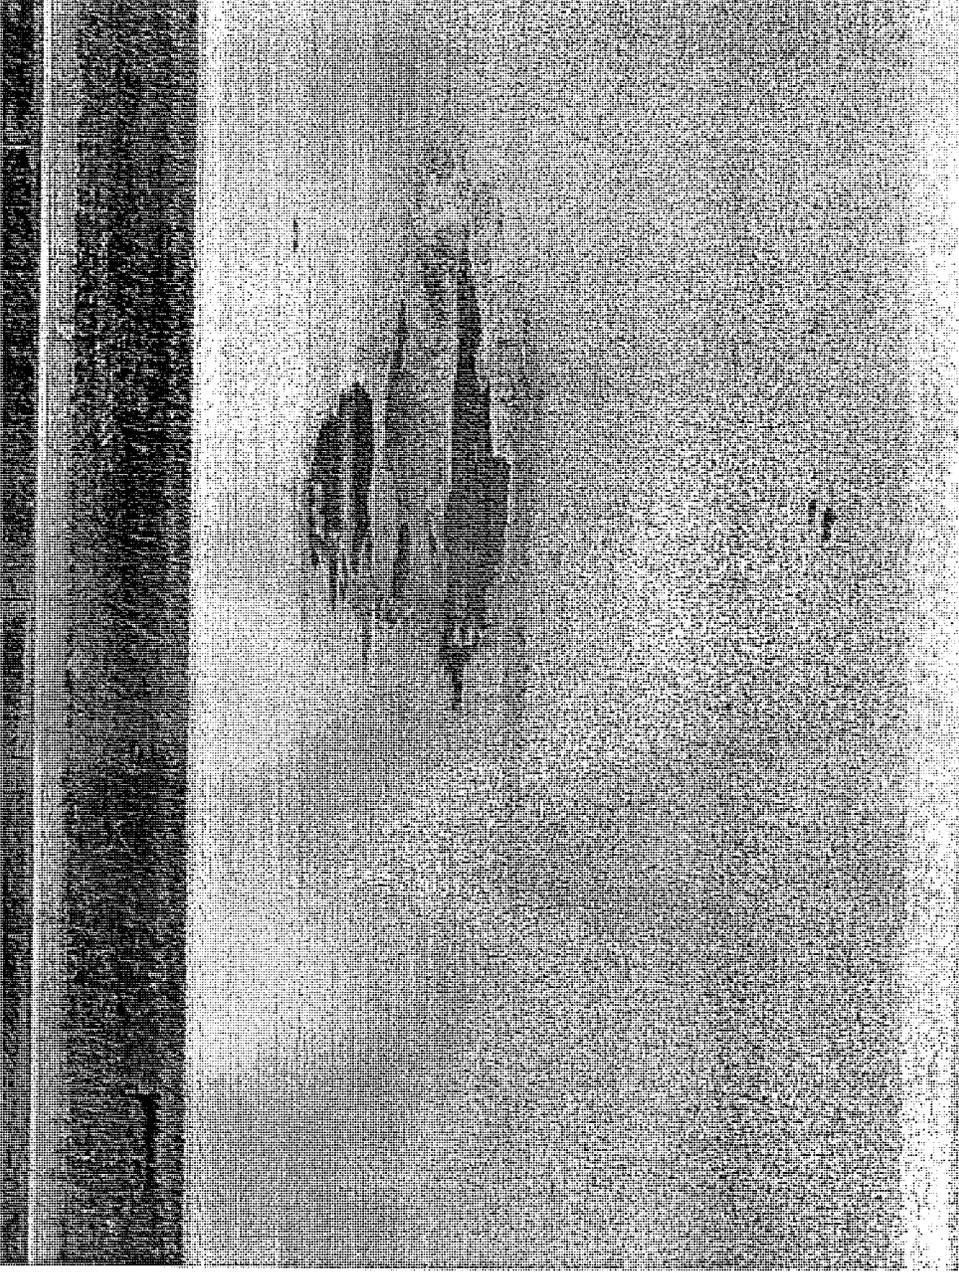
Figure 3.16 Shear failure along I-196 NB, Control Section 70024 Job Number 35987 BMP 12.6, EMP 15.6

8. Shear failure (reported in the tables as patches) was found at three locations along I-196 south of Grand Rapids as shown in figure 3.16.

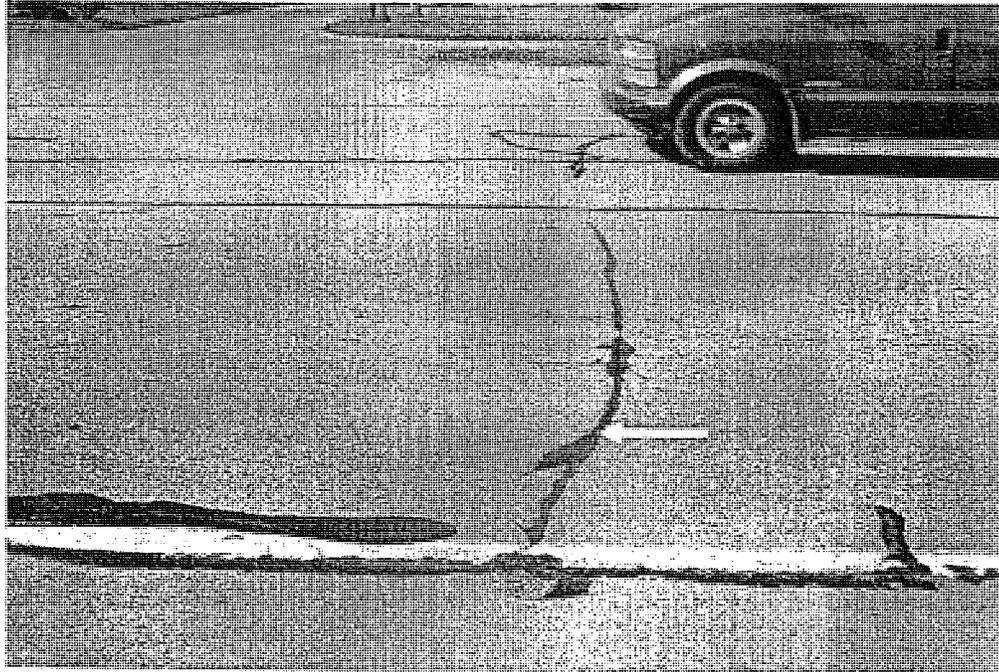
a) M-50

b) Saginaw Road

Figure 4.3 Reflective cracks in rubblized pavements

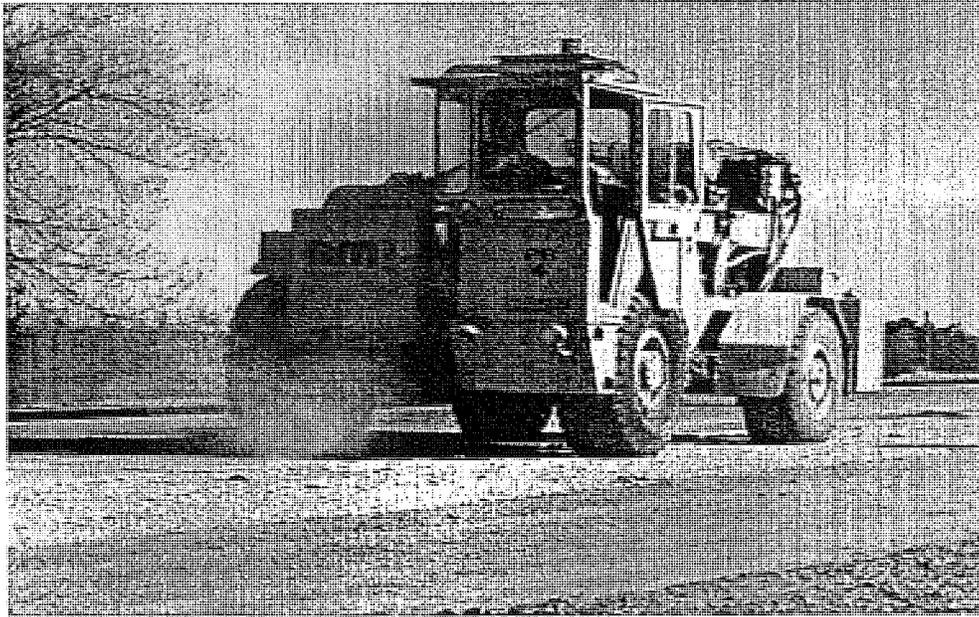
a) General view

b) Close-up of the sonic shoe

Figure 4.5 Resonant frequency pavement breaker

loaded at the top by a 12,000-lb counter-weight. The principle on which the resonant breaker operates (figure 4.5) is that a low amplitude (0.5 in.) high frequency resonant energy is delivered to the concrete slab, which causes high tension at the top of the pavement. This causes the slab to fracture on a shear plane inclined at about 45-degrees from the pavement surface. Hence, the fractures are top-down cracking that start at the pavement surface and propagate downward. Figure 4.6 shows a schematic of the sonic shoe.

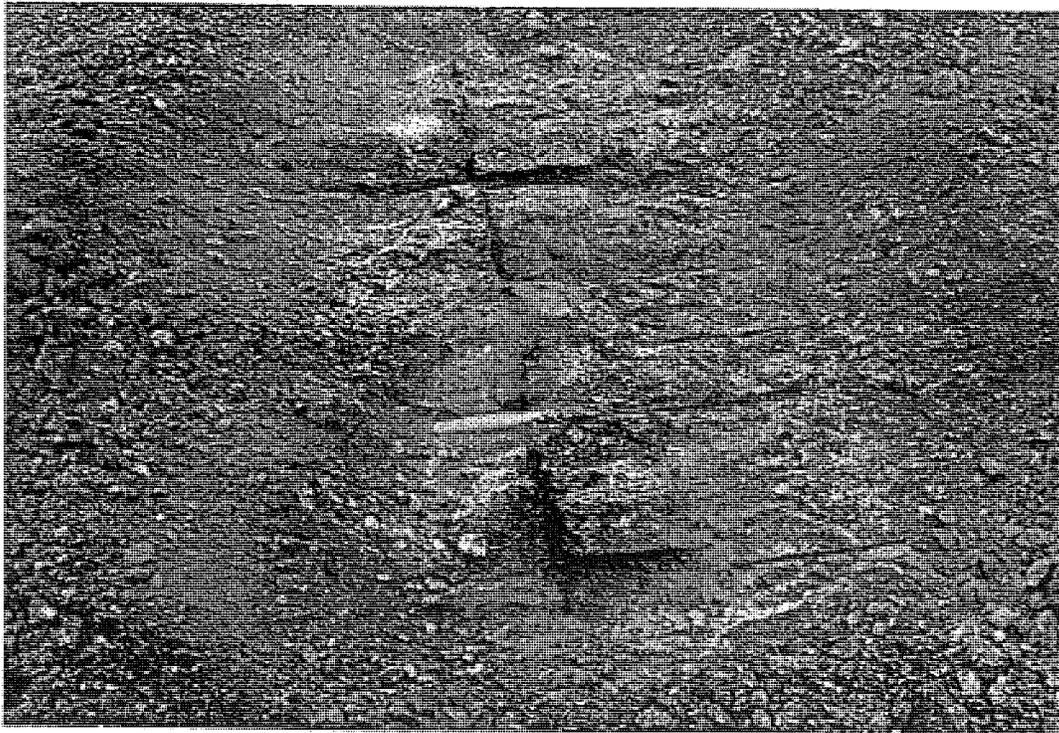
Figure 4.17 Partial destruction of the joint integrity (US-131)

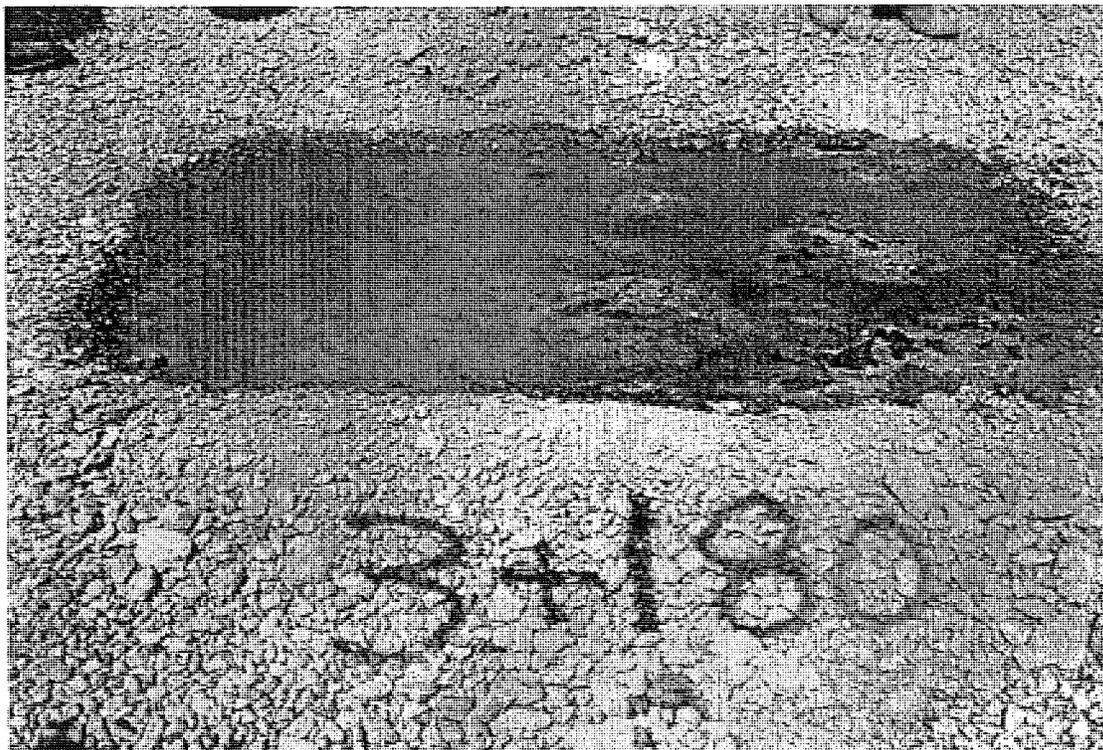
Figure 4.18 Trapped water above the fractured concrete in a trench along M-18

4. On some projects, the drainability of the fractured concrete layer was poor (see figure 4.18). The layer would trap water that infiltrates through cracks in the asphalt layer. The trapped water under the asphalt layer would increase the stripping potential of the asphalt layer.

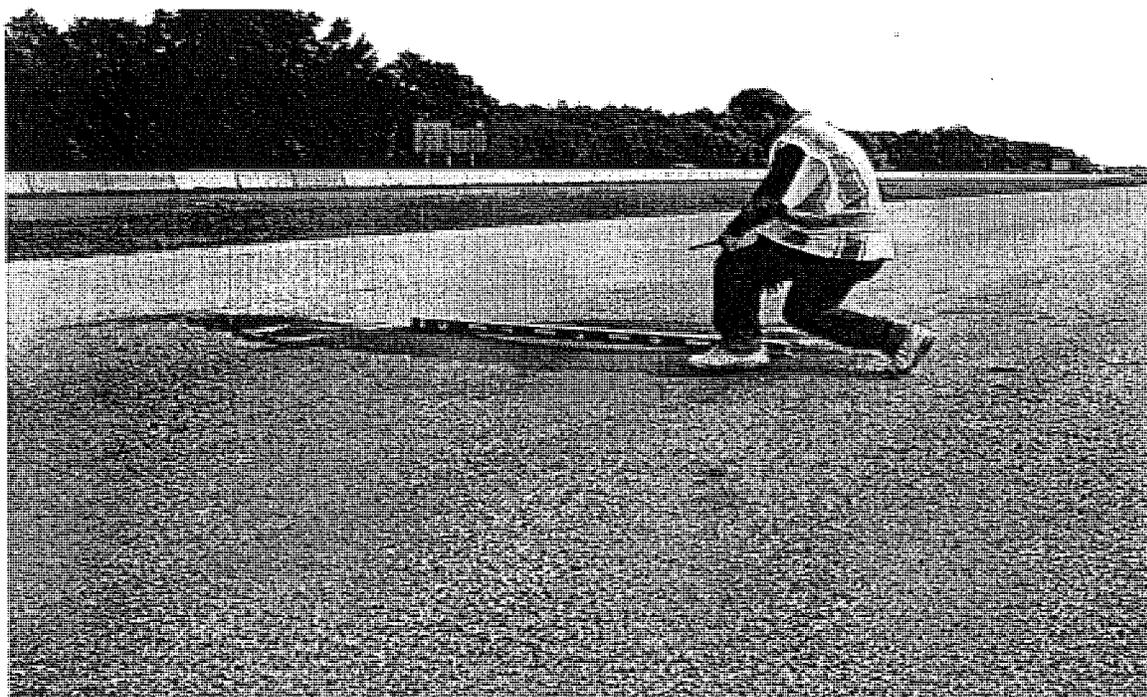
Figure 4.19 Shear failures in the rubblized pavement along NB I-196, August 2001

5. At some locations, the rubblization procedure caused some large concrete pieces (more than 8 in.) to rotate and/or penetrate the underlying base or roadbed material. This implies that the base and/or the roadbed soil have failed in shear action (bearing capacity). This failure is mainly caused by saturated base and/or weak roadbed soil. If the shear failure in the base and/or subbase is not corrected, the finished pavement will experience shear failures in these locations as shown in figures 4.19 through 4.21.

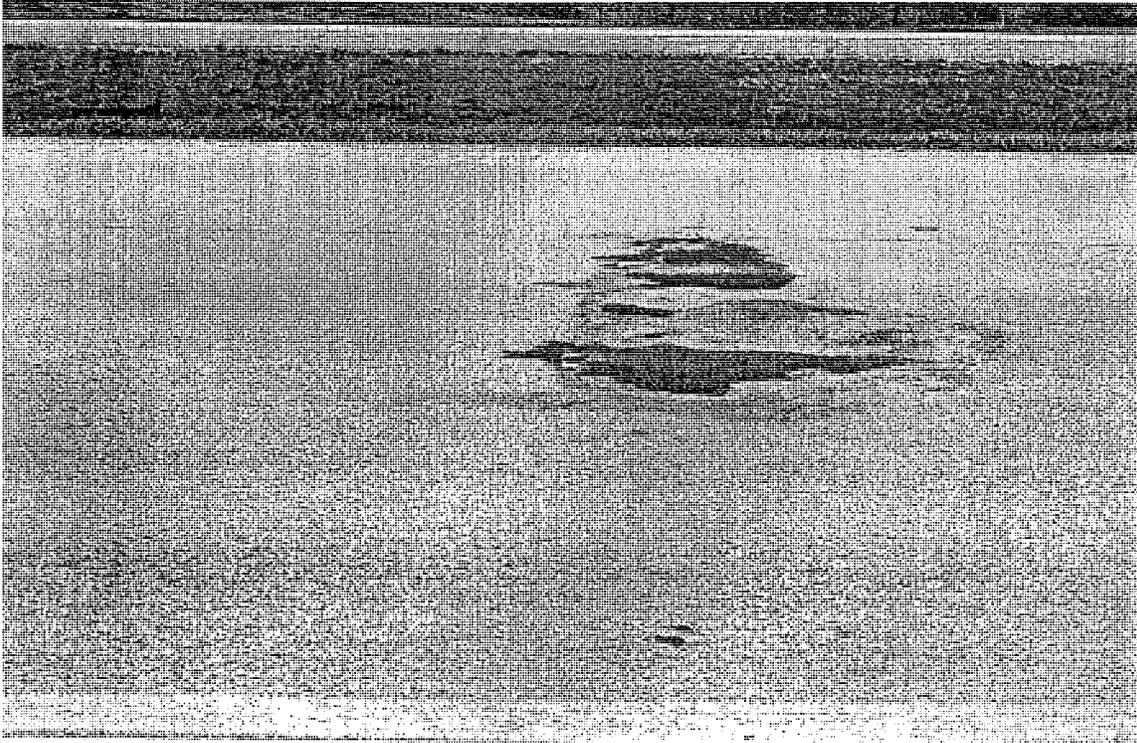
Figure 4.20 A shear failure along the rubblized pavement on NB I-196, May 2002
