PRESSURE-INDUCED FAILURES IN JOINTED  
CONCRETE PAVEMENTS AND A MACHINE  
FOR INSTALLATION OF PRESSURE RELIEF JOINTS

C. J. Arnold

Research Laboratory Section  
Testing and Research Division  
Research Project 74 F-140  
Research Report No. R-949

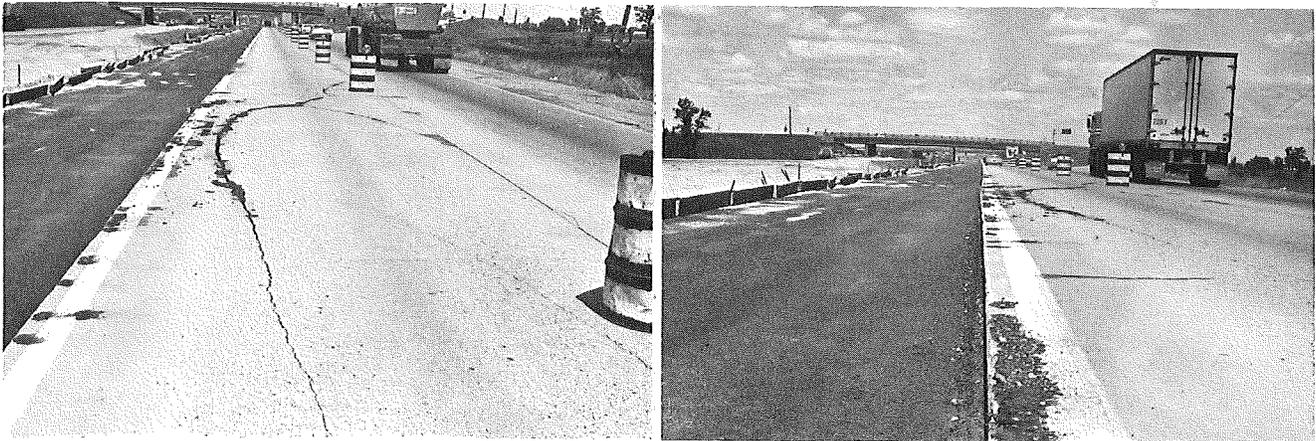
Figure 1. Lateral buckling of two-lane pavement due to longitudinal pressure from adjacent three-lane pavement, I 75 near US 25 south of Detroit. Note protrusion of slab edge at right. (Shoulder material had been removed for widening.)

Compressive forces in the pavement can reach extremely high values. Most people are familiar with the appearance of the typical damage that results from blow-up or crushing of deteriorated joints. Figures 1, 2 and 3 show other types of problems that can occur due to high compressive forces in pavements with better joints.

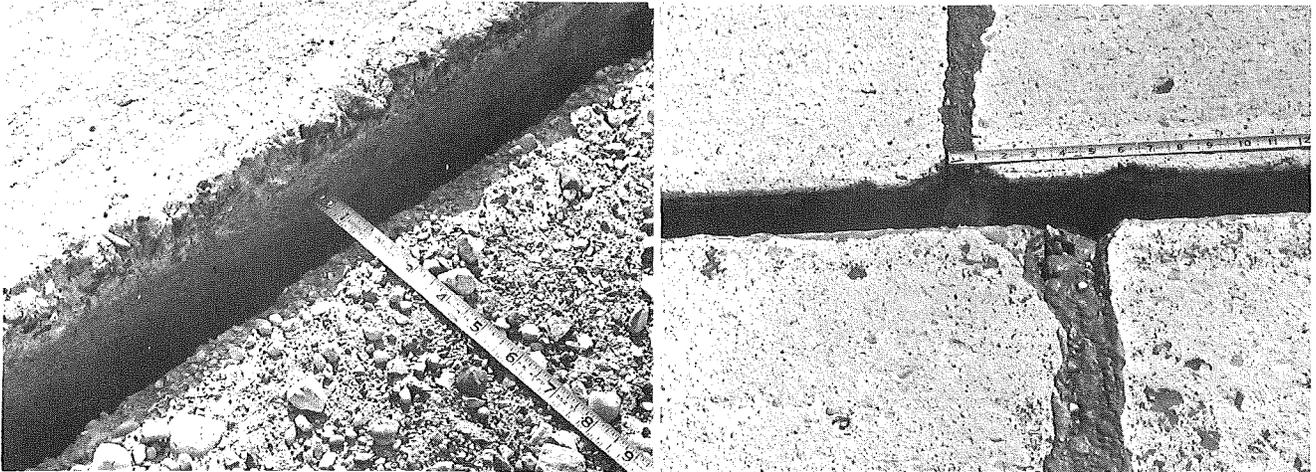
Figure 2. Lateral and longitudinal movement of a curved ramp due to pressure from straight portion of ramp, I 96 and Cedar St interchange at Lansing.

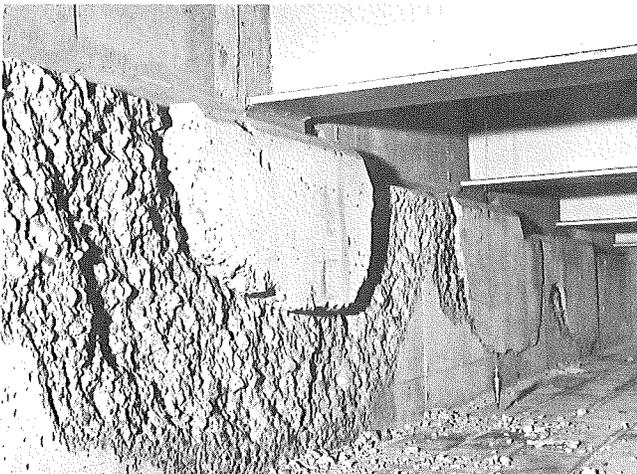
Figure 3. Structural damage caused by pavement pressure on a bridge (X05 of 33045). Sometimes piers may also be cracked.

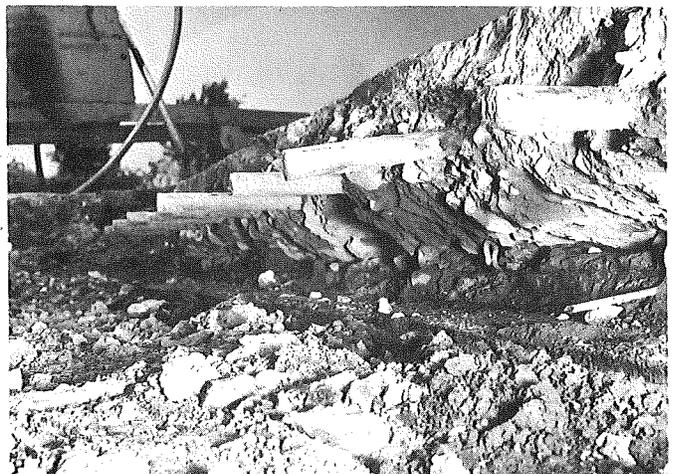
Figure 4. Deterioration of joint face that leads to blow-up or crushing. Infiltrated salts attack and destroy the concrete in the lower part of the joint face.

Deterioration or rotting of the concrete begins near the bottom of the joint faces, and slowly proceeds upward with time so that a joint that has a fairly good appearance on the pavement surface may be entirely rotten underneath (Fig. 4). This deterioration appears to be caused by infiltration of salt around the joint seal, which is then trapped above the steel baseplate of the joint. (The steel baseplate was placed under the joints to prevent "pumping" of base materials out through the joint by the combined action of water and traffic, a problem that had plagued earlier pavements.) Once trapped in the joint, the salts, coupled with incompressible materials and joint movement, completely destroy the concrete of the lower joint face to the point where it resembles only gravel and can be broken out with a wooden stick or with the hands. The joint seal groove removes the top 2 to 2-1/2 in. of bearing surface across the joint face and surface spalls sometimes remove still more. When only the portion of the joint face above the rotted lower face and below the joint groove remains to withstand compression, and especially when the compressive forces become concentrated over a narrow width, buckling, crushing, or a blow-up occurs. Representative examples are shown in Report R-582 published previously by the Research Laboratory. Since the deterioration proceeds slowly from the bottom of the joint where it cannot be seen, baseplates were used for many years before the effect was known. However, the real culprit appears to have been the leaky joint seals, which allowed salt solution and incompressibles to enter the joints.

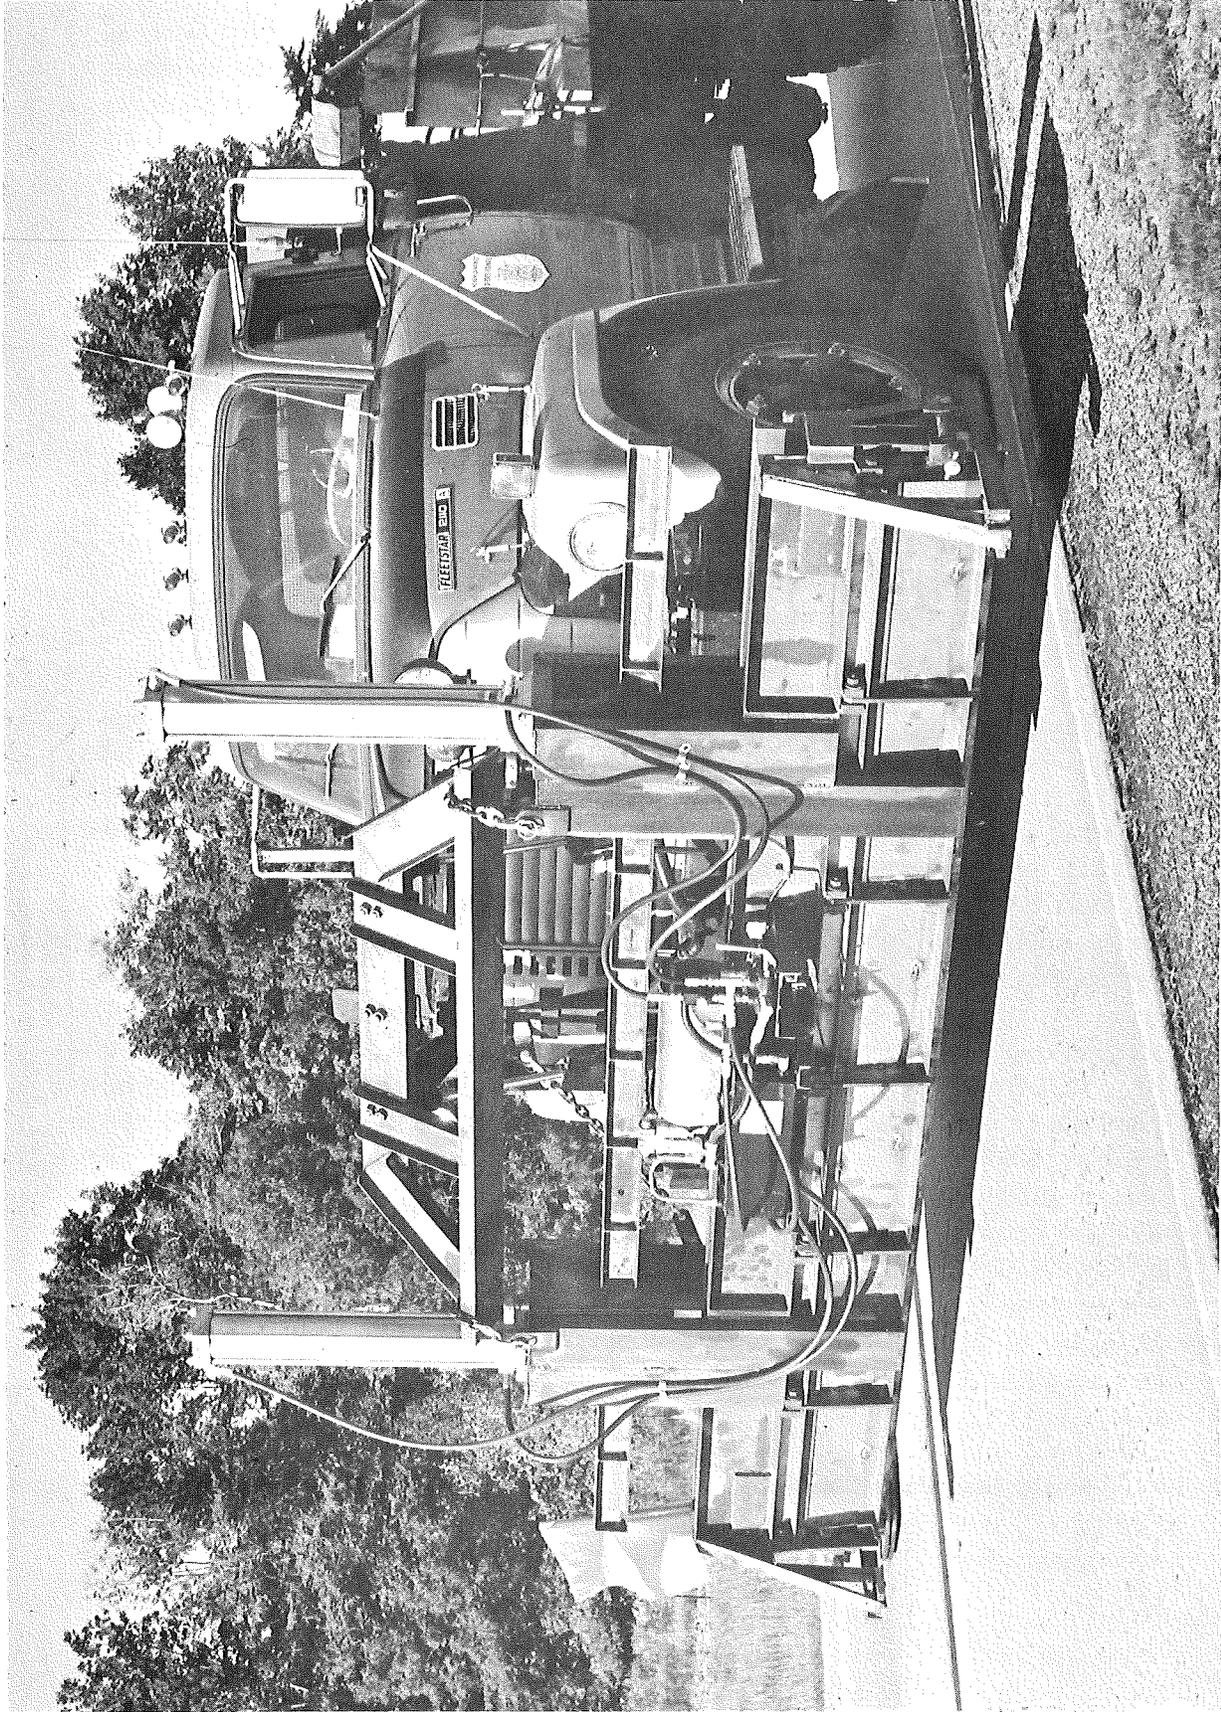
Figure 5. Ethafoam installation device mounted on snow-plow lift, on heavy duty maintenance vehicle.

The machine that was developed is shown in Figure 5, mounted on one of the Maintenance Division's heavy snow-plow trucks. The plow-lift frame and hydraulic cylinders were used to lift the machine for transport, and also for holding the machine down against the pavement while the foam is inserted into the sawed groove. Although no measurements were made, it was estimated that more than four tons of downward reaction were required for some difficult installations. Figures 6 through 12 show the sequence of operations for installing filler, once the joint is sawed and cleaned. Filler is pressed downward by an I-beam connected to two 4-in. bore by 30-in. stroke, double-acting hydraulic cylinders. Hydraulic pressure is provided by a 12/24 volt electric pump, powered by the truck's battery. It would be possible in this case to tap into the truck's hydraulic supply to run the cylinders; however, the machine was designed to work with any vehicle, since a snow-plow vehicle may not always be available. If a vehicle without a hydraulic lift were used, a reaction frame would be required on the truck, and two more hydraulic cylinders mounted beside the existing ones would provide the downward reaction to hold the machine in place during insertion of the filler into the joint. Chains coupled to the I-beam punch of the machine and the reaction frame on the truck could then lift the machine for transport.

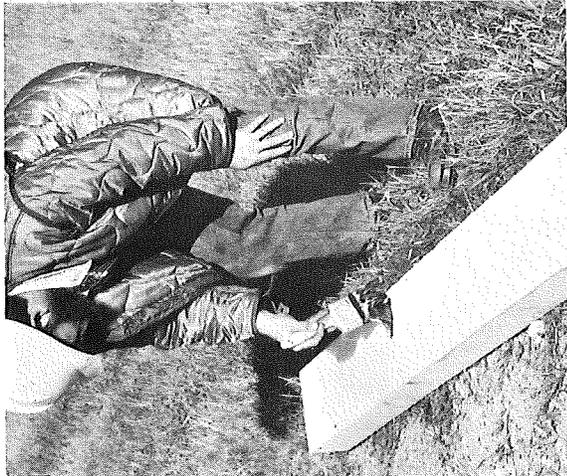
Figure 6. Application of lubricant to ethafoam filler. "Rubber-Lube," a commercial lubricant for tire changing, proved to be suitable for use with the foam.

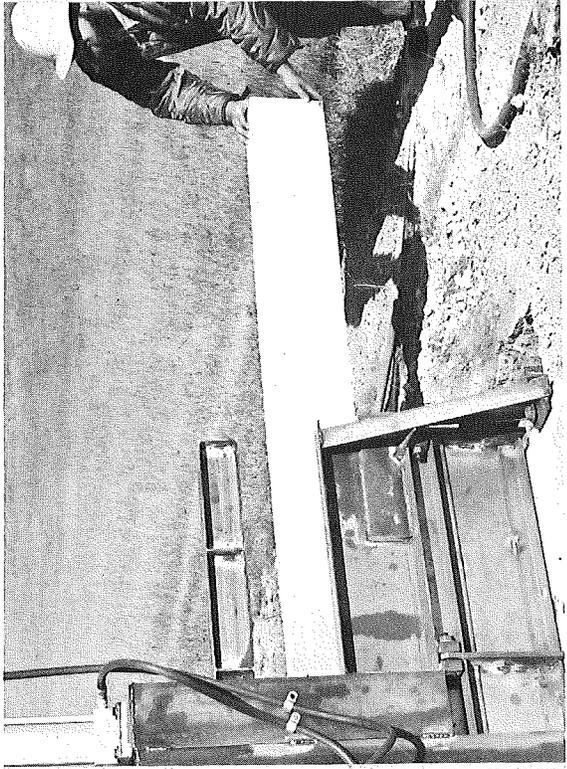
Figure 7. Inserting filler into the machine.

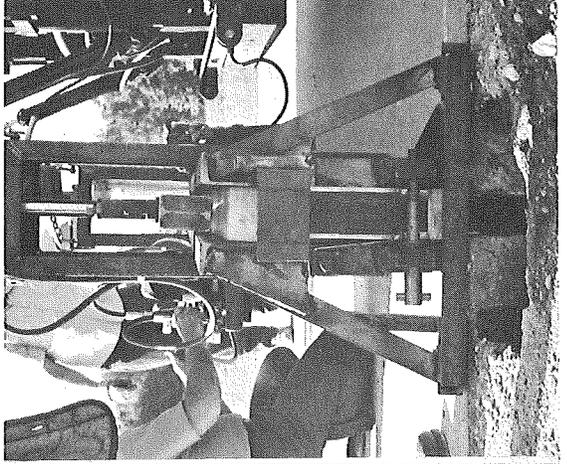
Figure 8. Punch approaching filler.

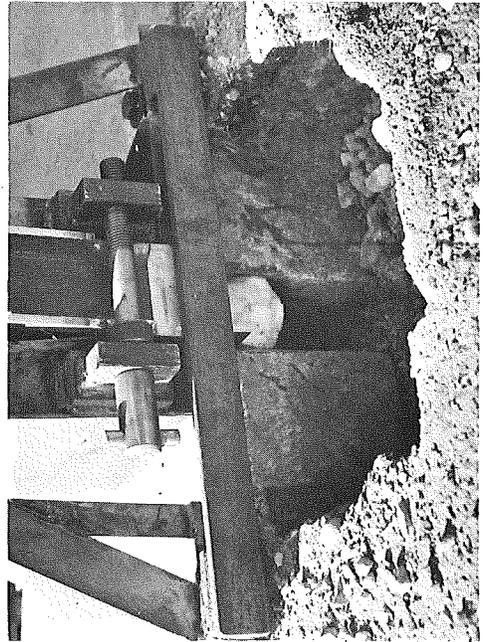
Figure 9. Filler partially inserted in joint.

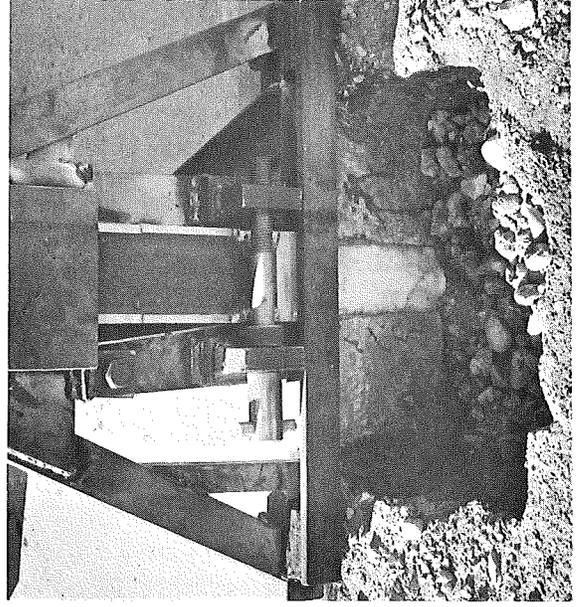
Figure 10. Filler fully inserted in joint.

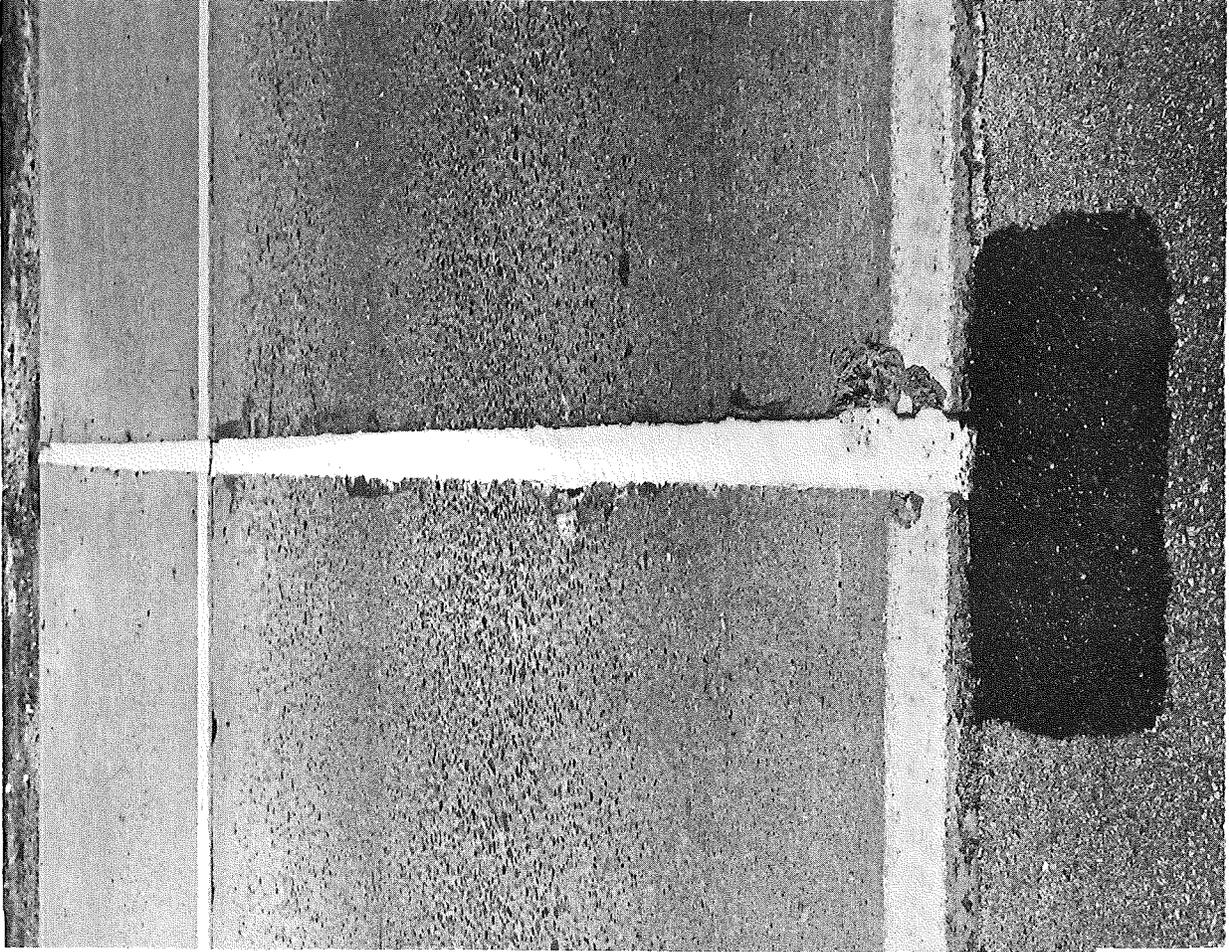
Figure 12. Finished joint.

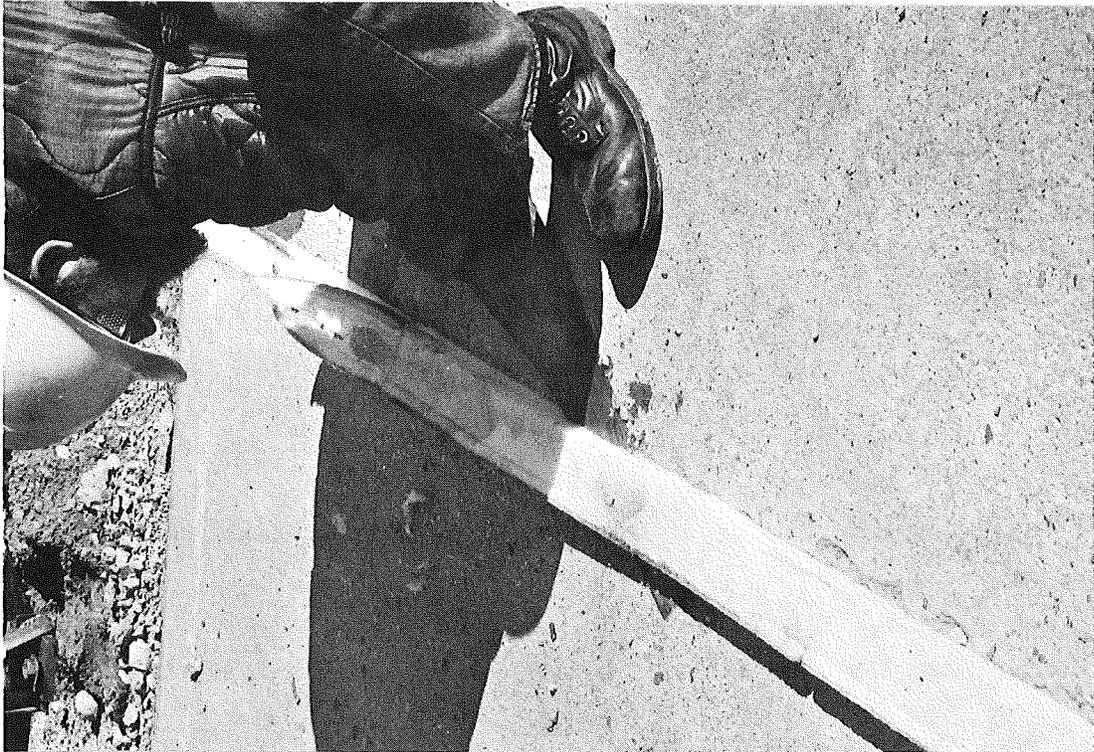
Figure 11. Removal of excess material.

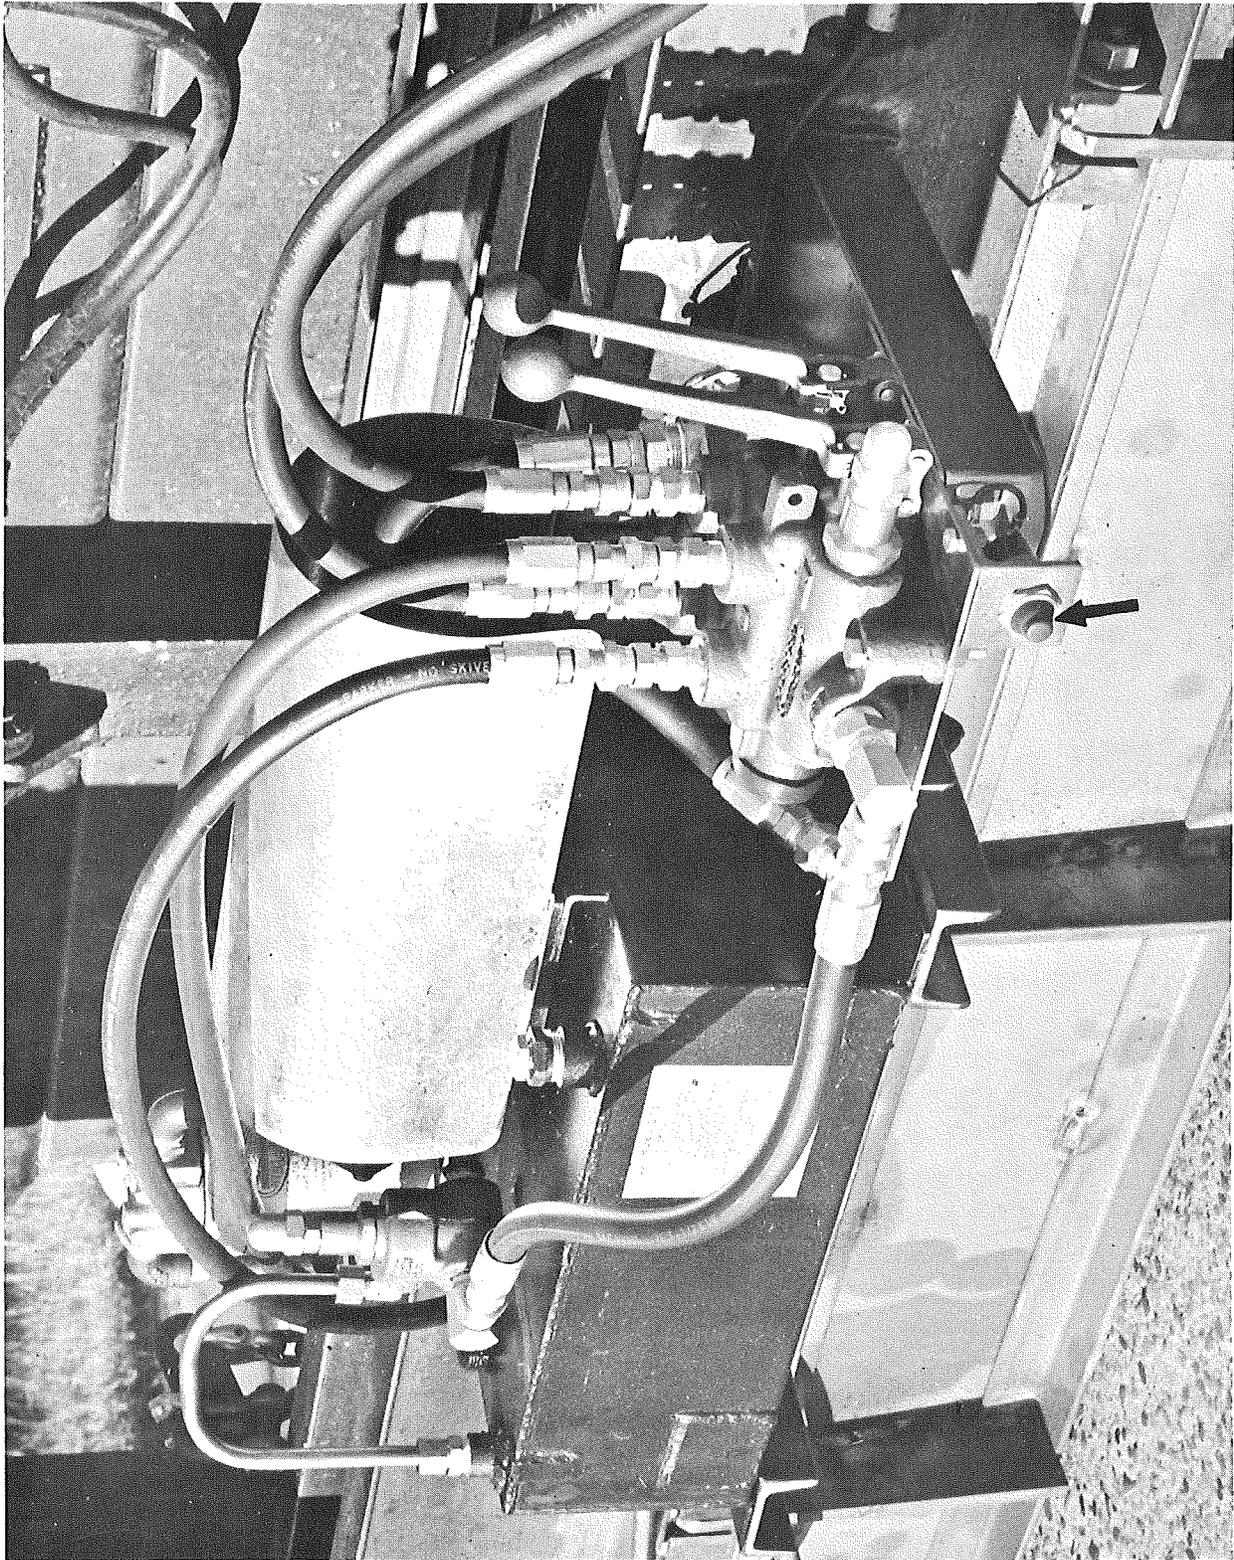
Figure 13. Special control valves and reservoir. Pump is under the sheet metal cover. Pump-motor switch is just below the valve handles (arrow) for knee operation.

The cylinders must be separately controlled in order to function properly. Figure 13 shows the special control valves, oil reservoir, bypass valve, and piping. The motor switch is directly beneath the valve platform,

and is activated by the operator's knee. The pump is located beneath the sheet metal cover on top of the reservoir. Reservoir capacity is 5 gal. The pump will provide up to 2,000 psi pressure, but is set at 1,000 psi at present and provides adequate force through the large bore cylinders. These particular cylinders were chosen to allow operation at lower pressure, and to obtain the larger rod diameter for additional strength and stiffness at maximum stroke.
