CHAPTER 3: TESTING & RESULTS

3.1 Introduction

This chapter presents the test methodology and the test results for the five control decked bulb T beams and the bridge model. The results are presented in the form of charts showing the relationship between the applied load and the response of the test specimens including deflection, strain of concrete, and strain in CFCC strands. In addition, for each test specimen, the ductility ratio was calculated to evaluate the failure mode analytically.

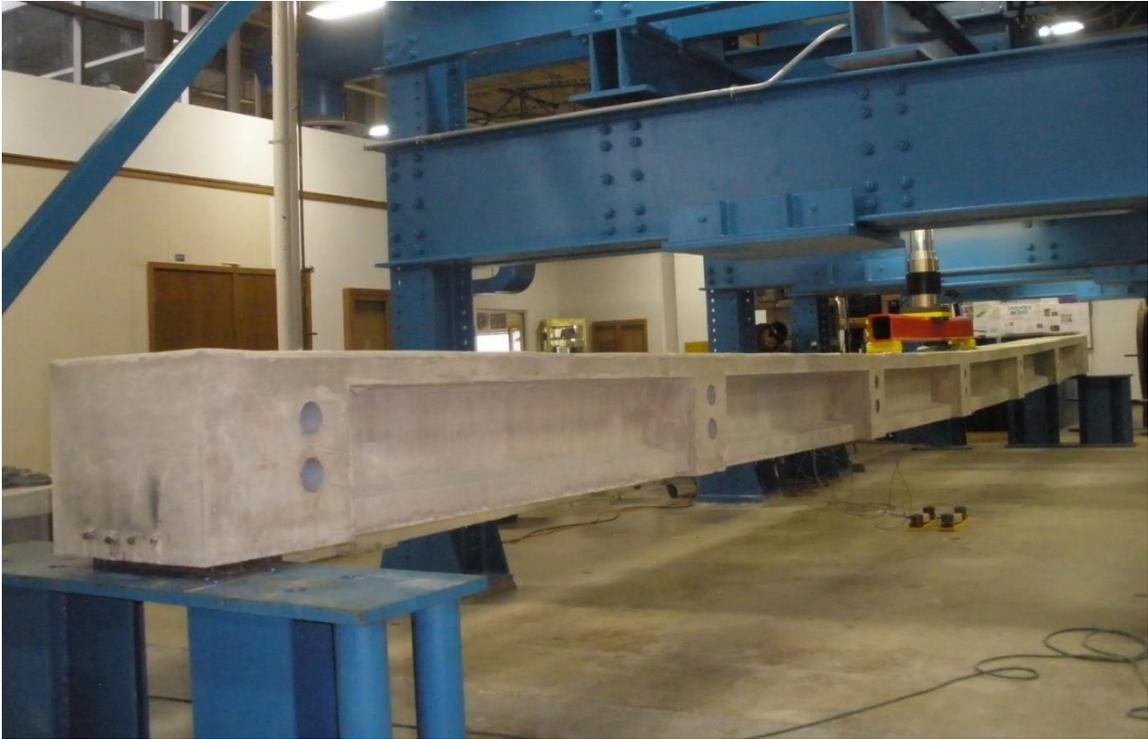
Figure 3.2-1 Typical four-point-loading test setup for control beams

Beam C-S-F-U had a total length of 41 ft and was constructed with four bottom prestressed CFCC strands in addition to five top non-prestressed CFCC strands, two web non-prestressed CFCC strands, and steel stirrups. The theoretical analysis for the cross section using force equilibrium and strain compatibility indicated a tension failure by rupture of CFCC prestressing strands. During the test, the beam was simply supported over two elastomeric bearing pads with an effective span of 40 ft. The bearing pads had a length of 12.0 in., a width of 6.0 in., and a thickness of 1.0 in. The load was applied to the beam using a steel spreader with two-point load as shown in Figure 3.2-1. The distance between the points of loading was 78 in. This distance was maintained through the testing of this control beam and other flexurally tested control beams.

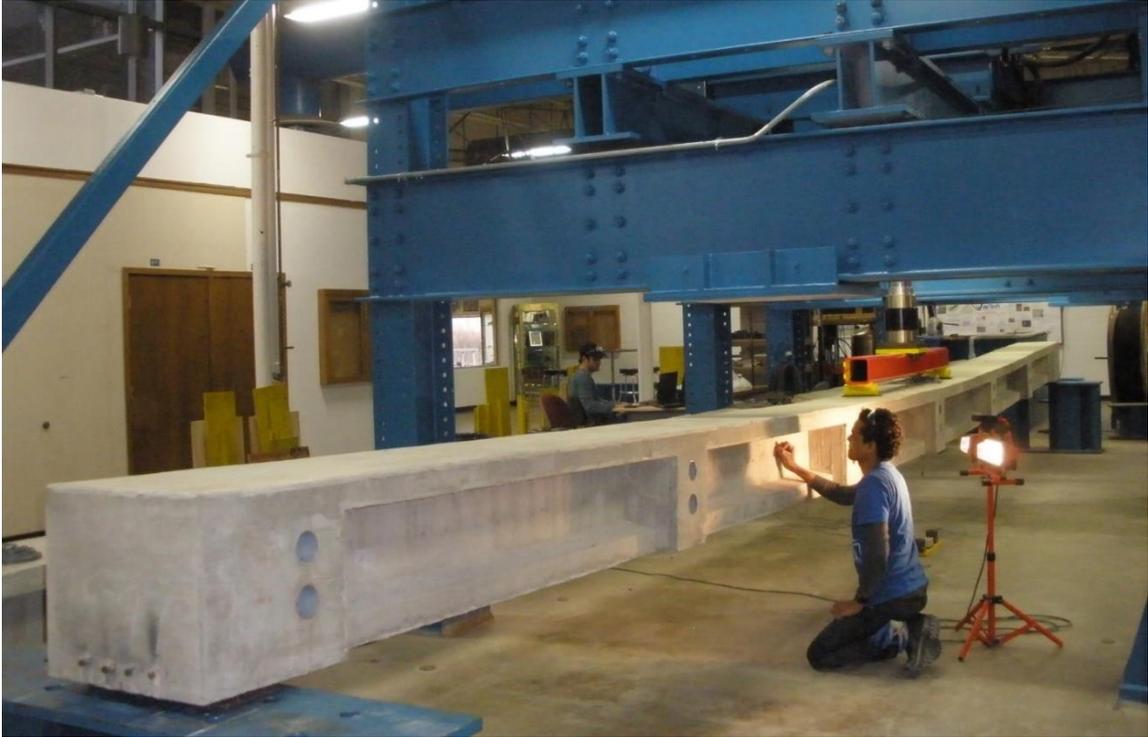
Figure 3.2-3 Crack mapping between load cycles

The load cycles were continued and new cracks were marked after every load cycle as shown in Figure 3.2-3. The cracks were vertical and uniformly distributed under the loading spreader but they were inclined outside the loading points due to combined effect of shear and moment. As shown in Figure 3.2-4, this control beam was characterized with a dense crack map before failure. The cracks typically overlapped the stirrups and the average distance between the cracks was around 4 in., which matched the spacing between the stirrups. It should be also noted that the beam exhibited a significant deflection before failure. The deflection can be visually observed as shown in Figure 3.2-5. In practice, this deflection will be difficult to go unnoticed and it will be accompanied by cracking and collapse of non-structural components such as utility pipes, sidewalks, and barriers. Therefore, it serves as a significant visual warning sign before failure.

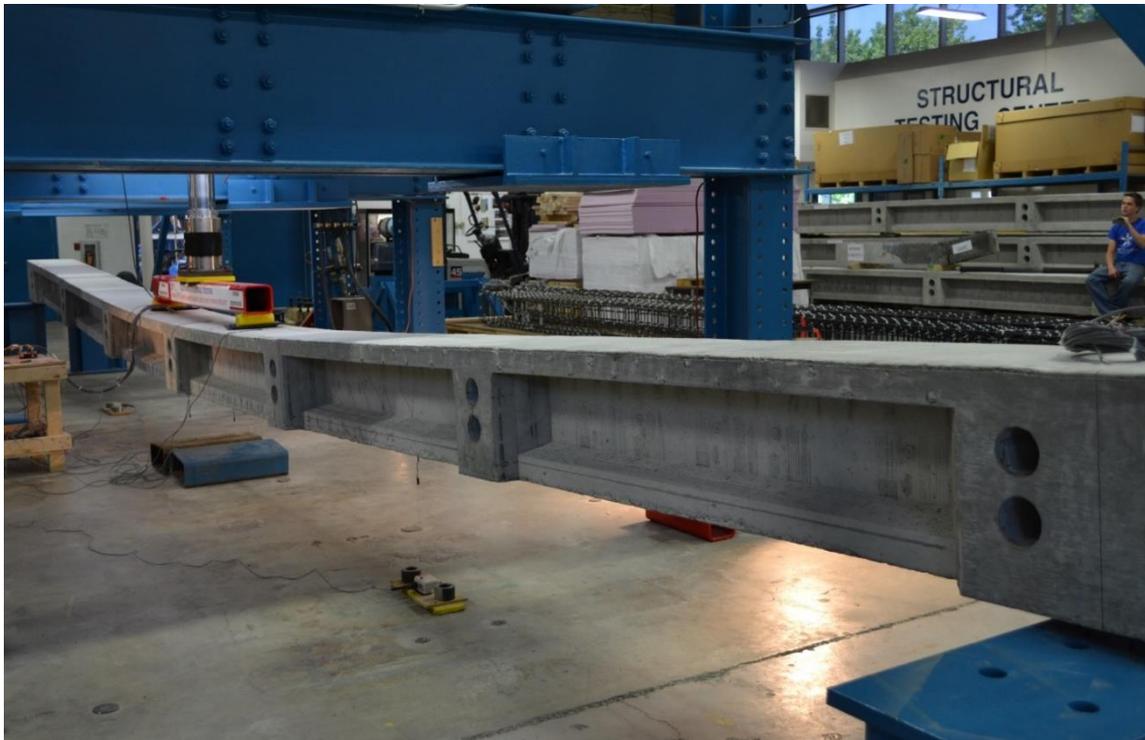
Figure 3.2-5 Deflection of Beam C-S-F-U

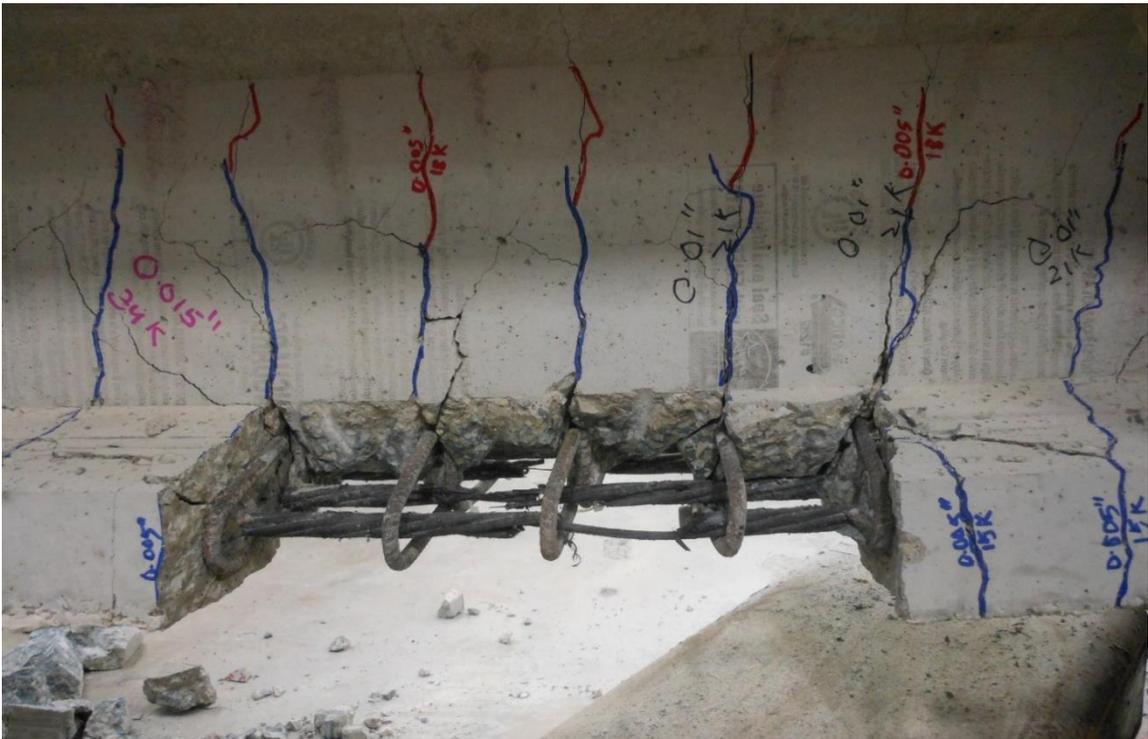
Figure 3.2-9 Rupture of prestressing CFCC strands in Beam C-S-F-U

After failure, the beam was inspected and it was found that there was a spalling of the concrete cover at multiple locations (Figure 3.2-8). Failure in the CFCC strands was also observed and was linked to the concrete spalling (Figure 3.2-9). It was determined that the popping sounds that were heard during the test were the sound of CFCC strands rupture. However, it should be noted that

due to the configuration of the CFCC strand, which encompasses seven wires, the tensile failure usually occurs on the wire level and not the strand level. In other words, every popping sound heard could have represented the rupture of single wire in the CFCC strand.

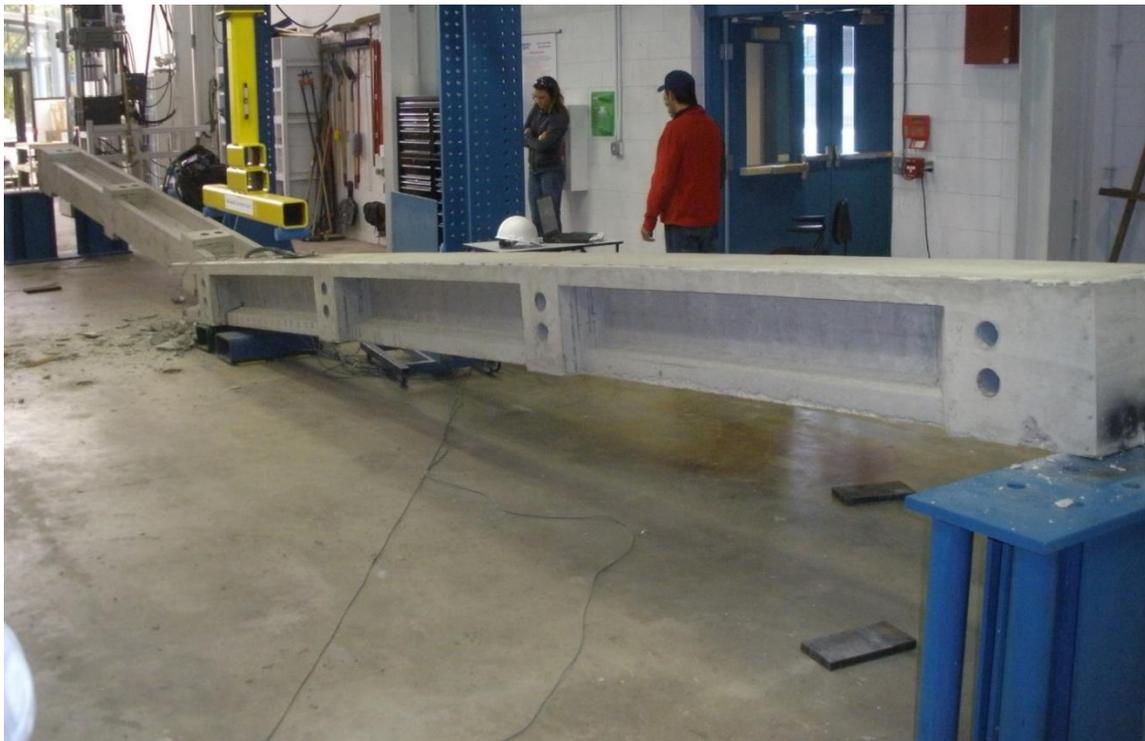
Figure 3.3-1 Balanced failure of Beam C-S-F-B

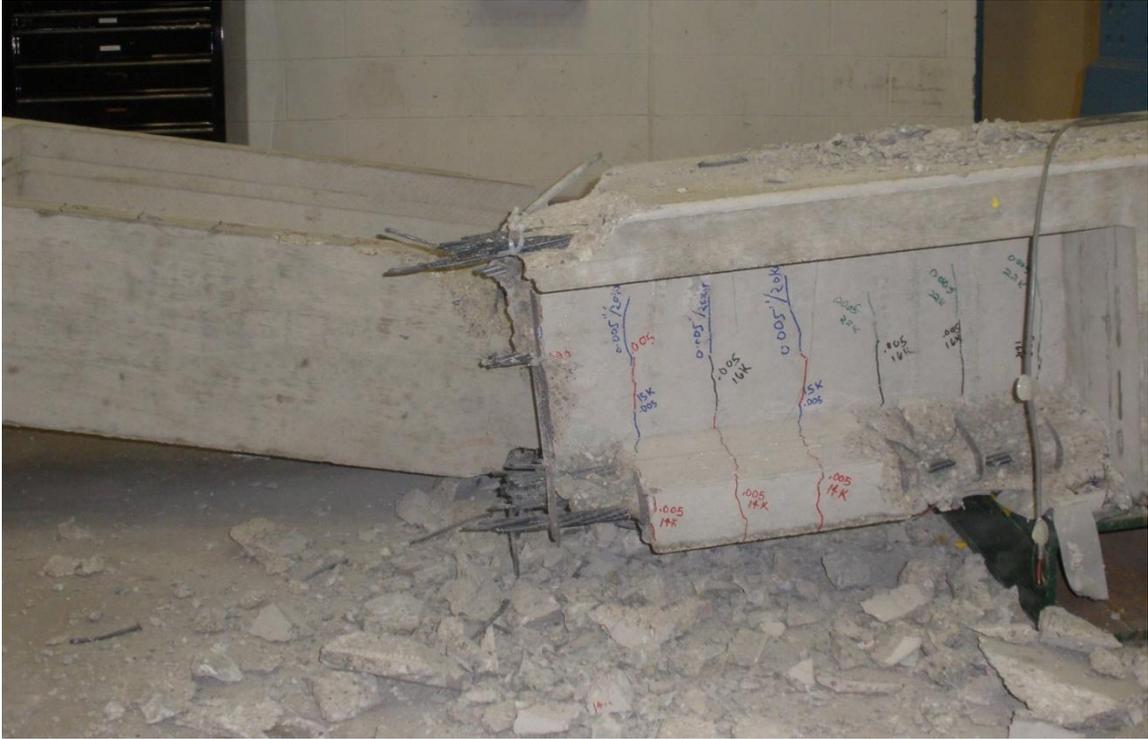
Figure 3.3-2 Balanced failure resulting in complete separation of Beam C-C-F-B

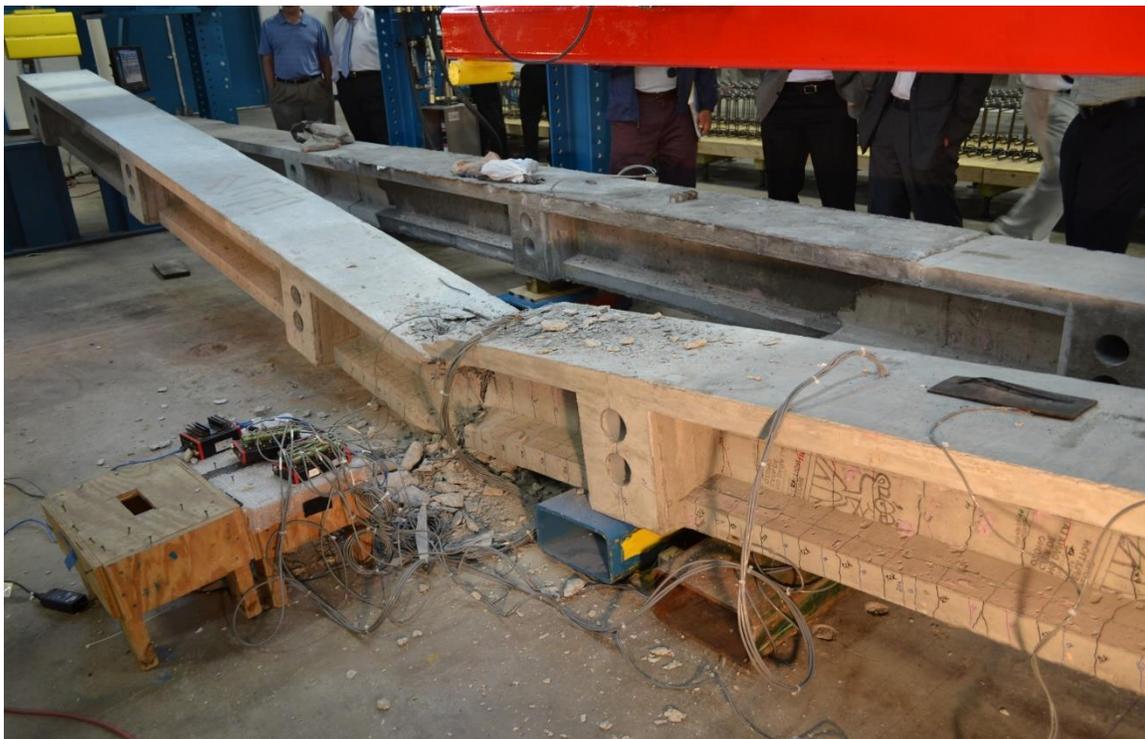
Figure 3.4-1 Beam C-S-F-O at failure

This control beam was provided with four bottom prestressing CFCC strands and five bottom non-prestressing CFCC strands. This amount of bottom reinforcement guaranteed the compression failure mode. As shown in Figure 3.4-1 through Figure 3.4-3, the failure of this beam was characterized by the crushing of the concrete in the top flange followed by shearing and rupturing of both prestressing and non-prestressing CFCC strands and breaking of the beam into two pieces.

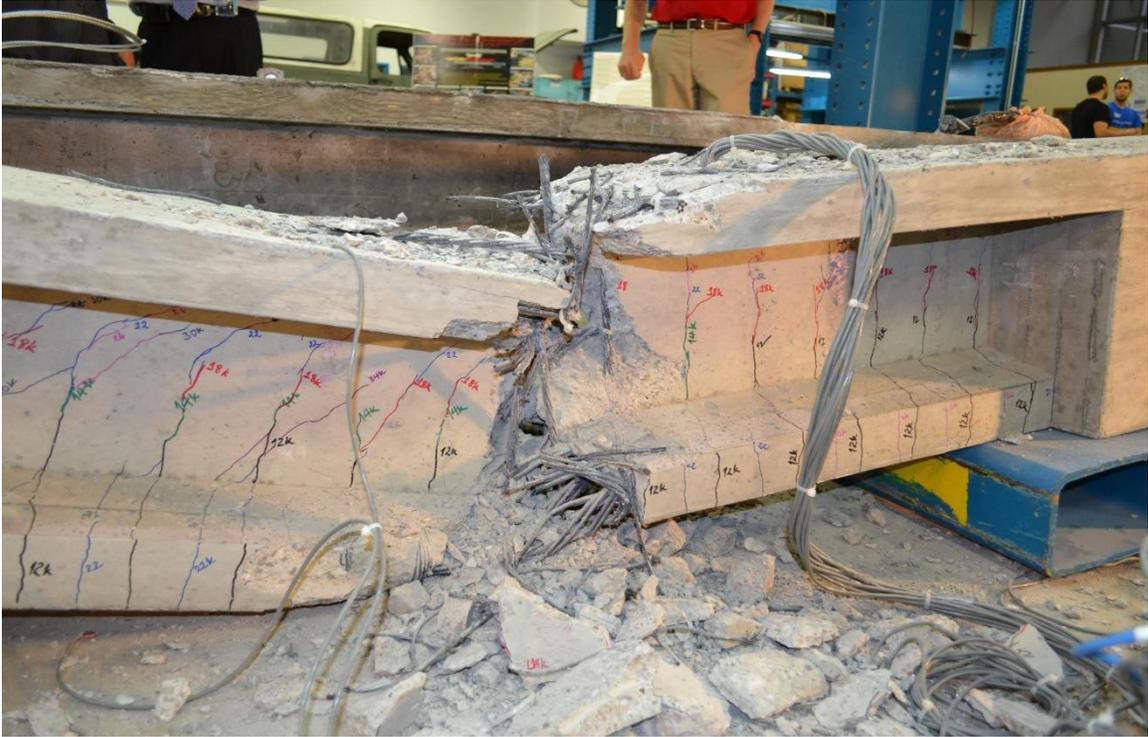
Figure 3.4-2 Compression failure followed by rupture of strands in Beam C-S-F-O

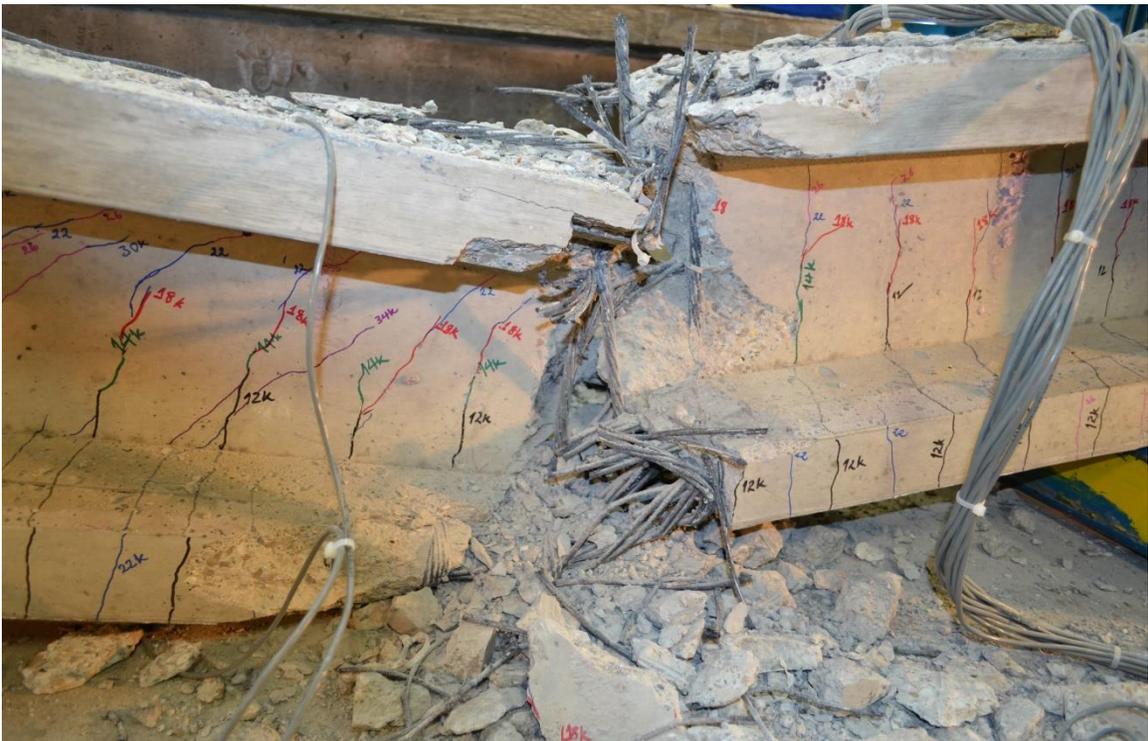
Figure 3.4-3 Close view showing the failure section of Beam C-S-F-O

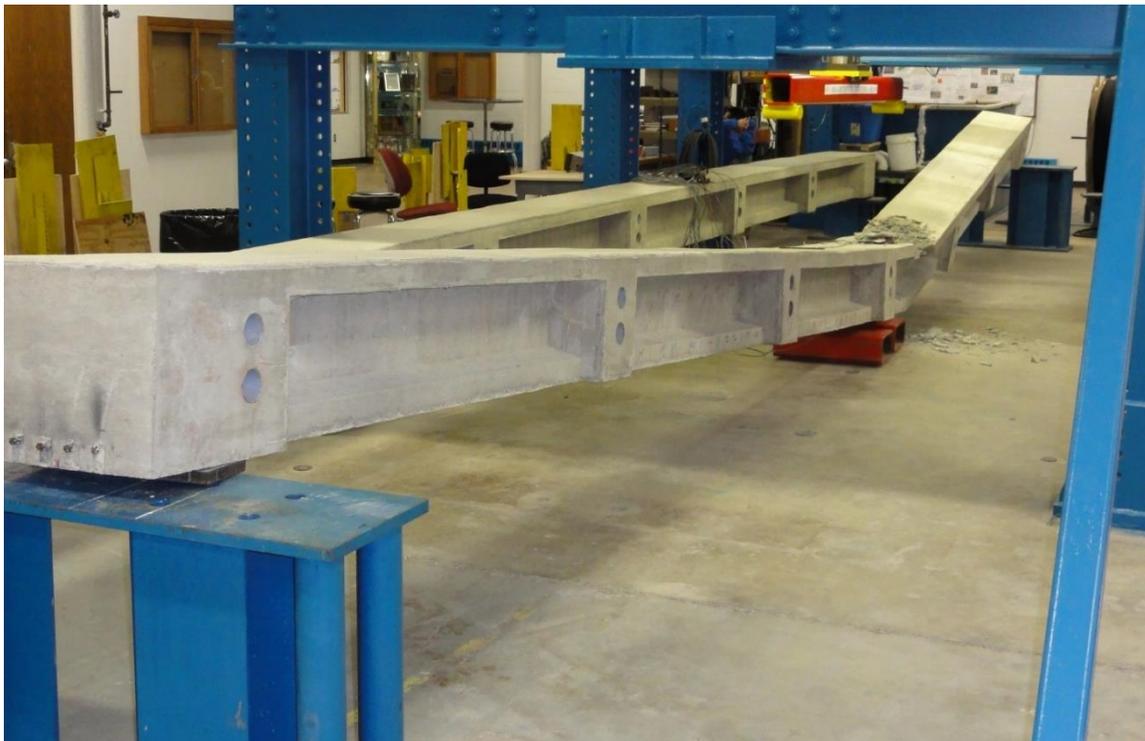
Figure 3.5-1 Flexural failure of Beam S-S-F-U

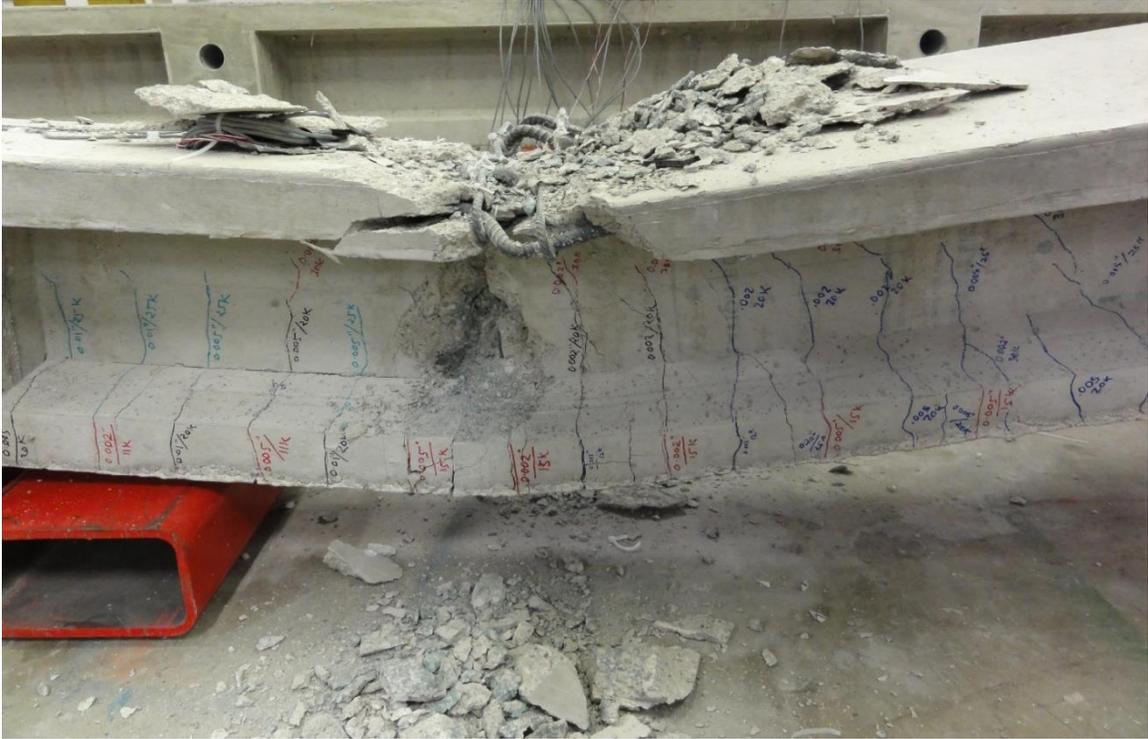
Figure 3.5-2 Failure of Beam S-S-F-U showing crushing of concrete after yield

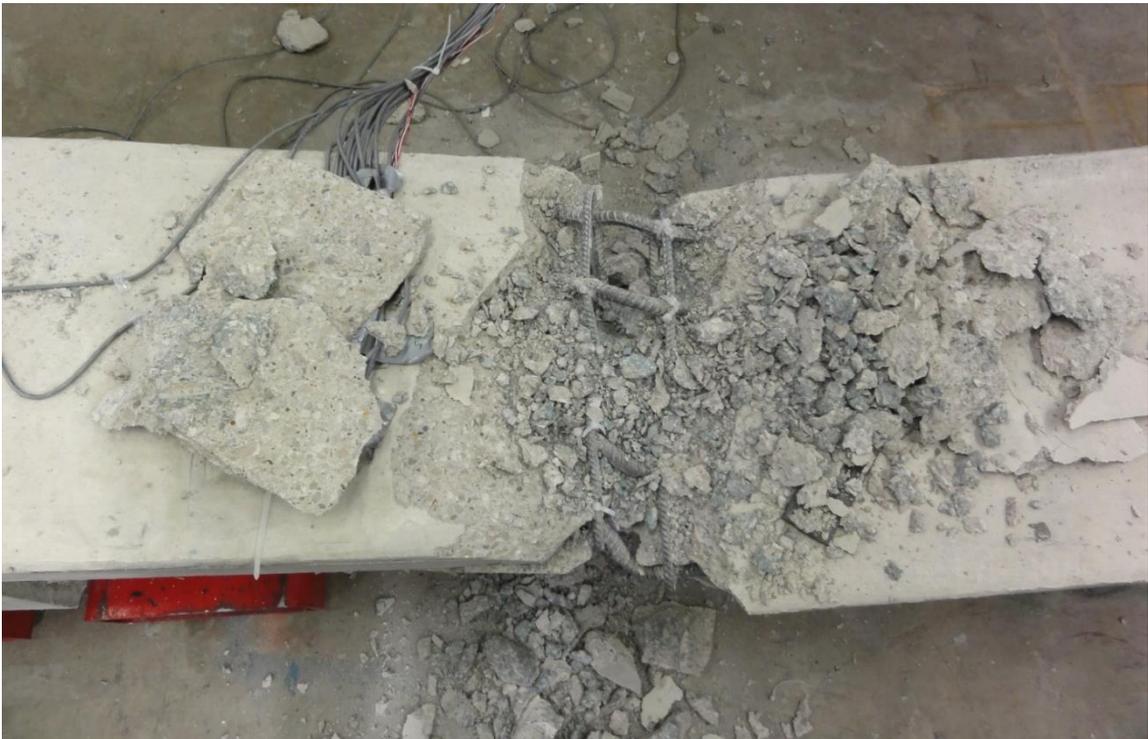
Figure 3.5-3 Buckling of top reinforcement in Beam S-S-F-U at failure

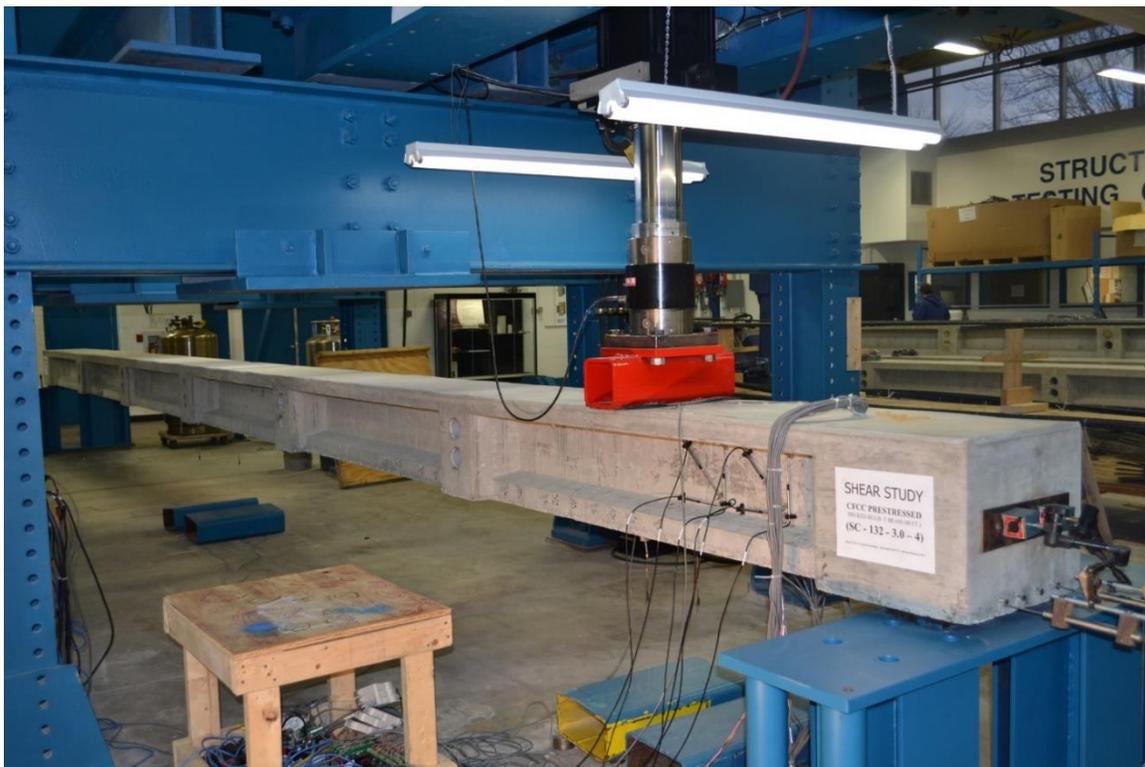
Figure 3.7-1 Test setup of Beam C-C-S-B

As shown in Figure 3.7-1, the load was applied near the end of the beam with an effective shear span of 45 in., which resulted in a shear-span-to-depth ratio of 3.0 and consequently promoted the shear failure in this control beam. To capture the shear loading mechanism and the shear failure mode, the beam was instrumented with multiple LVDTs to record the slippage of CFCC strands at the end of the beam as shown in Figure 3.7-2. The beam was also provided with a series of linear strain gages, rosette strain gages, and LVDTs through the shear span as shown in Figure 3.7-3 and Figure 3.7-4. In addition, strain gages were provided on the top flange near the loading point to record the strain in the concrete. LMTs were attached to the beam under the point of loading and under the mid-span section.

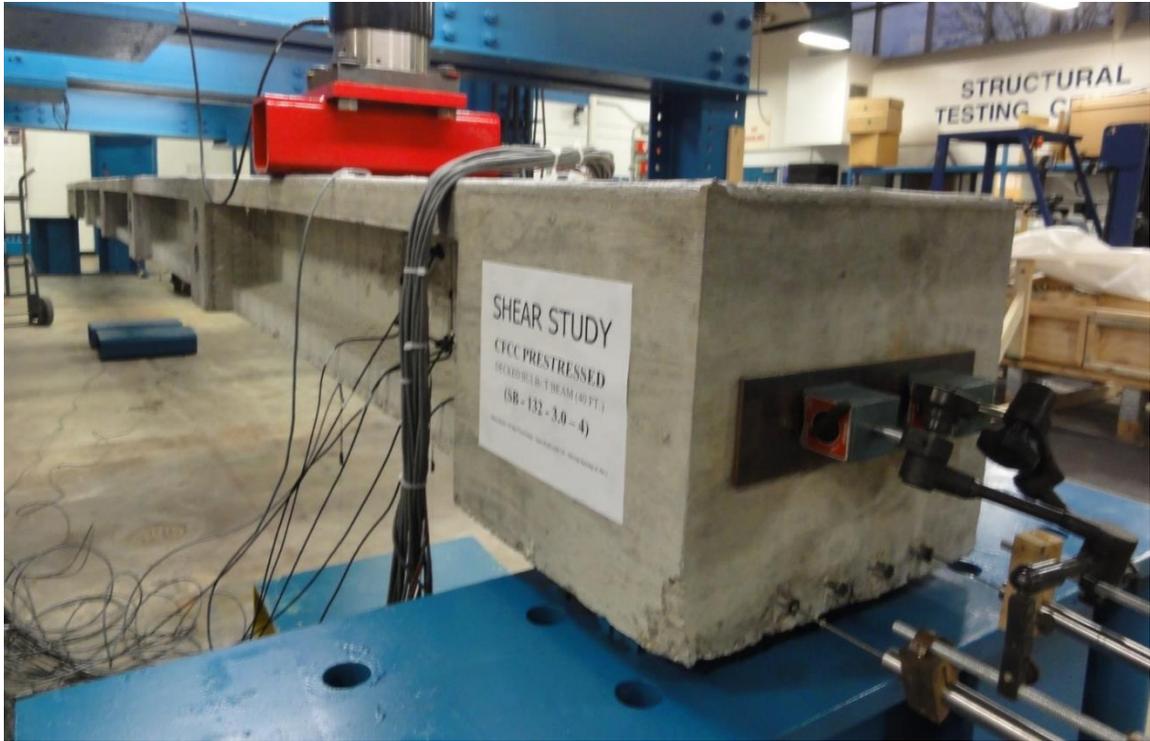
Figure 3.7-2 Monitoring slippage of prestressing CFCC strands using end LVDTs

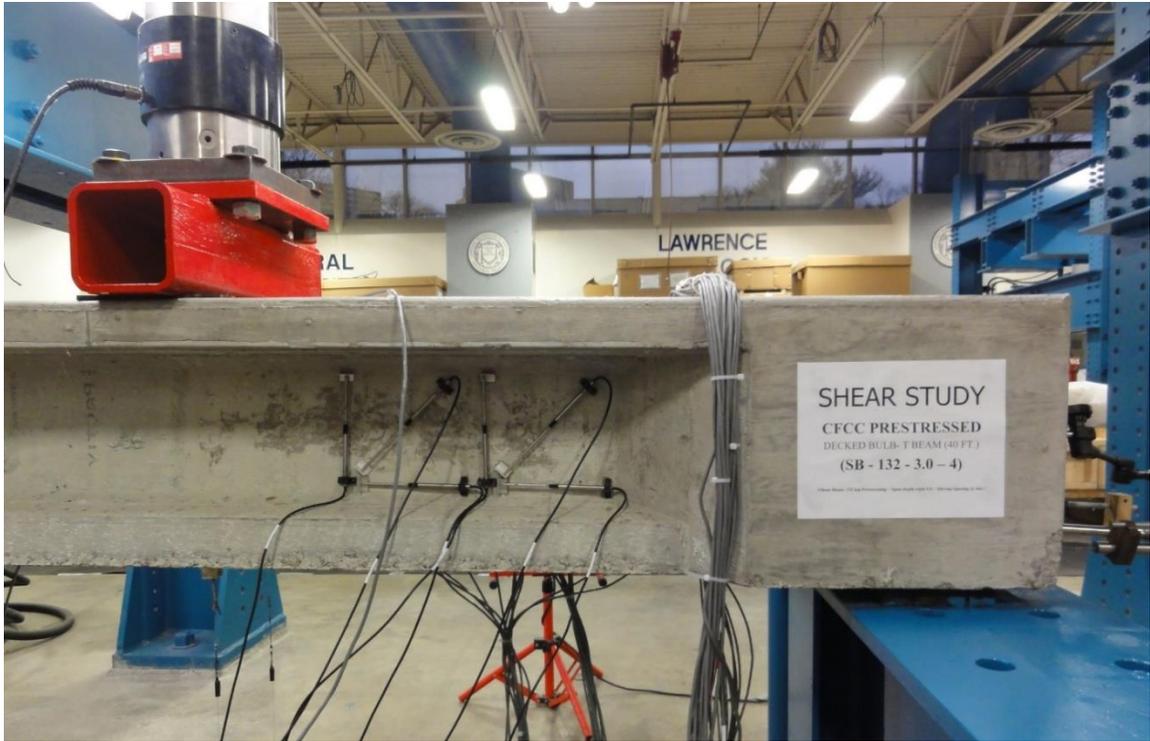
Figure 3.7-4 LVDTs at 0, 45, and 90° to evaluate shear cracking

On the other side of the beam, the LVDTs recorded significant relative displacements only after cracking. As the LVDTs crossed the shear cracks, the average crack width was determined by analyzing the readings from the LVDTs in three different directions 0, 45, and 90 degrees according to Shehata (2000).

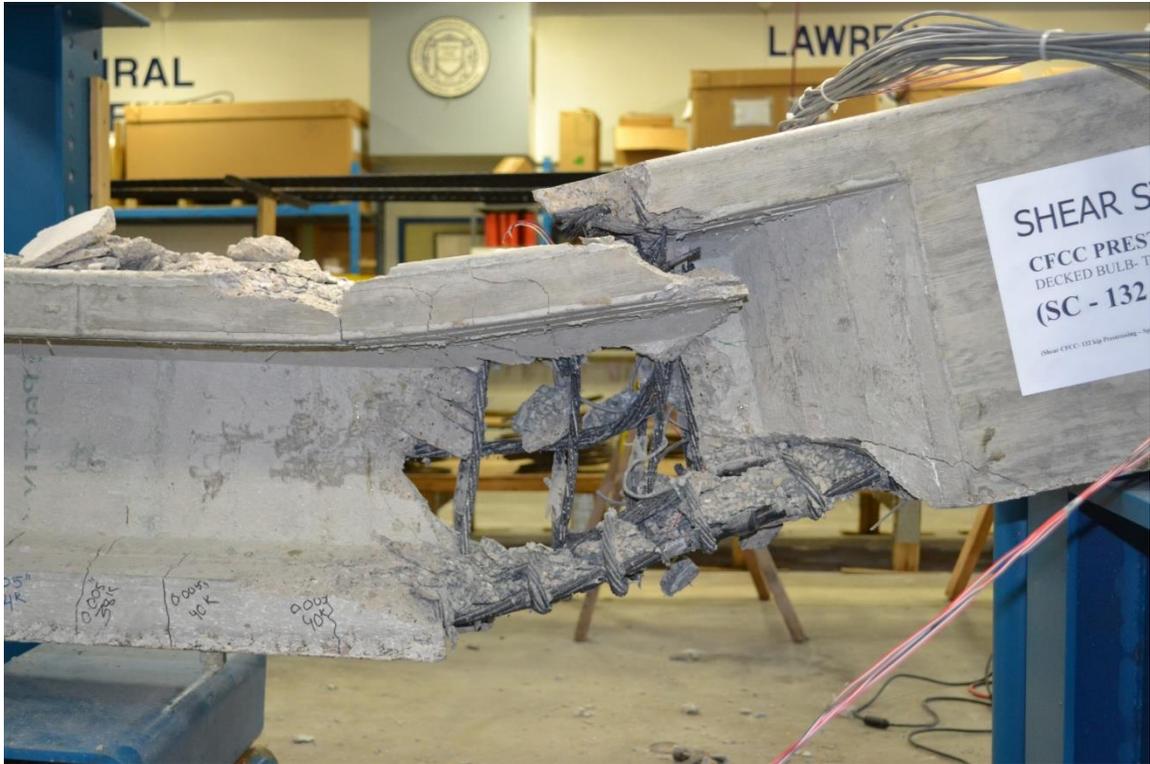
Figure 3.7-10 No rupture of CFCC stirrups was observed in Beam C-C-S-B

The failure of the beam took place at a shear force level of 41.24 kip. The failure was explosive in nature (Figure 3.7-8). The only warning sign was the development of a main diagonal shear crack extending from the support after the diaphragm and across the shear span to the loading point. The failure was characterized by the crushing of the concrete strut in the web and subsequently in the deck flange as shown in Figure 3.7-9. After failure, the stirrups were exposed and inspected for failure but no rupture of CFCC stirrups was observed (Figure 3.7-10).

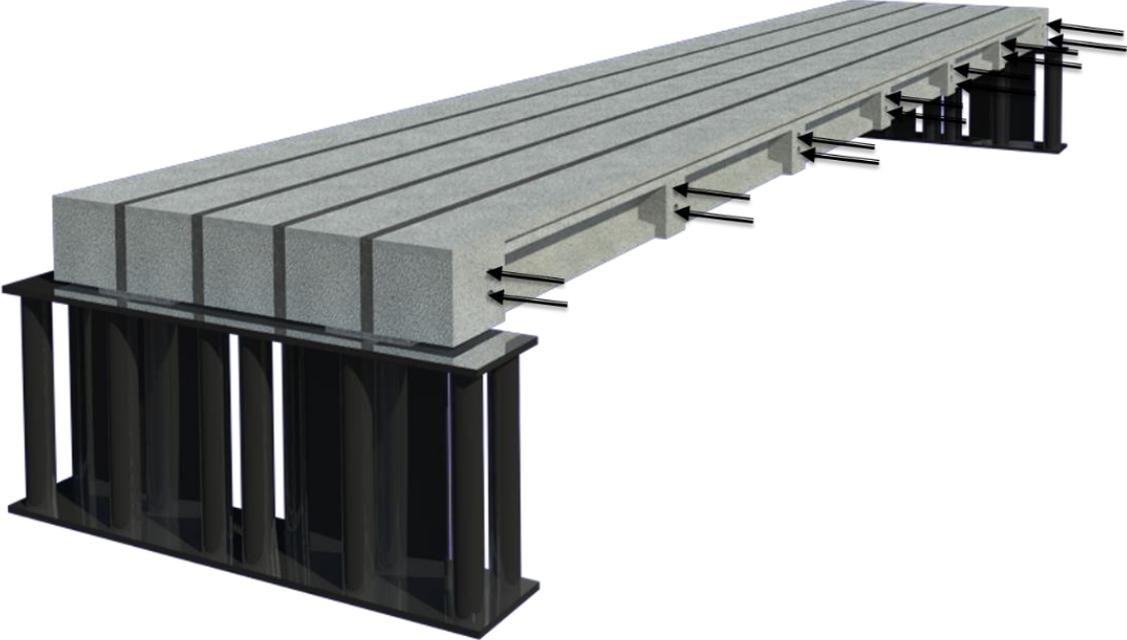
Figure 3.8-1 Schematic diagram showing the location of the transverse post-tensioning forces

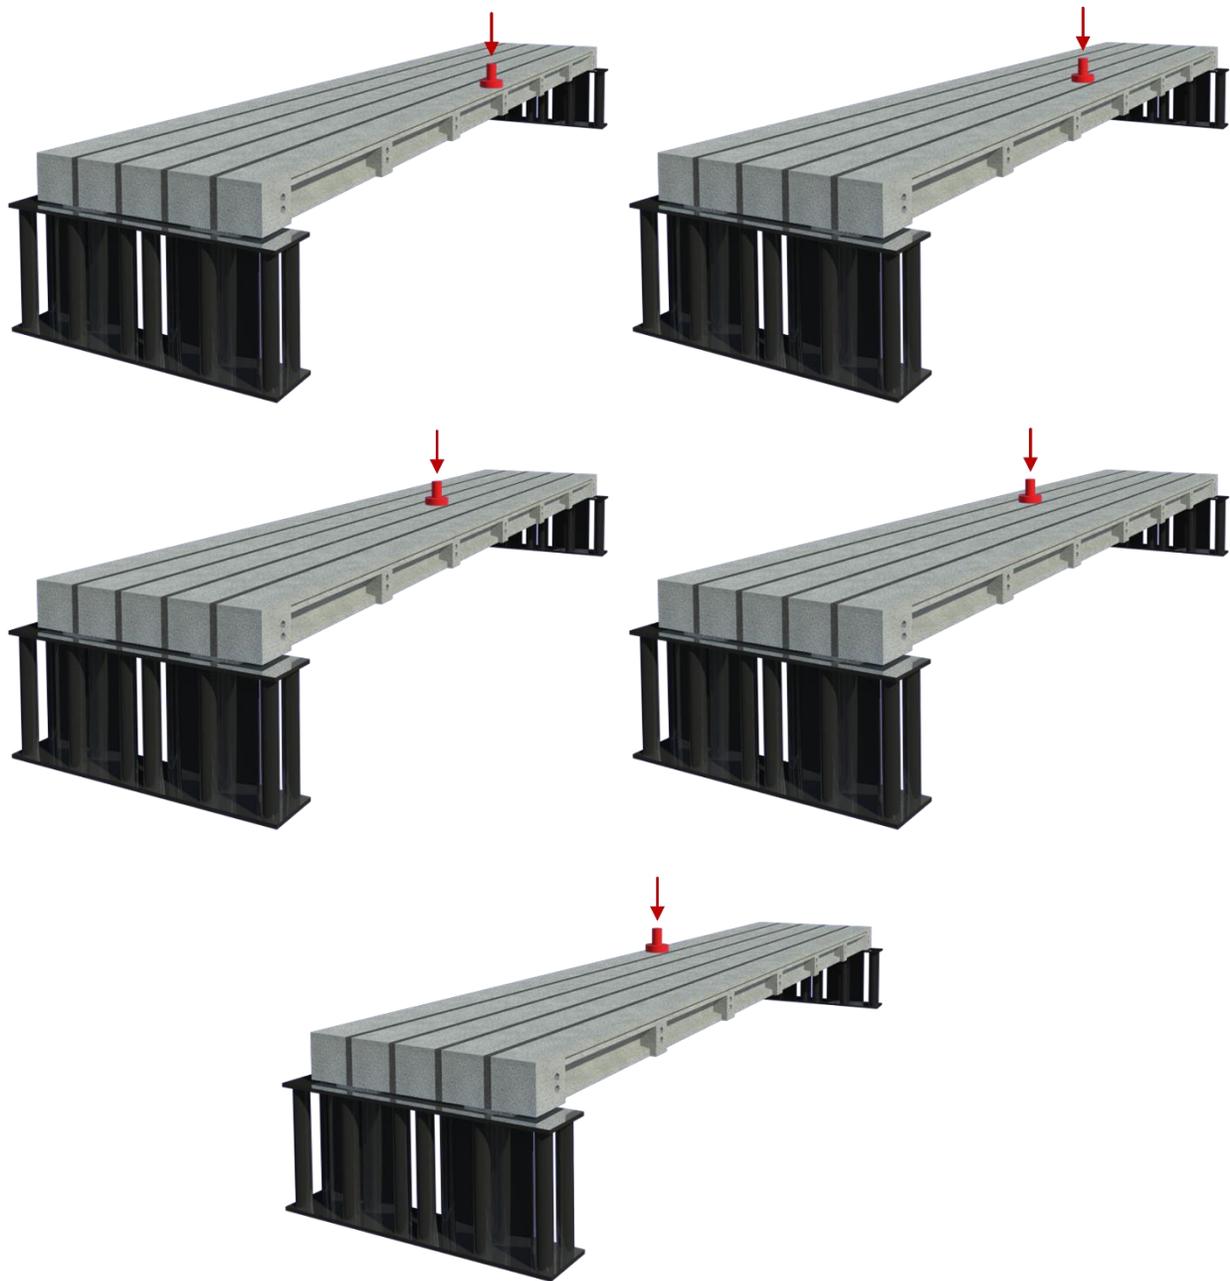
Figure 3.8-2 Sequence of service load application with/without TPT force

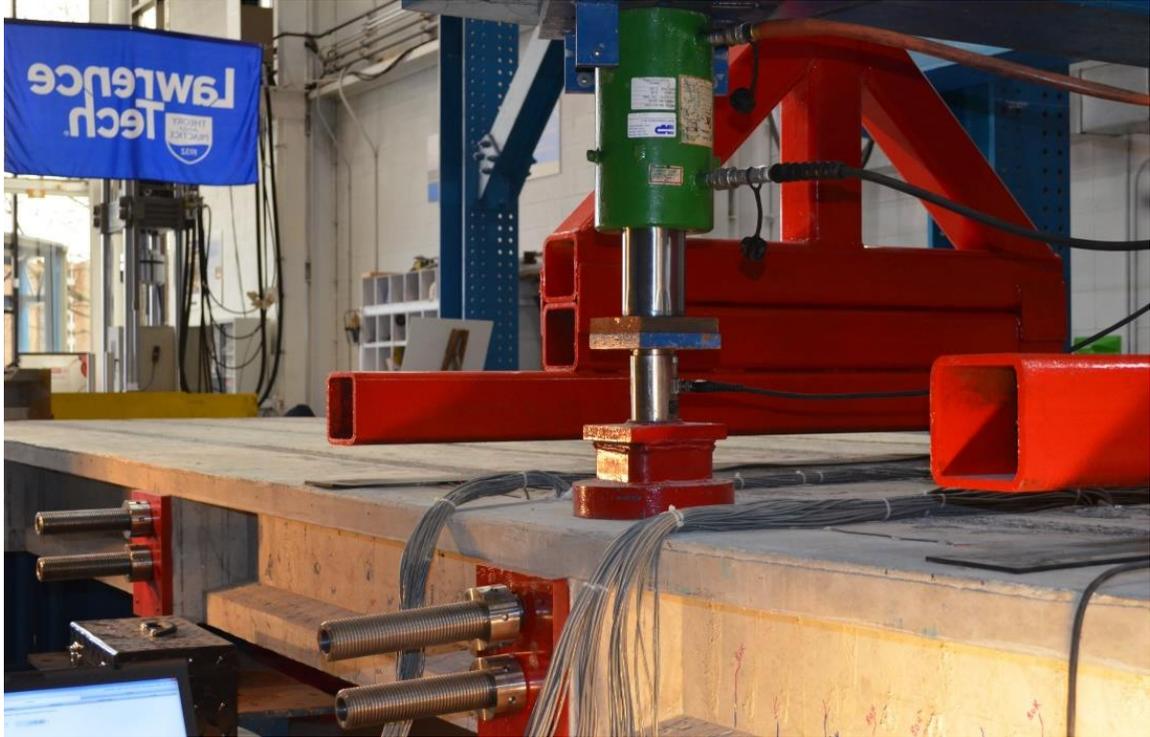
Figure 3.8-3 Service limit state testing of the bridge model

Figure 3.8-3 shows the test setup. The load was applied using a 200,000-lb hydraulic cylinder connected to a hydraulic pump. A load cell was provided to monitor the applied load and as shown in Figure 3.8-4, the load was applied first to the exterior beam followed by the interior beam, the intermediate beam, the second interior beam, and finally the second exterior beam. It should be noted that the response of the bridge model when the load was applied on one side was a mirror image to that when the load was applied on the opposite side. To avoid repetition, only the deflection curves obtained from loading one side (exterior, interior, and middle beams) are presented in the discussion.

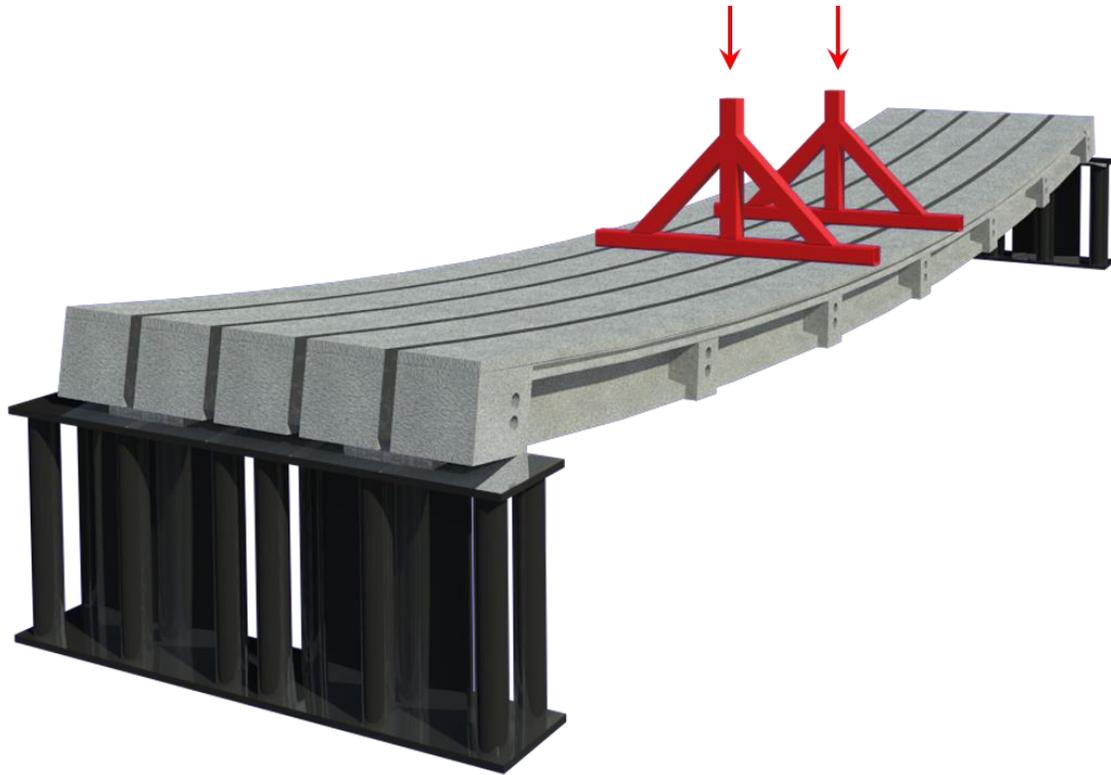
Figure 3.8-8 Four-point-loading setup for inducing flexural cracks

To induce the flexural cracks, the bridge model was loaded in a four-point loading setup as shown in Figure 3.8-8 and Figure 3.8-9. The distance between the points of load was adjusted to 78 in. The load was applied through cycles of loading and unloading with a load increment of 10 kip between cycles. After each loading cycle, the bridge model was inspected for cracks. The first flexural crack was observed during the 60 kip load cycle (Figure 3.8-10). After evaluating the load-deflection curves, it was determined that the first crack developed at a load level of 53.2 kip with a corresponding deflection of 1.23 in. The development of cracks marked a rapid change in the slope of the load-deflection curve.

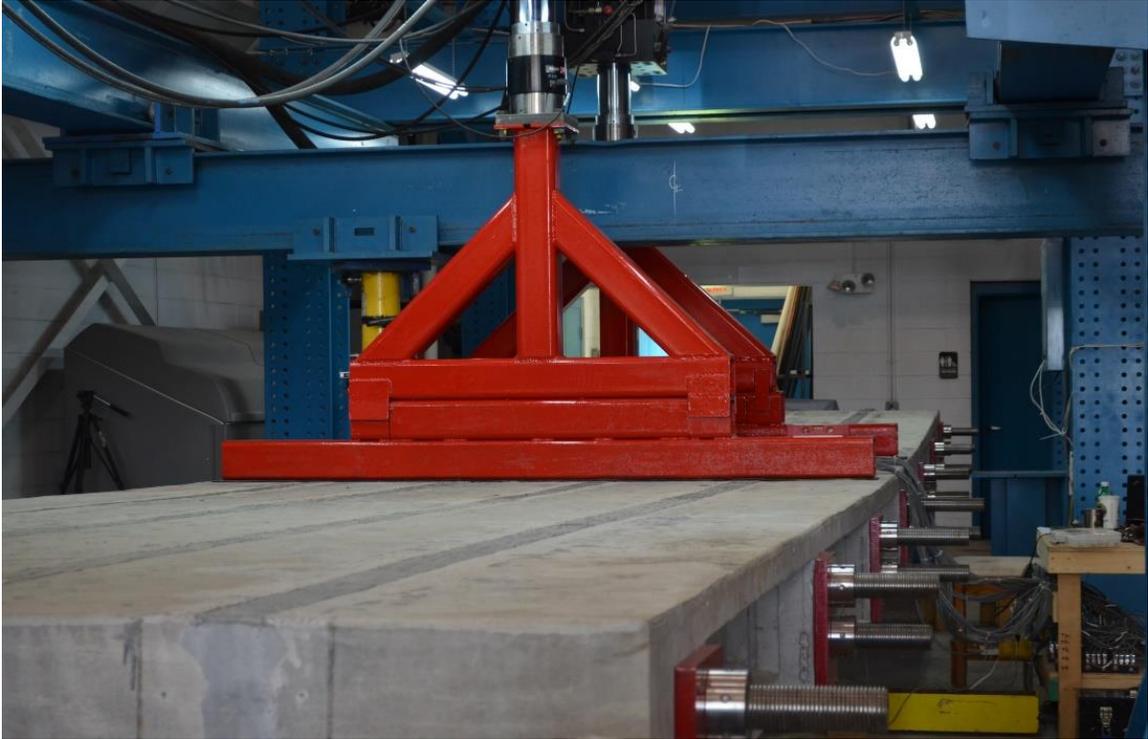
Figure 3.8-9 Four-point loading of bridge model

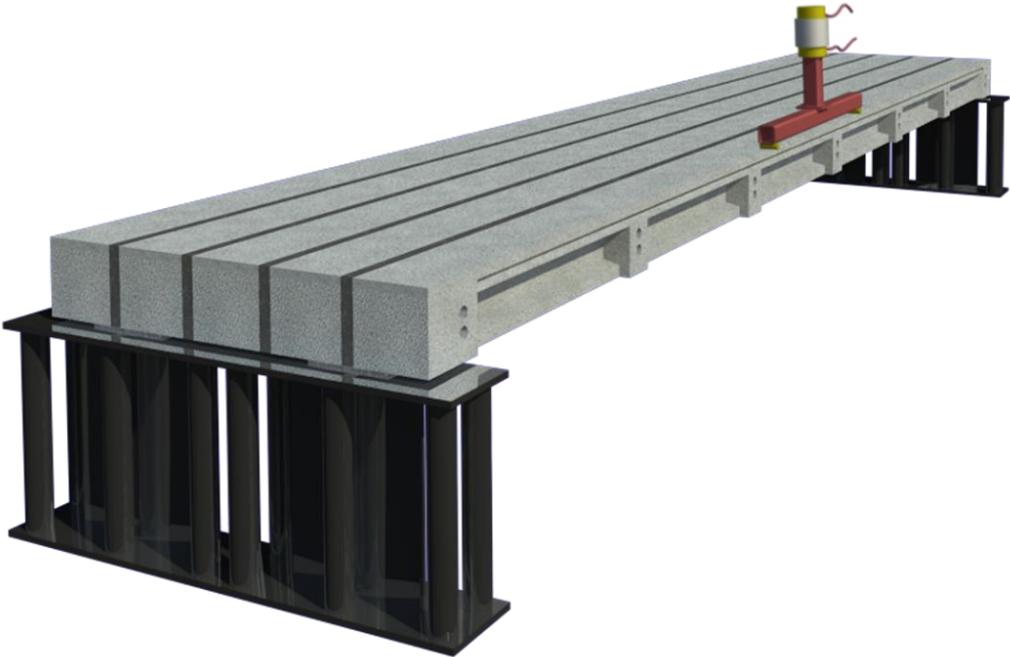
Figure 3.8-13 Schematic diagram showing testing of shear key joint

The testing scenario was developed to directly evaluate the performance of UHPC shear joints along with the transverse diaphragms. An exterior beam of the bridge model was loaded until localized shear key cracks were developed. As shown in Figure 3.8-13 and Figure 3.8-14, the exterior beam was loaded through a four-point loading setup with 78-in. distance between the two points of load. No TPT force was applied at any of the transverse diaphragms. The load was applied in cycles starting from 60 kip with an increment of 10 kip. The bridge model was inspected for cracks after each load cycle.

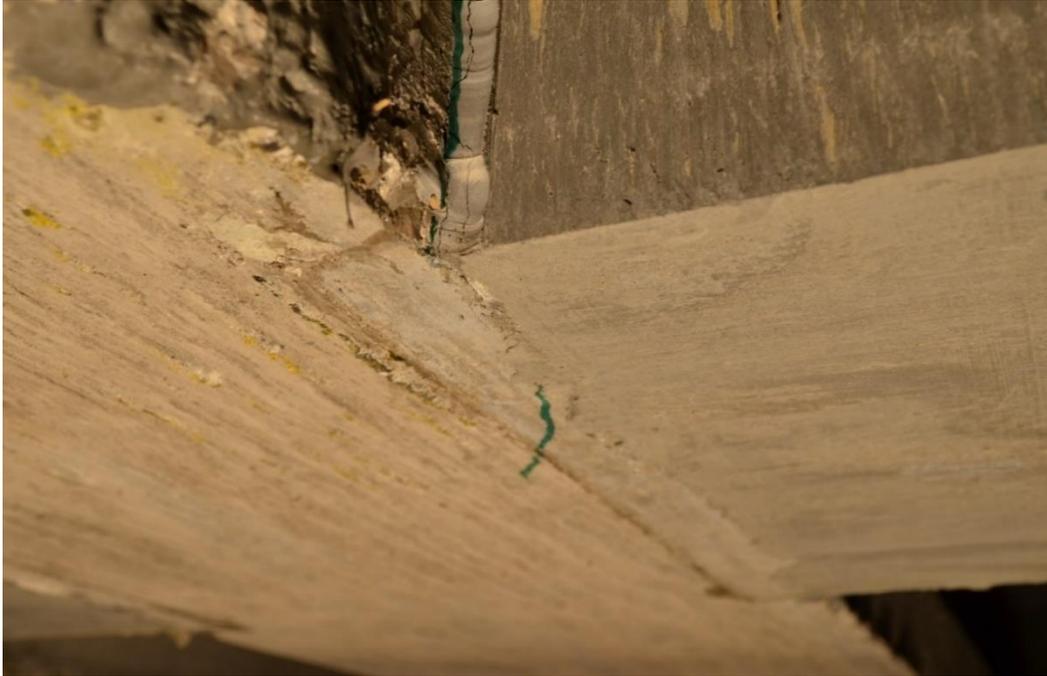
Figure 3.8-15 Bottom view of bridge model showing development of cracks at diaphragm

No cracks developed at a load level of 70 kip. At a load level of 80 kip, minor cracks developed around the three intermediate diaphragms in addition to a limited hairline crack at the shear key joint near the applied load as shown in Figure 3.8-15 through Figure 3.8-17. All cracks developed on the concrete side of the joint and not on the UHPC side. In addition, when the load increased to 90 kip, the cracks seemed to slightly propagate.
