CHAPTER 3: TESTING & RESULTS

3.1 Introduction

This chapter presents the test methodology and the test results for the five control decked bulb T beams and the bridge model. The results are presented in the form of charts showing the relationship between the applied load and the response of the test specimens including deflection, strain of concrete, and strain in CFCC strands. In addition, for each test specimen, the ductility ratio was calculated to evaluate the failure mode analytically.

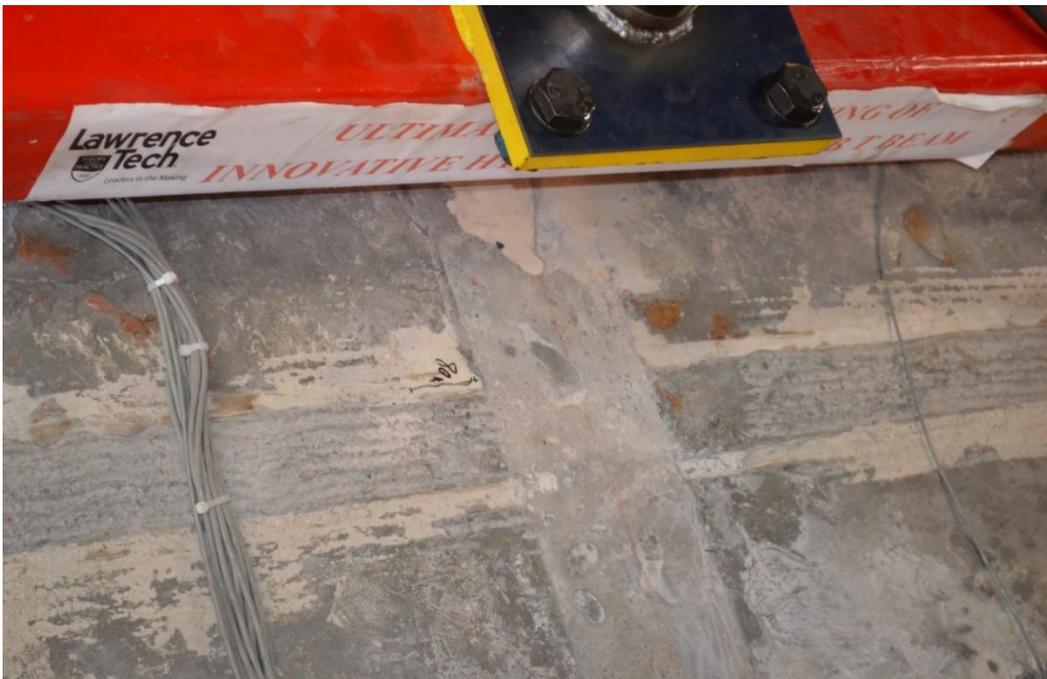
Figure 3.8-16 Localized shear key cracks at load level of 80 kip

No cracks developed at a load level of 70 kip. At a load level of 80 kip, minor cracks developed around the three intermediate diaphragms in addition to a limited hairline crack at the shear key joint near the applied load as shown in Figure 3.8-15 through Figure 3.8-17. All cracks developed on the concrete side of the joint and not on the UHPC side. In addition, when the load increased to 90 kip, the cracks seemed to slightly propagate.

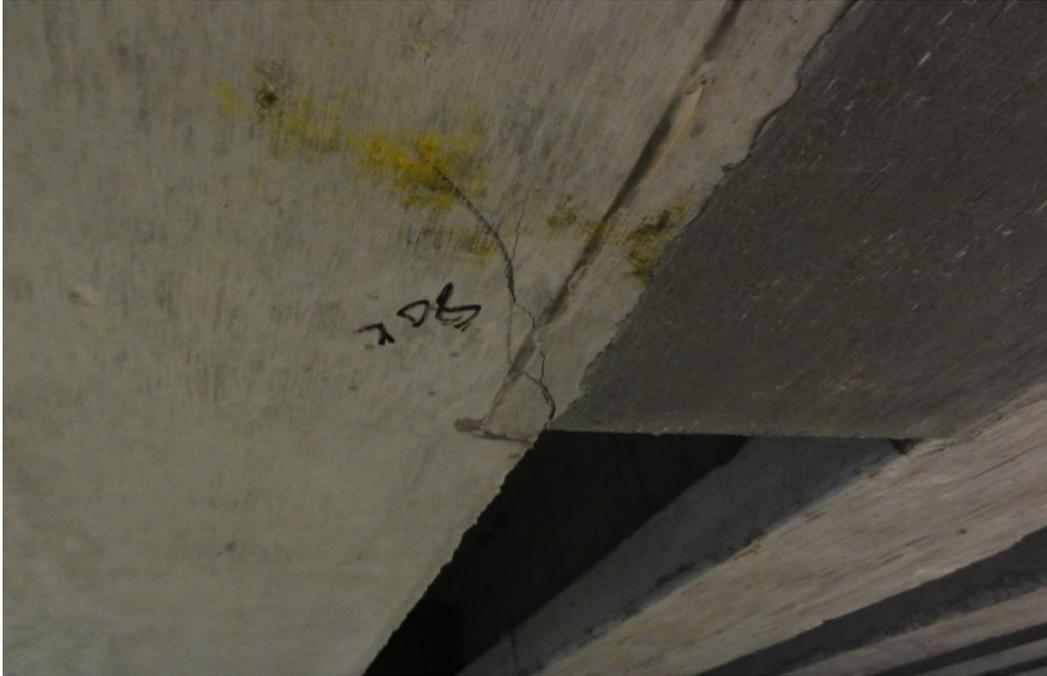
Figure 3.8-17 Cracks under a load of 80 kip near intermediate diaphragm

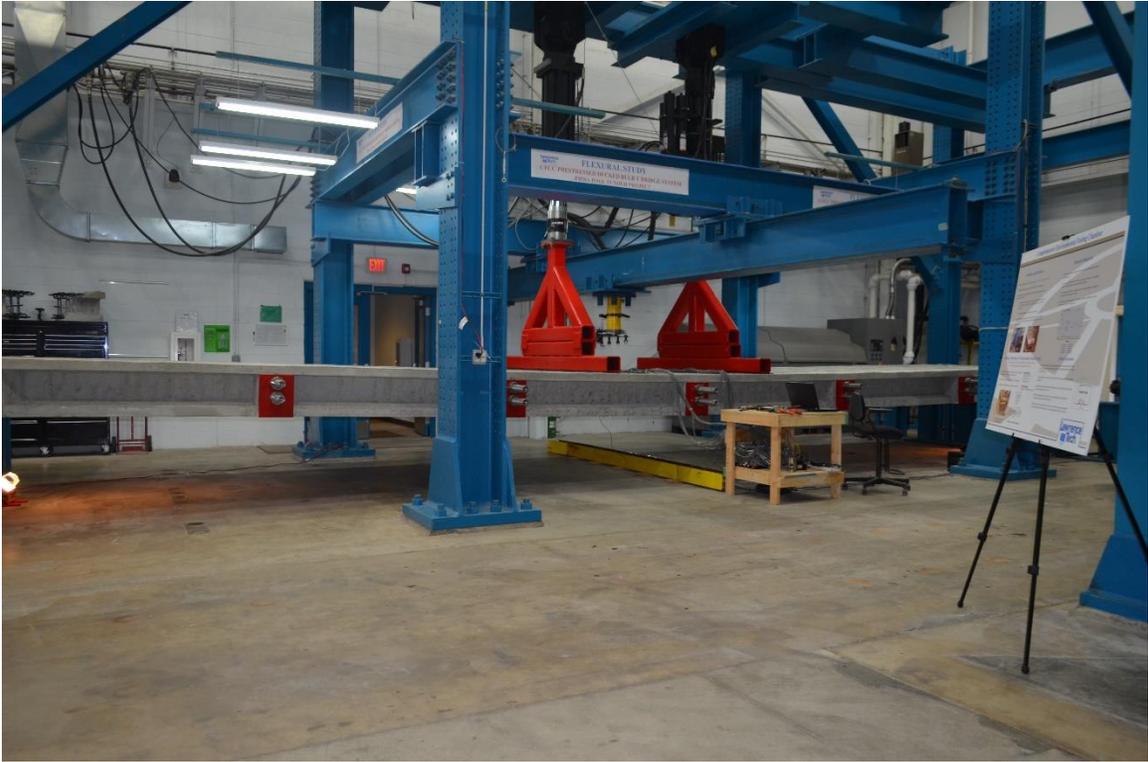
Figure 3.8-19 Load cycle test of bridge model

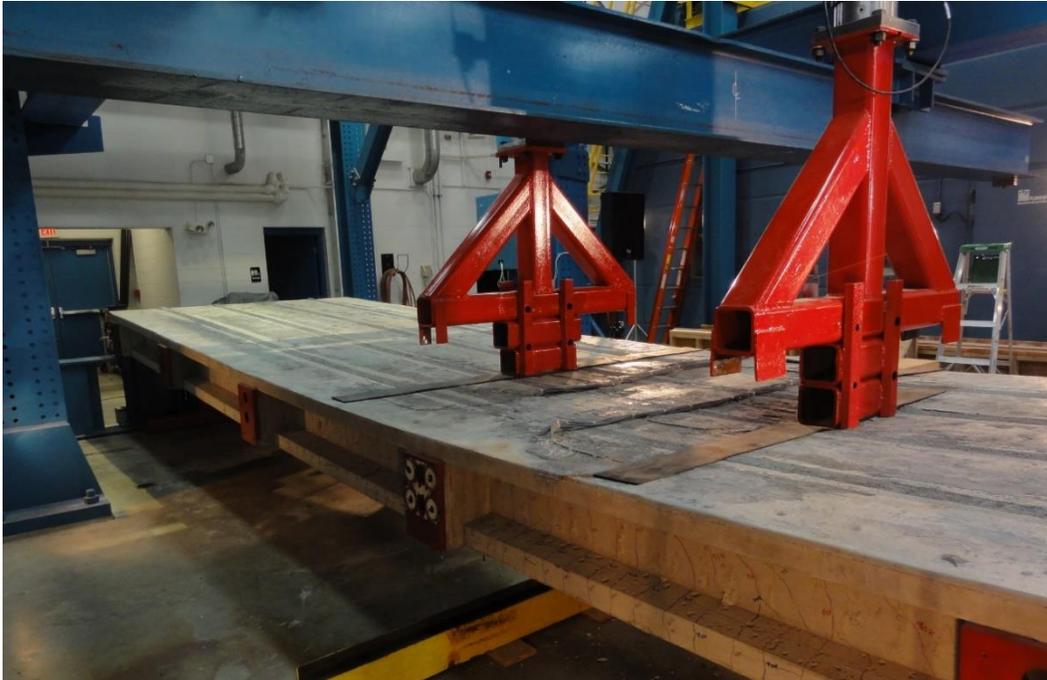
Figure 3.8-23 Four-point loading of intermediate beam at strength limit state testing

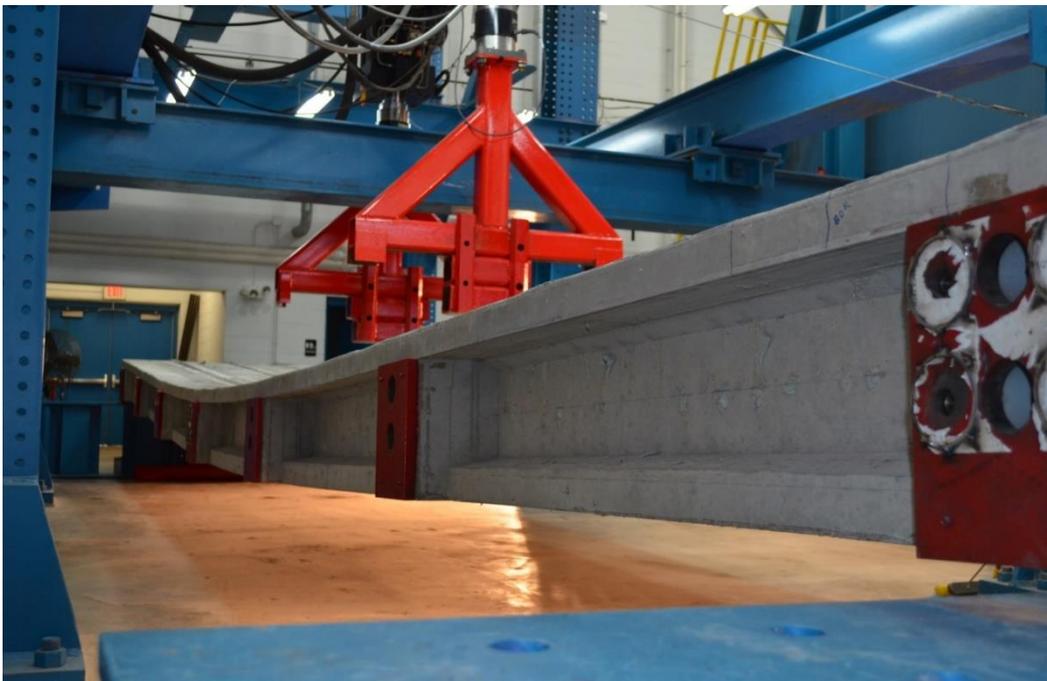
Figure 3.8-26 Bridge model at failure

The bridge model achieved a load level of 220 kip with a corresponding deflection of 18.14 in. With further increasing the load, a popping sound corresponding to rupture of CFCC strands was heard. With every strand rupture, spalling of concrete and sudden drop in the load were observed. Initially, the concrete in the top flange did not show any signs of crushing but after the rupture of a few CFCC strands, signs of partial concrete crushing at the exterior beam were observed (Figure 3.8-26 and Figure 3.8-27).

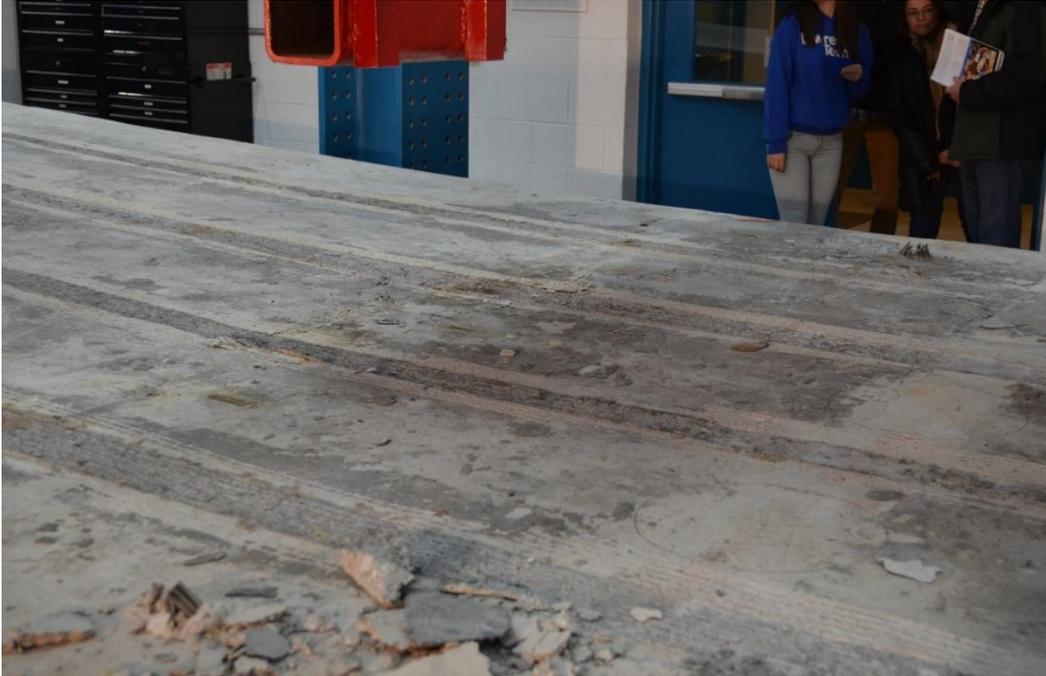
Figure 3.8-27 Partial concrete crushing in top flange after failure

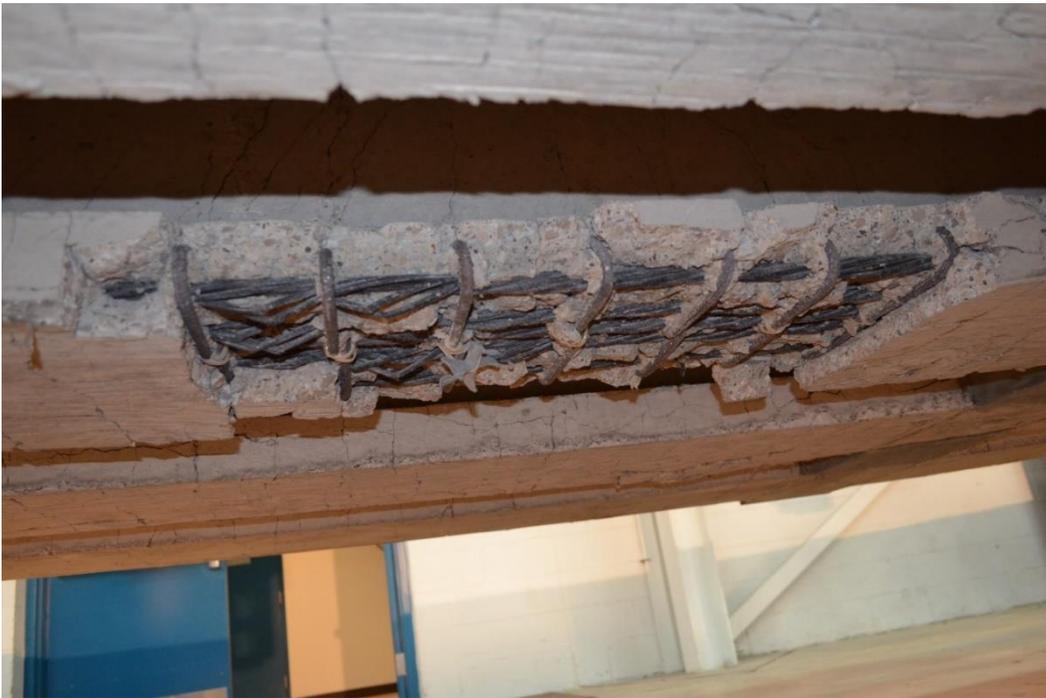
Figure 3.8-28 Spalling of concrete from bottom of loaded intermediate beam at failure

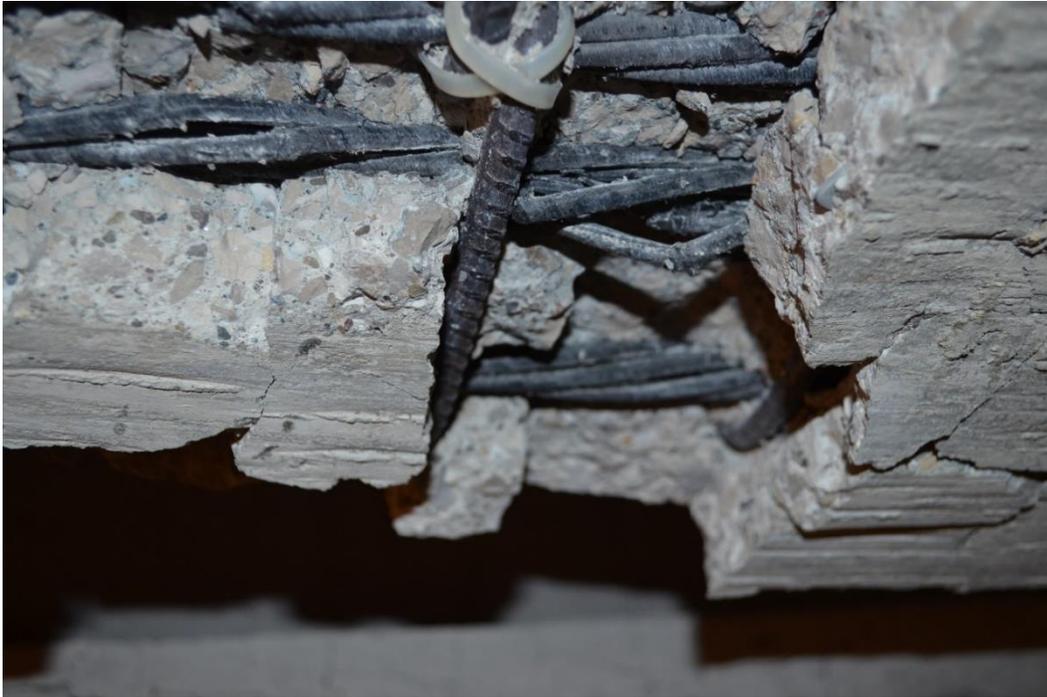
Figure 3.8-29 Rupture of prestressing CFCC strands in bridge model in intermediate beam
