EPA & DEQ

Town Hall Meeting

Wolverine Update

March 26, 2019

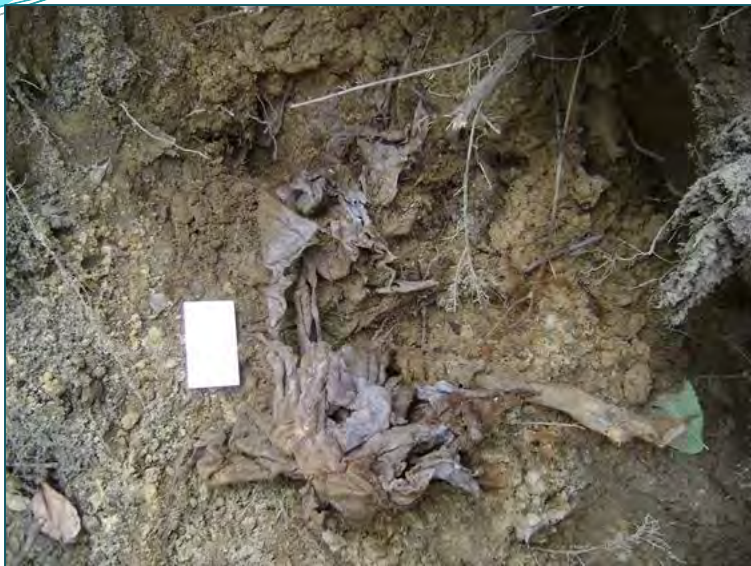
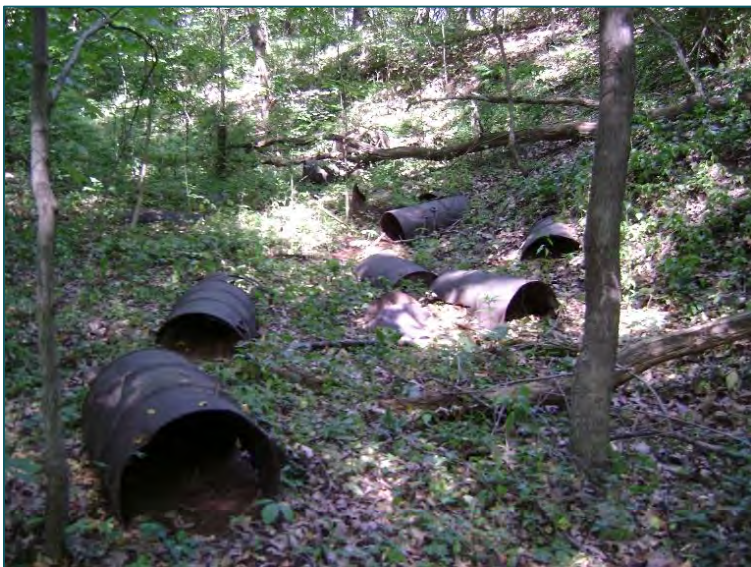
Drums and leather scraps on House Street

- 1930s/1940 – First reference to Wolverine disposal activities on House Street.
- 1964 – Wolverine purchases site
- 1966 – Licensed disposal facility
- 1970 – Disposal activities stop
- 2017 – Citizen group meets with DEQ

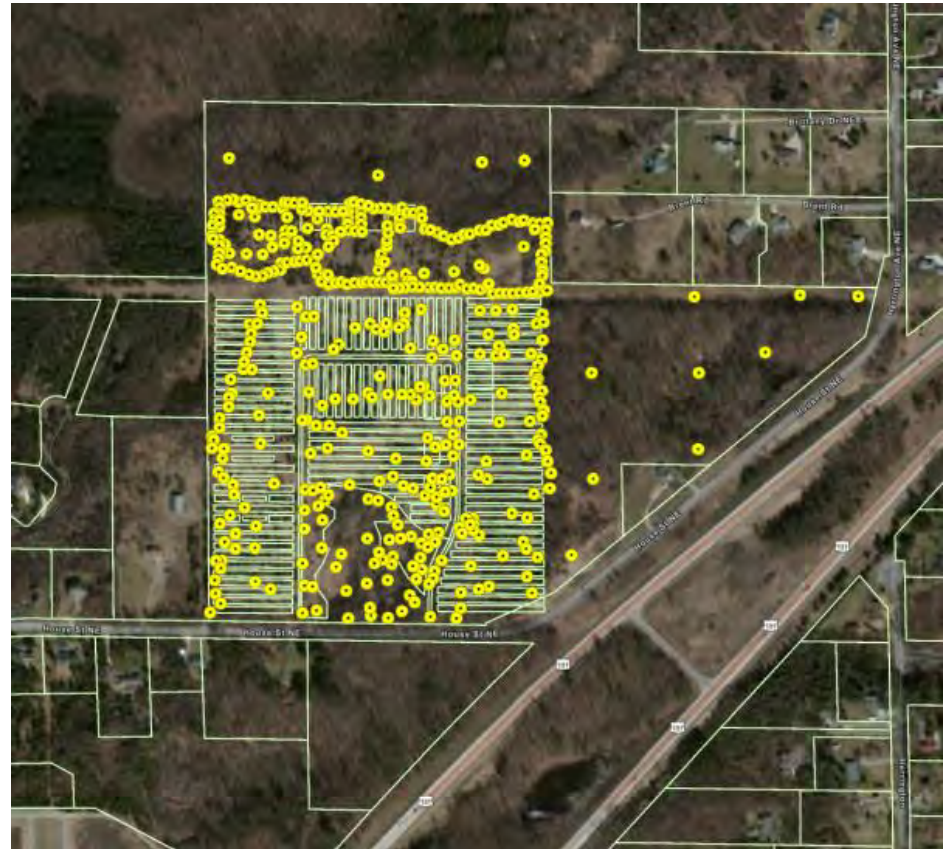
Soil Sample Locations on House Street Site – Figure from USEPA

- 676 Soil Borings Installed
- 284 Soil Borings Contained Waste (PFAS concentrations as high as 220,000 ppb in the waste)
- 874 soil samples collected (PFAS concentrations as high as 81,000 ppb in the soil)

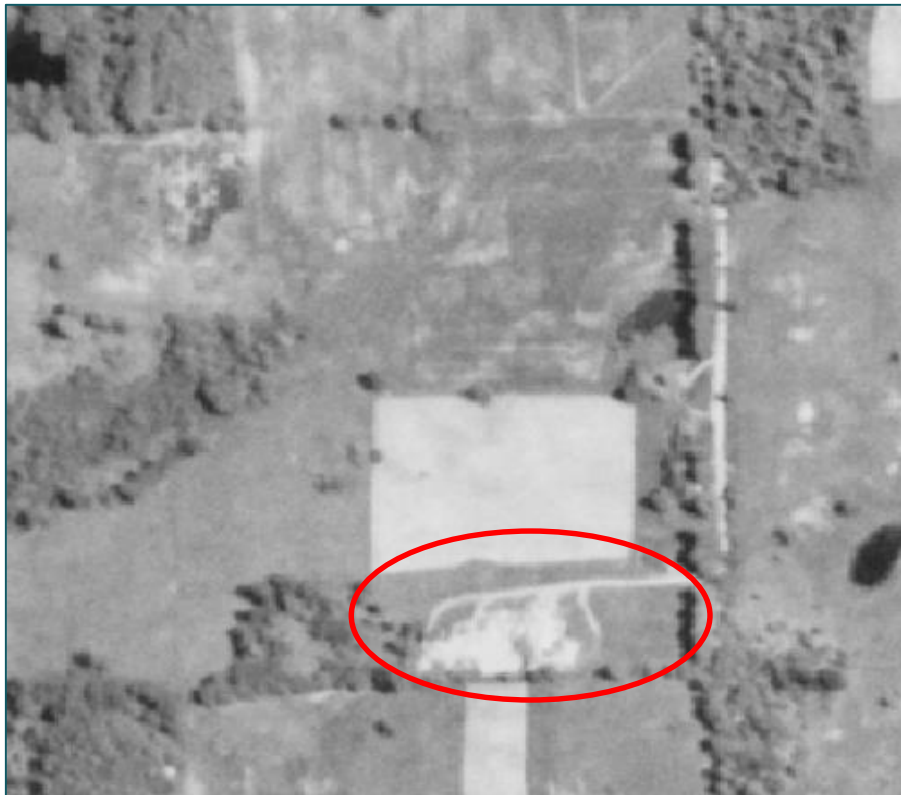
1953 USGS

- Gravel pit where disposal occurred is active in the 1950s but inactive by 1965
- Different waste stream then House Street
- Wolverine began well sampling Fall 2017
- DEQ and EPA conducted soil sampling Summer 2018

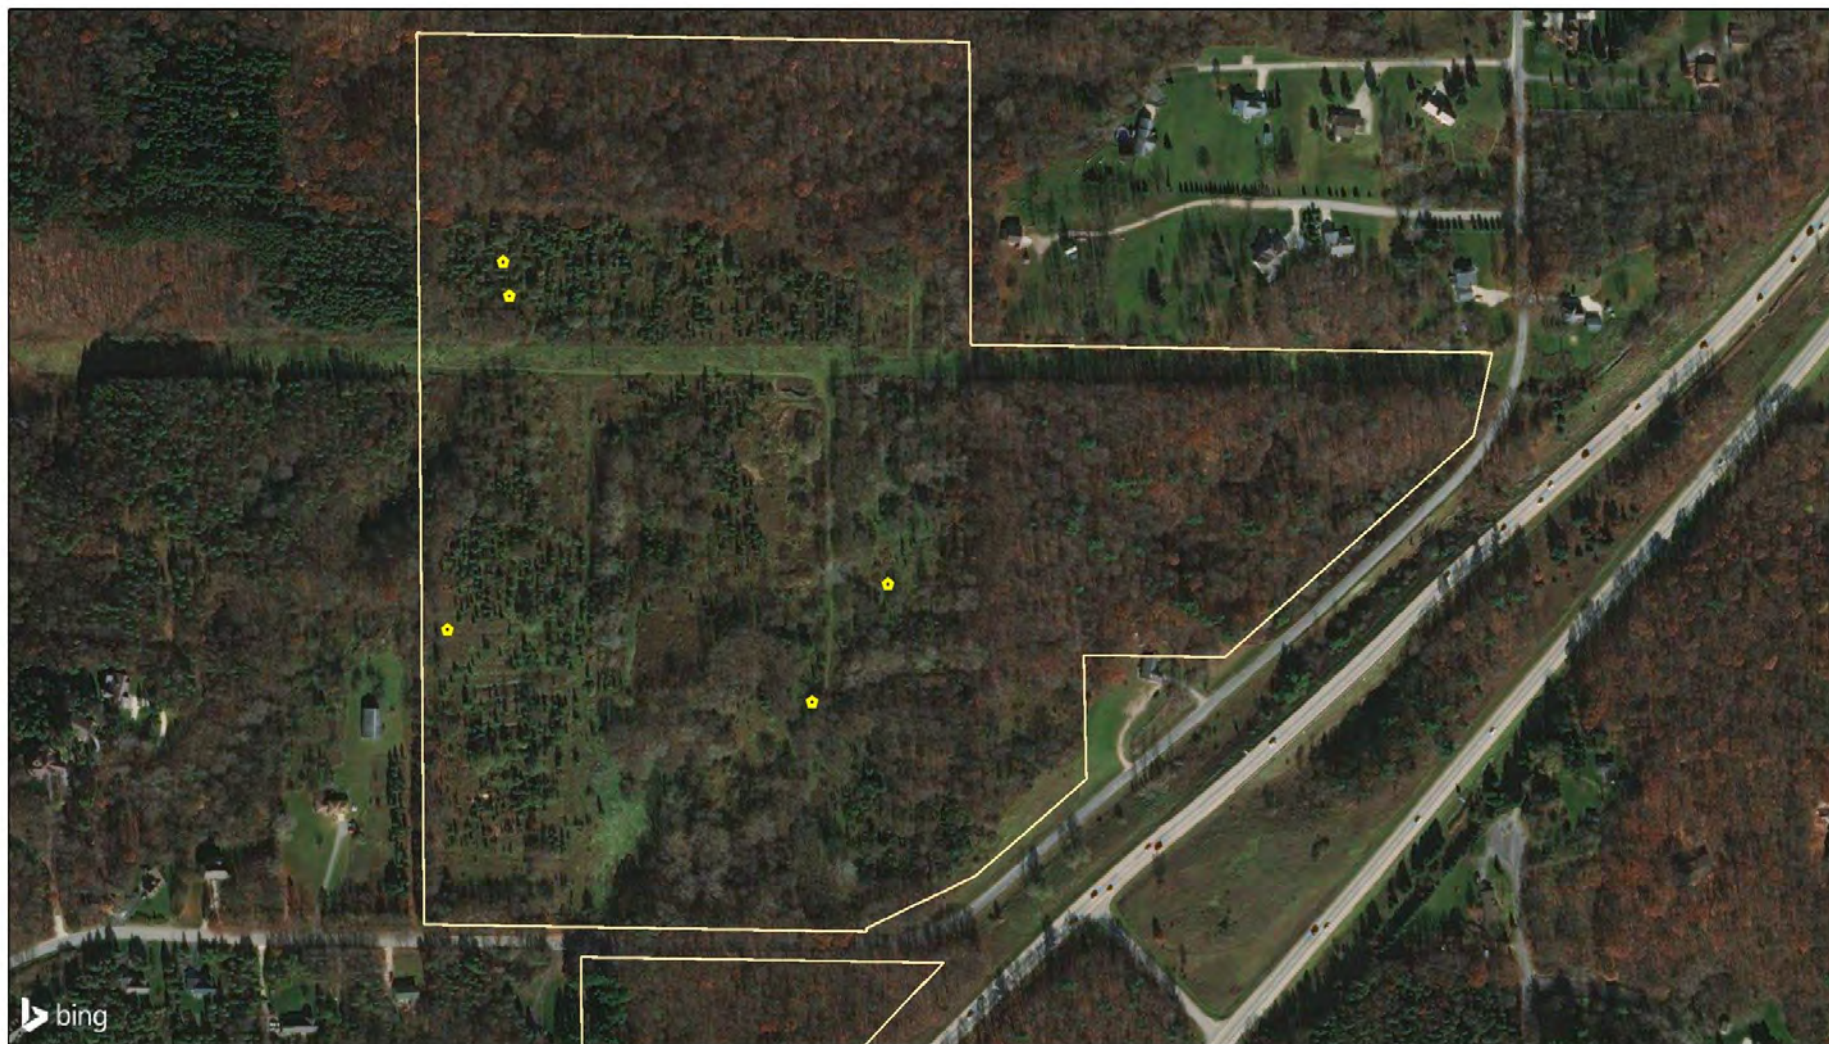
House St Soil TCLP Hazardous Waste Exceedances - Metals

⬠ TCLP Chromium ≥ 5 (EPA Haz)

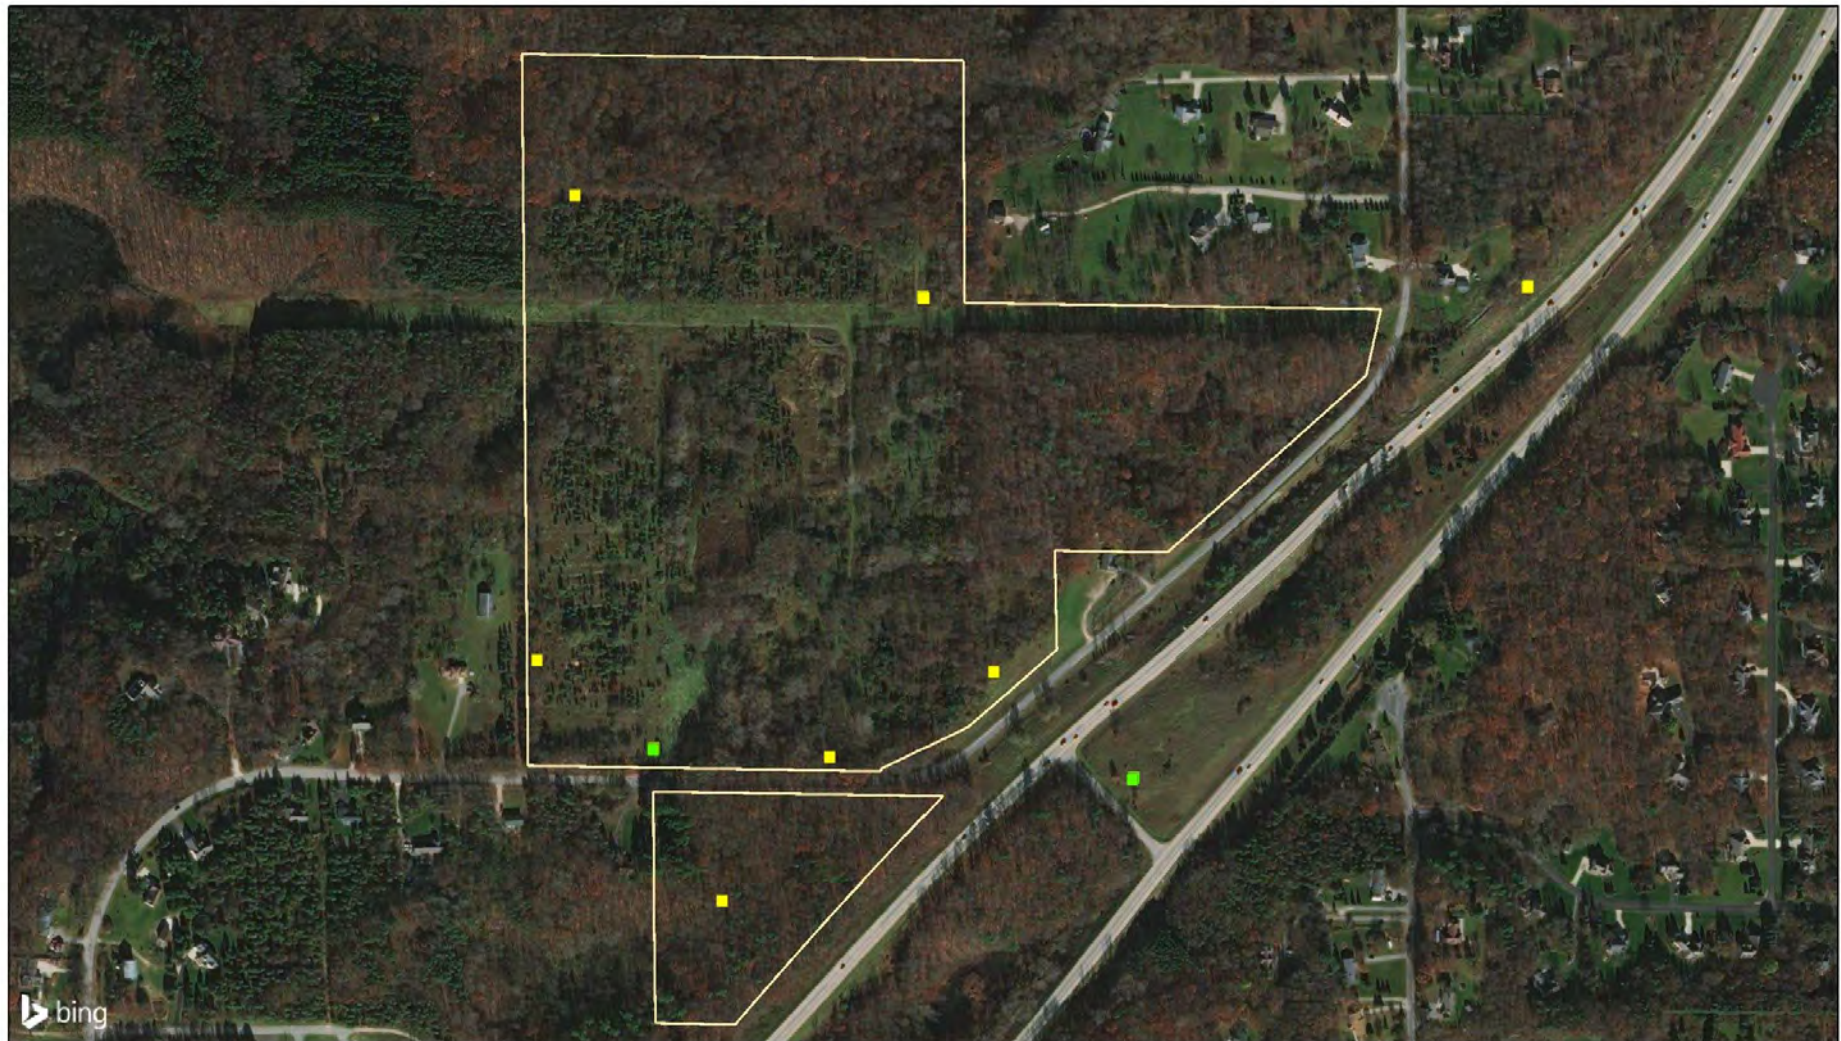
House St Deep GW Residential Drinking Water Exceedances - Metals, General Chemistry

- Groundwater Acetic Acid ≥ 4200 (Res Drink)
- Groundwater Chloride $\geq 250,000$ (Res Drink)
- Groundwater Nitrate-Nitrite + Ammonia $\geq 10,000$ (Res Drink)
- Groundwater Sulfate $\geq 250,000$ (Res Drink)
- Groundwater Aluminum ≥ 50 (Res Drink)
- Groundwater Iron ≥ 300 (Res Drink)

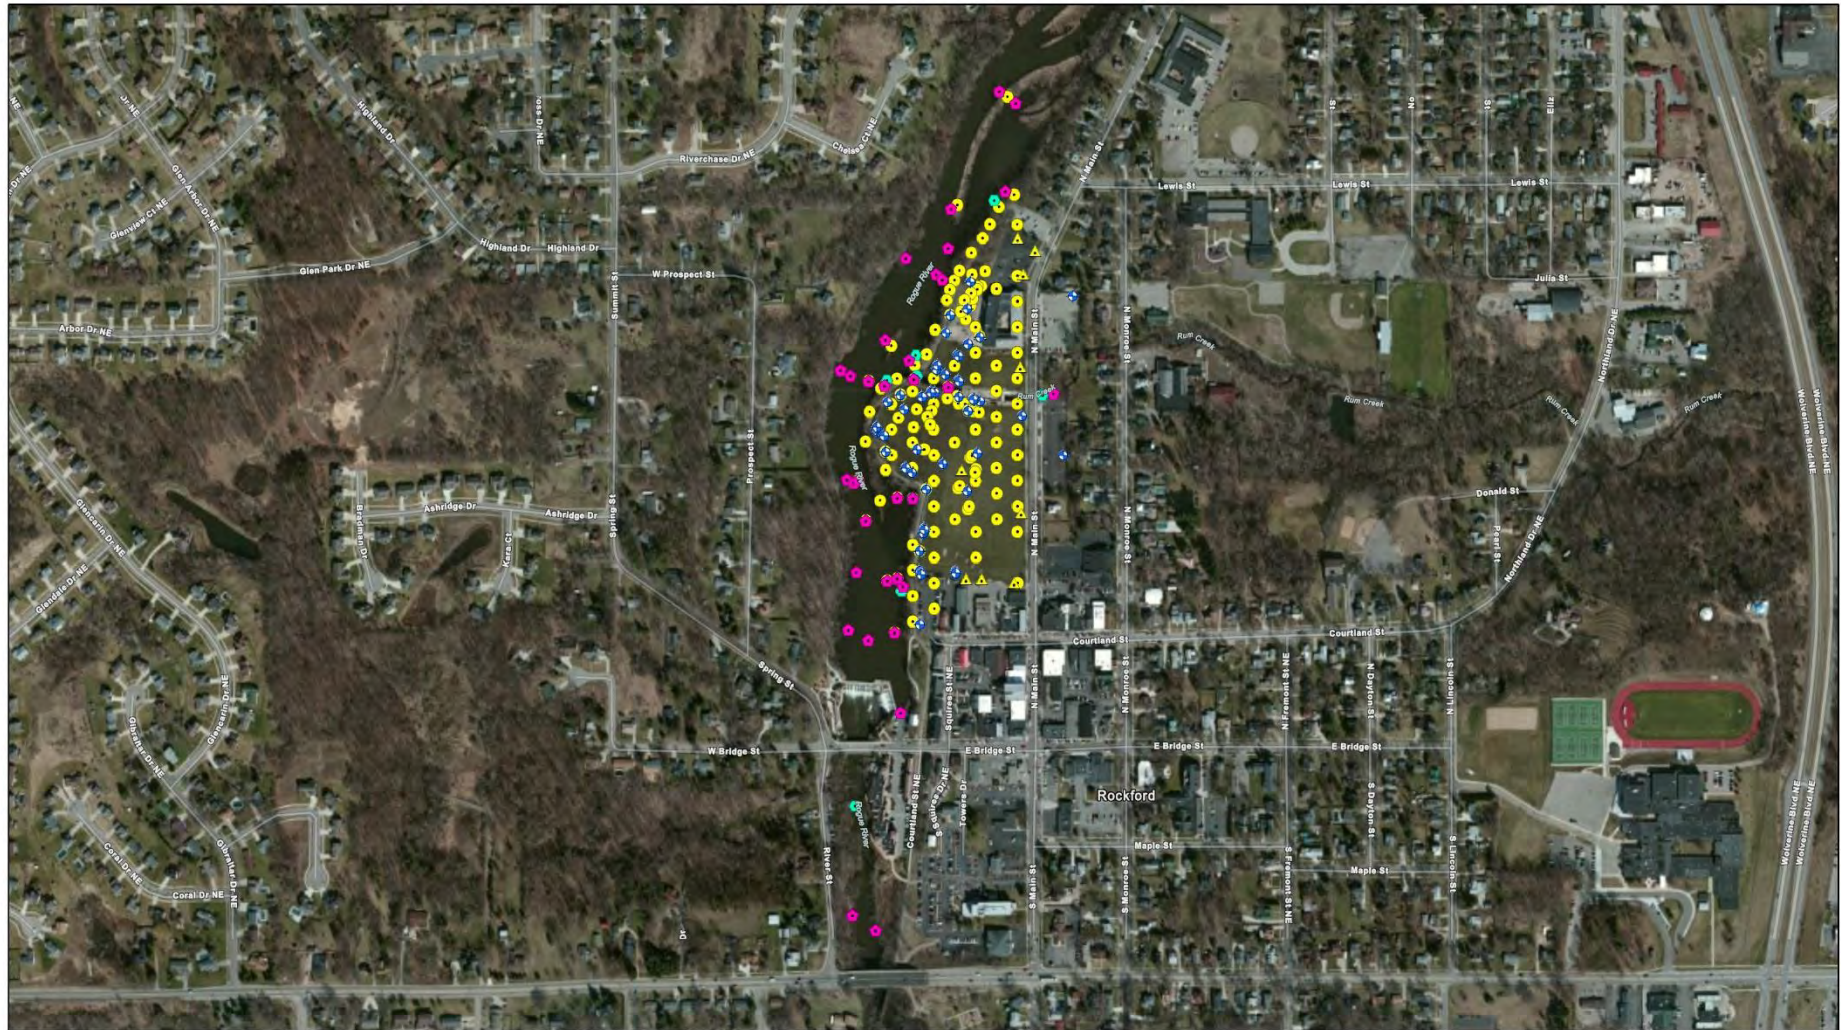
Tannery Sampling Location Summary

- Soil sampling
 - 113 boring locations
 - 244 soil samples
 - Screening showed:
 - 12 Locations with observed leather scraps
- Sediment Sampling
 - 10 Transects
 - 33 Sediment Cores
 - 91 sediment samples

- Groundwater sampling
 - 2 rounds of sampling
 - 56 Sampling Locations
 - 118 groundwater samples collected
- Surface Water Sampling
 - 2 rounds of sampling
 - 7 locations in Rogue River and Rum Creek
 - 16 surface water samples
- Soil Gas Sampling
 - 2 rounds of sampling
 - 10 soil gas well locations
 - 22 soil gas samples collected

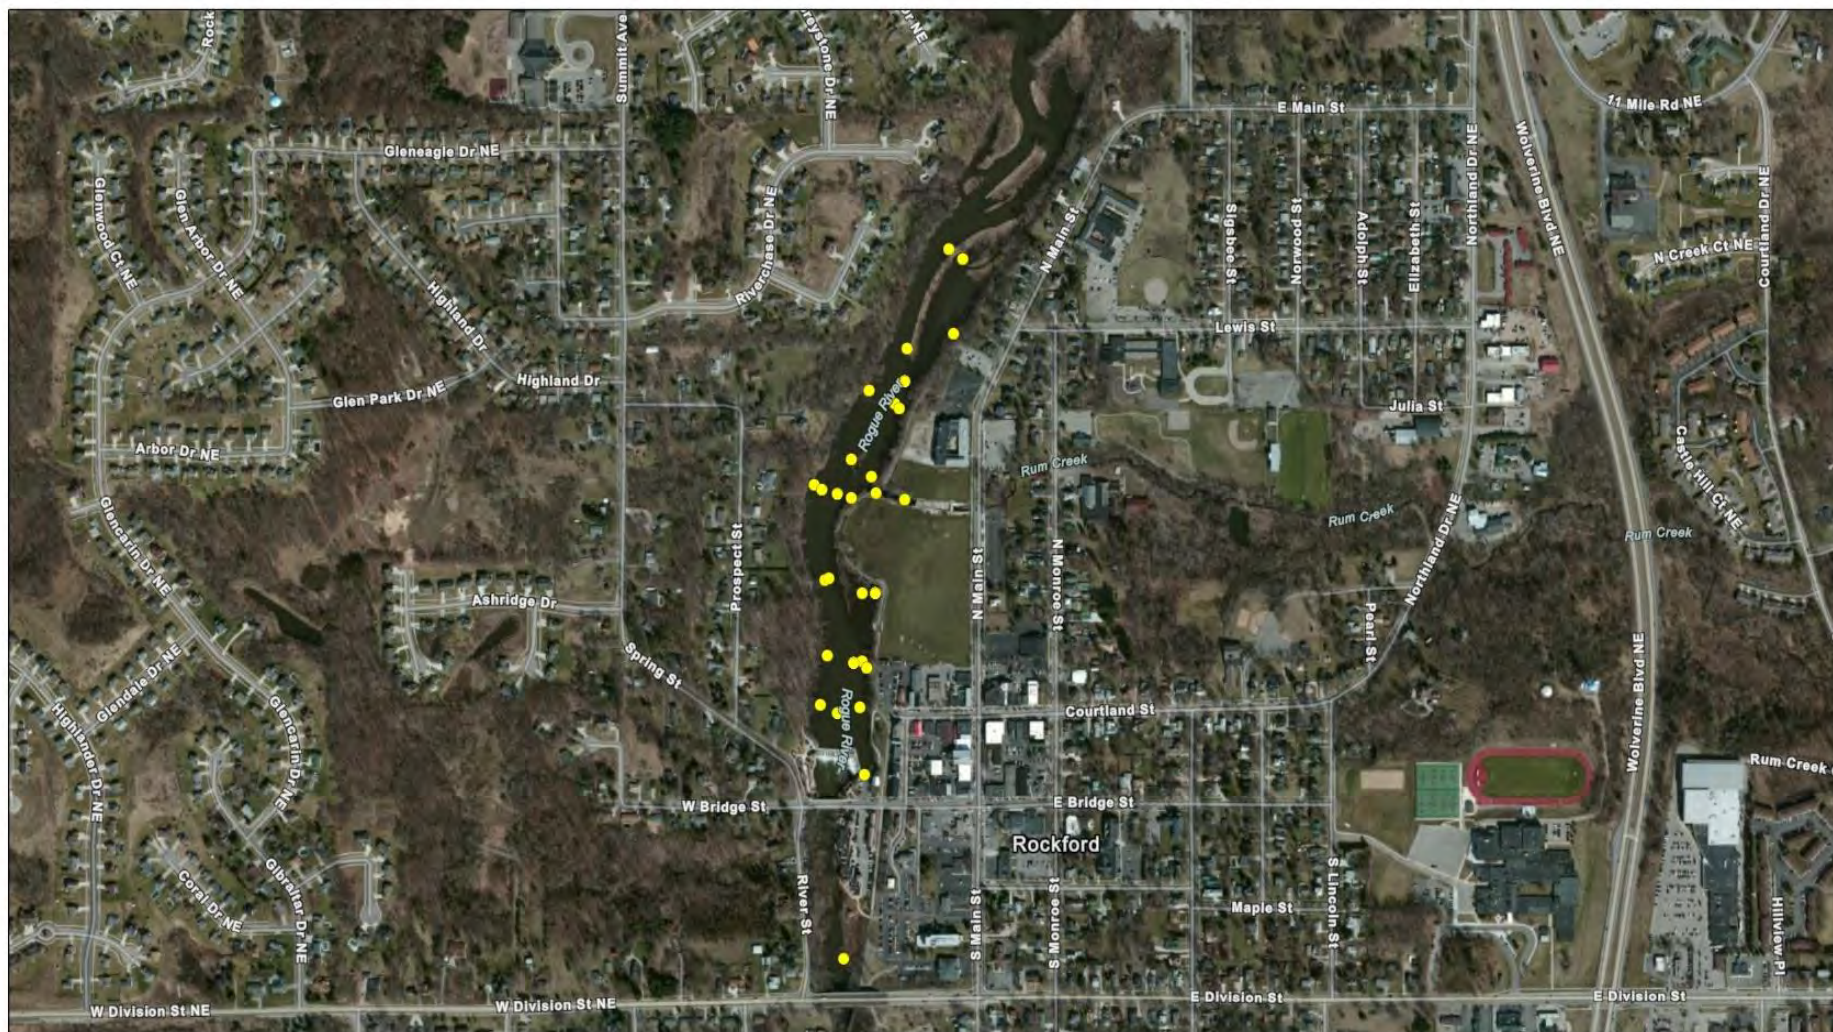
Tannery Sediment GSI Exceedances - Metals

- Arsenic ≥ 4.6 (GSI)
- Hex Chromium ≥ 3.3 (GSI)
- Cobalt ≥ 2 (GSI)
- Manganese ≥ 26 (GSI)
- Mercury $\geq .05$ (GSI)
- Selenium ≥ 0.4 (GSI)
- Silver ≥ 0.1 (GSI)
- Zinc ≥ 230 (GSI)

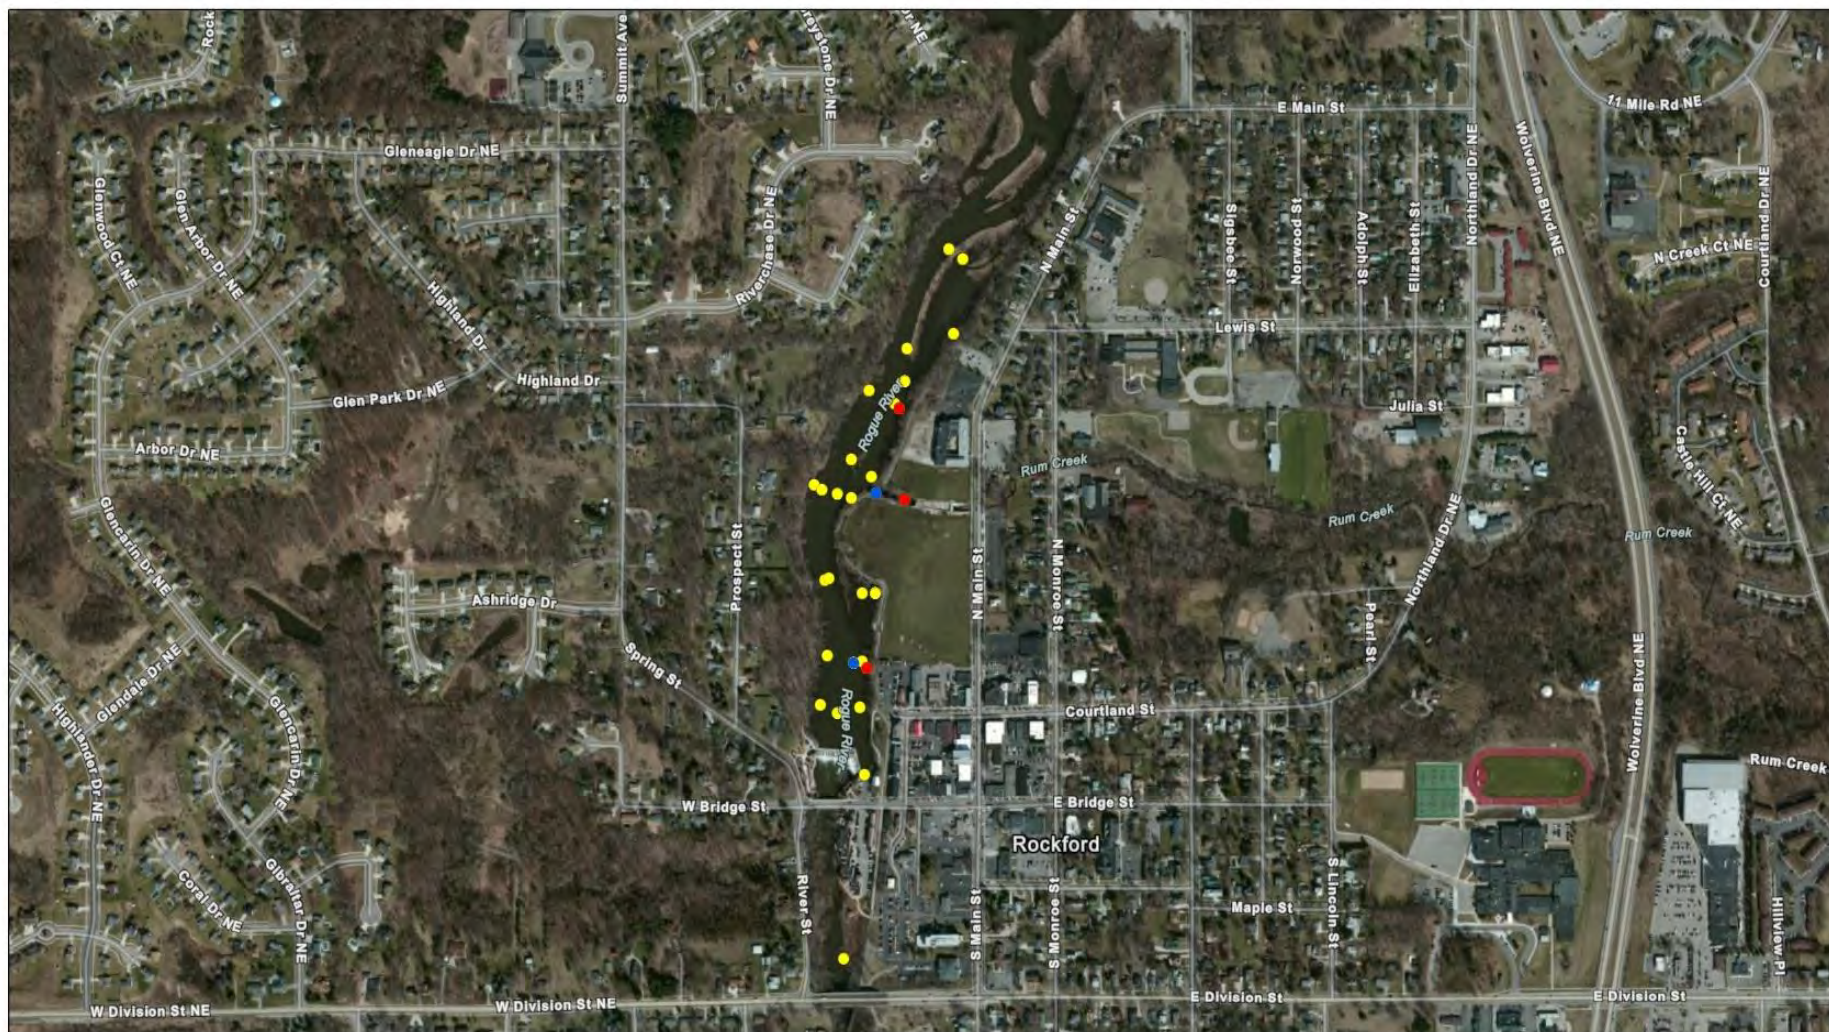
Tannery Sediment GSI Exceedances - Metals, SVOCs, VOCs

- Bromomethane ≥ 0.1 (GSI)
- Naphthalene ≥ 0.73 (GSI)
- Phenanthrene ≥ 2.1 (GSI)
- Arsenic ≥ 4.6 (GSI)
- Hex Chromium ≥ 3.3 (GSI)
- Cobalt ≥ 2 (GSI)
- Manganese ≥ 26 (GSI)
- Mercury $\geq .05$ (GSI)
- Selenium ≥ 0.4 (GSI)
- Silver ≥ 0.1 (GSI)
- Zinc ≥ 230 (GSI)
