Subject: **Draft Final Phase 2 PFCs Site Inspection Report**
Selfridge Air National Guard Base, Mt. Clemens, Michigan
Contract No. W9133L-14-D-0001, TO 0007
AECOM Project Number: 60520893

Draft Final Site Inspection Report Air National Guard Phase II Regional Site Inspections for Per- and Polyfluoroalkyl Substances

Selfridge Air National Guard Base
Mt. Clemens, Michigan
NGB/A4OR

September 2018

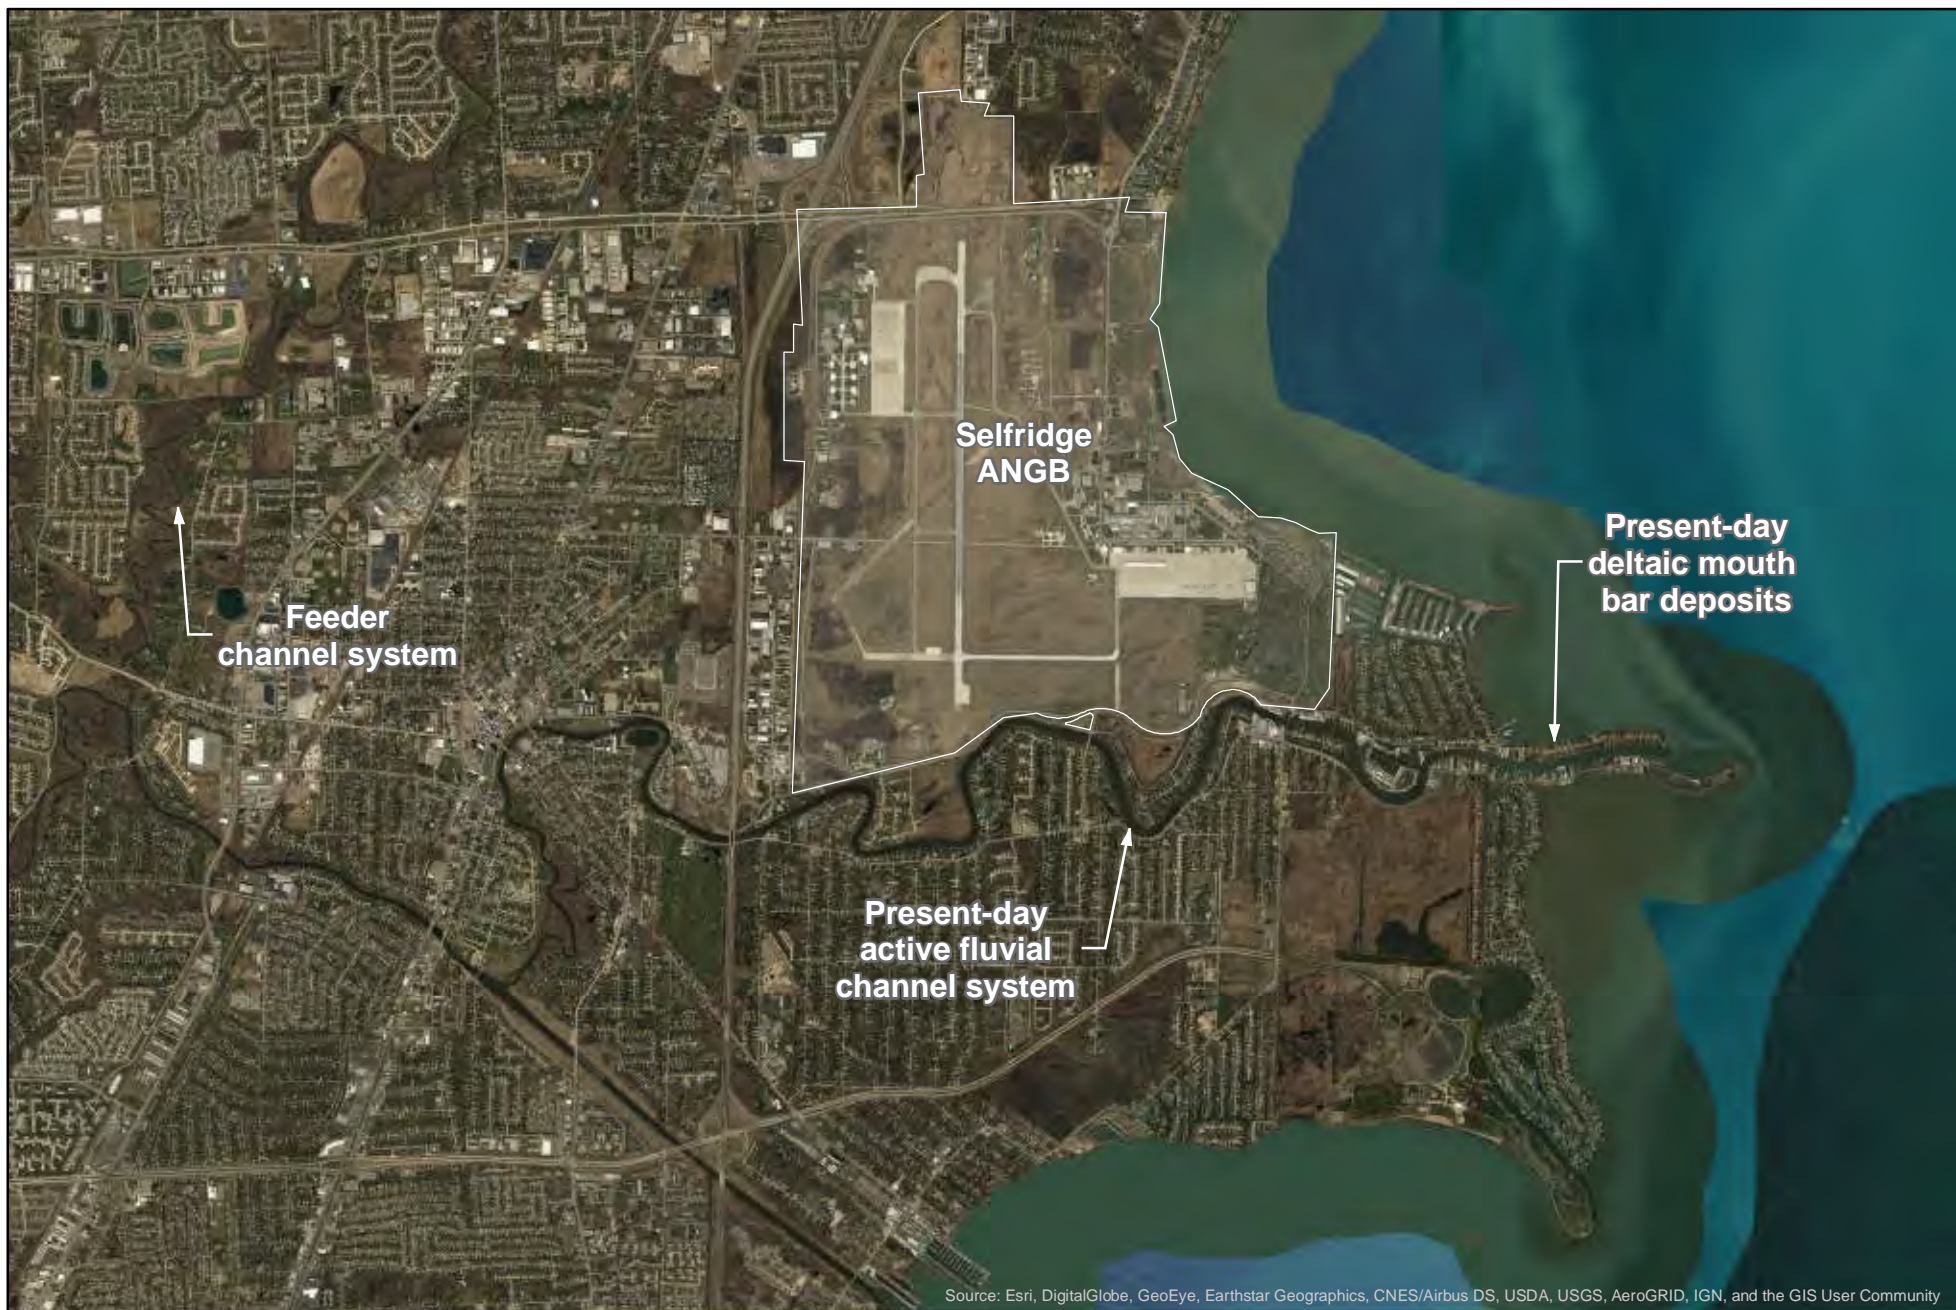
Figure 6-4 Geomorphological Features

Google Earth images for the Site area show lacustrine deltaic and fluvial deposits in the present day geomorphology around the modern Lake St. Clair that may provide excellent analogs for understanding interconnectivity of high-transmissive and low-transmissive units in the subsurface of Selfridge ANGB in general (**Figures 6-4** and **6-5**). However, based on the preliminary ESS review of available subsurface information, site-specific sedimentary deposits cannot be mapped at this time with enough confidence to predict refined groundwater flow pathways. Recommended actions related to the refined CSM are provided in **Section 7.2**.

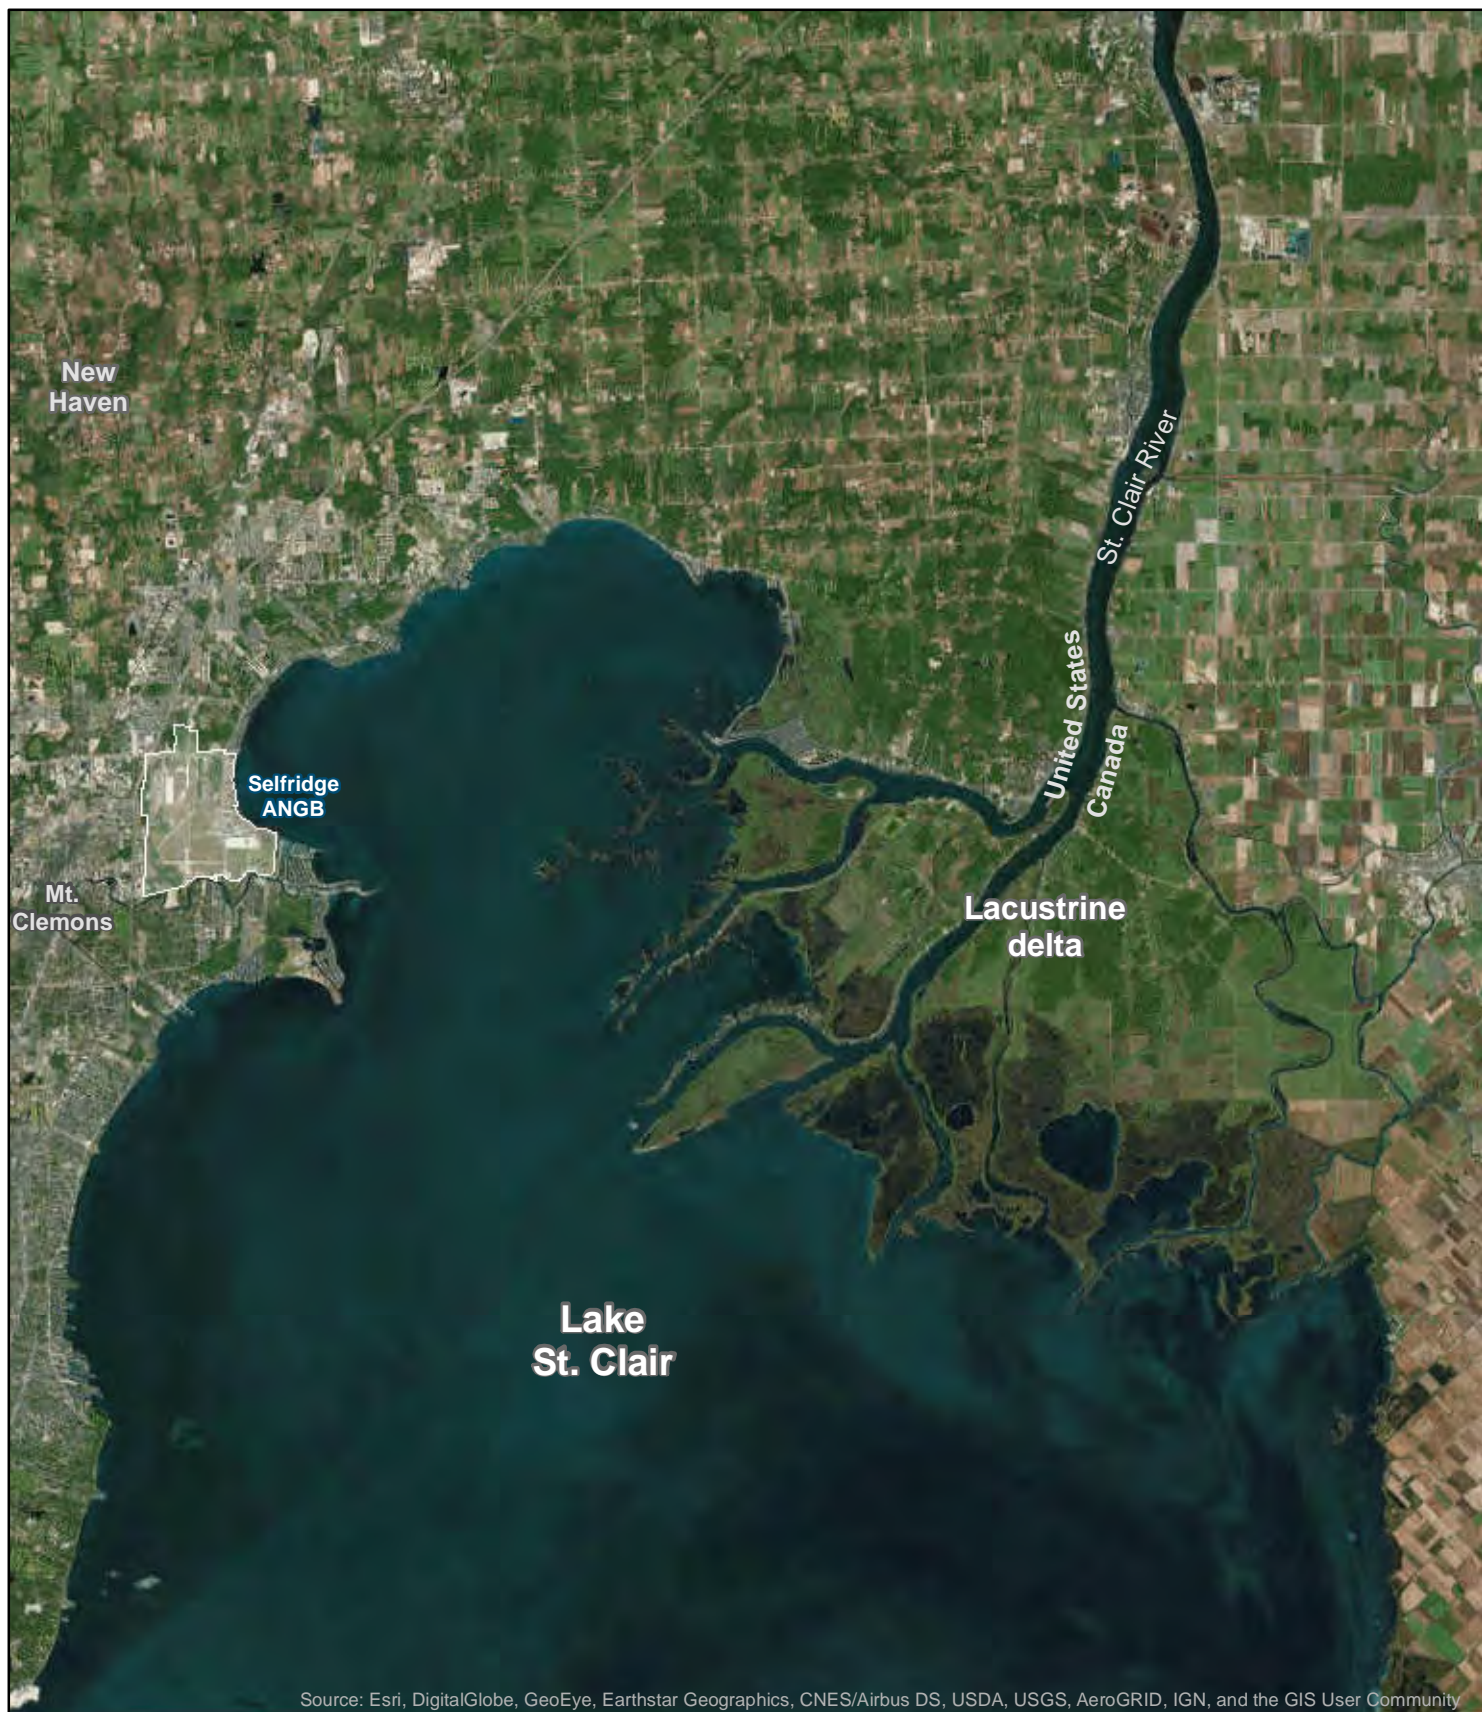
<p>AECOM</p> <p>3101 Wilson Blvd., Arlington, VA 22201 T (703) 682-4900 F (703) 682-4901</p>		<p>Figure 6-5</p> <p>Large Lacustrine Delta on East Side of Lake St. Clair</p> <p>Selfridge Air National Guard Base (ANGB) Perfluorinated Compounds Site Inspection Report Mount Clemens, Michigan</p>
<p>Drawn: DS 8/21/2018</p>	<p>0 1.75 3.5</p>	
<p>Approved: MD 8/21/2018</p> <p>Project No.: 60520893</p>	<p>1 in = 3.5 miles</p>
