Army National Guard

Comprehensive Environmental Response, Compensation, and Liability Act (CERCLA) Activities

Camp Grayling, Michigan

5 June 2018

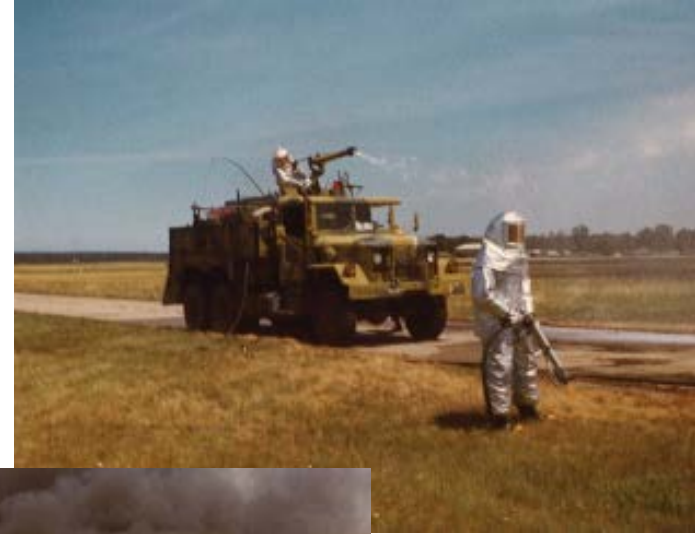
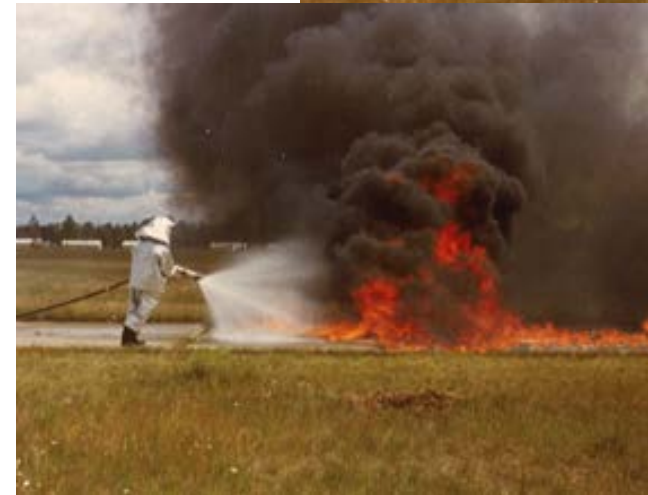
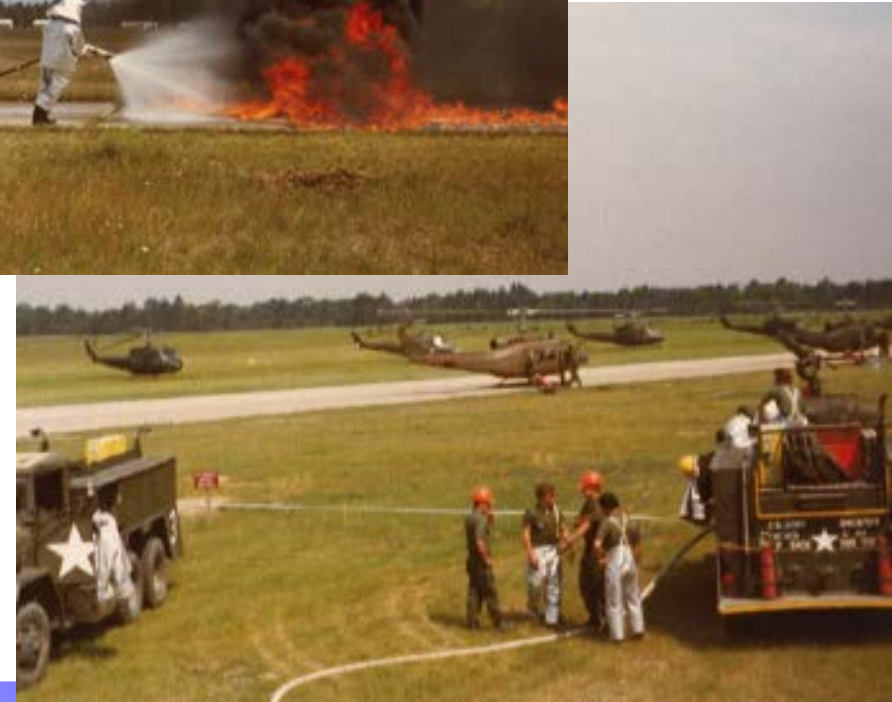
Grayling Army Air Field (GAAF) PA Findings

- Reviewed available data and conducted a 3-day site visit February 27-March 1, 2018
- Interviewed current and former Camp Grayling personnel
 - Environmental staff
 - Former firefighting personnel
 - Grayling City Fire Department Chief
 - Michigan Department of Natural Resources personnel
- Completed visual inspections at Areas of Interest and documented with photographs
- Areas of Interest -“Fire Training Areas” and “Non-Fire Training Areas”
- Final Preliminary Assessment Report becomes part of the Administrative Record that will be available to the public
