## Advancements with UAVs for analyzing transportation infrastructure and mapping invasive aquatic plants

## Augmenting Bridge Inspections through UAS-enabled Multi-Sensor Data Collections

**Implementation of Unmanned Aerial Vehicles (UAVs) for Assessment of Transportation Infrastructure – Phase II**  
Final Report, No. SPR-1674

## Unmanned aerial system multispectral imagery mapping for monitoring Eurasian watermilfoil treatments

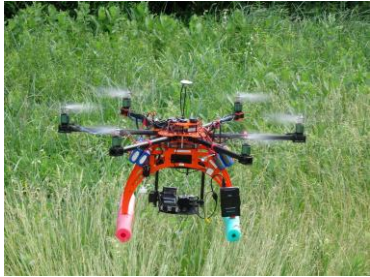
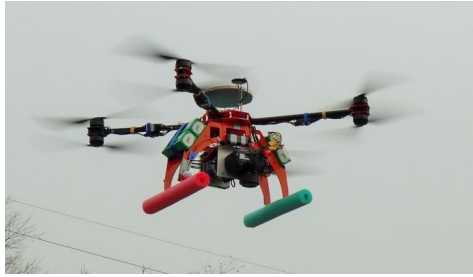
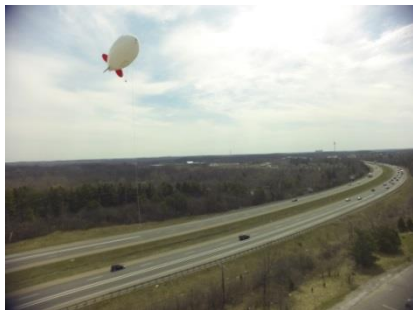
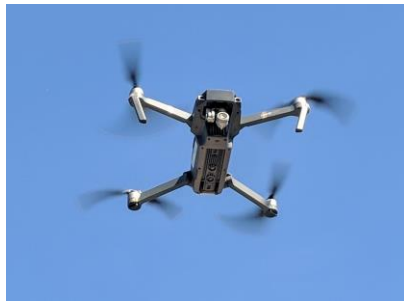
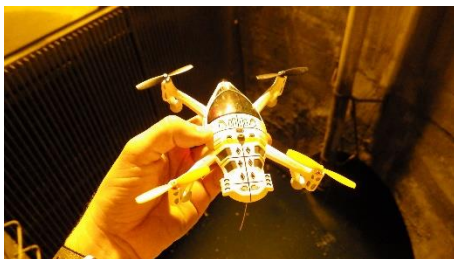
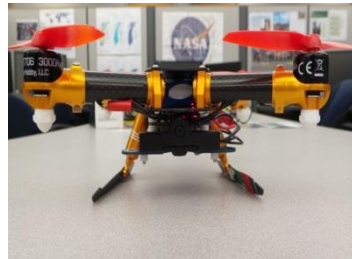
# UAV Platforms

- Multiple platforms have been tested
  - Focus on flexible, lower cost platforms
- Bergen Hexacopter & Quad-8
  - Price: \$4,500 to \$6,200
  - Flight time: 20 min
  - Payload: up to 4.5 kg (~10 lbs)
  - Hexacopter first tested on USDOT OST-R CRS&SI project on Unpaved Road Assessment project <http://www.mtri.org/unpaved/>
- Aerostat / Tethered Blimp
  - Test system: \$1500 (higher winds version ~\$4,500)
- Imaging small quadcopters (<\$1600)
  - DJI Phantom 3 Advanced
  - 3D Robotics IRIS+
  - Mariner, Splash2 (waterproof)
  - DJI Mavic Pro
- Micro-UAS quadcopters
  - Confined space imaging
  - <\$500

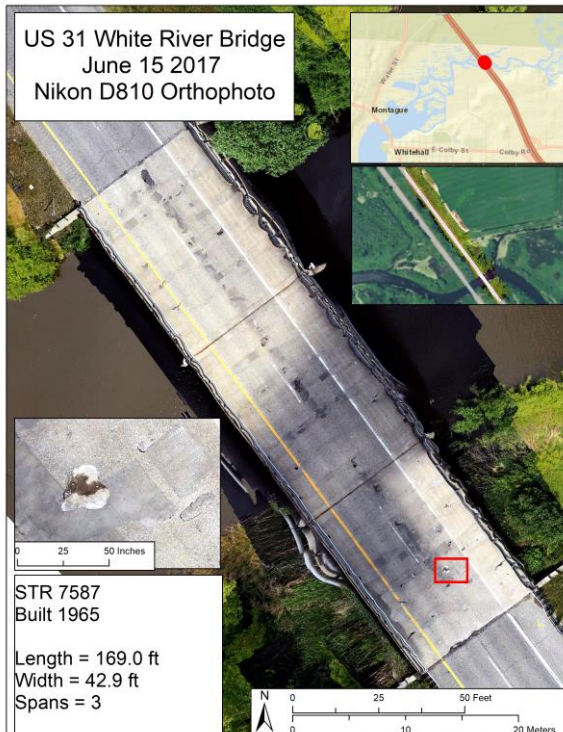
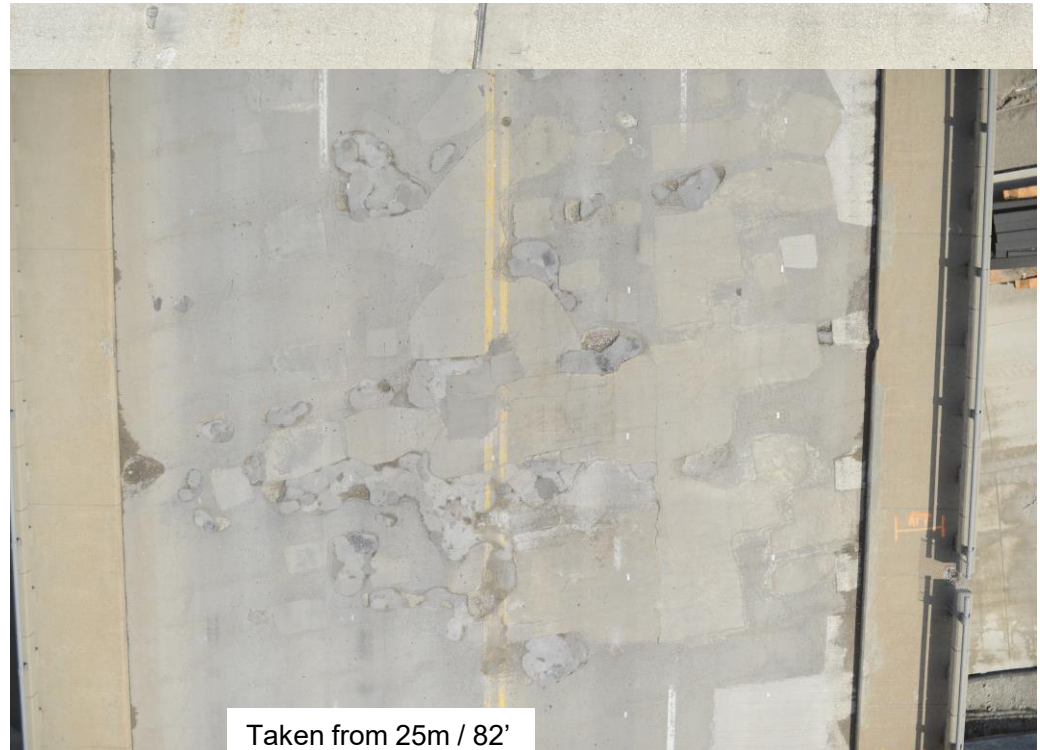
# Optical Sensor for Structure-from-Motion (SfM) photogrammetry

- Nikon D800, D810 – full-sized (FX) sensor, 36.3 MP, 4 fps - \$3,000
- 50mm prime lens - \$700
- Collect stereo overlapping imagery to create cm-resolution 3D surfaces
  - Structure from Motion (SfM) photogrammetry
  - AgiSoft Photoscan
  - MTRI SfM software workflow
- Demonstrated on USDOT unpaved roads project (CRS&SI – C.Singh)

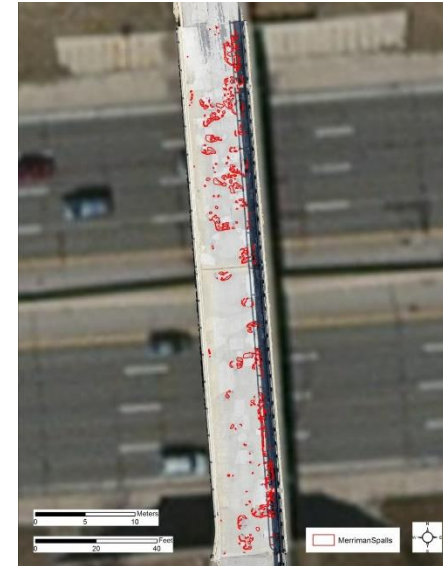
US 31 Bridge Deck  
Time Comparison

- Automated spall detection algorithm (developed by Brooks, Dobson, Aden, Graham)
- Applied to high-resolution 3D elevation model (DEM) of bridges created from UAS images
- Merriman East: 4.4% spalled (150.0 ft<sup>2</sup>)
- US-31/White River: 79.2 ft<sup>2</sup> (1.1%) spalling in 2017 vs. 33.6 ft<sup>2</sup> (0.5%) in 2014

Bridge Area - 7,250ft<sup>2</sup>  
 Spall Areas  
 2014 - 33.6 ft<sup>2</sup> (0.5% of the bridge deck)  
 2017 - 79.2 ft<sup>2</sup> (1.1% of the bridge deck)

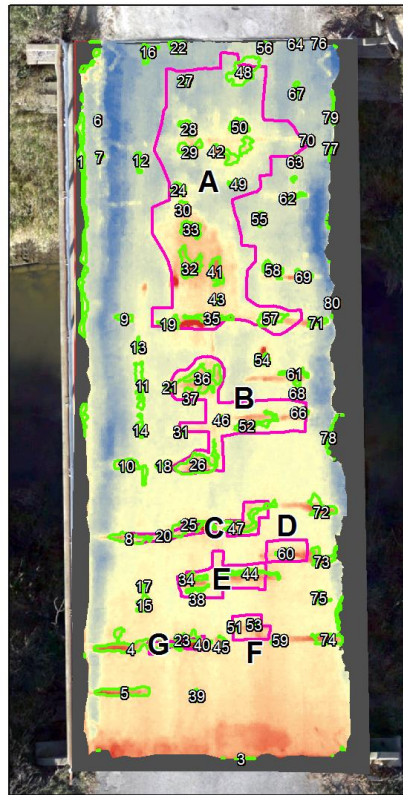
UAV Data - Beyer Rd Bridge  
Sounding Survey 12/30/16  
Algorithmic Delaminations  
Thermal Data 11/14/16  
Str#9293 Saginaw, MI

Area of Bridge = 1,756.13 sq ft  
Total Area of Sounding Survey  
Polygons = 313.28 sq ft  
Total Area of Delamination  
Polygons = 92.73 sq ft

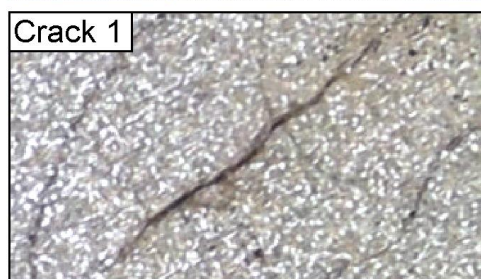
## US 31 Surface Cracking Nikon D810

# US-31 – crack comparisons (Nikon D810 imagery)

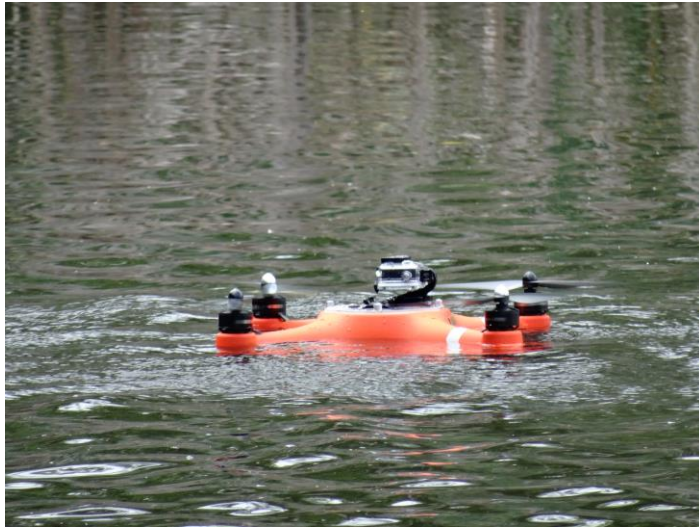
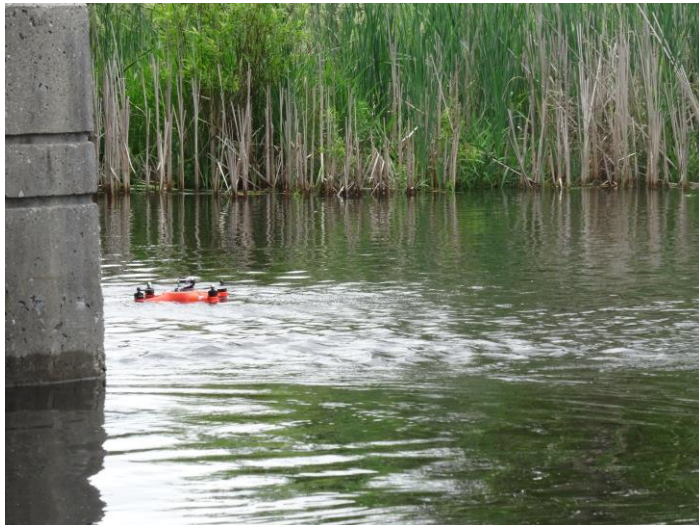
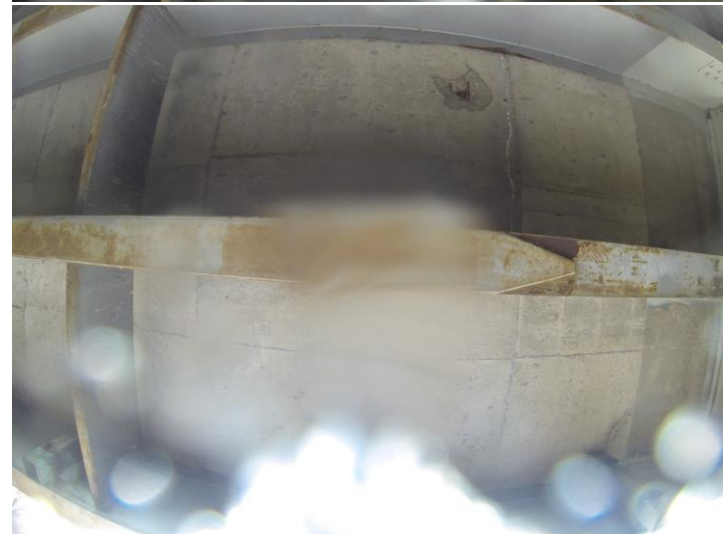
# Underside of US-31/White River bridge – Splash2 drone

- Application worked, but Splash2 needs further development

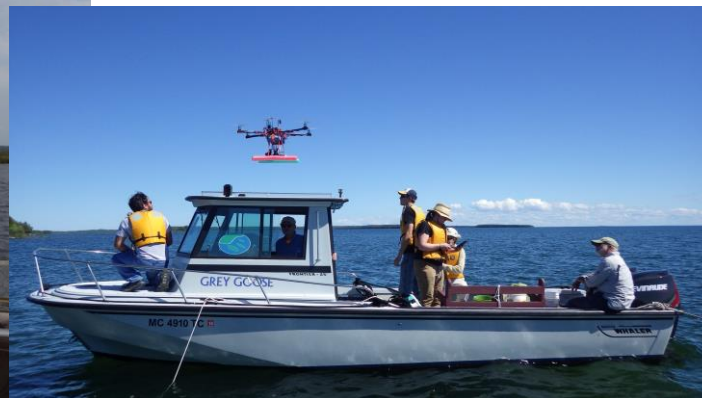
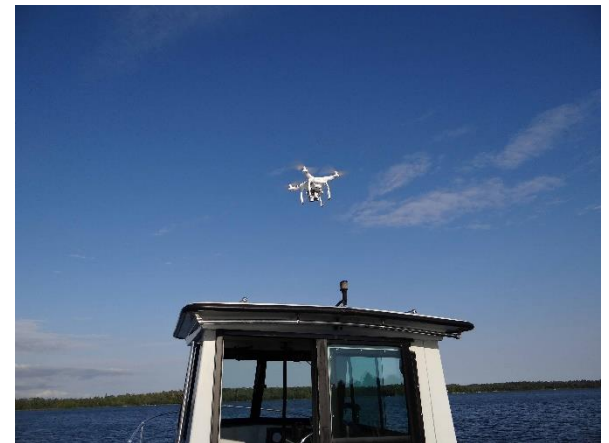
Wide, tiltable platform on Bergen can carry a DSLR & multispectral camera payloads

Boat-deployable platforms: the ~1 m diameter Bergen Hexacopter (left) and 350 mm DJI Phantom 15-20 minutes flight time, ~300m to 1 km radius, 15-30 ha

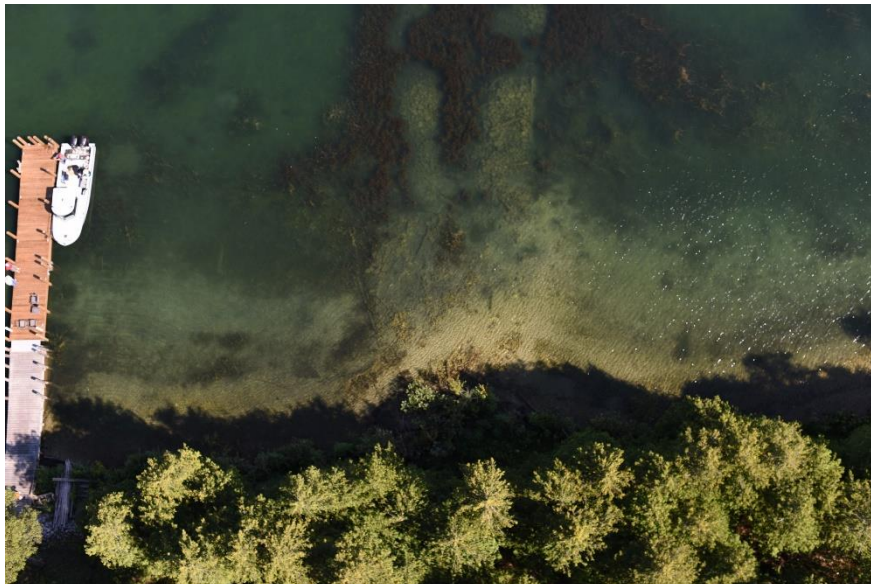
- Hexacopter-collected aerial image of EWM in Les Cheneaux, segmented using eCognition object-based image analysis software
- Provides sharp, high definition but less spectral information with which to differentiate similar vegetation types

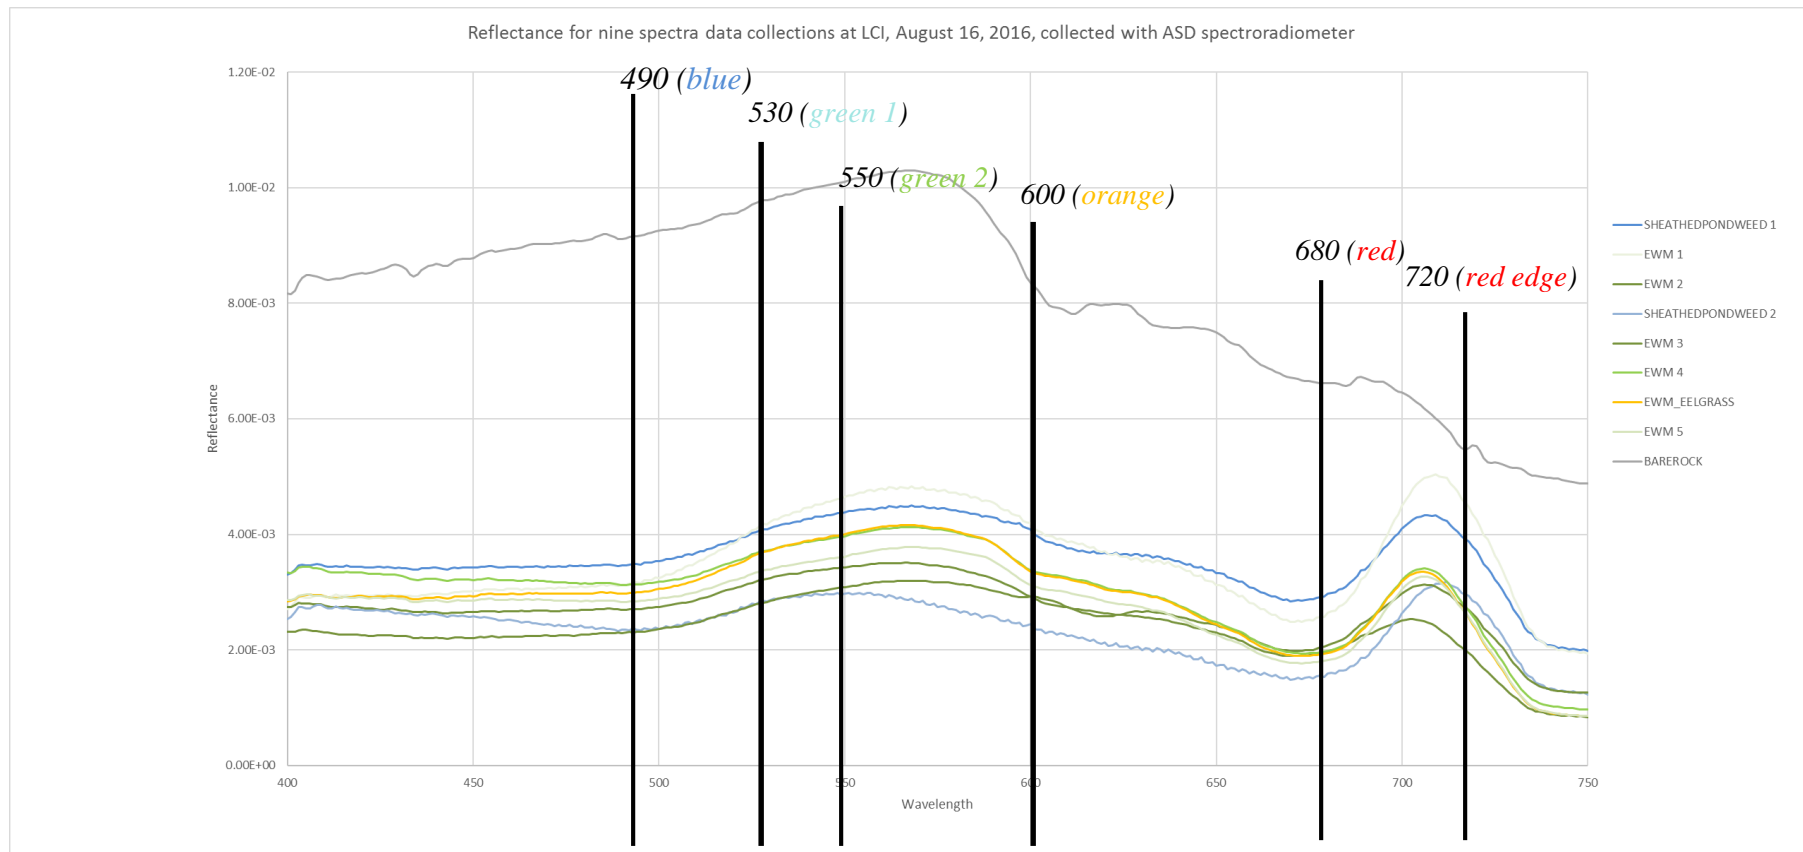
- The spectral signatures of common aquatic macrophytes show significant overlap, but also marked differences in shape that can be exploited with carefully selected bands & band ratios
- Key bands can be collected using a Tetracam tunable multispectral camera

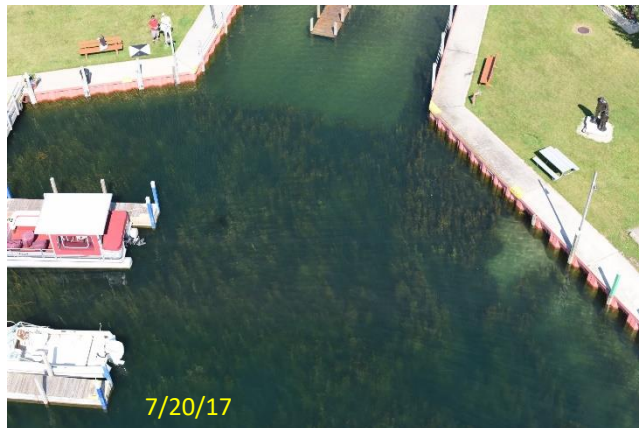
CHANGE IN EWM DENSITY IN HESSEL HARBOR / TIME

Biomass of untreated control increased / time compared with Mt-treated EWM that began to decrease in biomass after the 25 day measurement.

It appears that the Mt-infection took over three weeks to be reflected in decreased biomass expressed as mg EWM wet wt per cm stem length.
