*In-Situ Thermal Remediation of TCE  
DNAPL from Glacially Deposited  
Clay-Silt Diamicton and Subsequent  
Remedial Performance Assessment*

Great Lakes Environmental Remediation and Redevelopment  
Conference, Lansing MI.

16 October, 2019

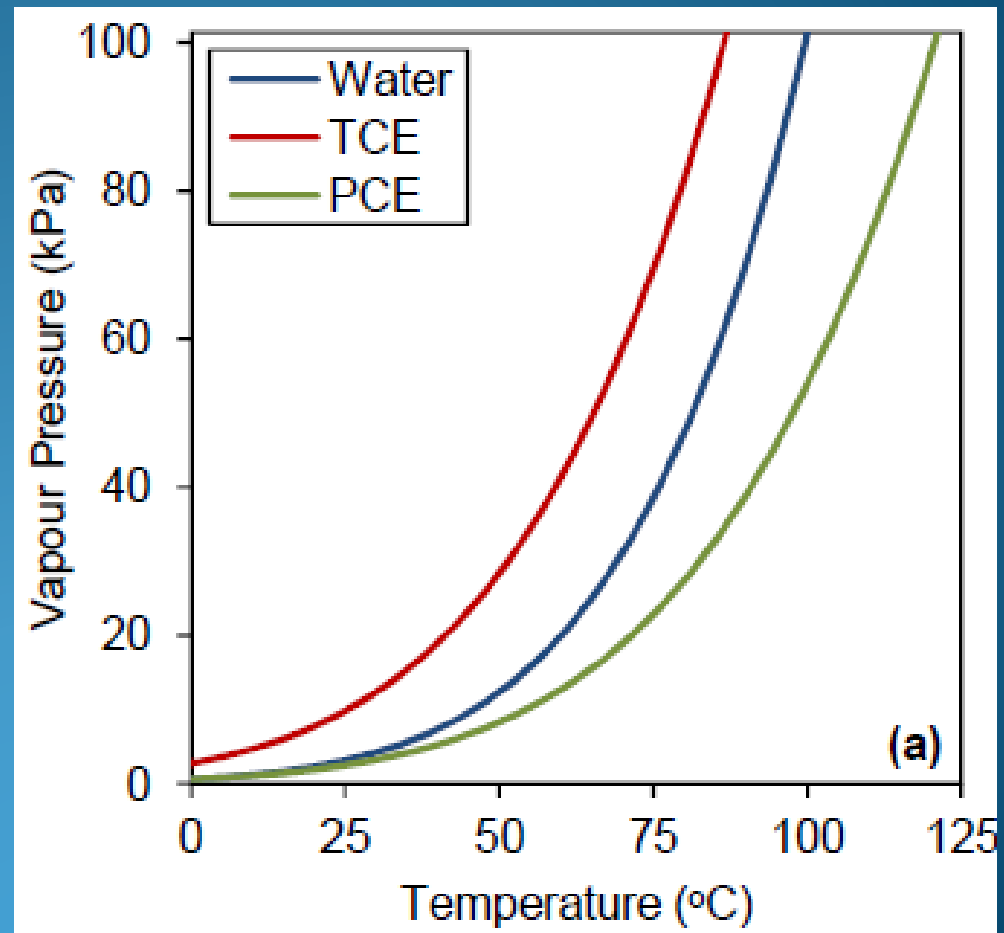
# ET-DSP™ System Design

- Remedial Goal
  - Ave TCE 5000 ug/kg
- Target Temperature
  - 70 to 100 Celsius
- Vapor Recovery Rate
  - 500 to 600 cfm
- Liquid Extraction Rate
  - 6 to 8 gpm
- Soil Resistivity
  - 23 - 109 ohm-meters

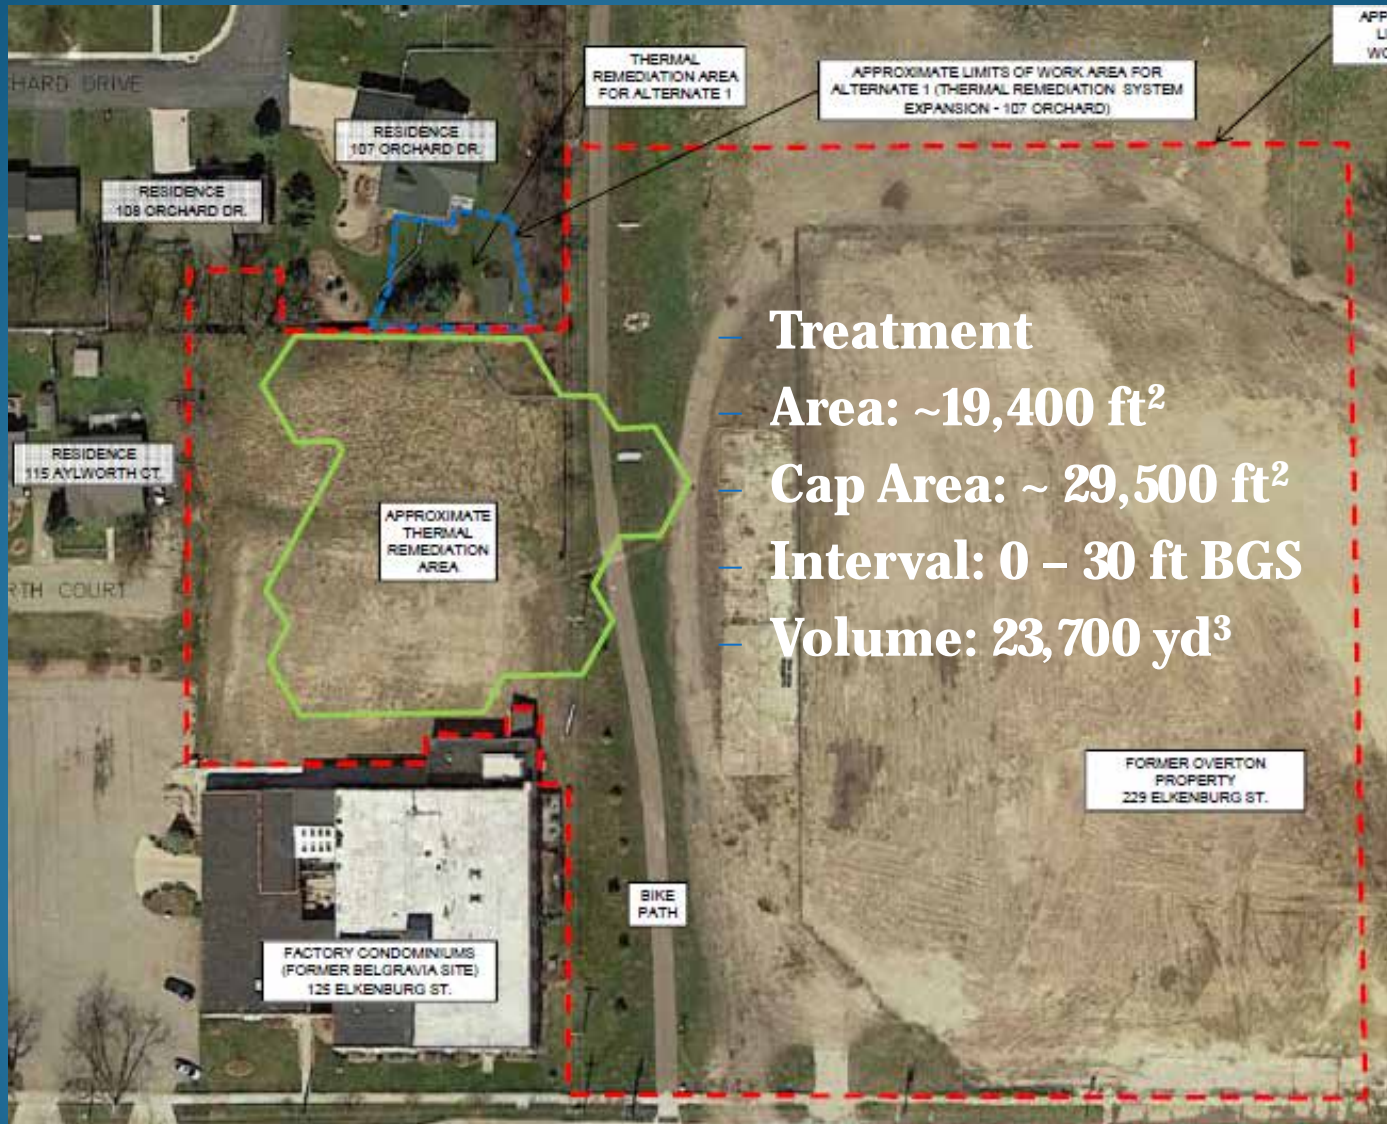
# ISTR - Treatment Area(s)

- Treatment
- Area: ~19,400 ft<sup>2</sup>
- Cap Area: ~ 29,500 ft<sup>2</sup>
- Interval: 0 - 30 ft BGS
- Volume: 23,700 yd<sup>3</sup>

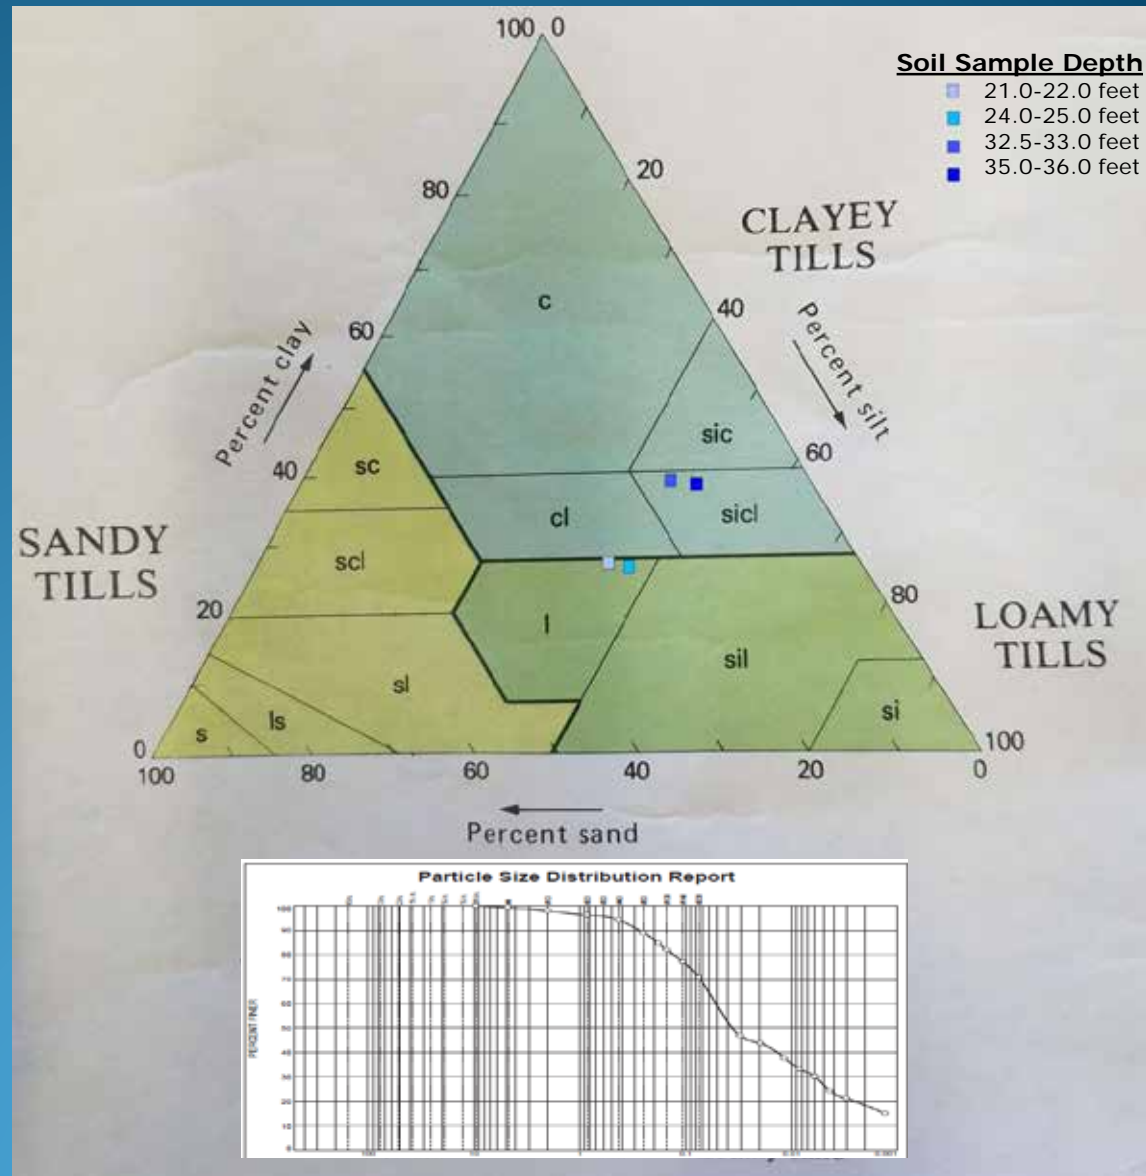
# Diamicton - Grain Size Distribution

Grain Size Distribution			
Depth (feet)	% Fine Sand	% Silt	% Clay
21.0-22.0	23.6	43.9	26.8
24.0-25.0	22.5	46.5	26.0
32.5-33.0	12.8	45.6	38.4
35.0-36.0	10.4	49.2	37.4

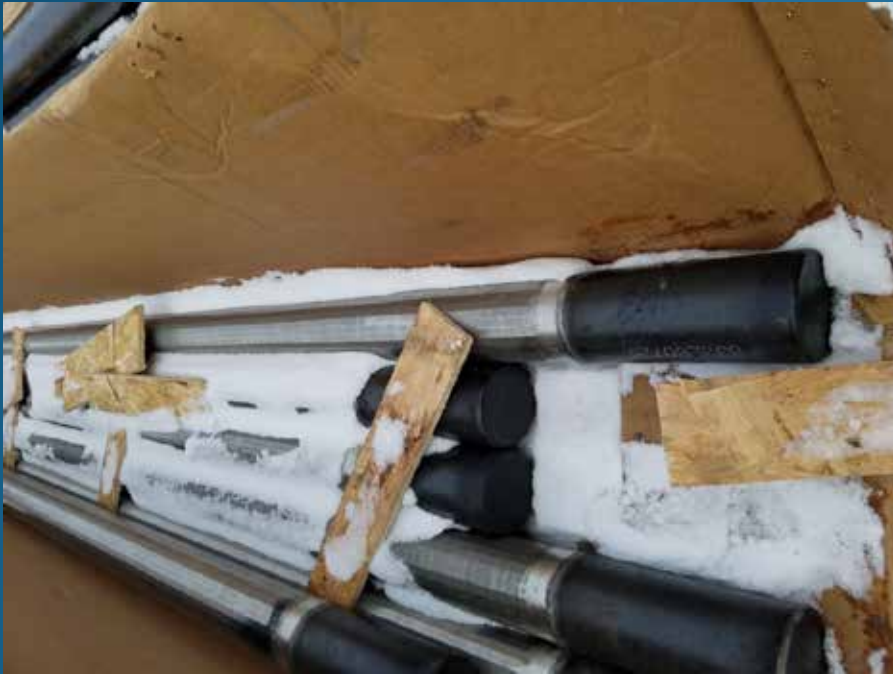
MPE Well w/Sump

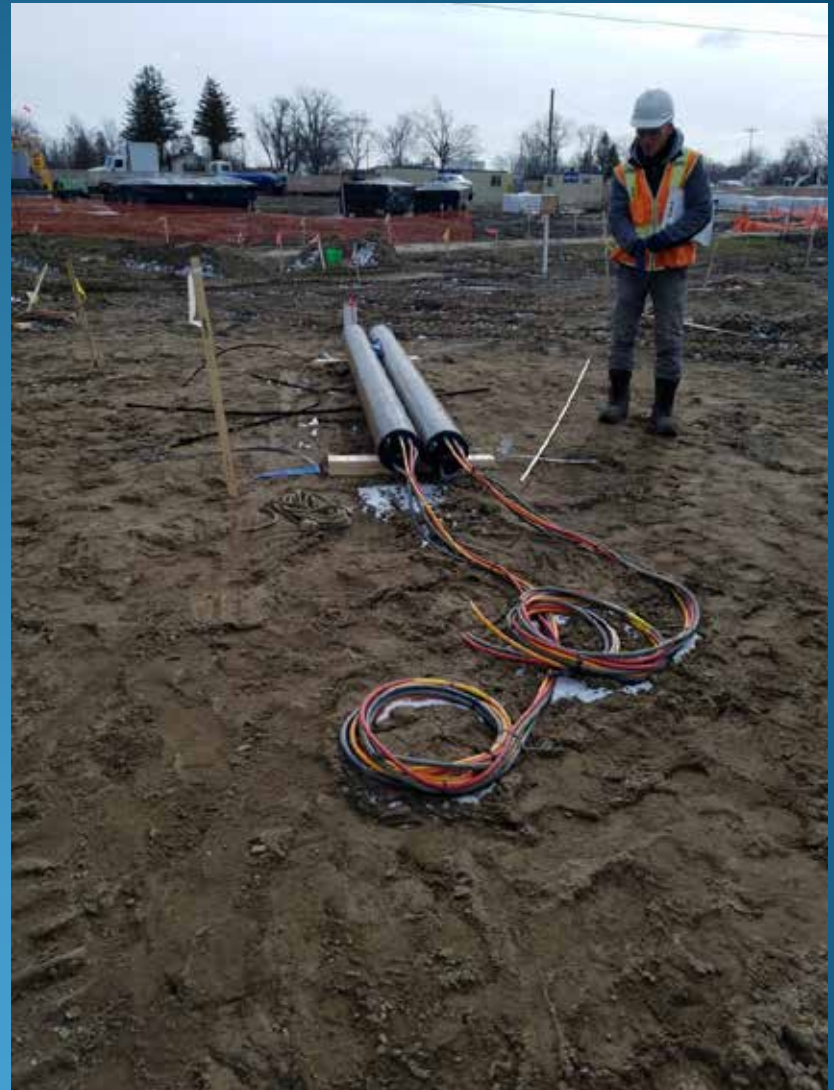
Electrode Stack

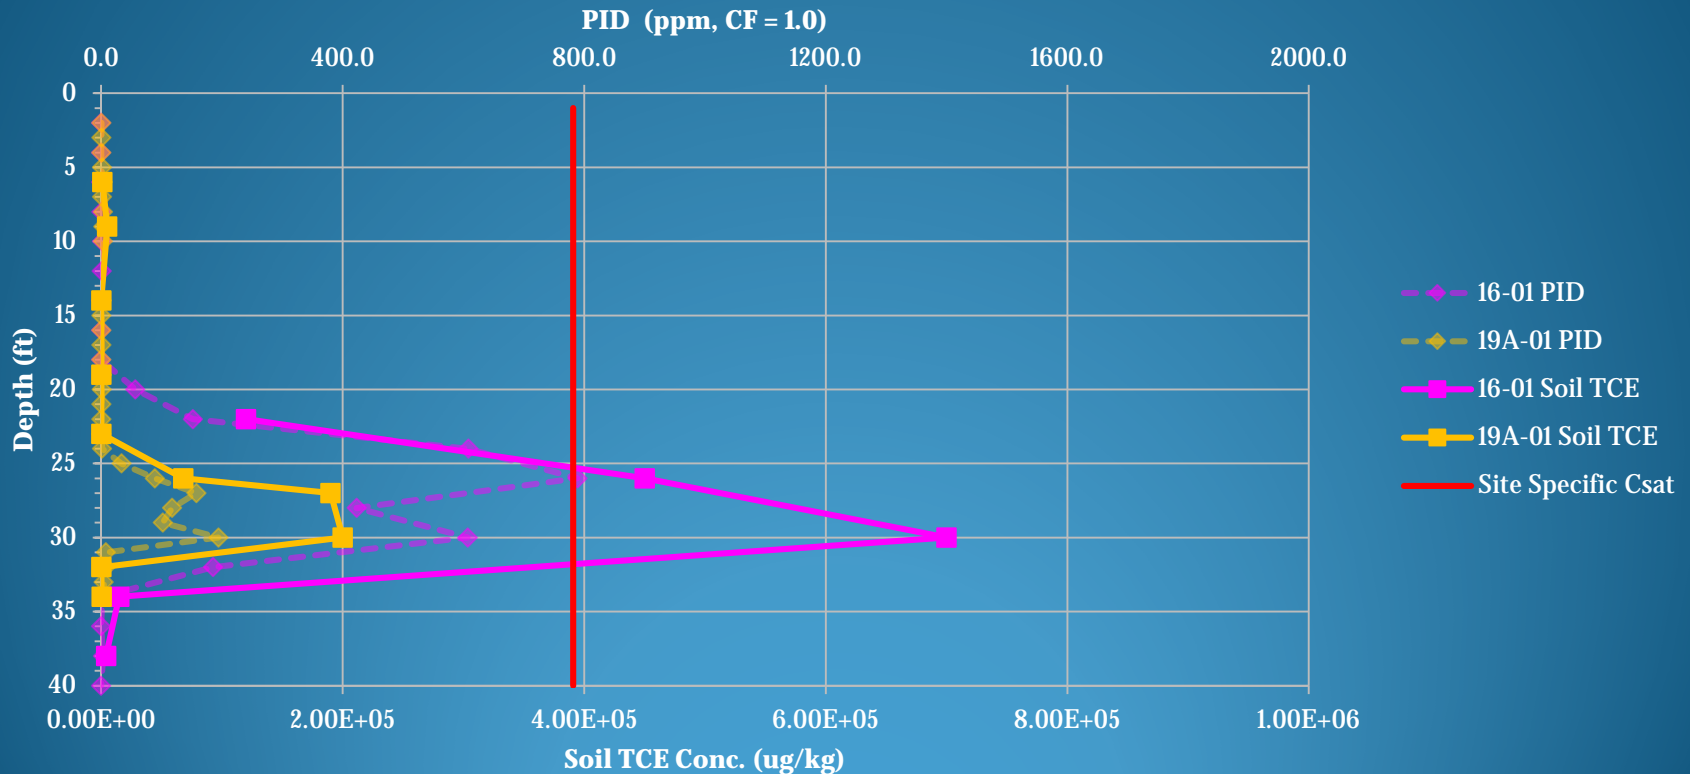
## VSR-19A-01, SB-16-01: PID & Soil TCE Conc. vs Depth

# S. Mass Reduction Trends (5 Mo ISTR)

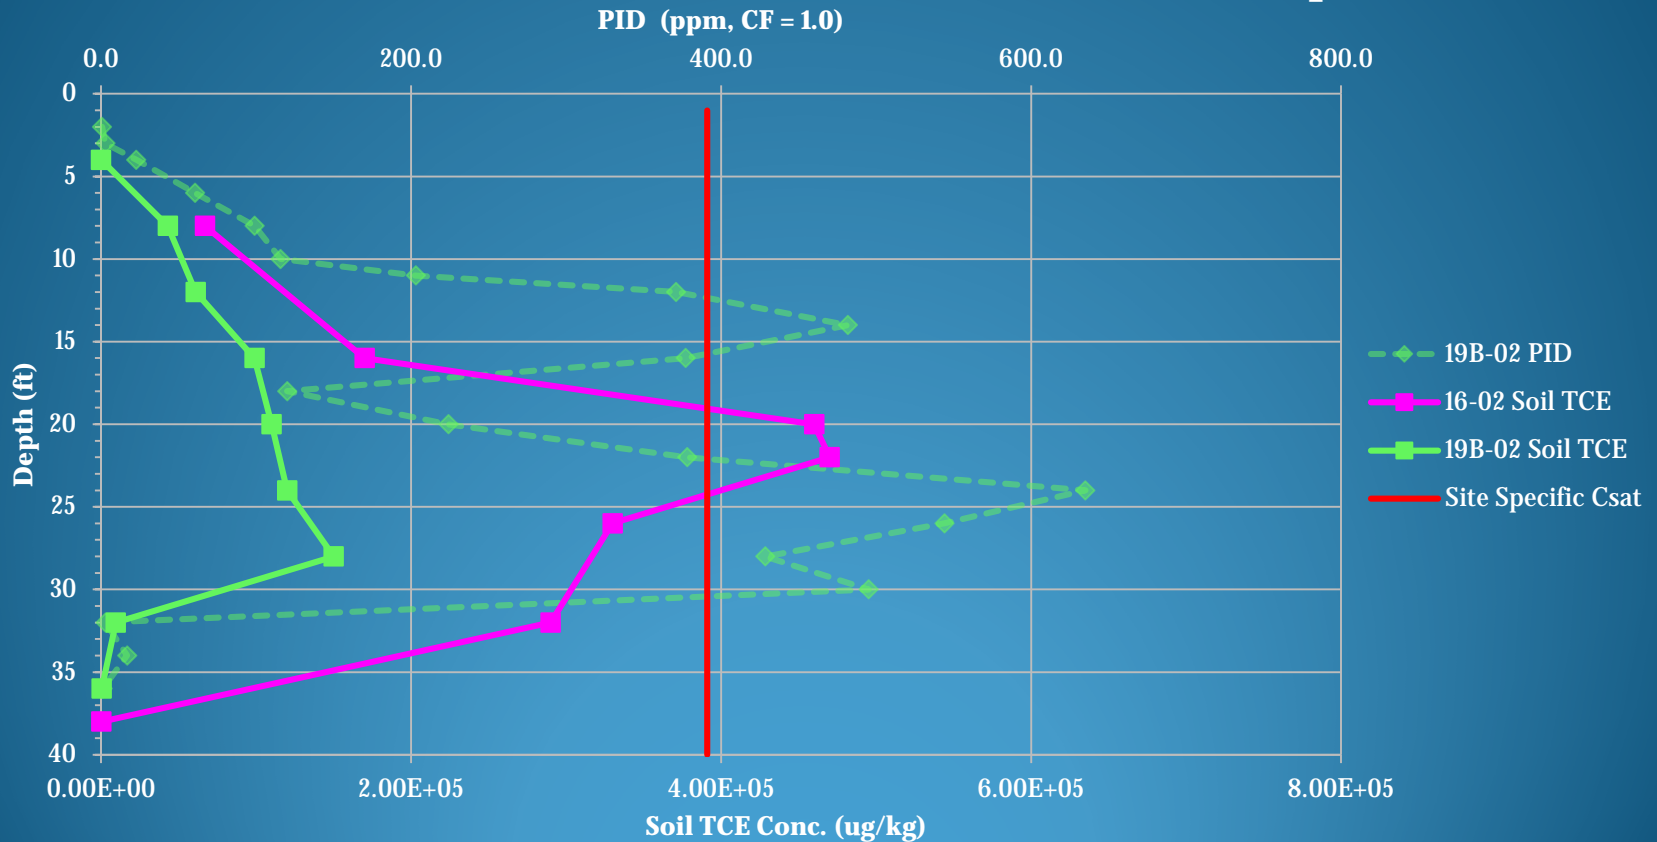
## VSR-19B-02, SB-16-02: PID & Soil TCE Conc. vs Depth

# S. Mass Reduction Trends (9 Mo ISTR)

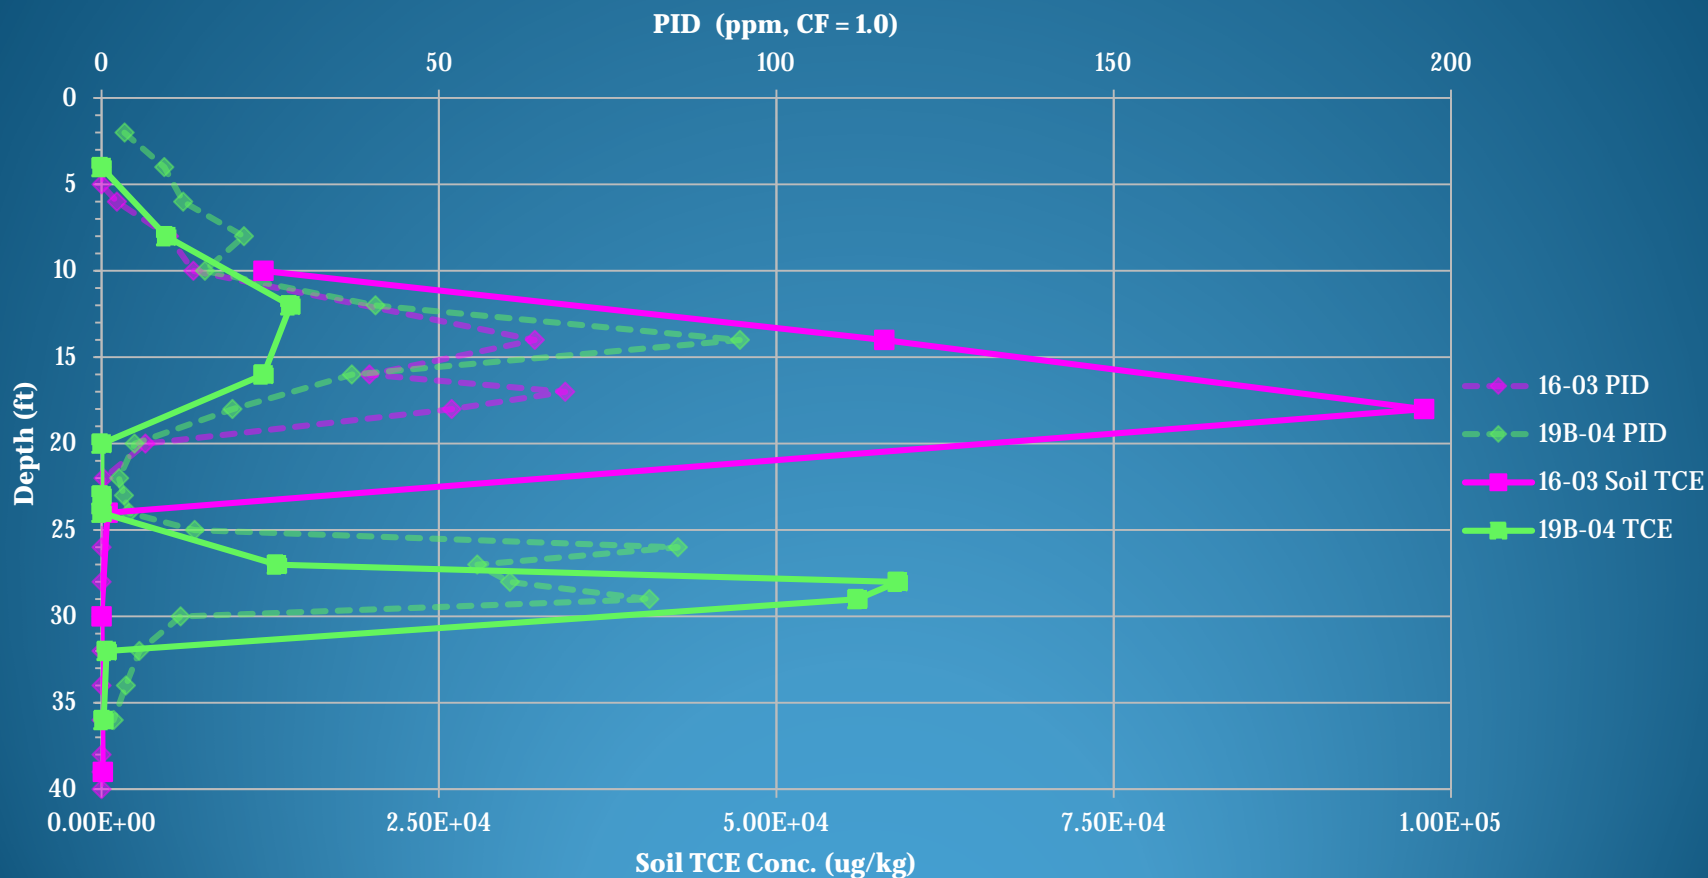
## VSR-19B-04 and SB-16-03: PID & Soil TCE Conc. vs Depth

# S. Mass Reduction Trends (9 Mo ISTR)

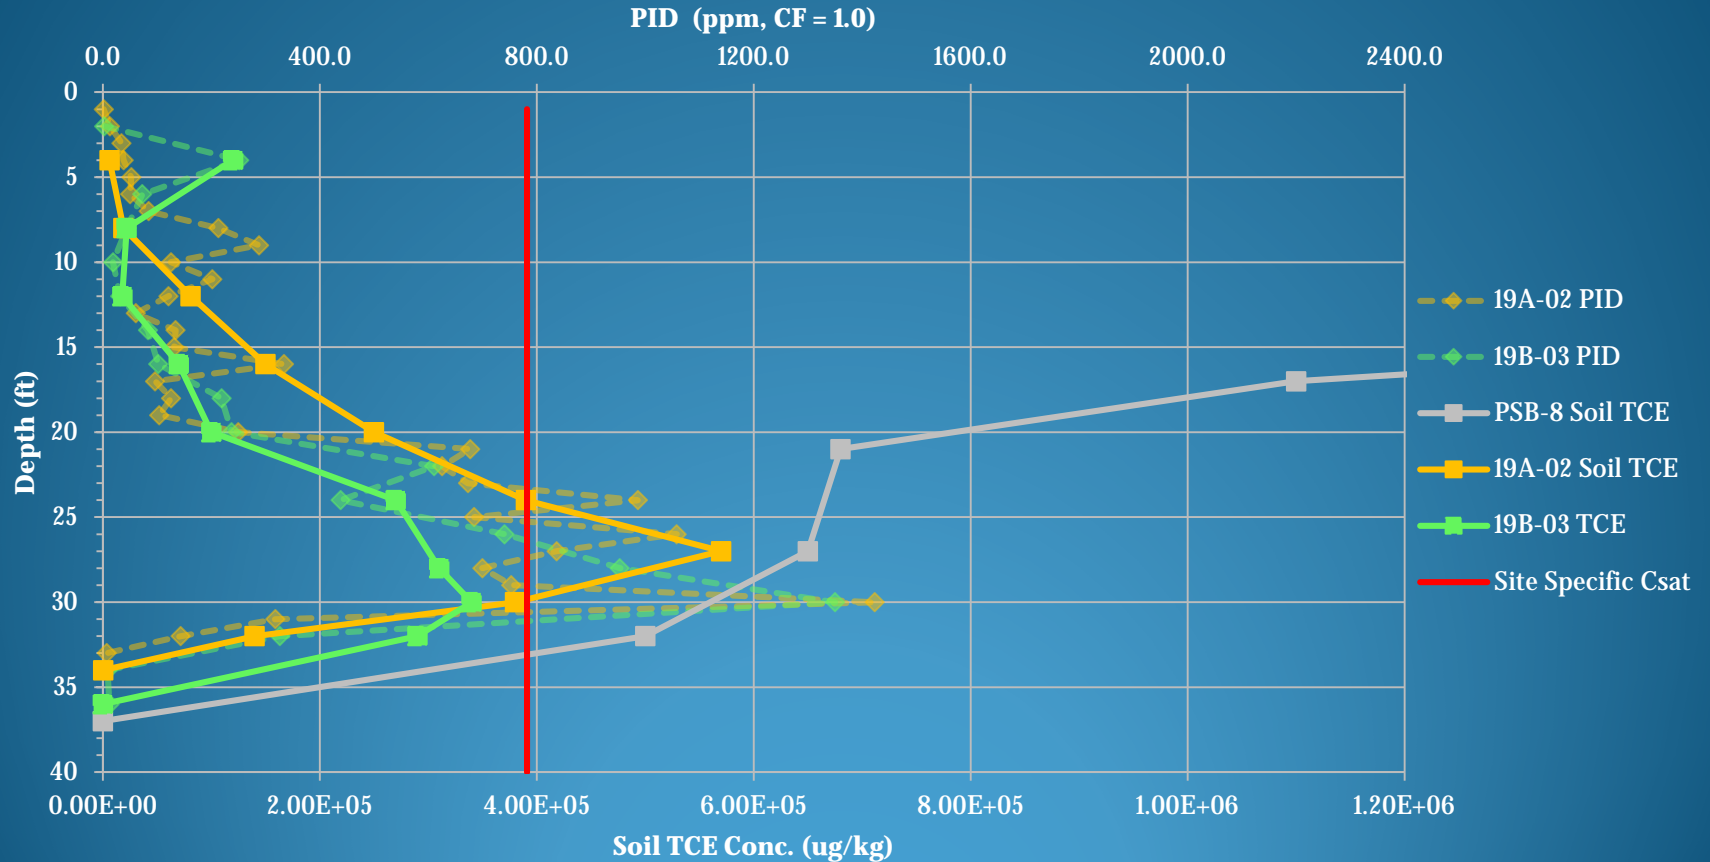
## VSR-19B-03, VSR-19A-02, PSB-8: PID & Soil TCE Conc. vs Depth

# C. Mass Reduction (5 & 9 Mo ISTR)

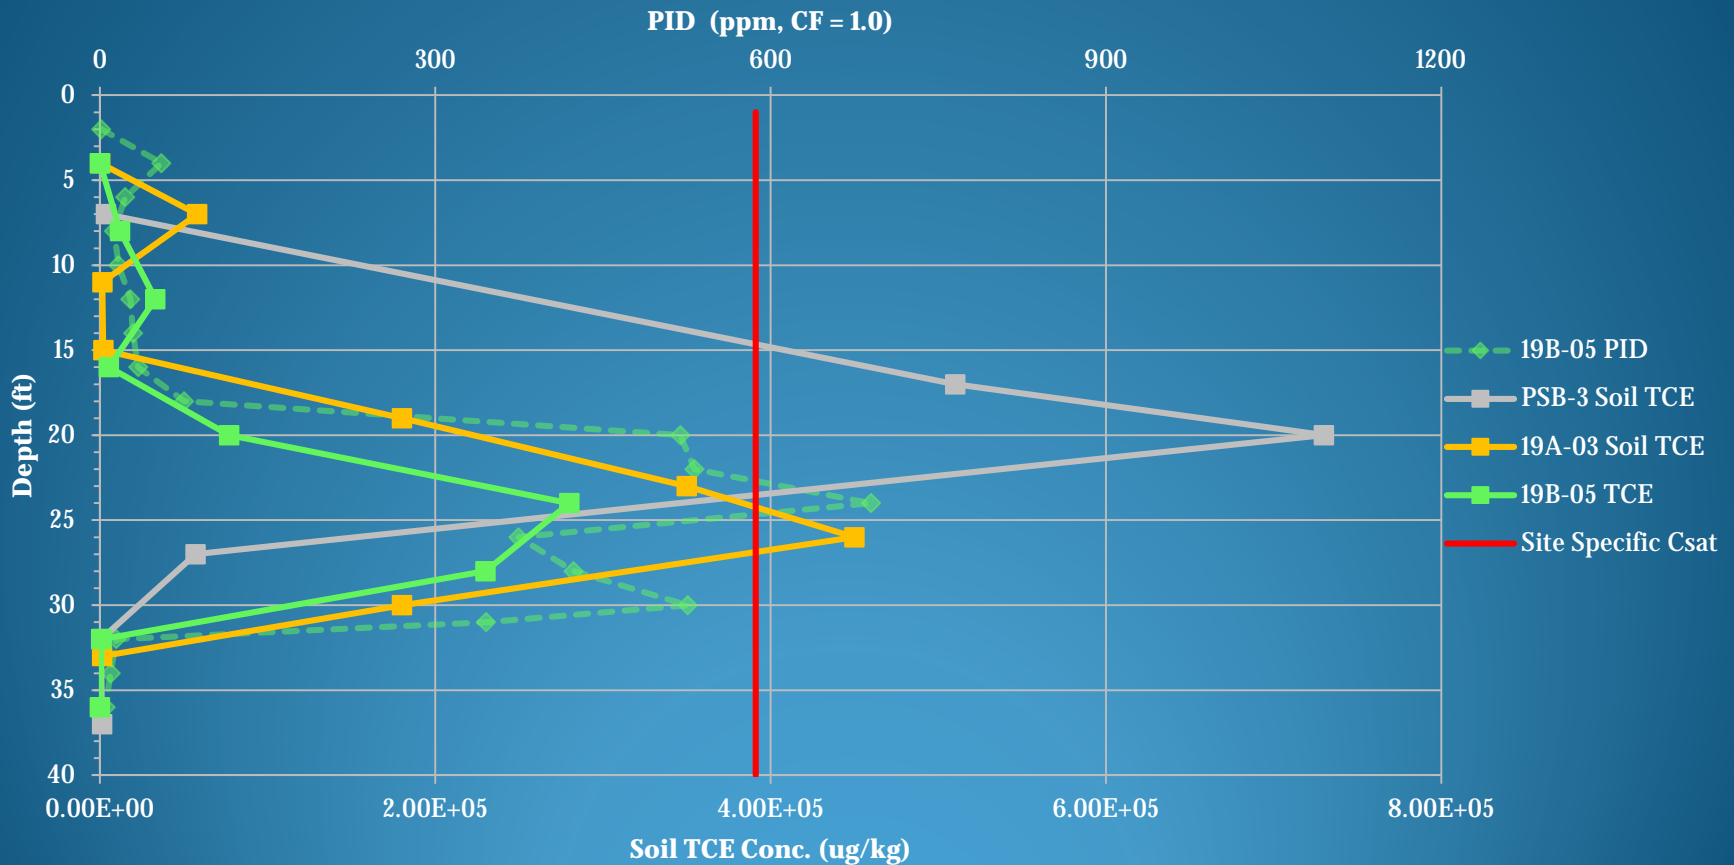
## VSR-19B-05, VSR-19A-03, PSB-3: PID & Soil TCE Conc. vs Depth

# C. Mass Reduction (5 & 9 Mo ISTR)

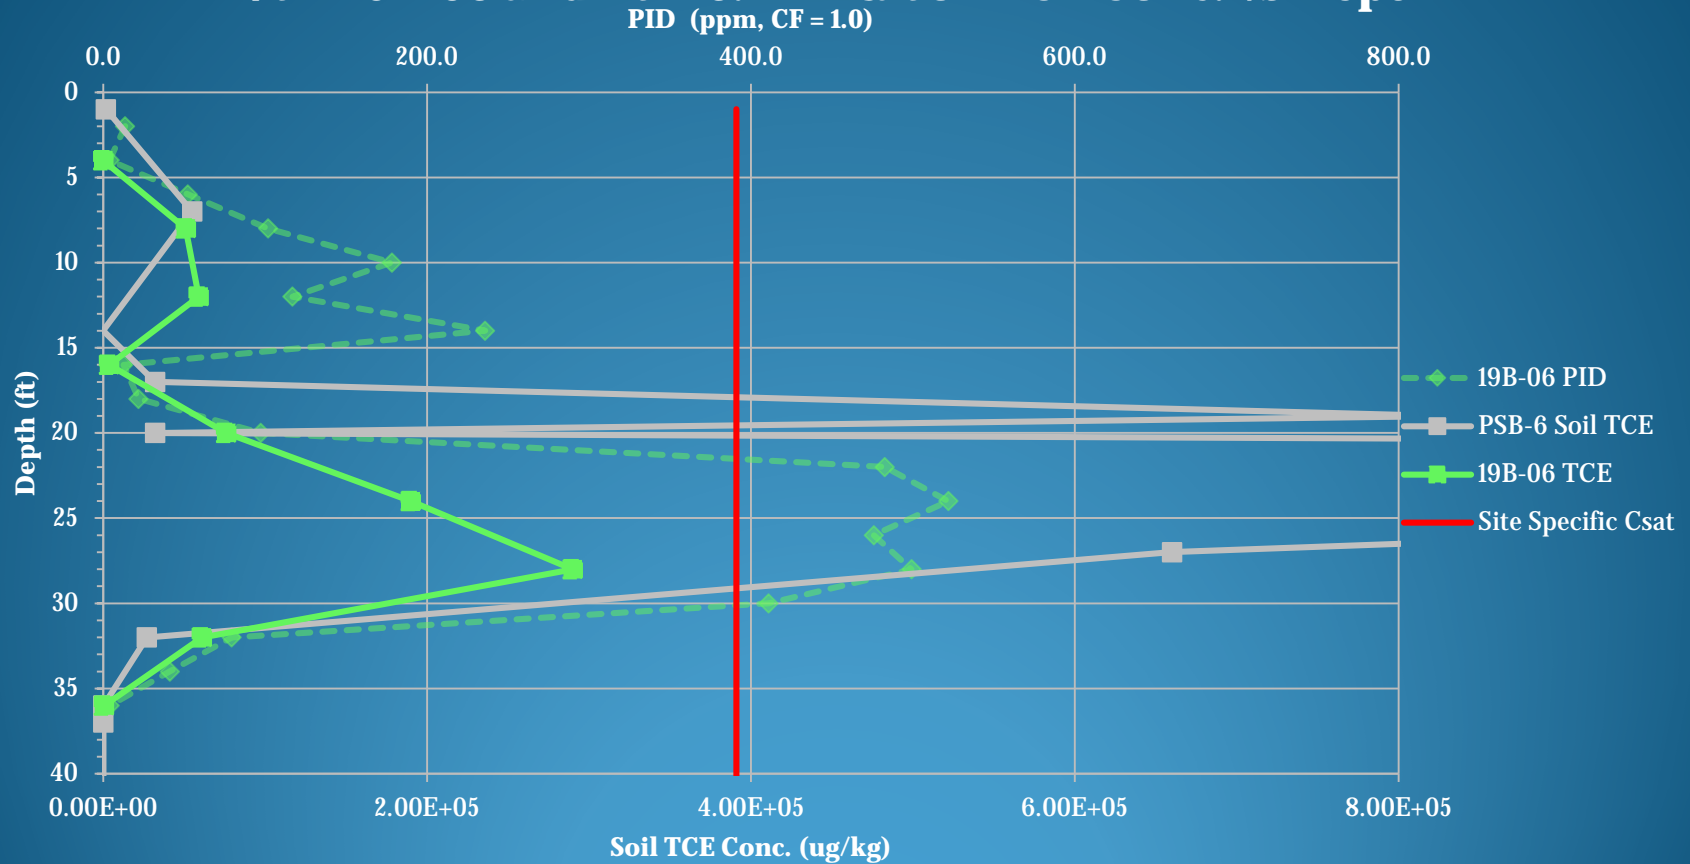
## VSR-19B-06 and PSB-6: PID & Soil TCE Conc. vs Depth

# N. Mass Reduction (9 Mo ISTR)

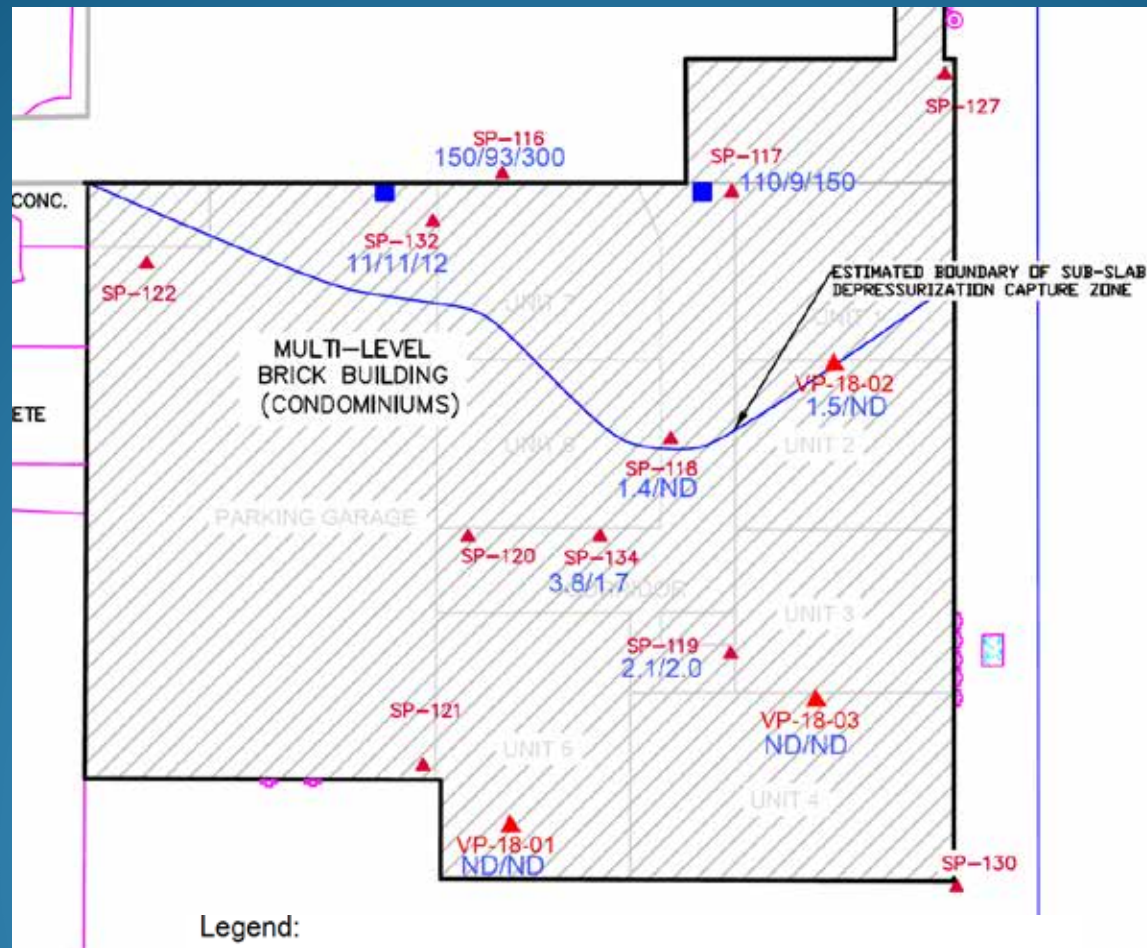
# Pressure Field Extension/S.G. Results

- ▲ VP-18-01 Sub-slab soil gas sampling location with TCE concentrations in  $\mu\text{g}/\text{m}^3$   
ND/ND July 2018/December 2018/July 2019 or July 2018/July 2019
- Sub-slab depressurization extraction point (installed 2015)
