**Subject: Revisions to the Annual Mining and Reclamation Report, Eagle Mine, LLC
Nonferrous Metallic Mineral Mining Permit (MP 01 2007), Eagle Mine**

Eagle Mine

2024 Annual Mining and Reclamation Report Mine Permit MP 01 2007

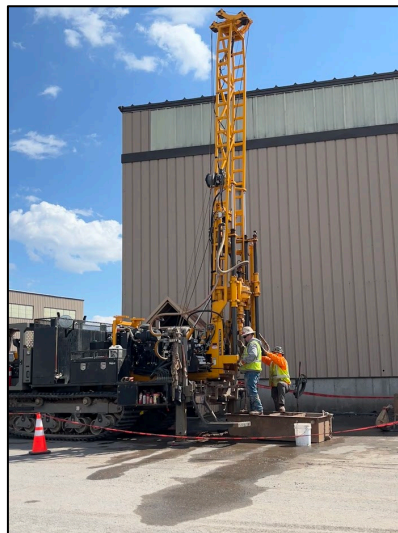
Figure 1 – Drilling Near the Proposed Paste Backfill Project

In March of 2024, geotechnical drilling was completed to gather data on the thickness of alluvium on the northeast edge of the coarse ore storage area (COSA) building and along the south edge of site within the fence line. The information gathered on this project was used to support the newly proposed paste backfill project permit amendment to add an enclosed tailings storage area, a paste backfill plant, and a paste borehole to convey the paste from the surface to the underground mine.

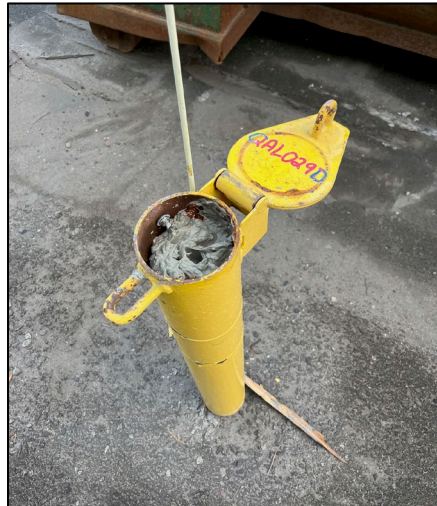
Figure 2 – Abandonment of QAL029A/D

The proposed paste backfill project would include an addition to the north side of the COSA building where an existing monitoring well nest, QAL029A and QAL029D, were located. Michigan Department of Environment, Great Lakes & Energy (EGLE) permitted abandonment of the two monitoring wells. To conform with Rule 425.406, a new nested well set to monitor the COSA, QAL077A and QAL077D, were installed to the northeast of the proposed building addition.

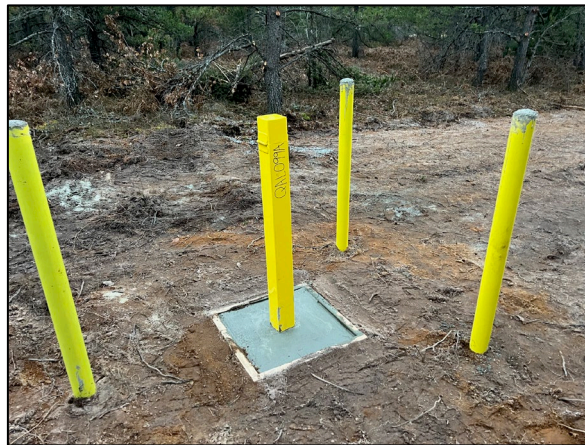
Figure 3 – New Monitoring Well QAL099A

Installation of Monitoring Well QAL099A On October 25th, 2024, a new monitoring well, QAL099A, was installed downgradient of treated water infiltration system (TWIS) monitoring wells QAL051D and QAL075A as required by the renewed GWDP issued on August 1st, 2024.

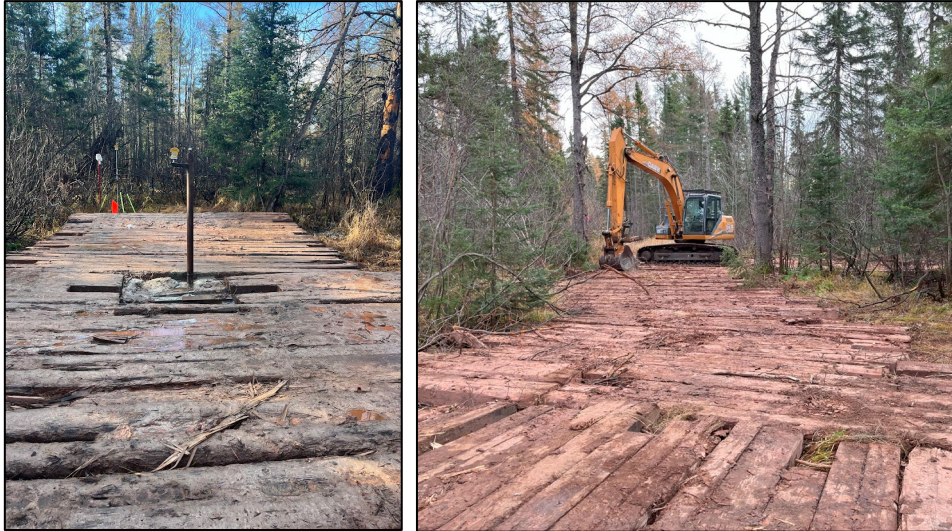
Figure 4 – Installation of two MPBXs above the crown pillar into bedrock

In 2024, there was measured displacement in a surface MPBX installed above the ore body. Additional monitoring was implemented in accordance with the *Subsidence Monitoring Plan*. MPBX instruments are valuable monitoring tools, but they have known limitations. For instance, they only measure the displacement of the rock in which they are installed, therefore, the movement measured in the MPBX may or may not be representative of what is happening in the surrounding rock mass as an isolated block or wedge of rock may move independent of the surrounding rock.

To be responsive to the MPBX displacement, Eagle hired WSP Global, Inc. (WSP) to complete further investigation. Through revised data collection and modelling, WSP determined that the movement of the MPBX was due to movement of a local structure that was isolated and is not expected to propagate to the surface. As a proactive measure, Eagle installed two additional MPBXs above the ore body from surface directly into bedrock. Additional information on this project is discussed in further detail in Section 4.

To confirm that the MPBX displacements noted in Section 3.1 were caused by localized structural conditions and to ensure that ongoing mining would not compromise the stability of the crown pillar, Eagle hired WSP to perform back-analysis using the model developed for the Phase 4 assessment. The life-of-mine stope sequence was analyzed to forecast the impact of continued mining. The results indicated that no measurable subsidence is projected at the bedrock/overburden or at the surface.

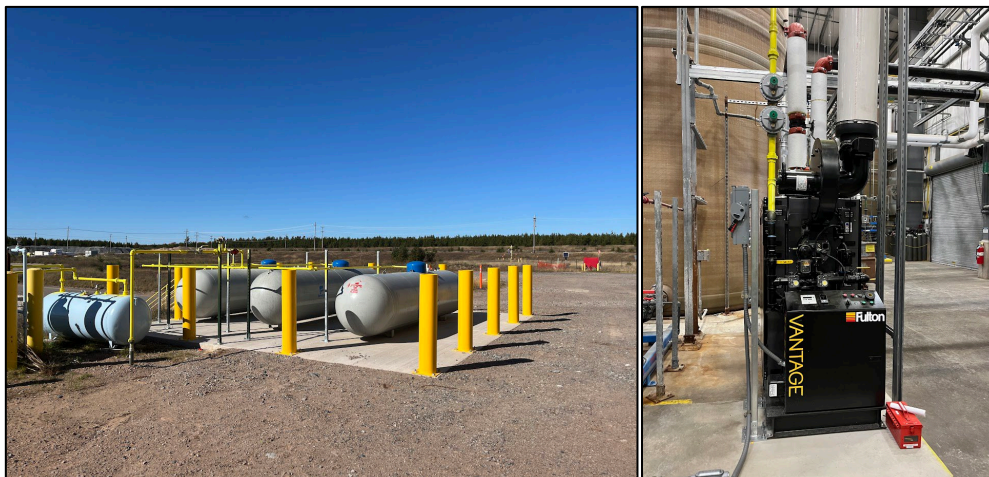
Figure 5 – New Propane Tanks at the WTP

Eagle placed new concrete as the foundation for additional 1,000-gallon (gal) propane tanks. The new tanks are located north of the existing water treatment plant (WTP) propane tanks and will provide additional propane storage capacity for the WTP and a 3rd boiler that was installed in February 2025.

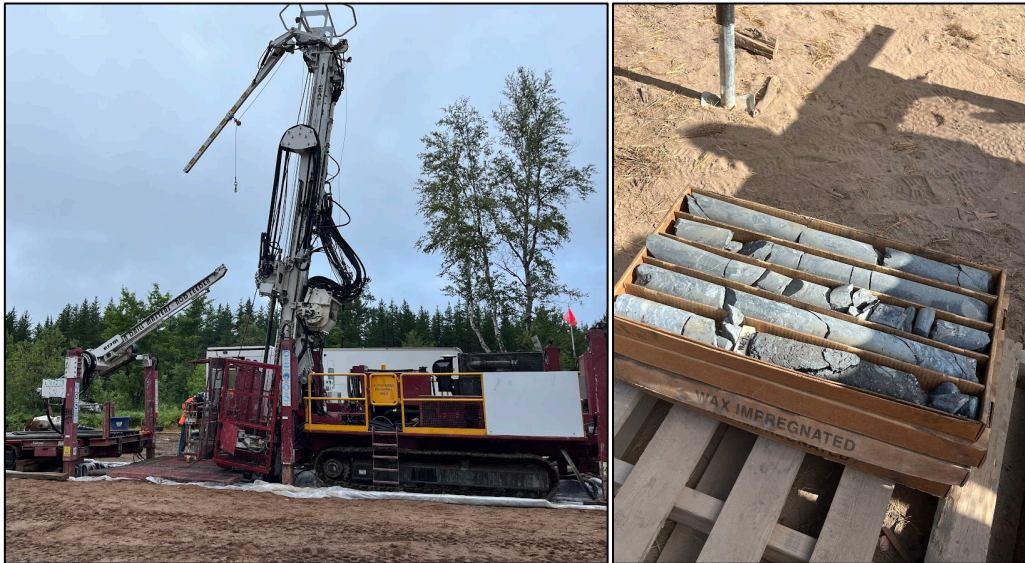
Figure 6 – Drill Rig and Core from Surface Exploration

On August 25th, 2024, a surface exploration drill rig operated by National Drilling was positioned approximately one mile east of the Mine. The surface exploration component is part of a larger program executed from primarily underground drill stations over the last three years. These drill holes

focused on investigating a geophysical anomaly detected during a magnetotelluric survey completed in late 2023.

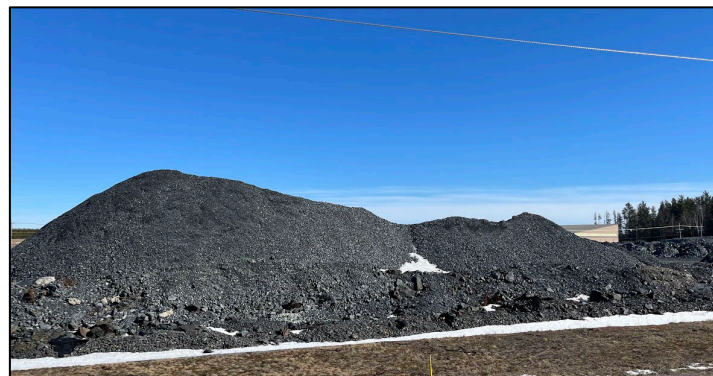
Figure 8 – Temporary Development Rock Storage Area

Month	Volume of Waste Rock Added to TDRSA (m ³)	Development Rock Removed from TDRSA for Backfill (m ³)	End of Year TDRSA Survey Volume (m ³)
2024 Total	27,903	0	124,558

Note: Development rock volume added to the TDRSA was based on the difference between the amount of development rock mined and the amount of development rock remaining underground as GOB fill.

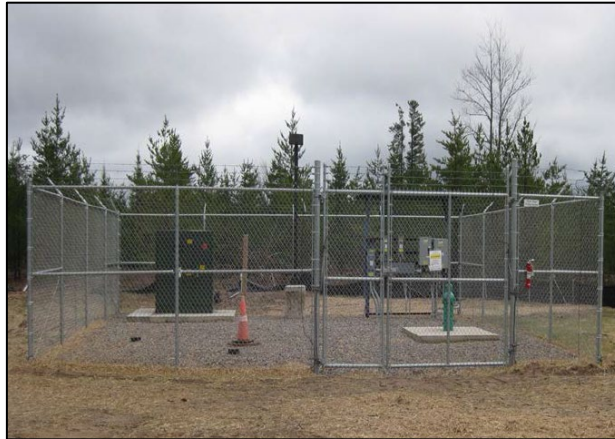
The third water source is recycled treated utility water supplied and used by the WTP. Utility water is produced by the treatment of water collected in the CWBs.

Figure 9 – Domestic Well at the Mine Site

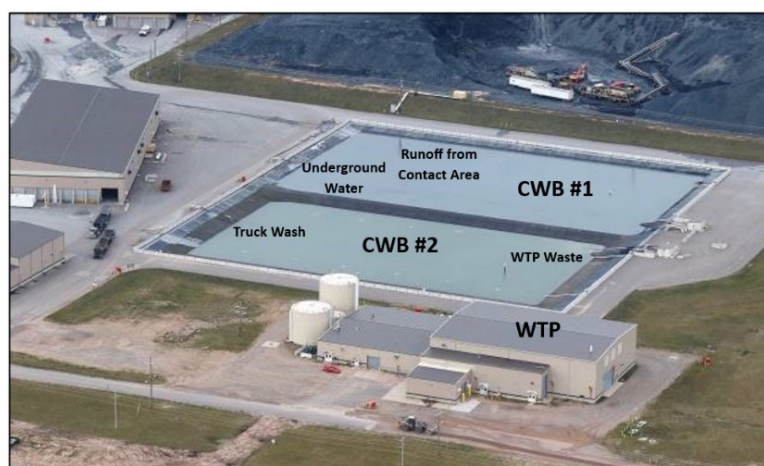
Figure 10 – Layout of the CWB's

Three primary sources of site water were discharged to the CWBs before treatment in the WTP. These included dewatering from the underground mine, the TDRSA, and storm water that falls on the paved contact area. Additional intermittent sources include dewatering from the sumps located in the COSA, truck wash, fuel area, batch plant, boot wash, and truck shop.

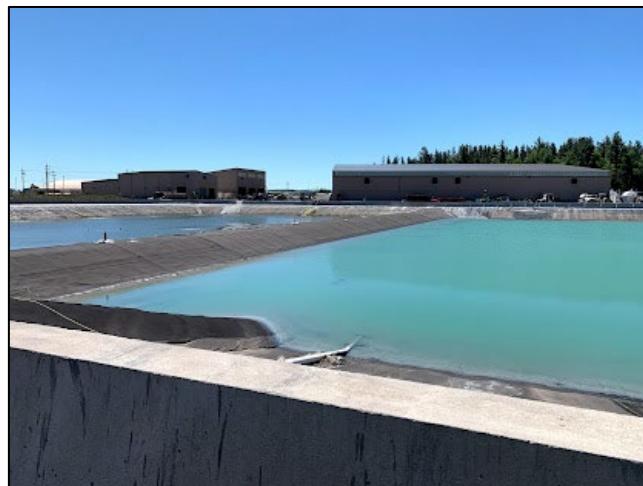
Figure 11 – View looking southeast at CWB #1

Like previous years, the CWB monitoring results fluctuate from quarter to quarter and are dependent on the areas being mined underground, TDRSA sump inputs, and the amount of dilution from precipitation. pH results ranged from 8.8 SU in Q3 to 9.7 SU in Q4. Water quality in CWB #2 is influenced by water being recirculated back to the basins from the WTP. Water in CWB #1 can be transferred into CWB #2 and vice versa, to optimize WTP operations.

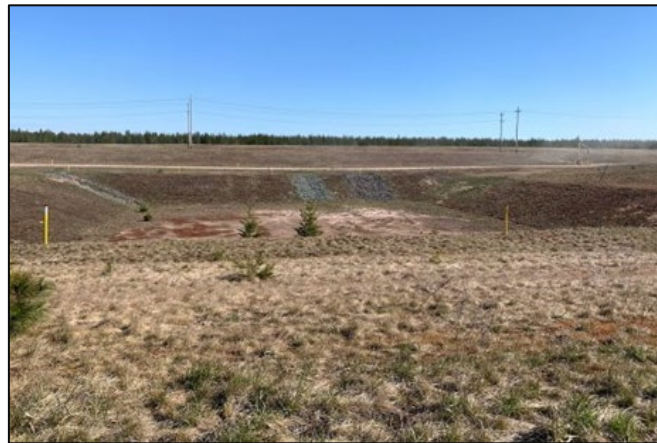
Figure 12 – NCWIB #1 Near the WTP

Inspections of the NCWIBs located near the surface facilities and ventilation air raise occur after wet weather events. The inspections indicate the basins are operating as expected to readily infiltrate storm water with the exception of brief ponding after spring melt or excessive rain events. The basins are monitored for excess silt that would prevent infiltration and ideal operation. No excessive silt was observed in 2024.

Per the mining permit, monitoring wells are required to be located downgradient of each NCWIB and must be sampled in the event of a surface discharge from the basin. Eagle Mine has chosen to sample these wells at least annually as surface discharge is not expected to occur. Monitoring wells QAL070A and QAL073A, located downgradient of NCWIBs #2 and #3, are monitored annually while QAL071A and QAL024A located downgradient of NCWIB #1 and #4 and are monitored quarterly.

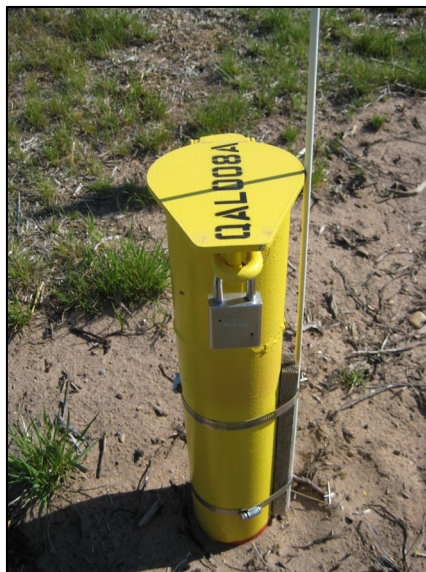
Figure 13 – Groundwater Monitoring Location QAL008A

Twenty-three groundwater samples were collected during each of the four quarterly sampling events. Samples collected from two additional monitoring wells were collected once in 2024 and the results are summarized below. Samples were collected using low-flow sampling techniques, and the field parameters dissolved oxygen (DO), oxidation reduction potential (ORP), pH, specific conductivity, temperature, and turbidity using a flow-through cell and YSI probe.

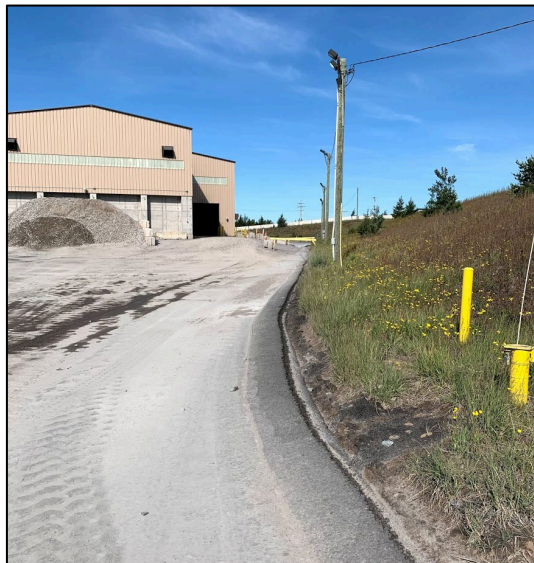
Figure 14 – Curbing Located Near QAL067A

- **Location:** QAL067A – Southeast Corner of the TDRSA
 - **Quarterly Parameters Above Benchmark:** alkalinity bicarbonate, chloride, nitrate, sulfate, sodium
 - **Annual Parameters Above Benchmark:** calcium, magnesium, hardness
 - **Summary:** The elevated quarterly and annual results at this location are also suspected to be associated with the historic use of salt on the contact area as no additional changes have occurred in the area. However, sodium, chloride, nitrate and sulfate decreased throughout 2024 with bicarbonate alkalinity slightly increasing again. Jersey barriers were placed at this location in December 2020 to prevent snow from being pushed into the vicinity of well QAL067A and asphalt curbing was enhanced along the berm in 2021. Chloride and sodium continue to decrease in 2024 and are expected to continue to trend toward baseline levels.

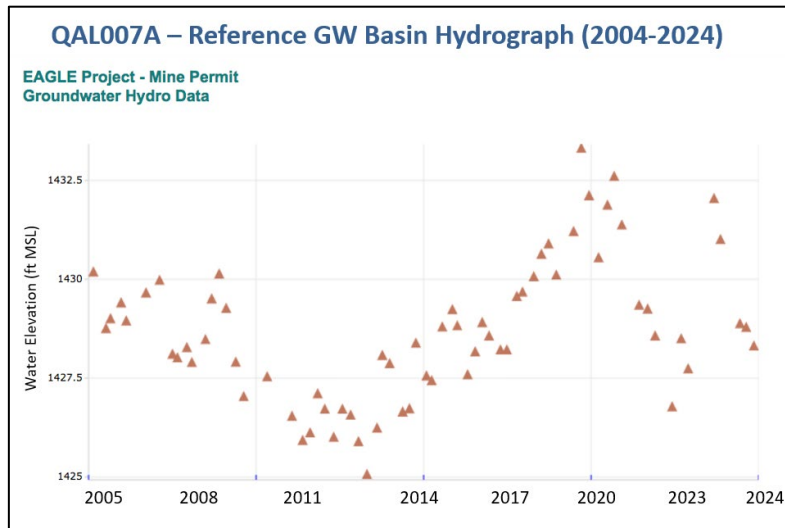
Figure 15 – QAL007A – Regional Decrease in Water Levels 2024

In addition, some of the short-lived fluctuations in deeper D-zone groundwater levels below the confining layer may be attributed to blasting events. In a confined aquifer, the impacts of blasting may be observed as an instantaneous pulse in groundwater levels due to increased pressure or changes in pressure. Water levels return to pre-blast levels typically within the hour after the blasting cycle is complete.

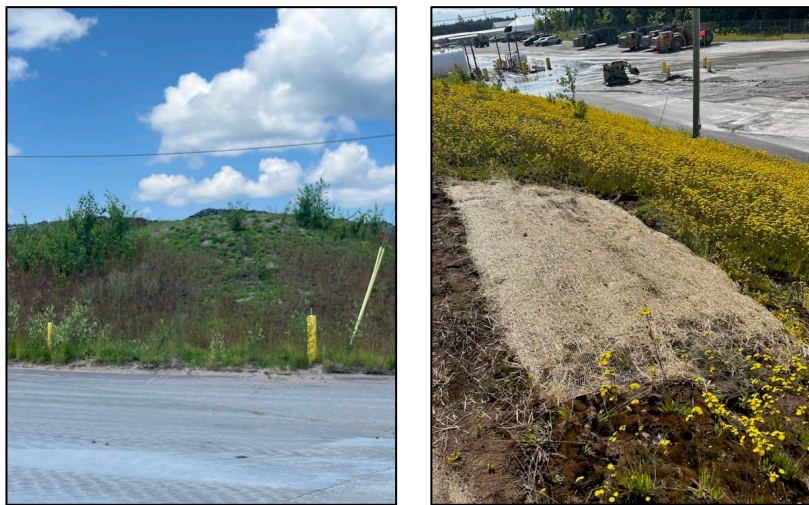
Figure 17 – Hydroseeding on the TDRSA Berm and Additional Mulch

In spring 2024, hydroseeding was completed along the TDRSA berms after tree removal was completed in 2023. The project was completed by M.J. Van Damme (MJVD) using a mulch with tackifier to hold seed to the sloped areas. Additional mulch and grass seed was applied on the south berm where the hydro seeder accessed the slope.

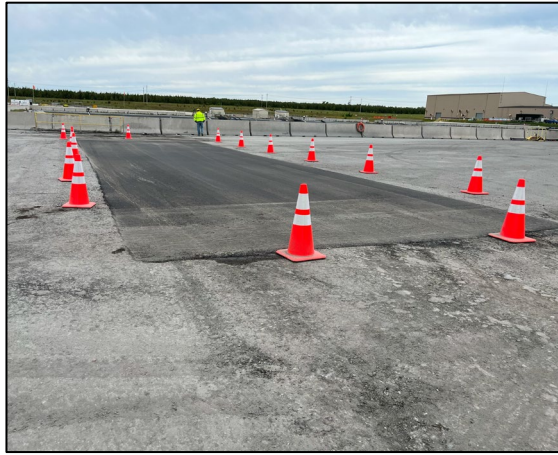
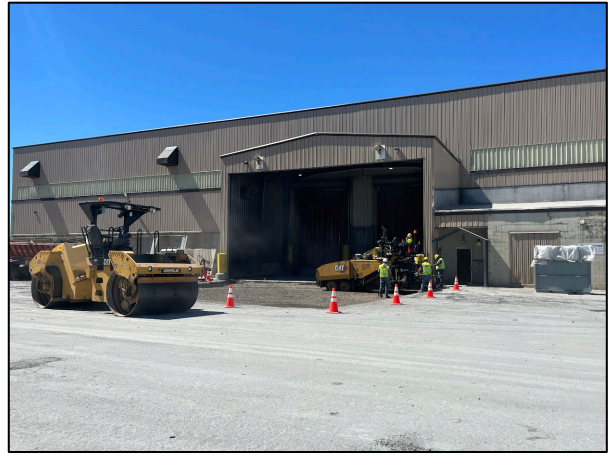
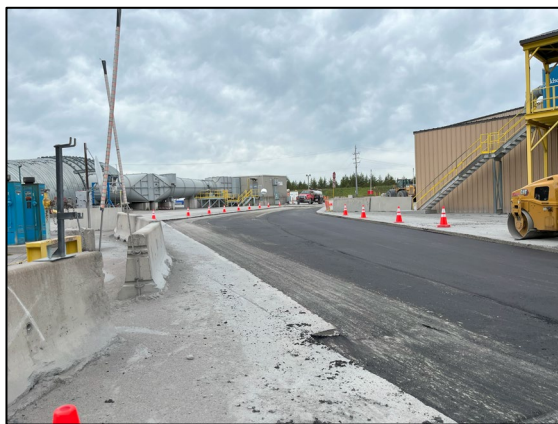
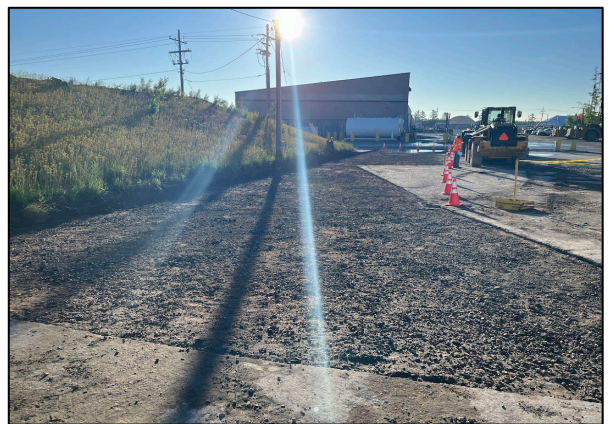
- Concrete seams were re-sealed on the WTP floors as well as the bulk hydrochloric room floor and sumps.
- Asphalt and concrete were removed and replaced on the contact area in June 2024 from multiple locations including near the CWBs, between the portal and CRF plant, east of the aggregate storage building (ASB), the COSA load bays, the TDRSA entrance/exit, and smalls sections near the fuel island and in the north laydown area.

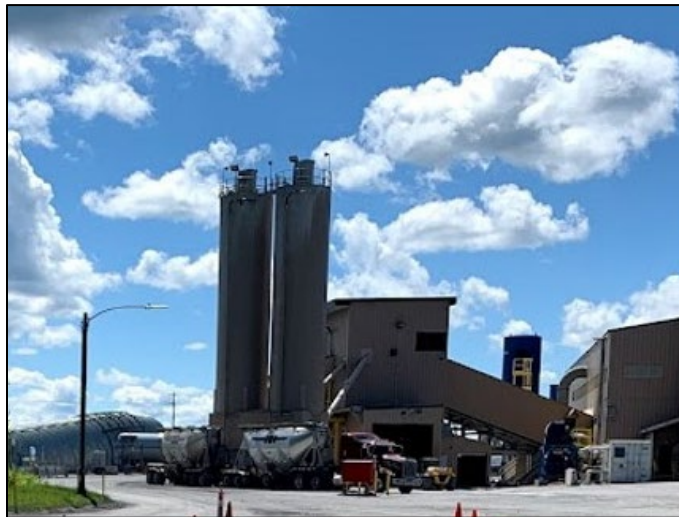
Figure 2 – Cemented Rock Fill (CRF) Plant

All CRF is made onsite at the batch plant and is transported underground using underground haul trucks. The CRF is currently composed of development rock or offsite aggregate, sand, cement, water, and a concrete admixture.

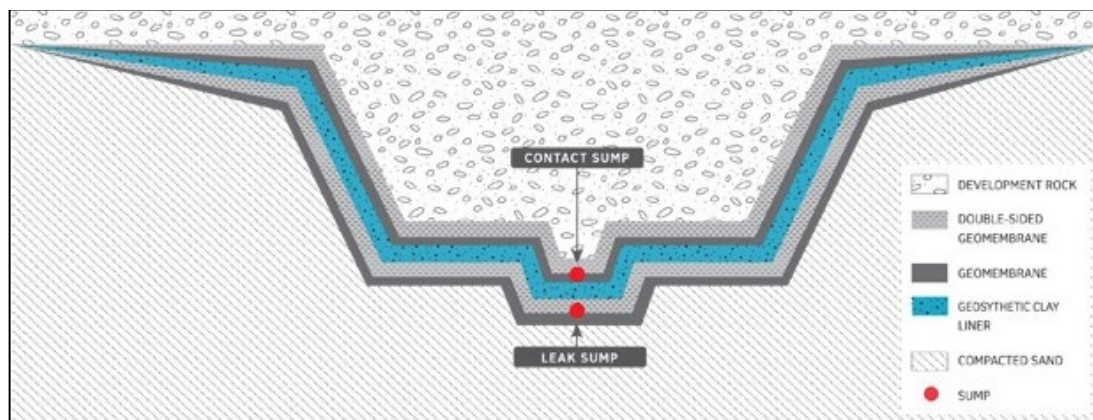
Figure 3 – Eagle Mine Rock Storage Area (TDRSA) Cross Section

The Temporary Development Rock Storage Area (TDRSA) was created to hold development rock until the material can be placed back underground as backfill. The storage area has multiple protective layers between the surface and the development rock. The TDRSA has two collection sumps; the contact water sump and the leak detection sump. The contact water sump collects drainage from the primary TDRSA liner where the water is in contact with development rock. The purpose of the leak detection sump is to capture water within the secondary liner system in the event of a failure of the primary liner.

The water currently in the leak detection sump is rainwater that entered the secondary collection system during construction in 2011 via rainfall and has been encapsulated in the secondary lining system since construction (estimated 26,000 gallons). Since that time, water has been pumped from the leak detection monthly.

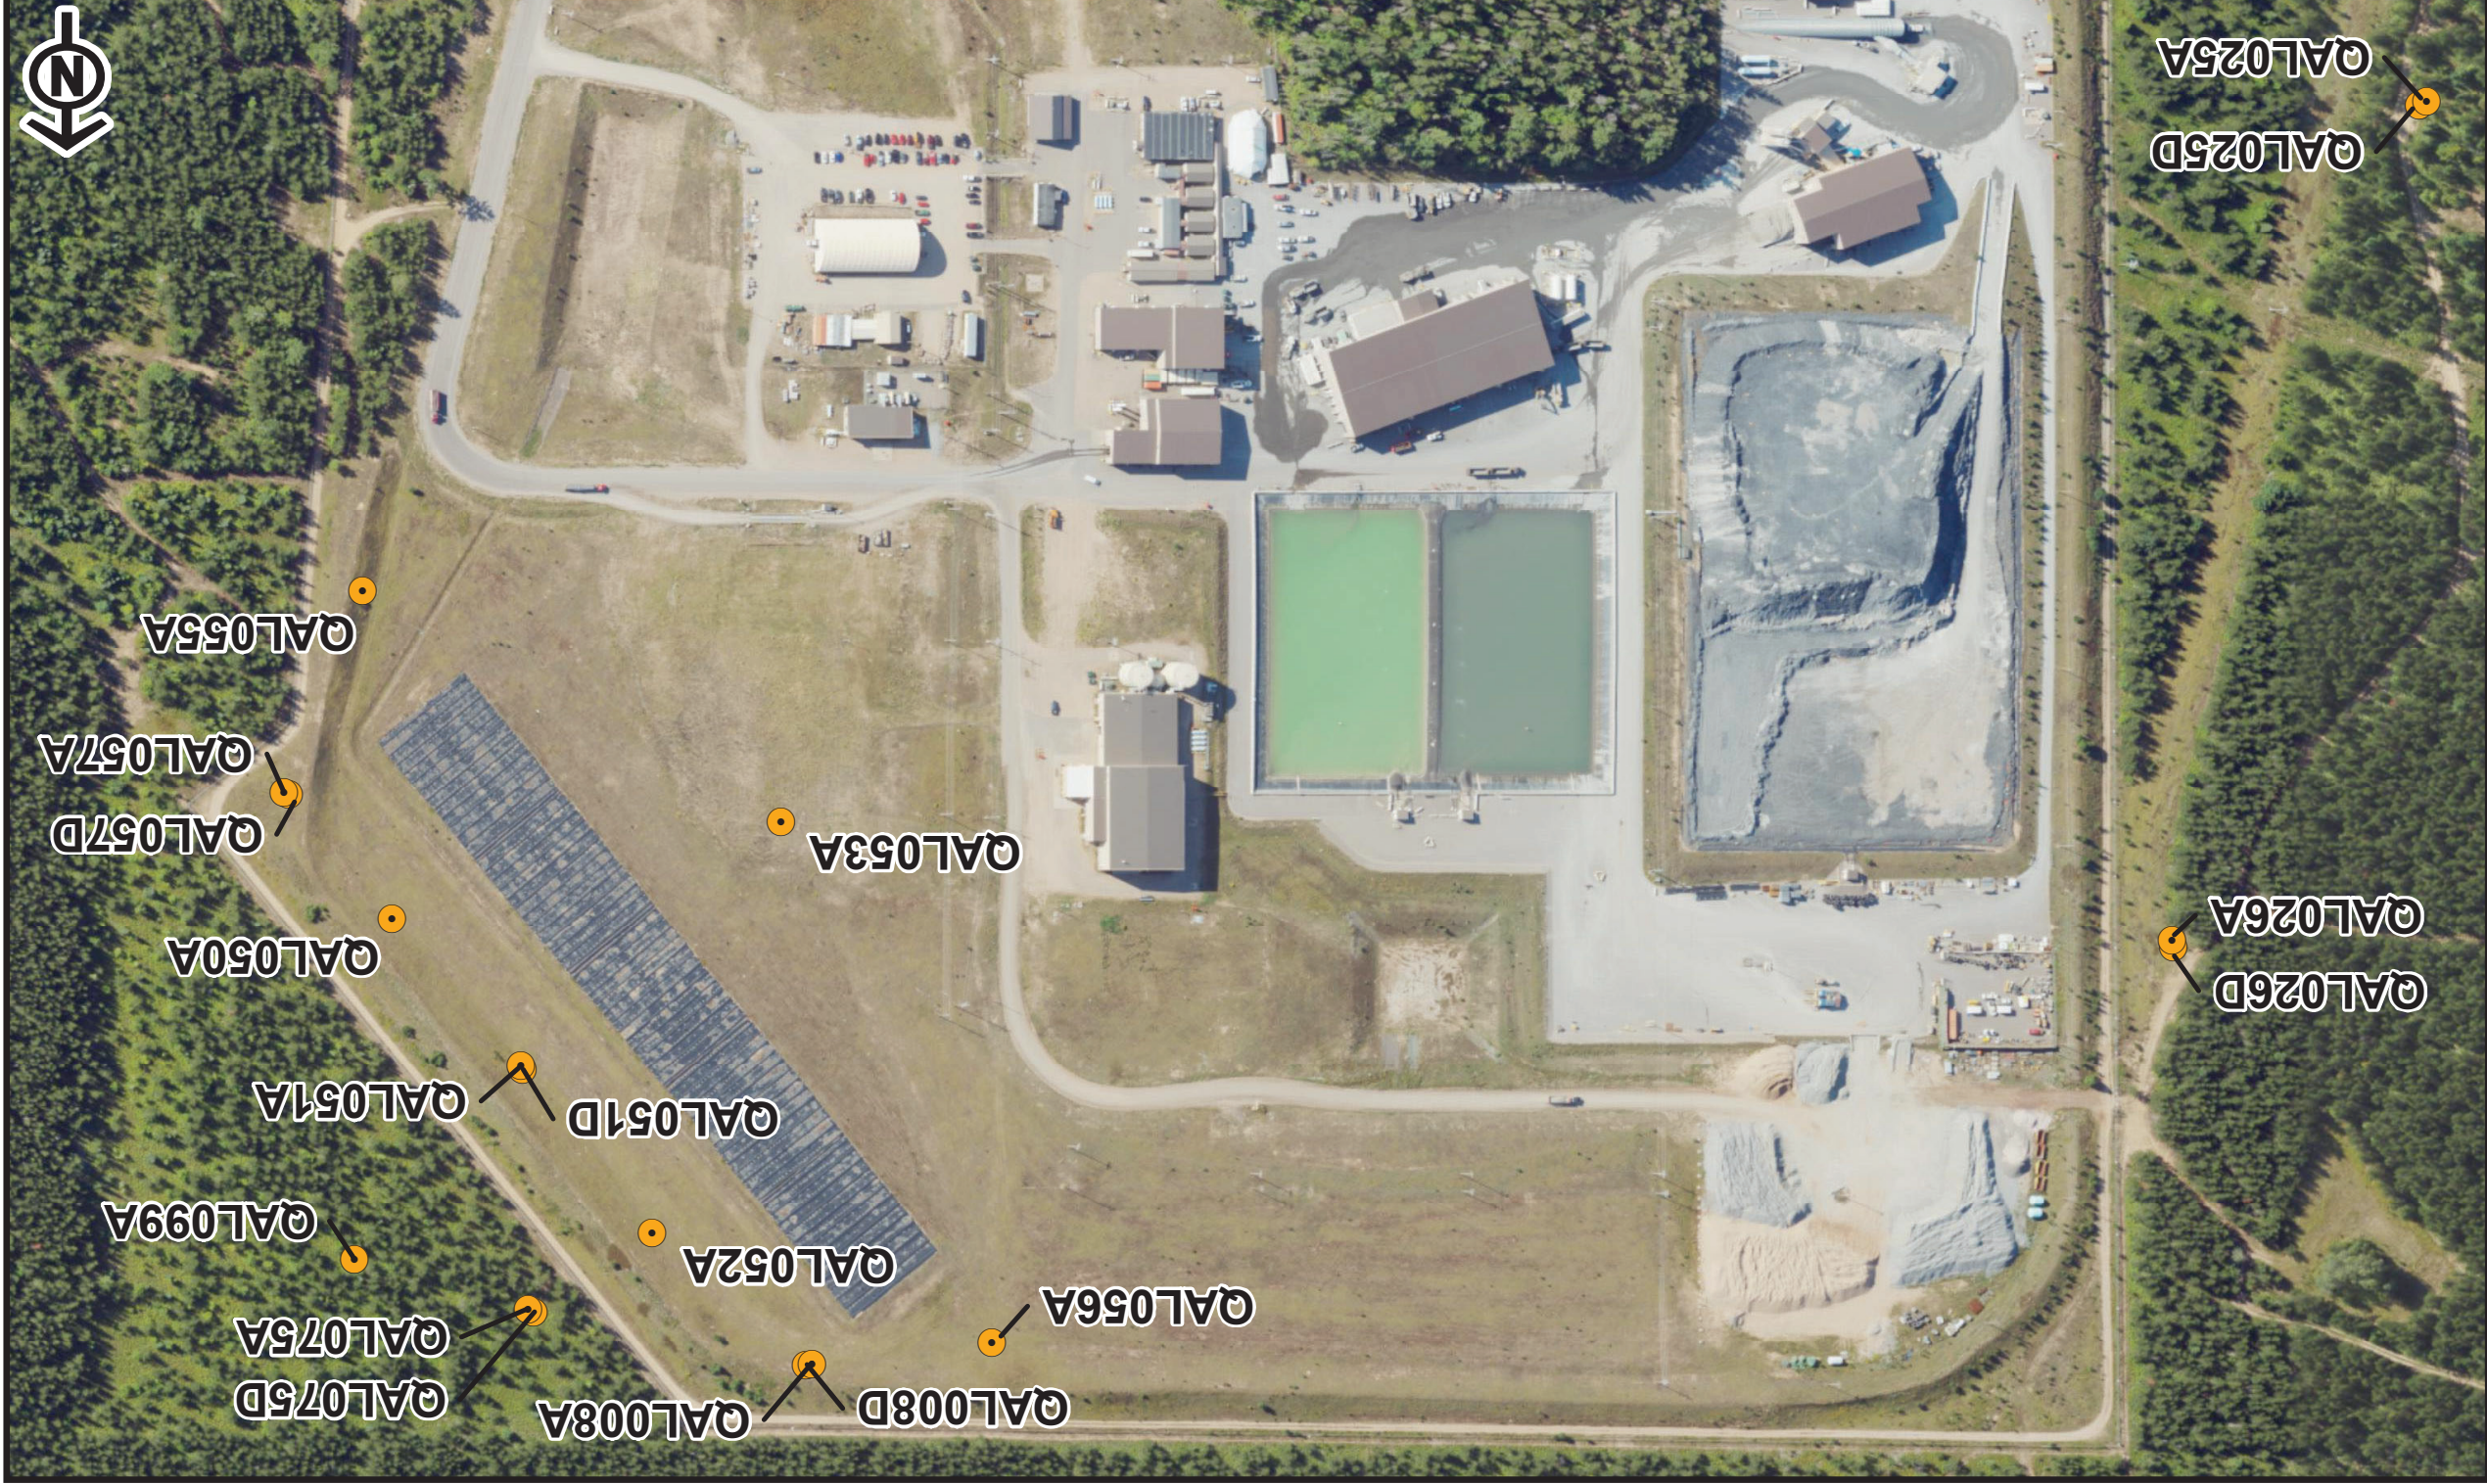
Figure 1

Groundwater Discharge Permit
Wells

Data source: Lundin Mining and North Jackson Company
*Well sampled on an annual rather than quarterly basis.
Basemap: National Agriculture Imagery Program
Satellite image taken August 11, 2020.
Projection & Datum: NAD 1983 UTM Zone 16N

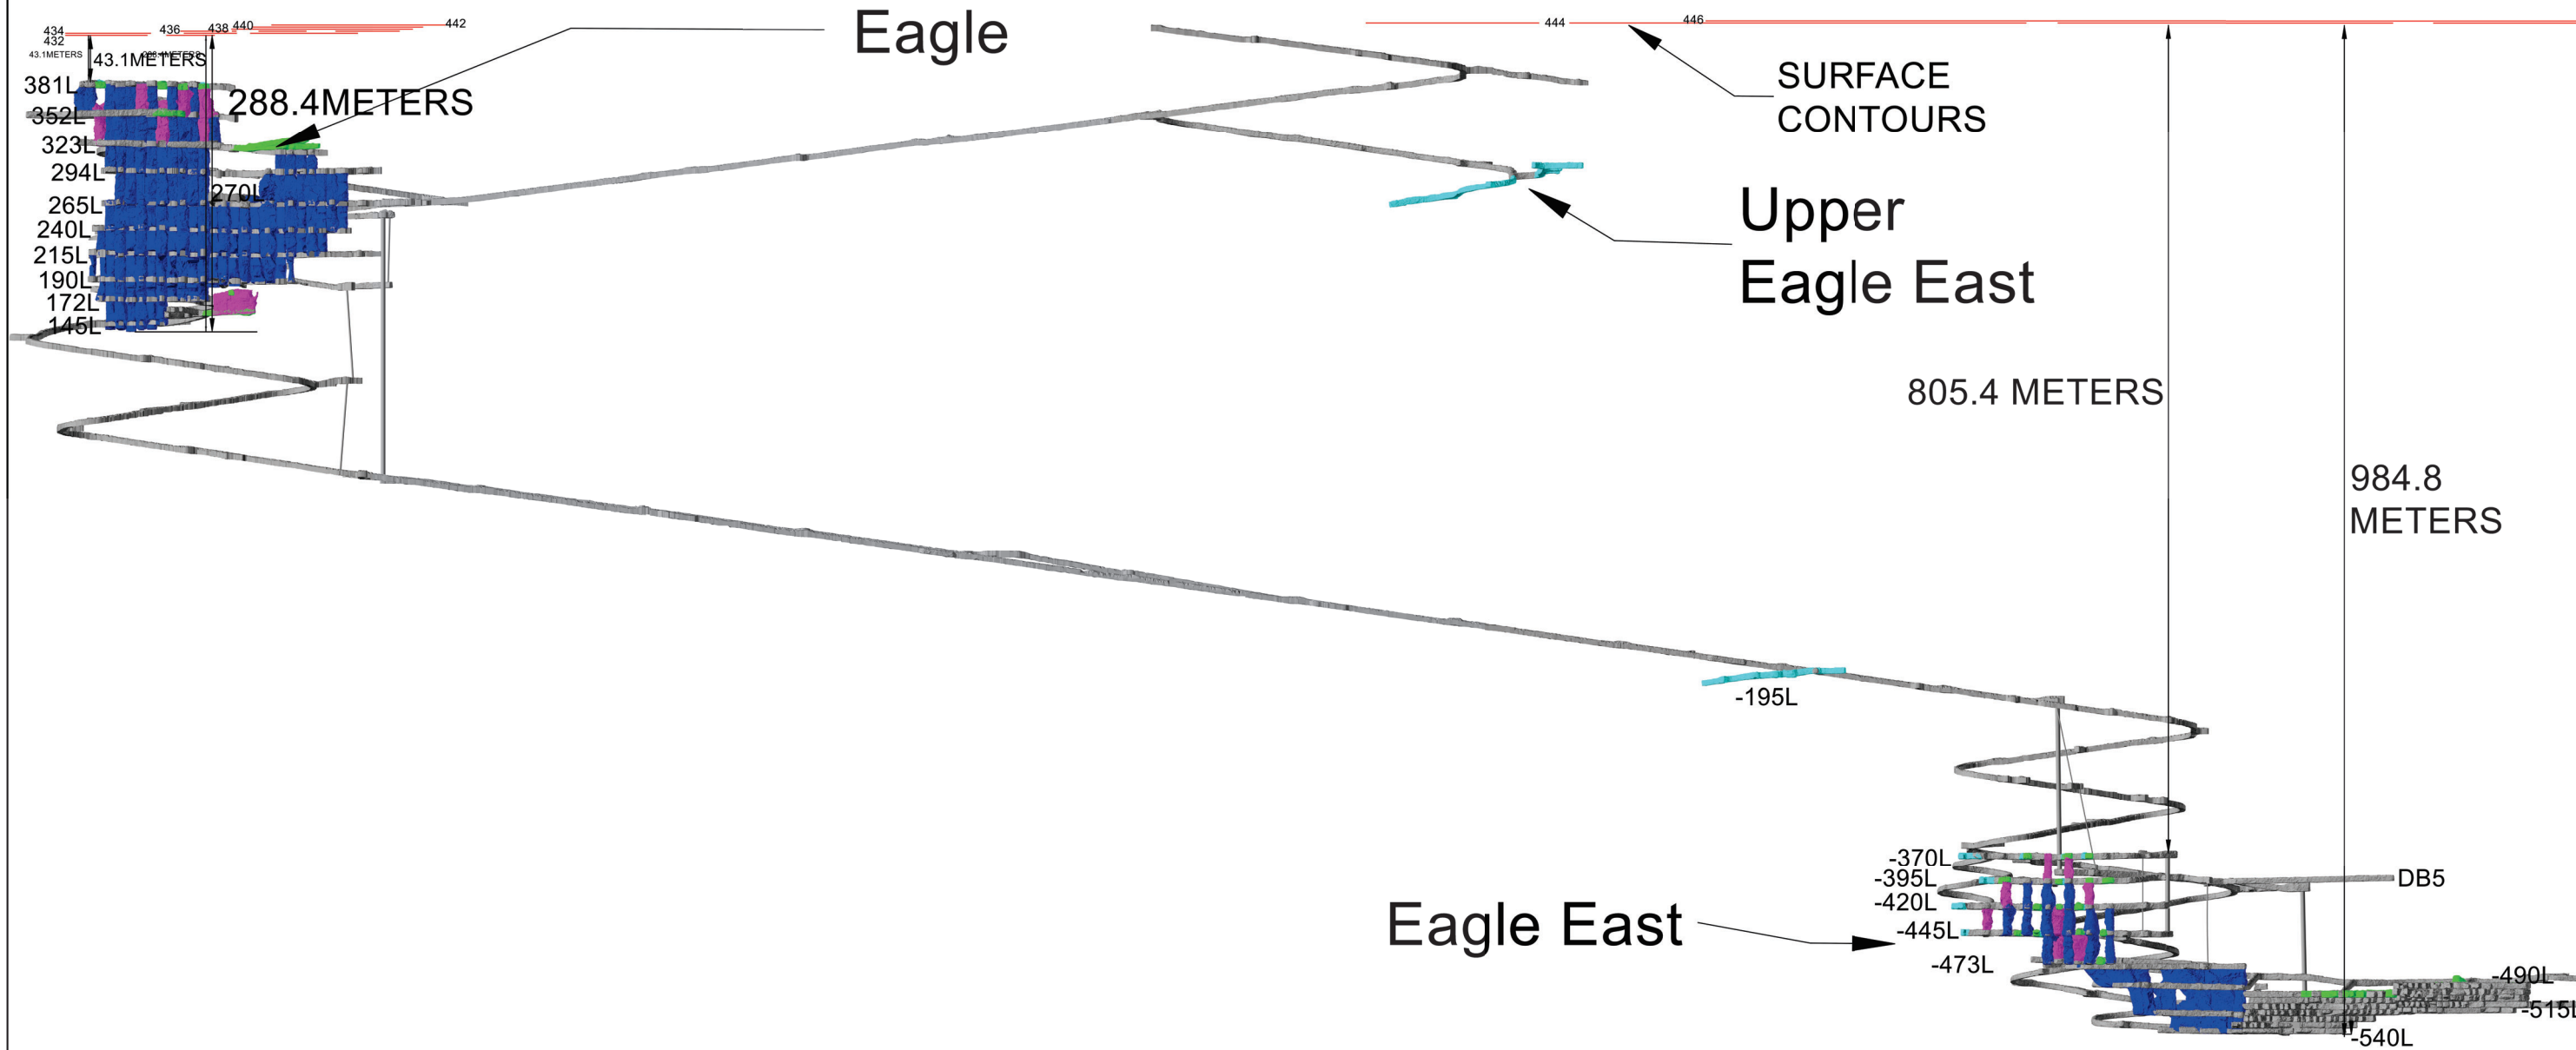
Maps of Eagle, Eagle East and Upper
Eagle East Development and Production
Mining Progress

NOTE: ALL ELEVATIONS IN METERS. IN THE LEVEL LABELS THE NUMBER REFERS TO HEIGHT ABOVE/BELOW MEAN SEA LEVEL (-540L HAS A SILL ELEVATION OF 540 METERS BELOW MSL)

NOTE: ALL ELEVATIONS IN METERS. IN THE LEVEL LABELS THE NUMBER REFERS TO HEIGHT ABOVE MEAN SEA LEVEL (381L HAS A SILL ELEVATION OF 381 METERS ABOVE MSL)
