Environmental Resources Management

GENERAL ELECTRIC
FORMER APPARATUS SERVICE CENTER
18075 KRAUSE STREET, RIVERVIEW, MICHIGAN

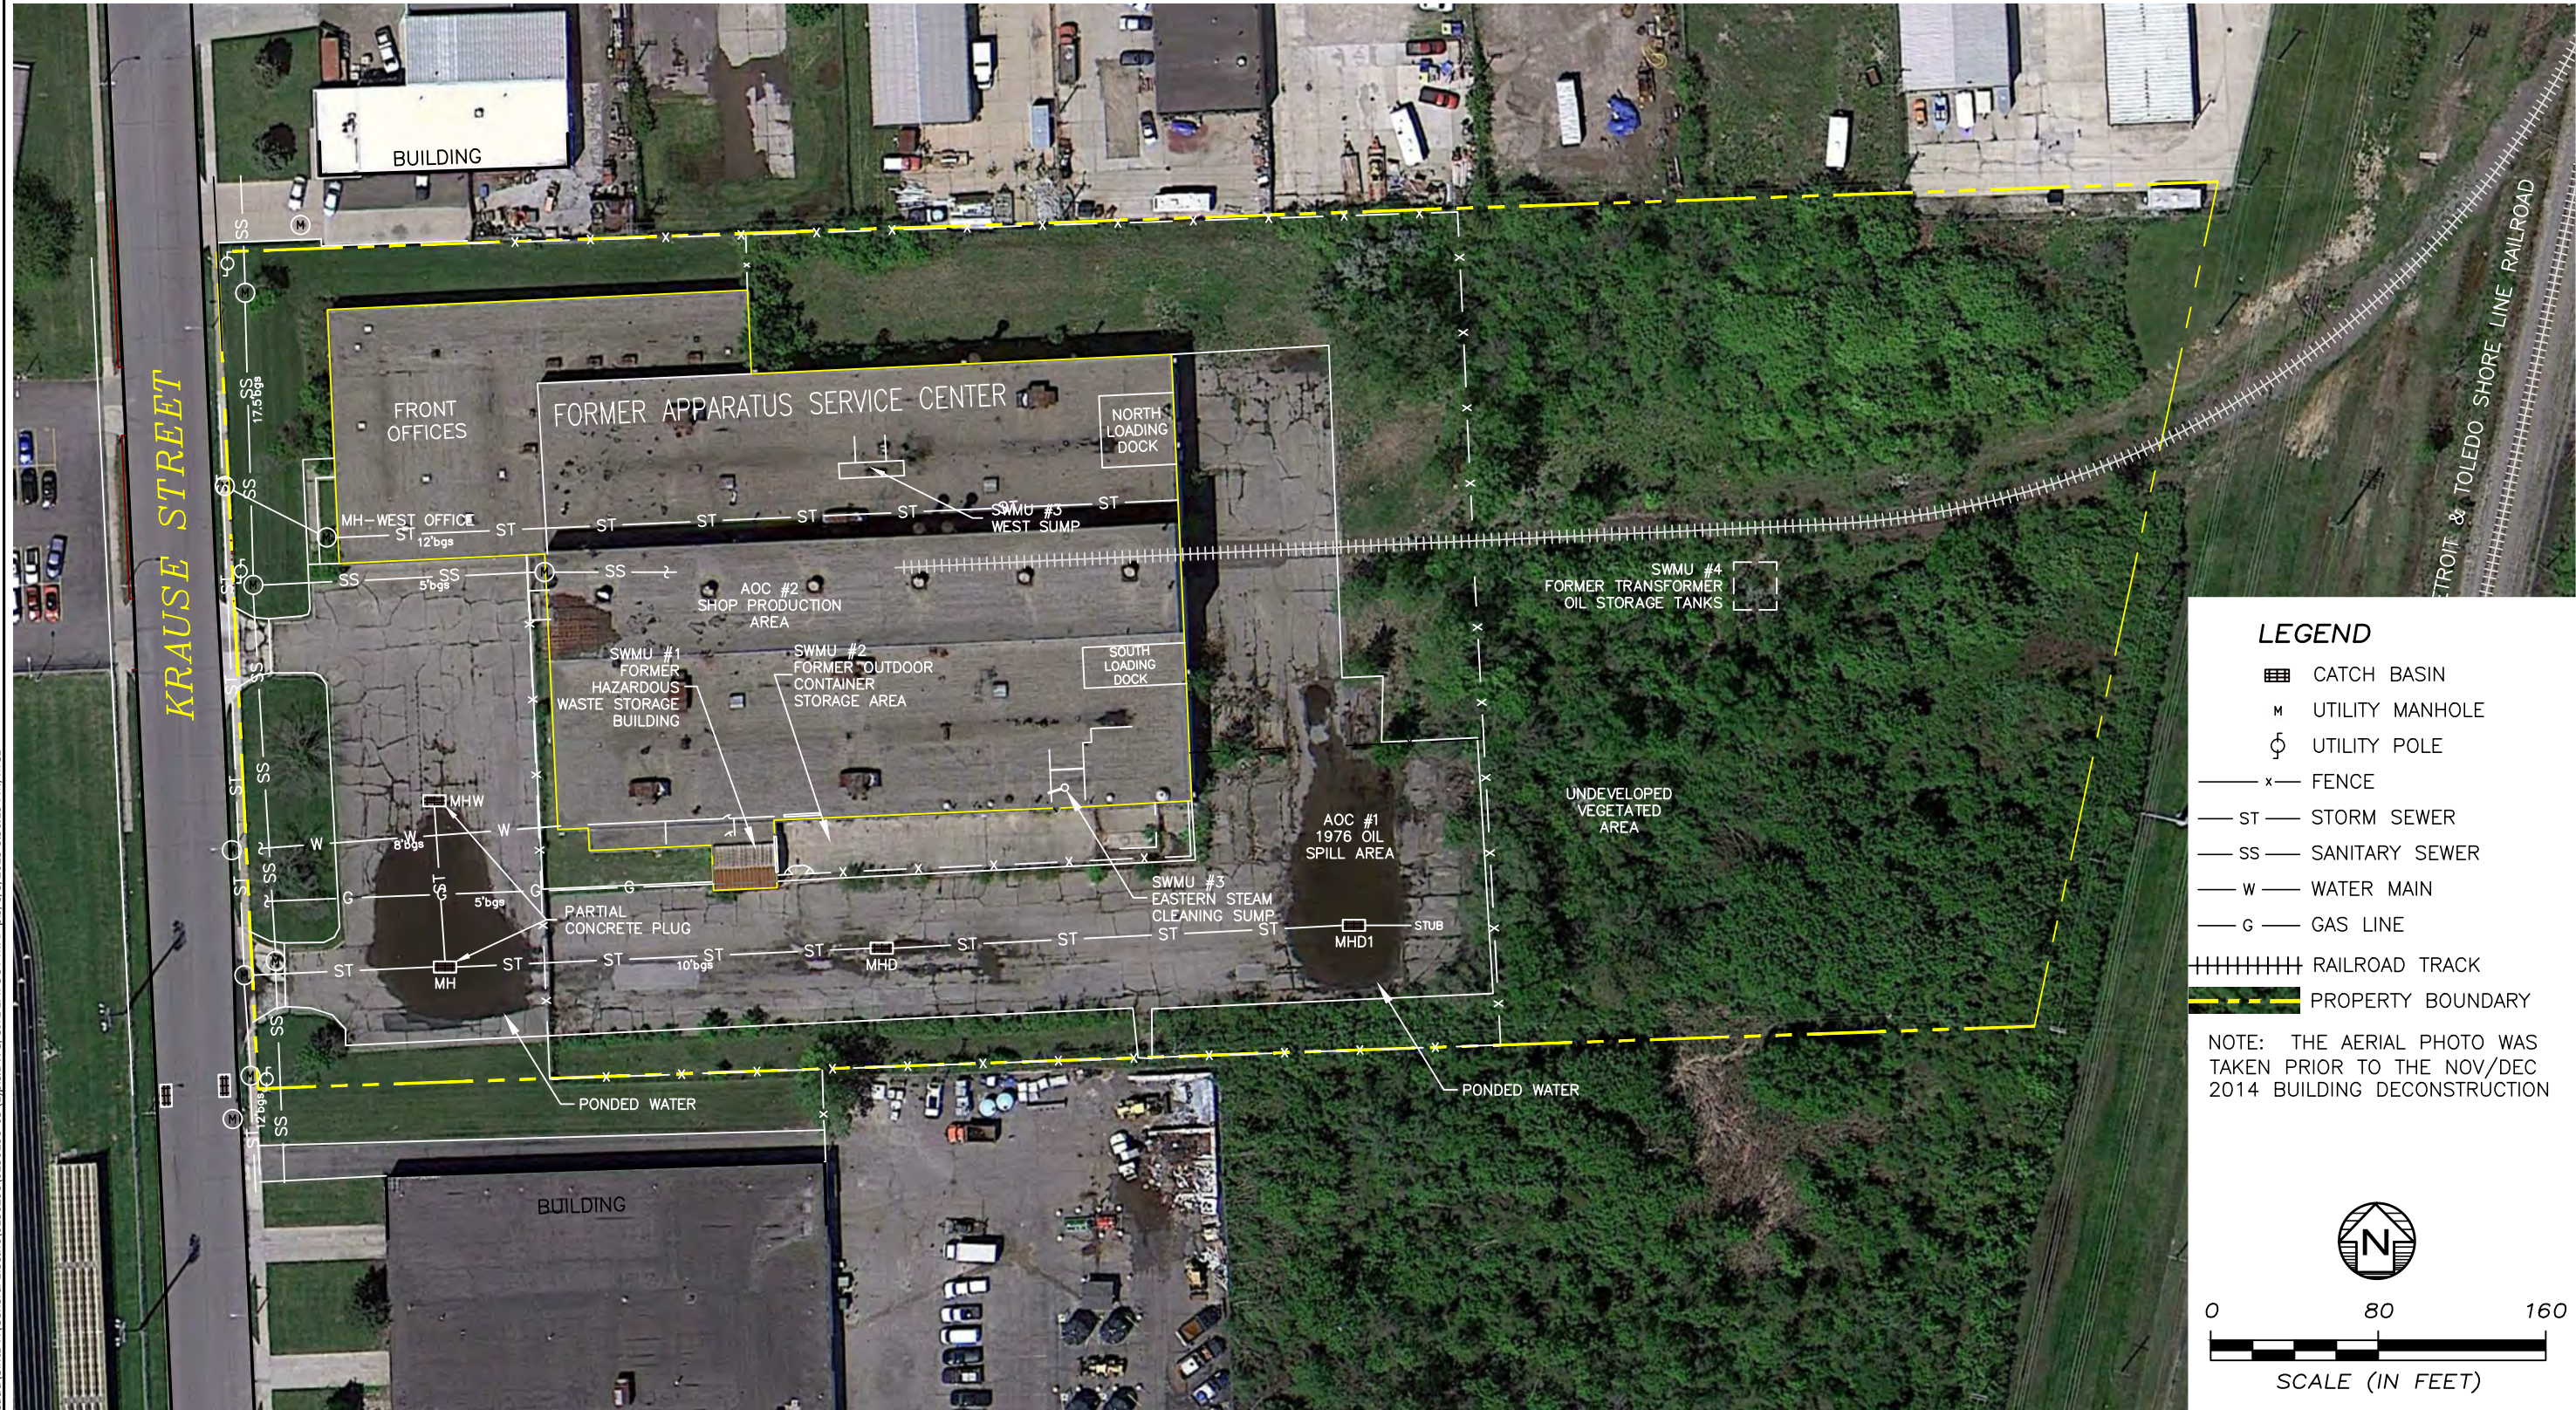
CHK'D MR
0150298
FIGURE 2

SITE LAYOUT MAP

NOTE: THE AERIAL PHOTO WAS TAKEN PRIOR TO THE NOV/DEC 2014 BUILDING DECONSTRUCTION
