**LETTER REPORT  
FOR  
LAKE LINDEN EMERGENCY RESPONSE SITE  
LAKE LINDEN, HOUGHTON COUNTY, MICHIGAN**

Date Prepared	November 30, 2007
TDD Number	S05-0001-0707-021
Contract Number	EP-S5-06-04
Document Control Number	248-2A-ABHD
START Project Manager	Daniel Capone
Telephone No.	(517) 381-5932
U.S. EPA On-Scene Coordinator	Brian Kelly

Re: Lake Linden Emergency Response Site  
Lake Linden, Houghton County, Michigan  
TDD: S05-0001-0707-021  
DCN: 248-2A-ABHD  
WO#: 20405.012.001.0248.00

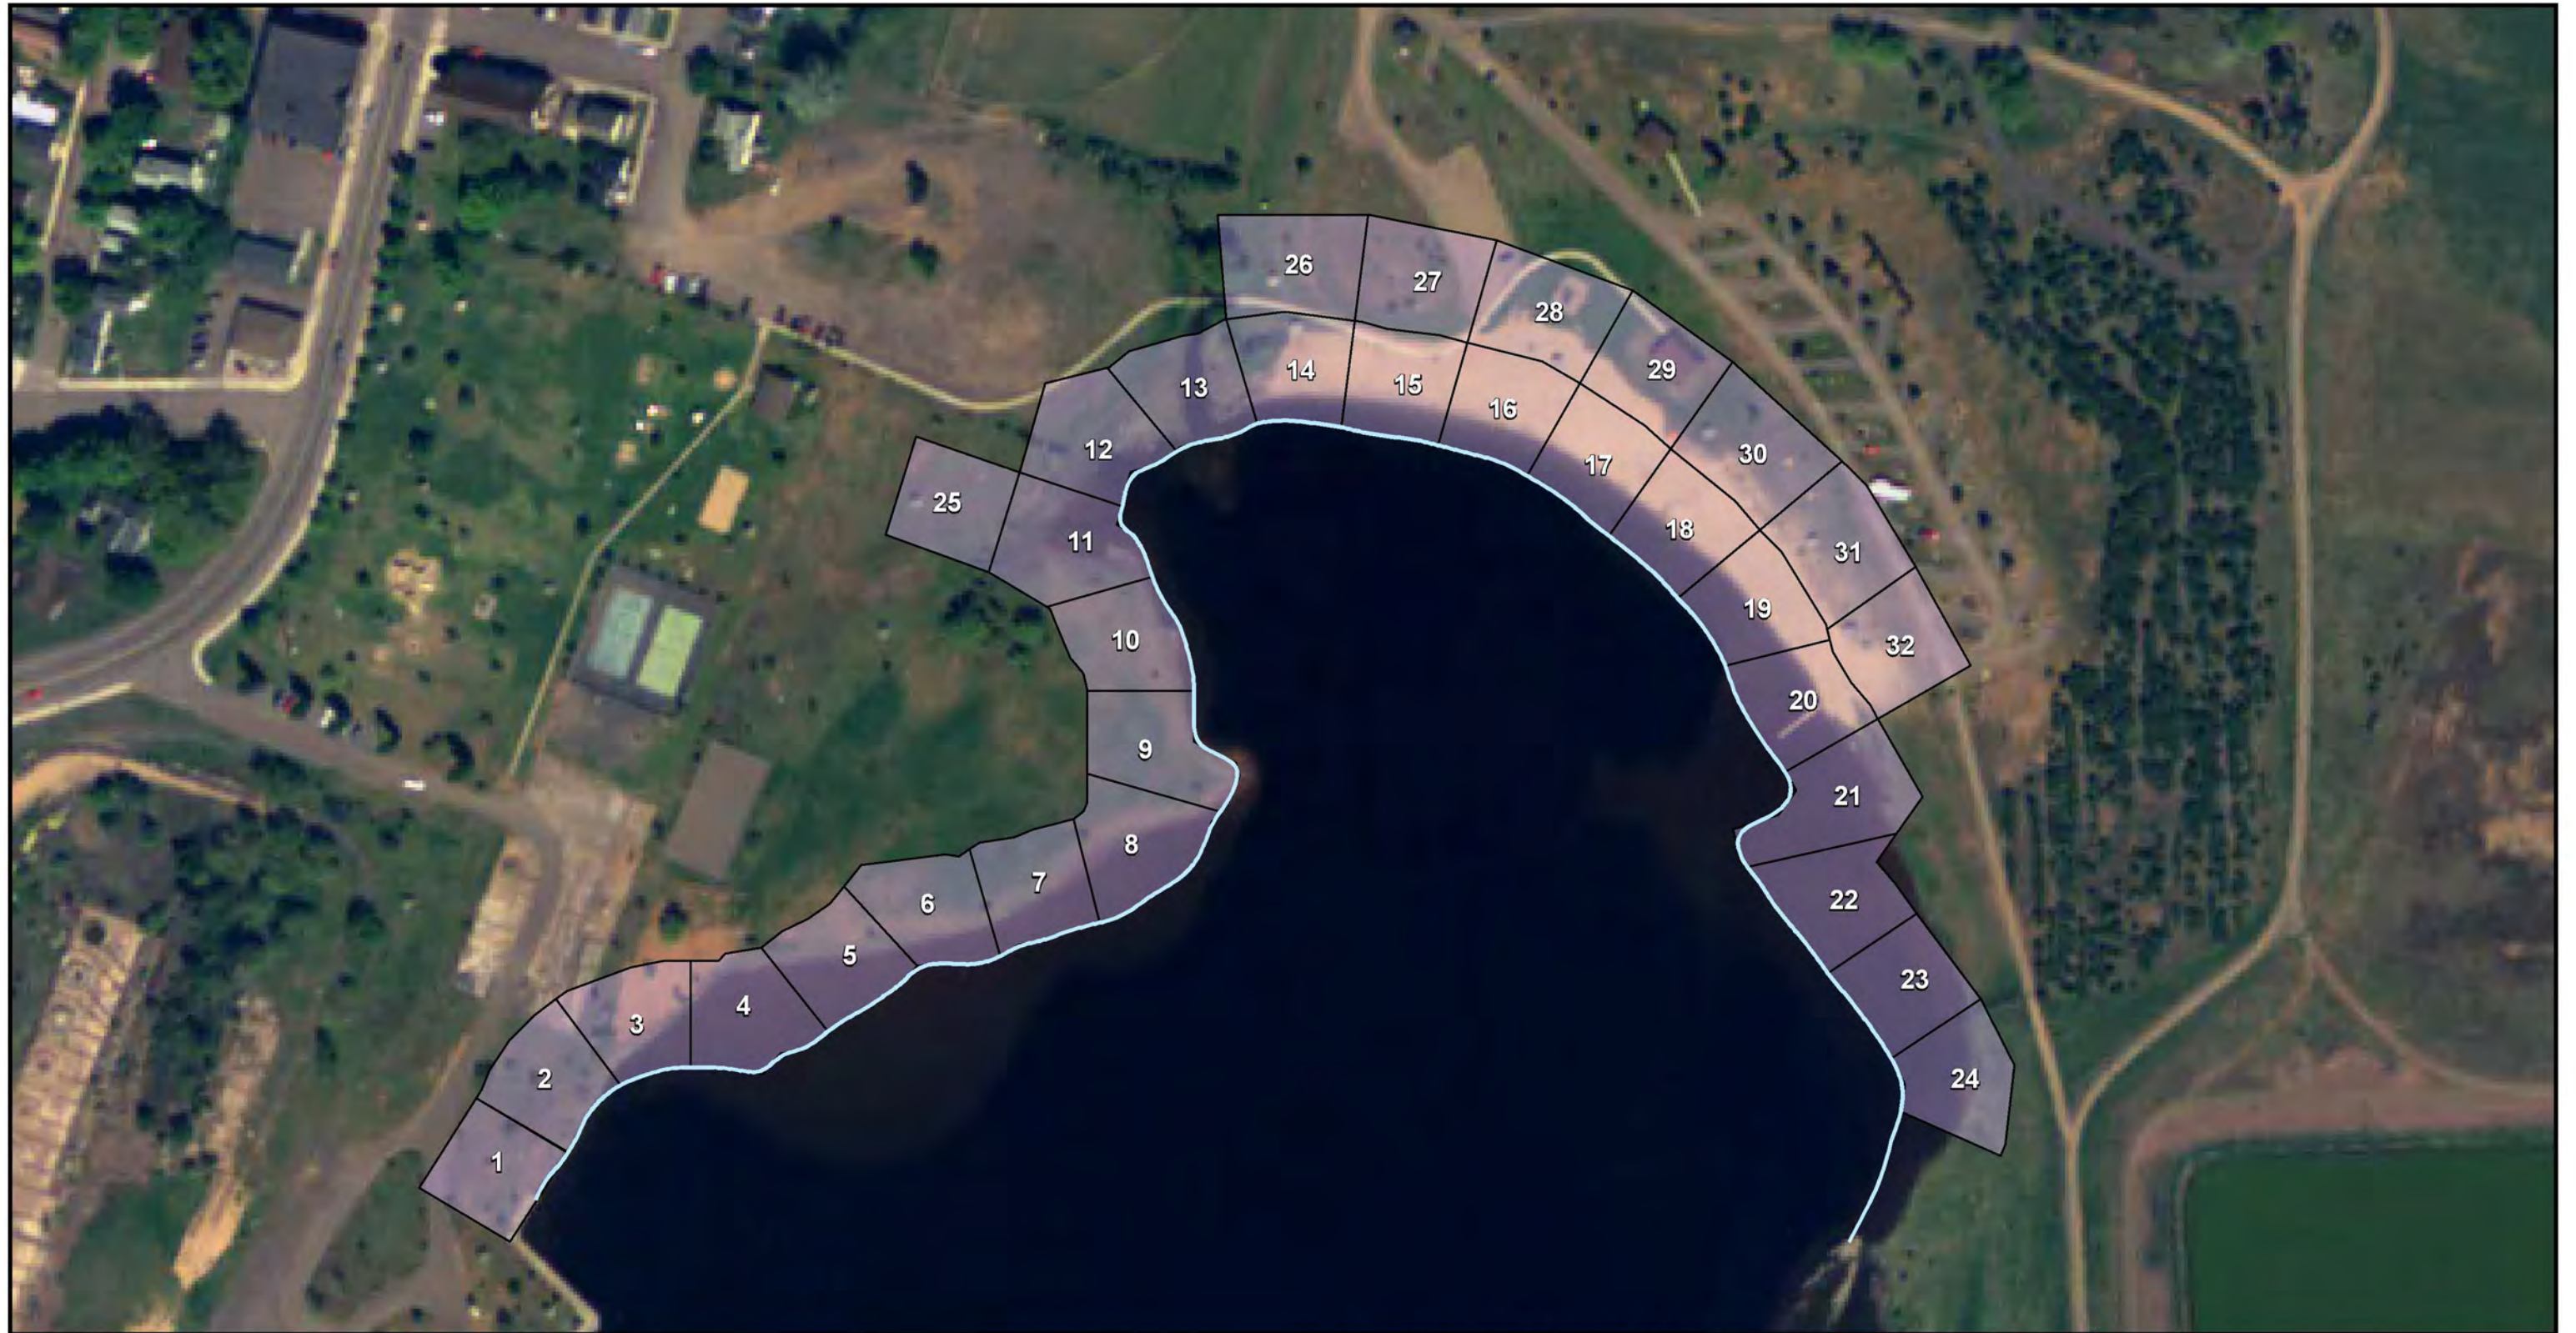
**Figure 2**

SOIL RECONNAISSANCE AND  
 SAMPLING GRIDS  
 LAKE LINDEN - ER  
 LAKE LINDEN, HOUGHTON CO., MI  
 September 2007  
 Scale: 1"= 150

- Established 100-foot by 100-foot sampling grids along the north shore of Torch Lake (LLRP property between the marina and the east side of LLRP Rustic Campground) as shown in **Figure 2 (Attachment A)**. In addition, 100-foot by 100-foot grids further inland from the shoreline grids, from west of the creek to the eastern edge of the swimming beach, were established. A total of 32 grids were identified. One biased sampling location was established within each grid based on visual observations and XRF screenings for metals in exposed soil/sediment or waste (white, clayey material), with the exception of Grid #11, which had been previously sampled by the MDEQ and START. At each grid sampling location, two soil/sediment samples were collected as follows:

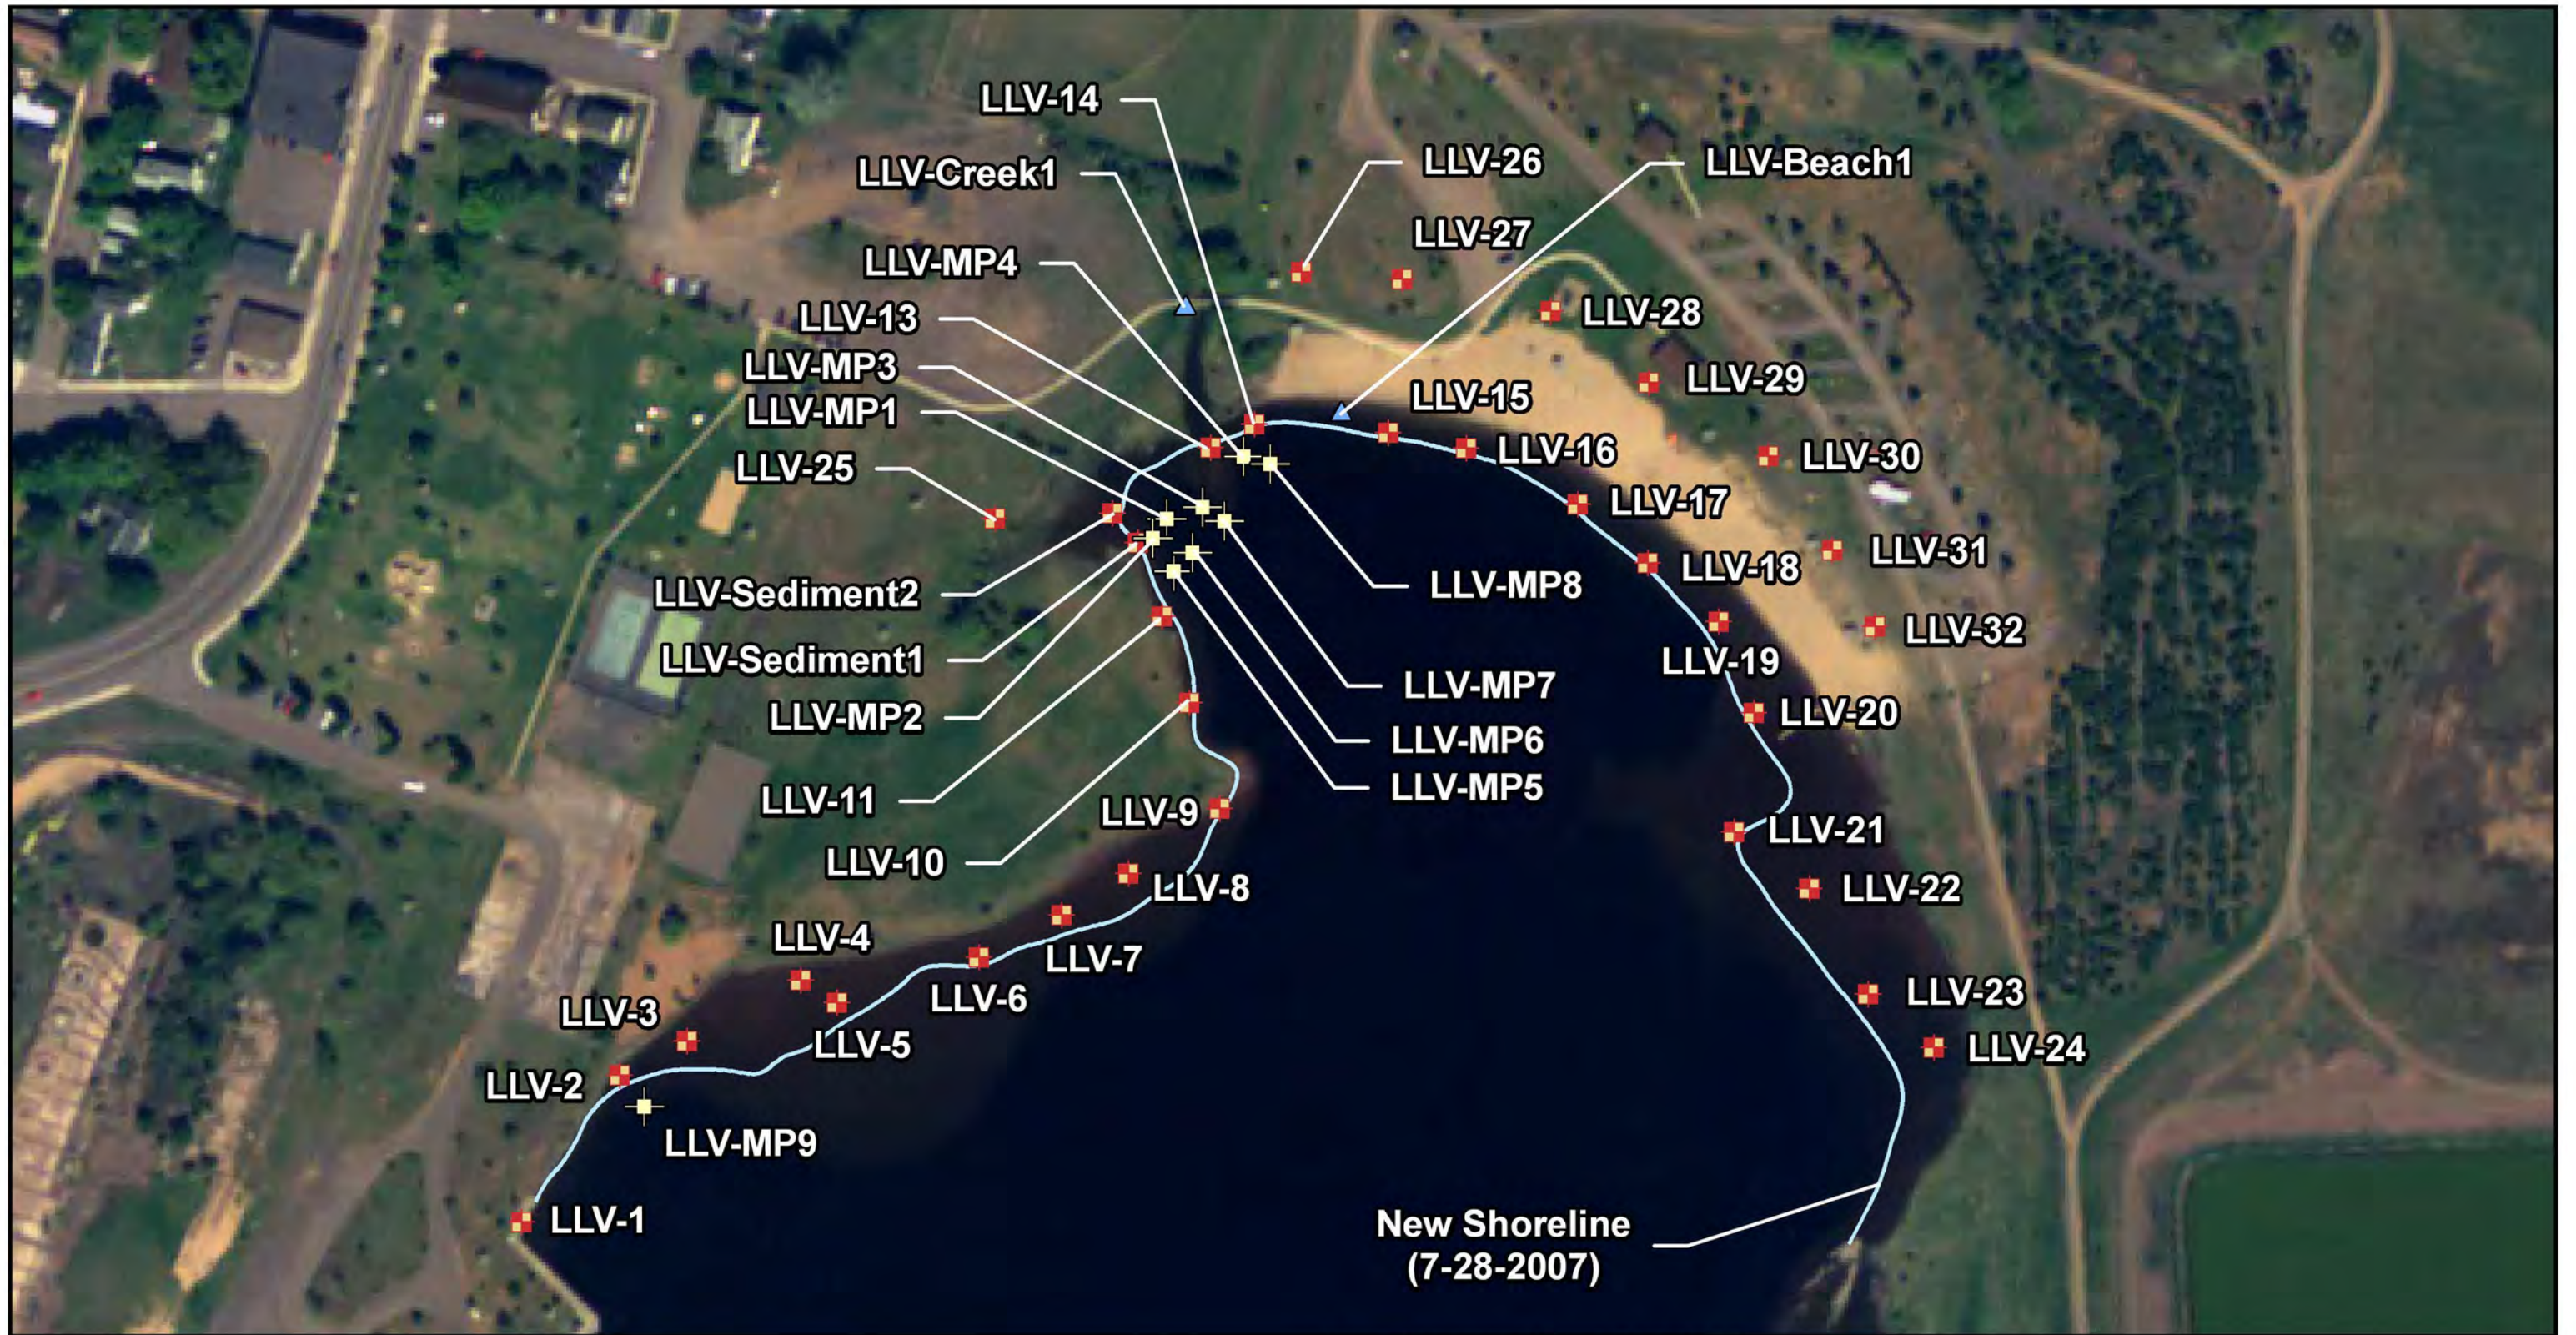
**Figure 3**

SAMPLING LOCATIONS  
 LAKE LINDEN - ER  
 LAKE LINDEN, HOUGHTON CO., MI  
 September 2007  
 Scale: 1"= 150

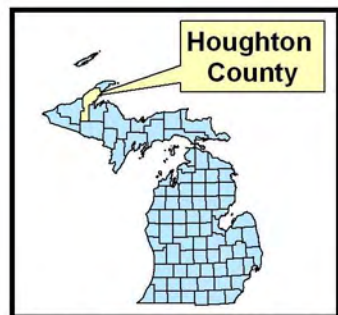
Between July 30, 2007, and July 31, 2007, WESTON START collected 75 soil samples, 2 from each of the 31 sampling grid locations, and 13 quality assurance/quality control (QA/QC) samples. All sampling locations are shown on **Figure 3 (Attachment A)**. One duplicate sample was collected for every 10 investigative samples from both the 0 to 3 inches bgs and 12 to 18 inches bgs sampling intervals. In addition, 1 equipment blank was collected for every 20 investigative samples. Samples were submitted to STAT Analytical Corporation laboratory in Chicago, Illinois, for analysis of five select metals via U.S. EPA Method 6020 (antimony, arsenic, barium, copper, and lead) and PCBs via EPA Method 8082. Results are presented in **Table 4 (Attachment C)**.

-   Mud Puppy Sampling Location
-   Soil Sampling Location
-   Water Sampling Location
-   Shoreline (7-28-2007)

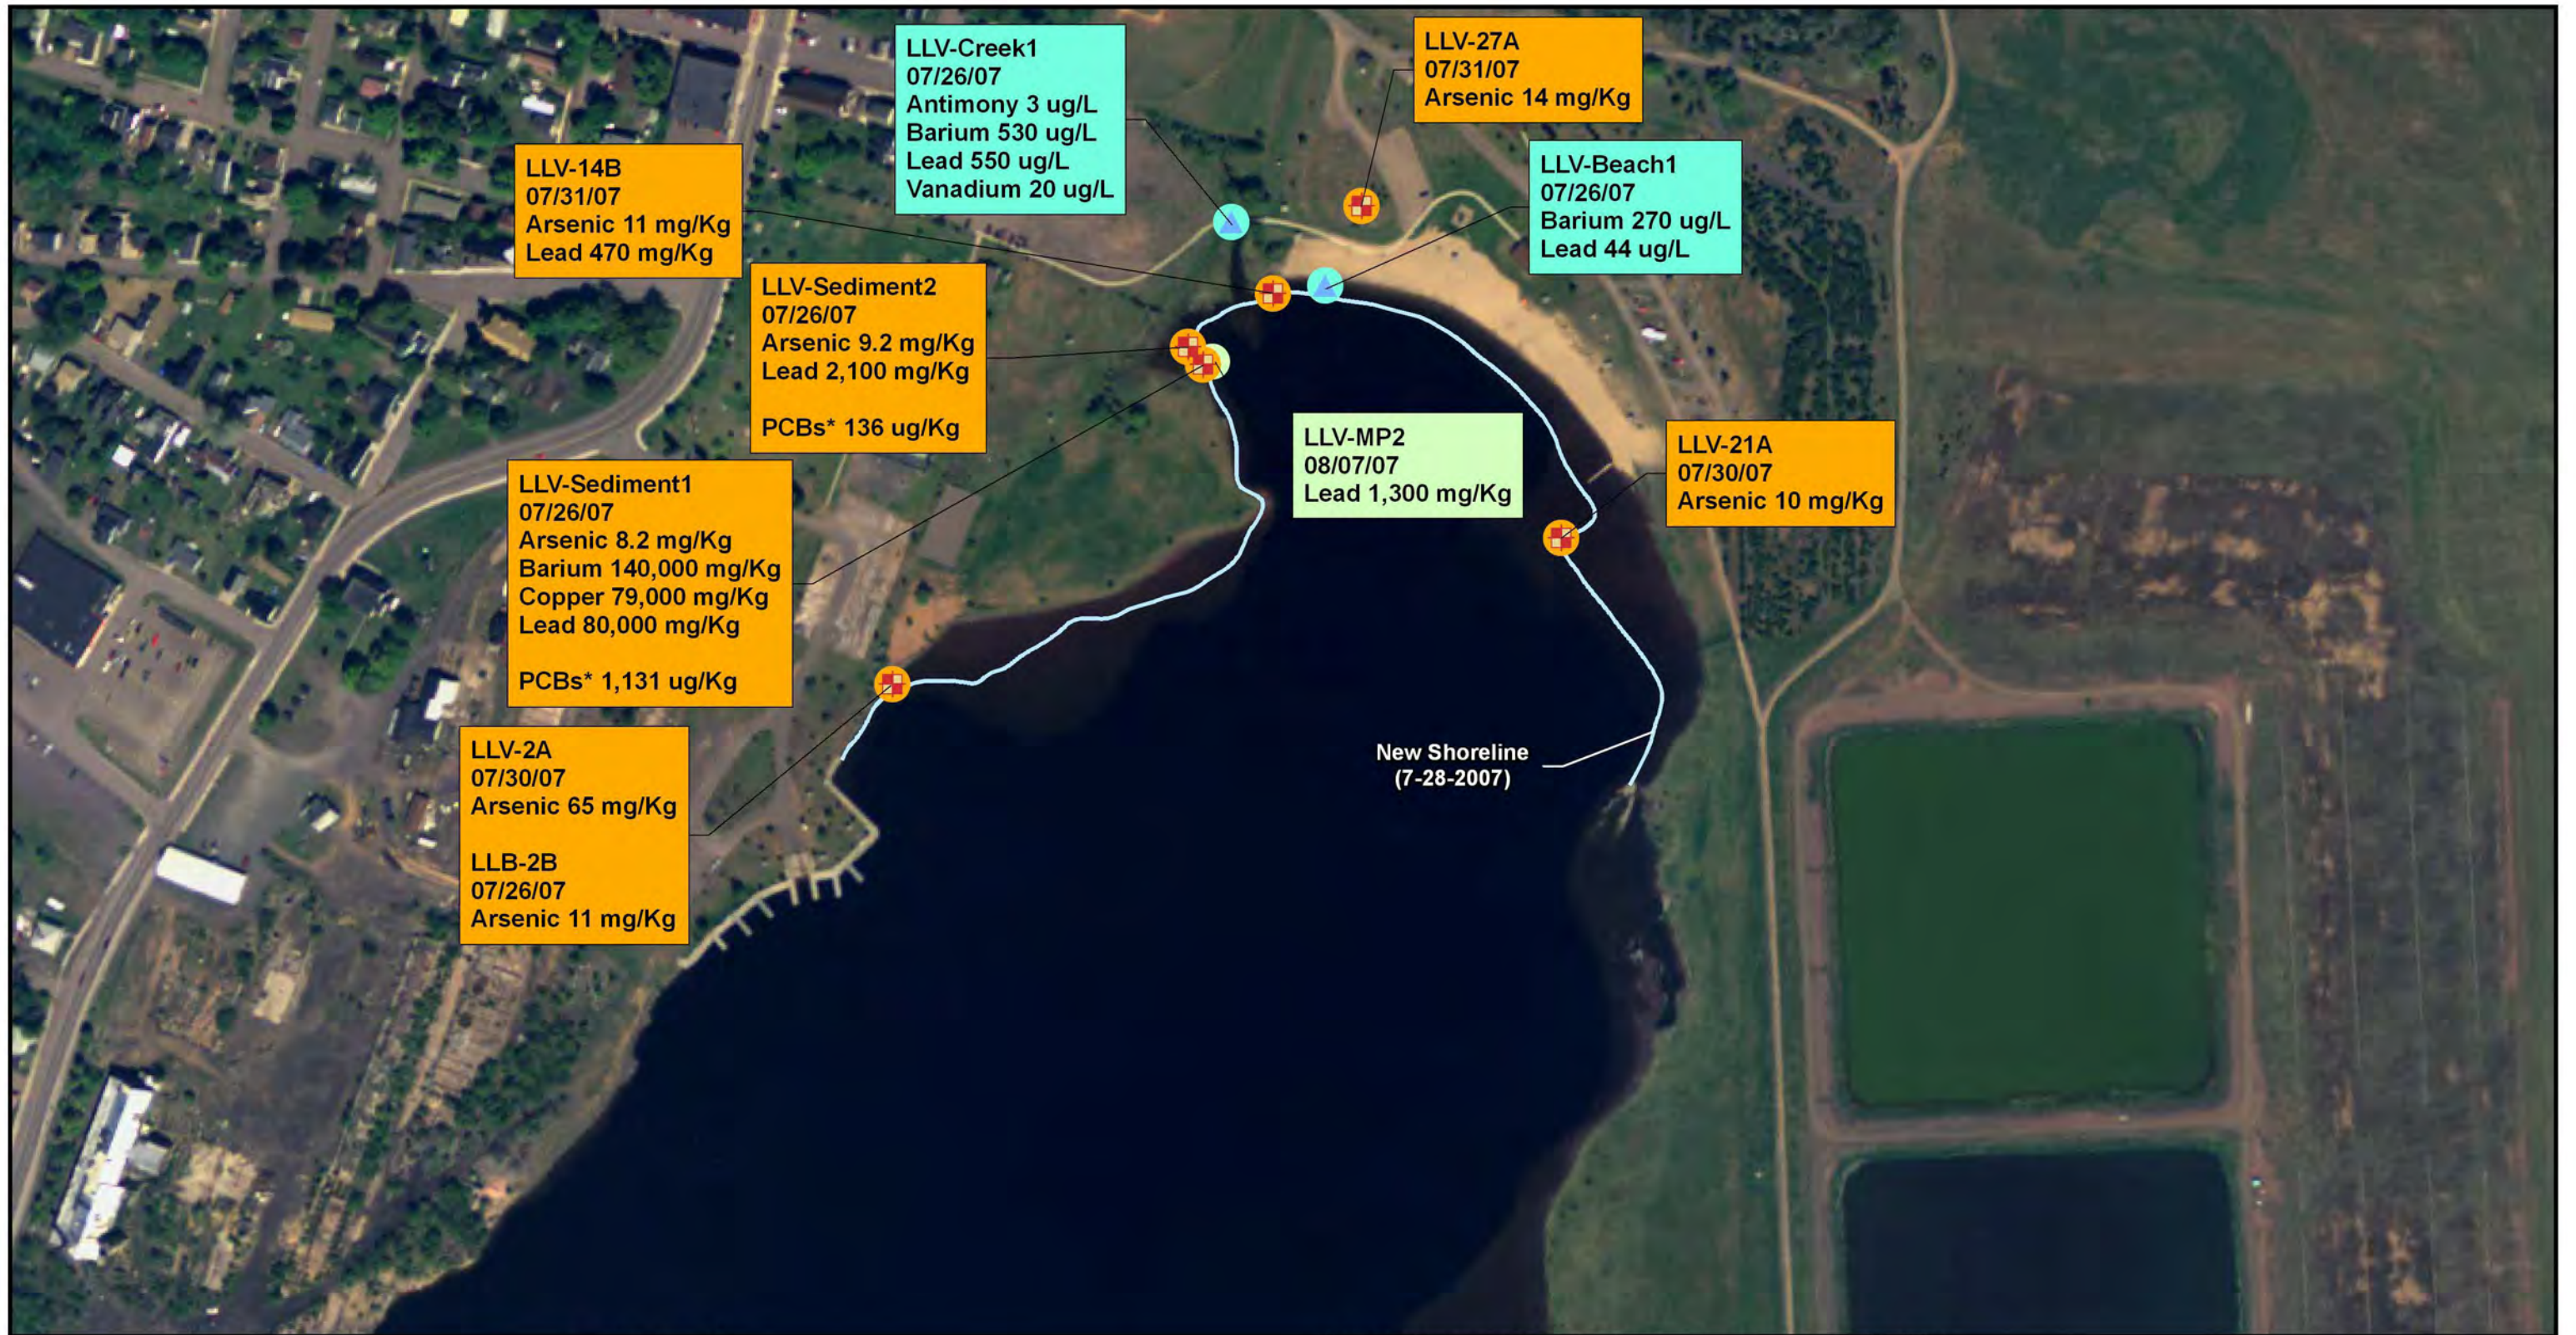
**Figure 4**

Prepared for: <b>U.S. EPA REGION V</b> Contract No: EP-S5-06-04	 Prepared by: <b>WESTON SOLUTIONS, INC.</b> 2501 Jolly Road, Suite 100 Okemos, MI	CRITERIA EXCEEDANCE MAP LAKE LINDEN - ER LAKE LINDEN, HOUGHTON CO., MI August, 2007 Scale: 1"= 250'
TDD No.: S05-0001-0707-021 DCN: 248-2A-ABHD

**Figure 4 (Attachment A)** shows the sampling locations of samples detailed in **Tables 2, 3, 4 and 5 (Attachment C)** that exhibit contaminant concentrations exceeding MDEQ Part 201 RDCC. These

samples include: LLV-Sediment1, LLV-Sediment2, LLV-Creek1, LLV-Beach1, LLV-2A, LLV-2B, LLV-MP2, LLV-14B, LLV-21A, and LLV-27A.

- Samples LLV-Sediment1, LLV-Sediment2, LLV-Creek1, and LLV-Beach1 were collected during initial Site activities and are proximal to the area containing white, clayey waste material. They contain several metals which exceeded the MDEQ Part 201 RDCC, as discussed previously (**Table 2 and 3**).

- Sampling location LLV-14B contained concentrations of arsenic (11 mg/kg) and lead (470 mg/kg) which exceeded MDEQ Part 201 RDCC (**Table 4**). The sample is located east of the creek, and northeast of the clayey waste material area.

- Location LLV-MP2 was collected off-shore from the area of white, clayey waste material with the U.S. EPA R/V Mud Puppy. The concentration of lead (1,300 mg/kg) exceeded the MDEQ Part 201 RDCC (**Table 5**).

- Sampling locations LLV-2A, LLV-2B, LLV-21A, and LLV-27A exhibited arsenic concentrations in excess of the MDEQ Part 201 RDCC (**Table 4**).
- The concentration of arsenic at LLV-2A (65 mg/kg) was more than ten times the MDEQ Part 201 RDCC and was flagged for further investigation.

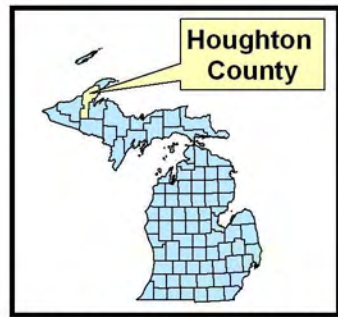
- ⊕ Soil Sample Exceeds Part 201 RDCC
- Water Sample Exceeds Applicable Part 201 Criteria
- Sediment Sample Exceeds Part 201 RDCC

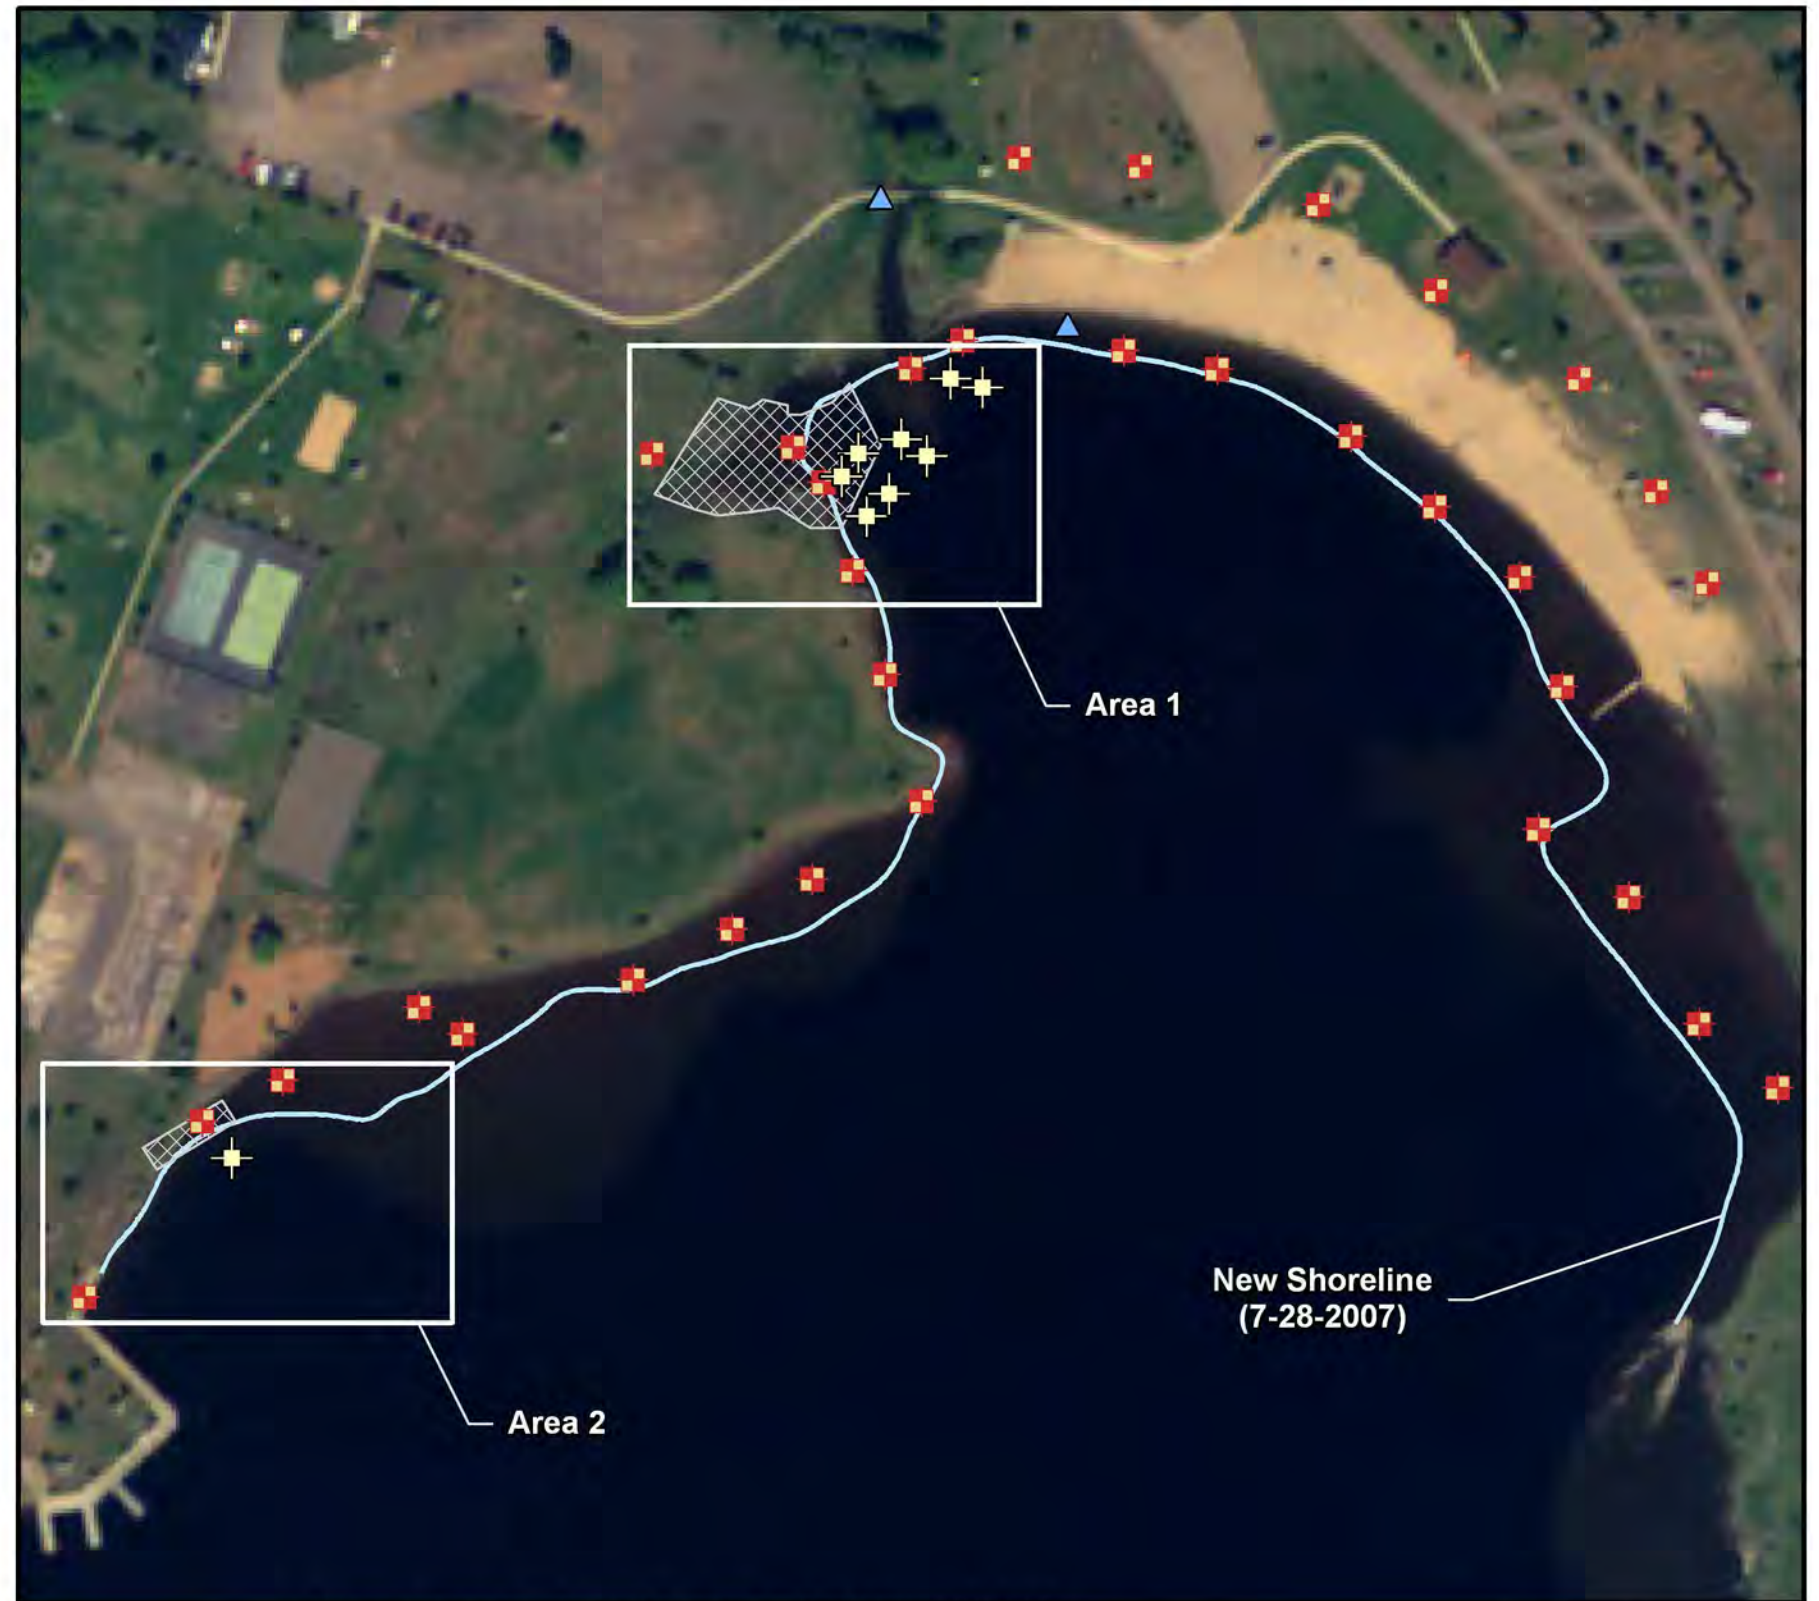
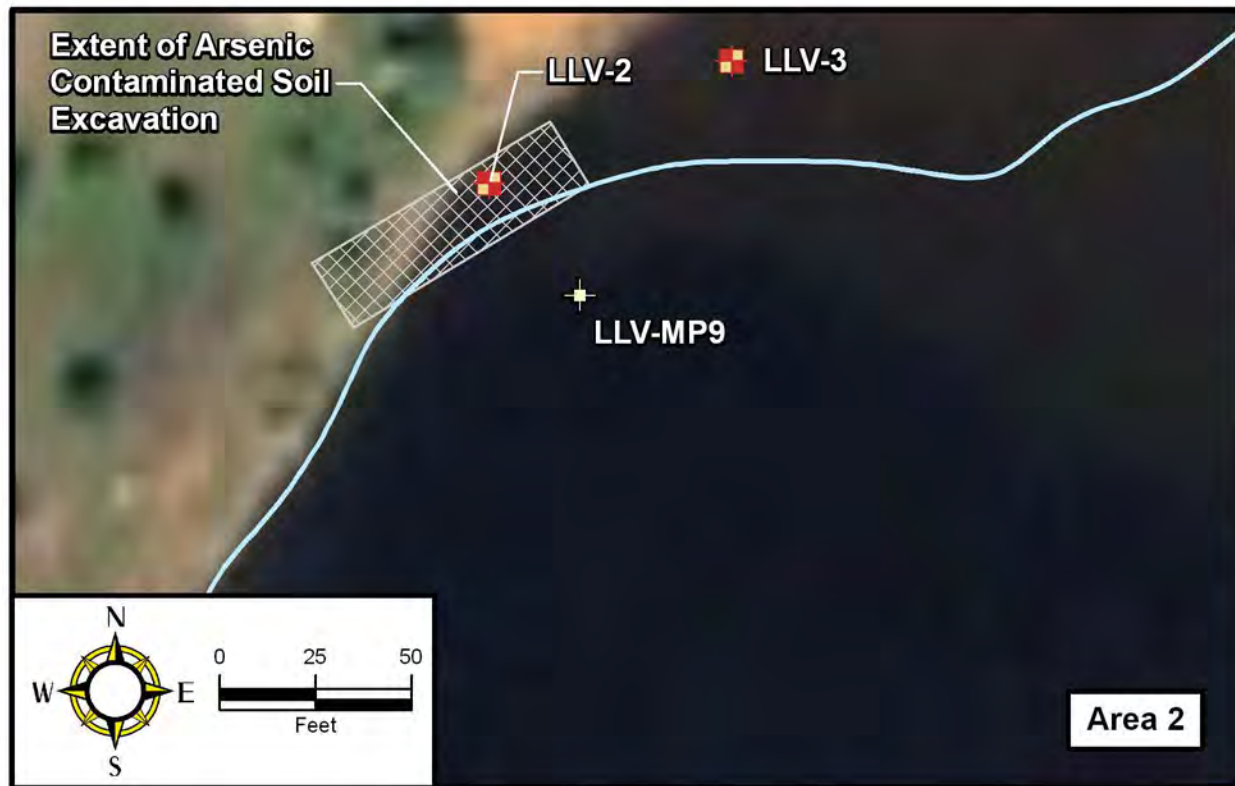
- Mud Puppy Sampling Locations
- Soil Sampling Location
- Water Sampling Location
- Excavation
- Shoreline (7-28-2007)

- ERRS initiated the soil/sediment excavation at Area 2 on August 13, 2007, and completed activities on August 15, 2007. The long-reach excavator was used to excavate the top 18 inches of soil from Area 2 (**Attachment A - Figure 5**). An estimated 64.69 tons of soil was removed and stockpiled at the Site for later disposal. ERRS covered the soil pile with plastic sheeting to prevent contact with the public and the addition of moisture.

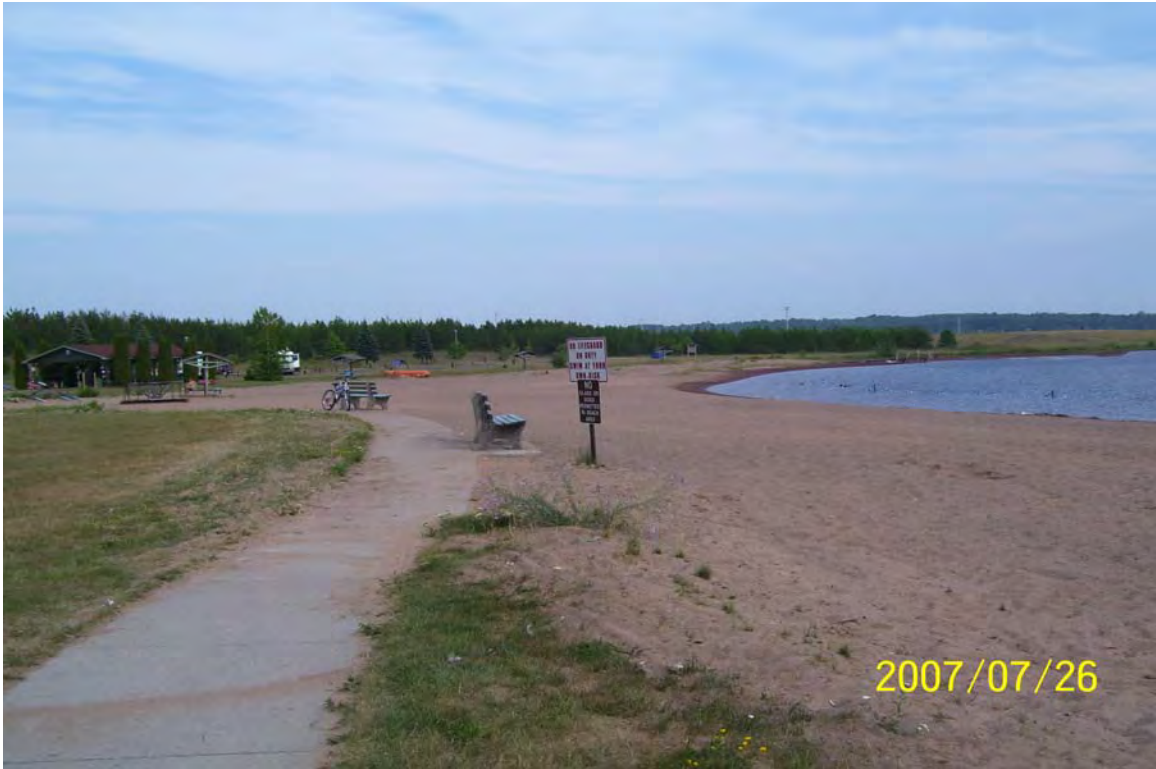
**Site:** Lake Linden ER  
**Photo Number:** 3  
**Direction:** East  
**Subject:** LLRP swimming beach

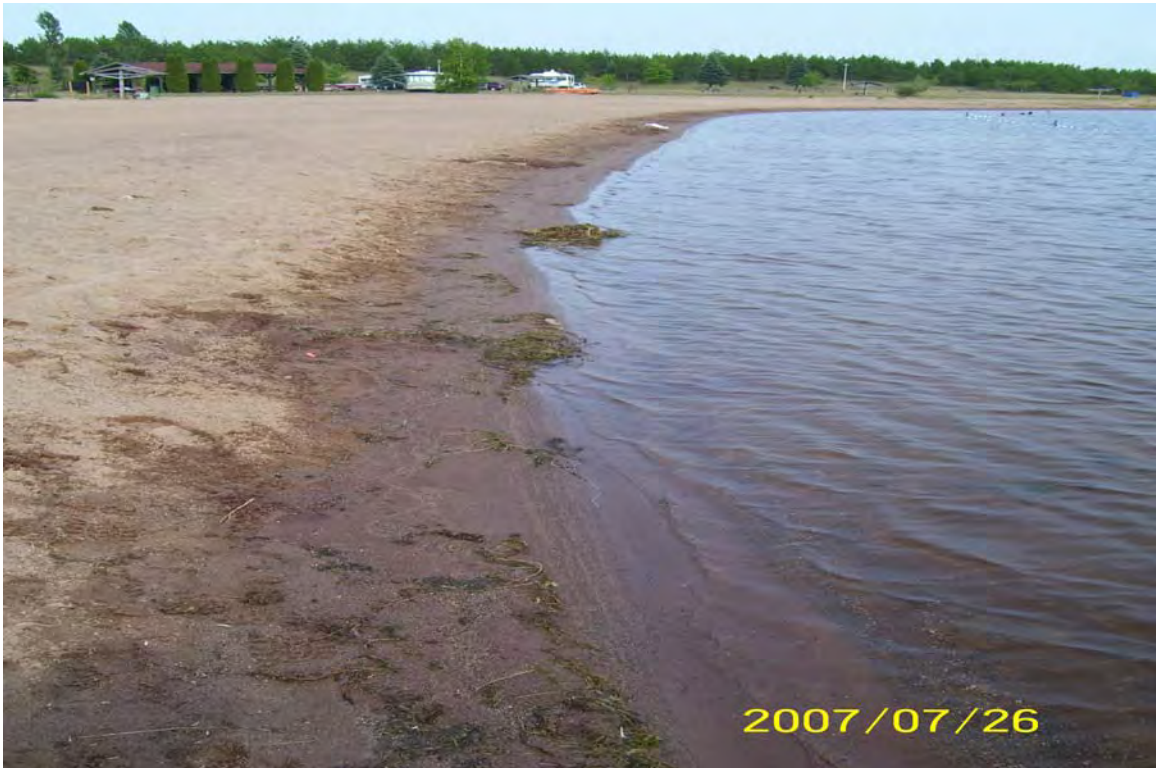
**Site:** Lake Linden ER  
**Photo Number:** 4  
**Direction:** East  
**Subject:** Shoreline of LLRP Swimming Beach

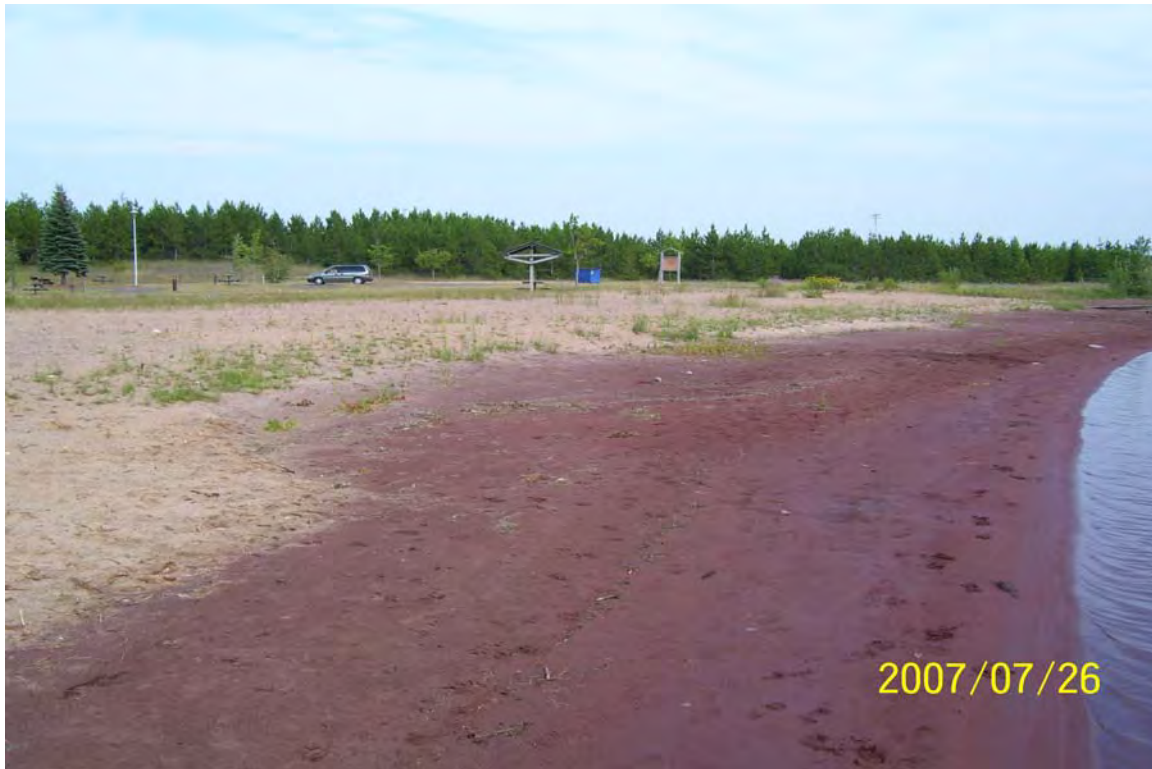
**Site:** Lake Linden ER  
**Photo Number:** 5  
**Direction:** East  
**Subject:** LLRP shoreline, east of swimming beach

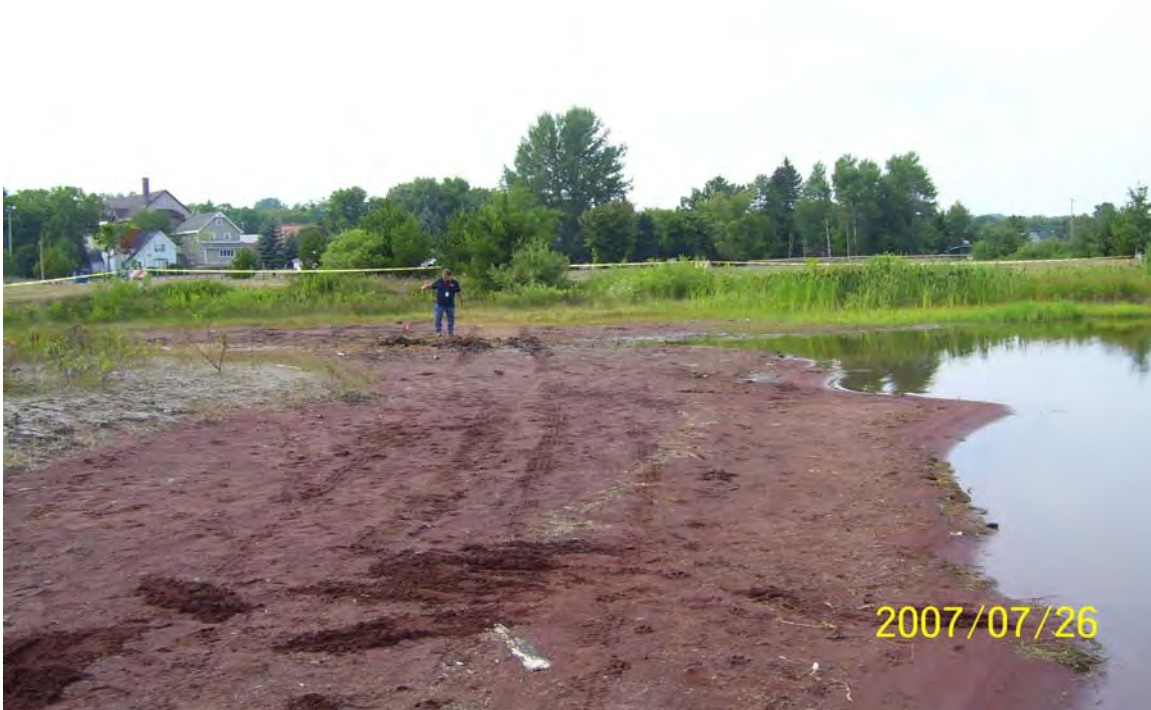
**Site:** Lake Linden ER  
**Photo Number:** 6  
**Direction:** North  
**Subject:** Clayey waste material area of LLRP (Area 1)

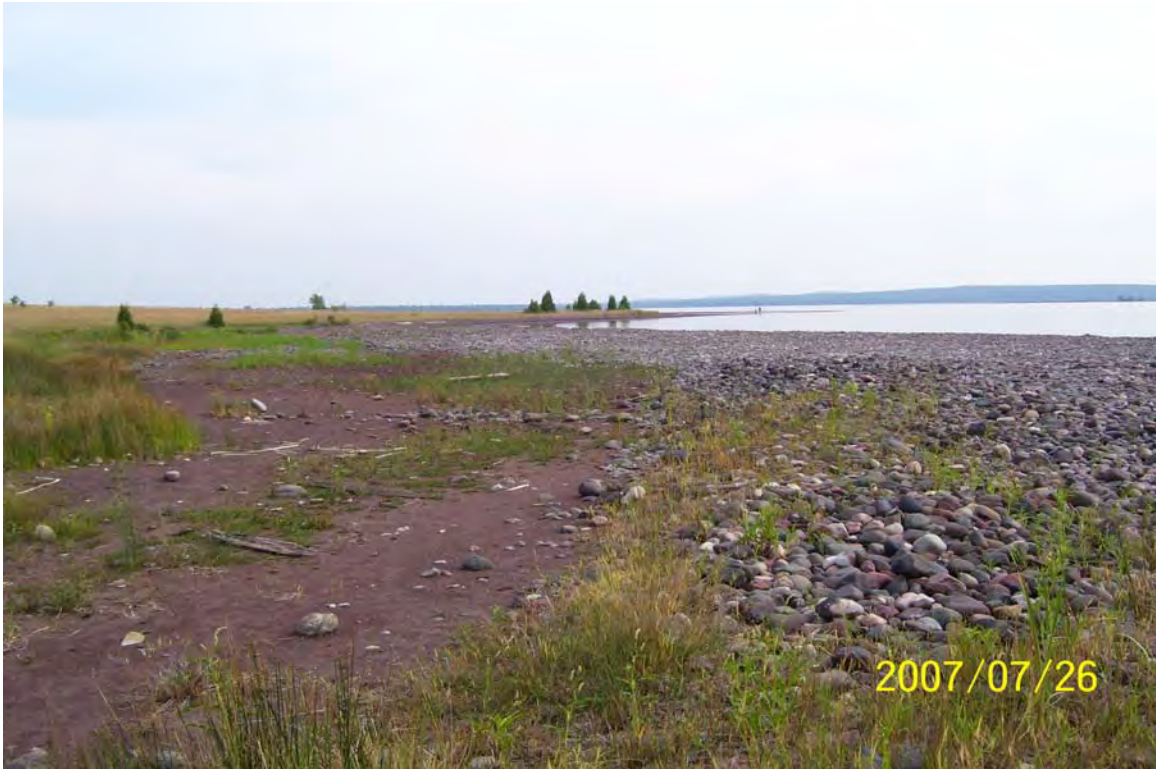
**Site:** Lake Linden ER  
**Photo Number:** 7  
**Direction:** South  
**Subject:** Shoreline of LLRP, south of campground

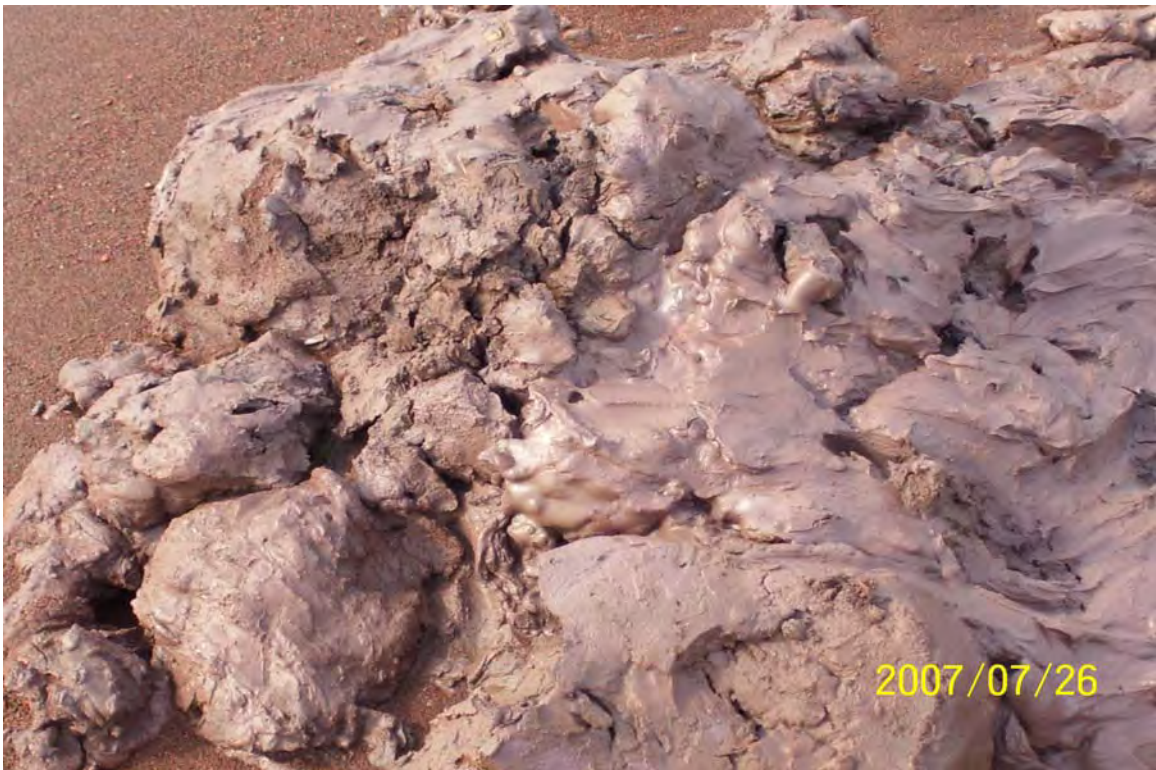
**Site:** Lake Linden ER  
**Photo Number:** 8  
**Direction:** Down  
**Subject:** Red clayey material on shoreline of LLRP, located south of campground area near boat dock

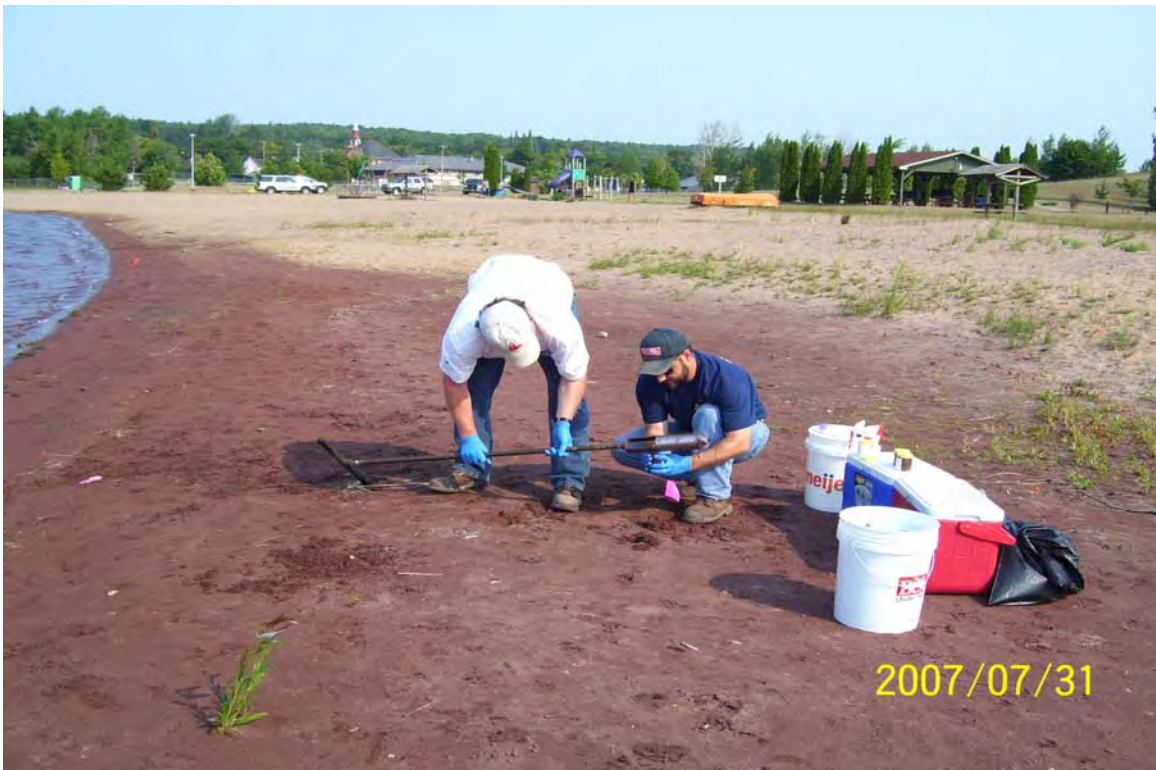
**Site:** Lake Linden ER  
**Photo Number:** 10  
**Direction:** West  
**Subject:** Soil sampling along shoreline of LLRP

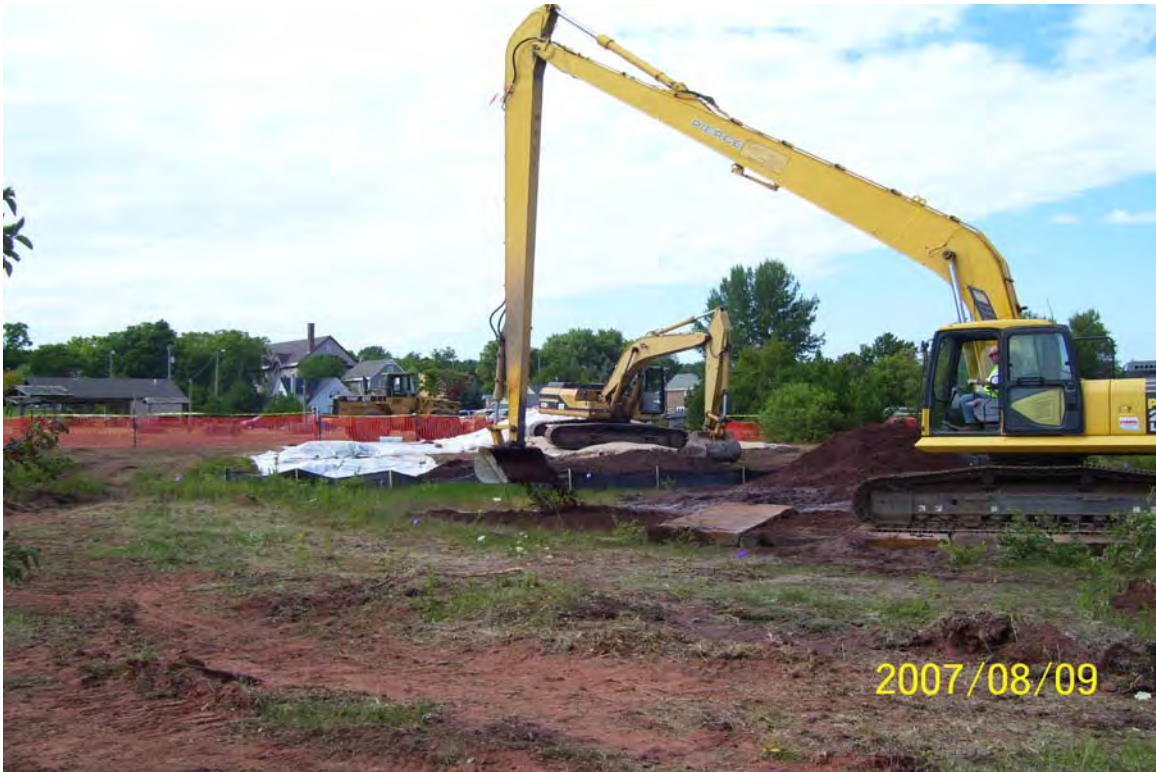
**Site:** Lake Linden ER  
**Photo Number:** 17  
**Direction:** North  
**Subject:** Long-reach excavator in Area 1
