**LETTER REPORT  
FOR  
LAKE LINDEN EMERGENCY RESPONSE SITE  
LAKE LINDEN, HOUGHTON COUNTY, MICHIGAN**

Date Prepared	November 30, 2007
TDD Number	S05-0001-0707-021
Contract Number	EP-S5-06-04
Document Control Number	248-2A-ABHD
START Project Manager	Daniel Capone
Telephone No.	(517) 381-5932
U.S. EPA On-Scene Coordinator	Brian Kelly

Re: Lake Linden Emergency Response Site  
Lake Linden, Houghton County, Michigan  
TDD: S05-0001-0707-021  
DCN: 248-2A-ABHD  
WO#: 20405.012.001.0248.00

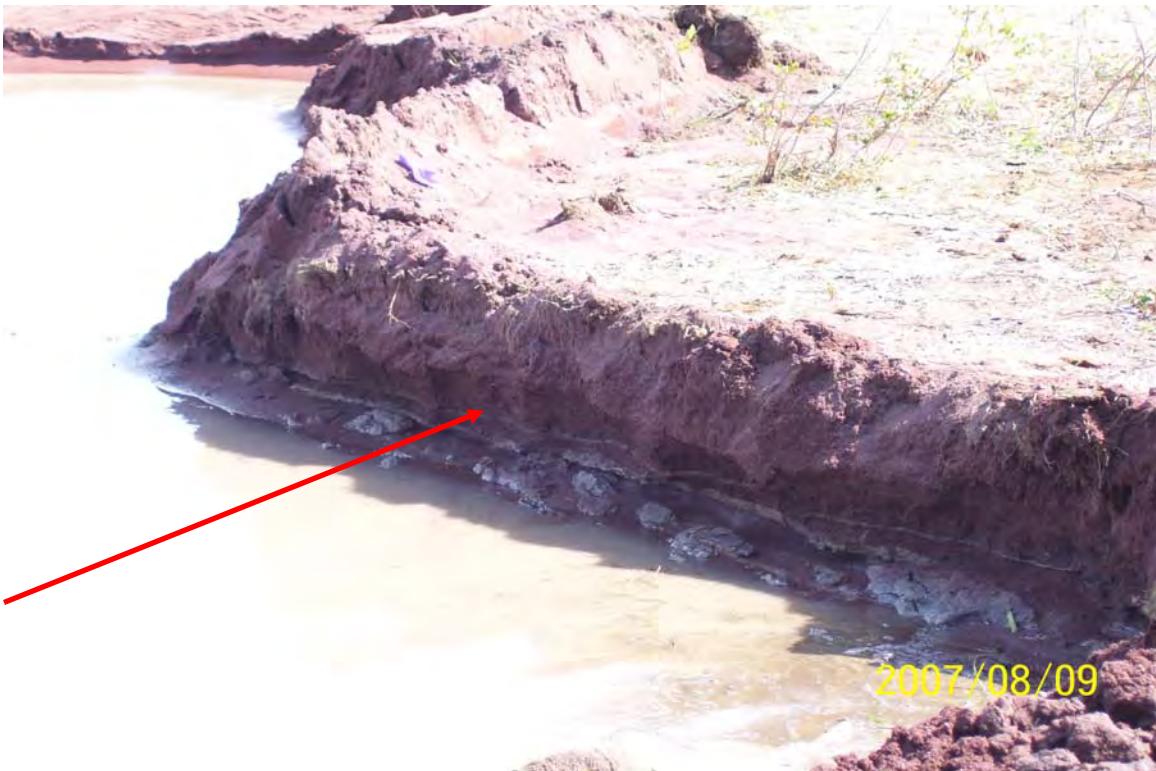
**Site:** Lake Linden ER  
**Photo Number:** 18  
**Direction:** South  
**Subject:** Striated, clayey waste material visible below soil surface in Area 1

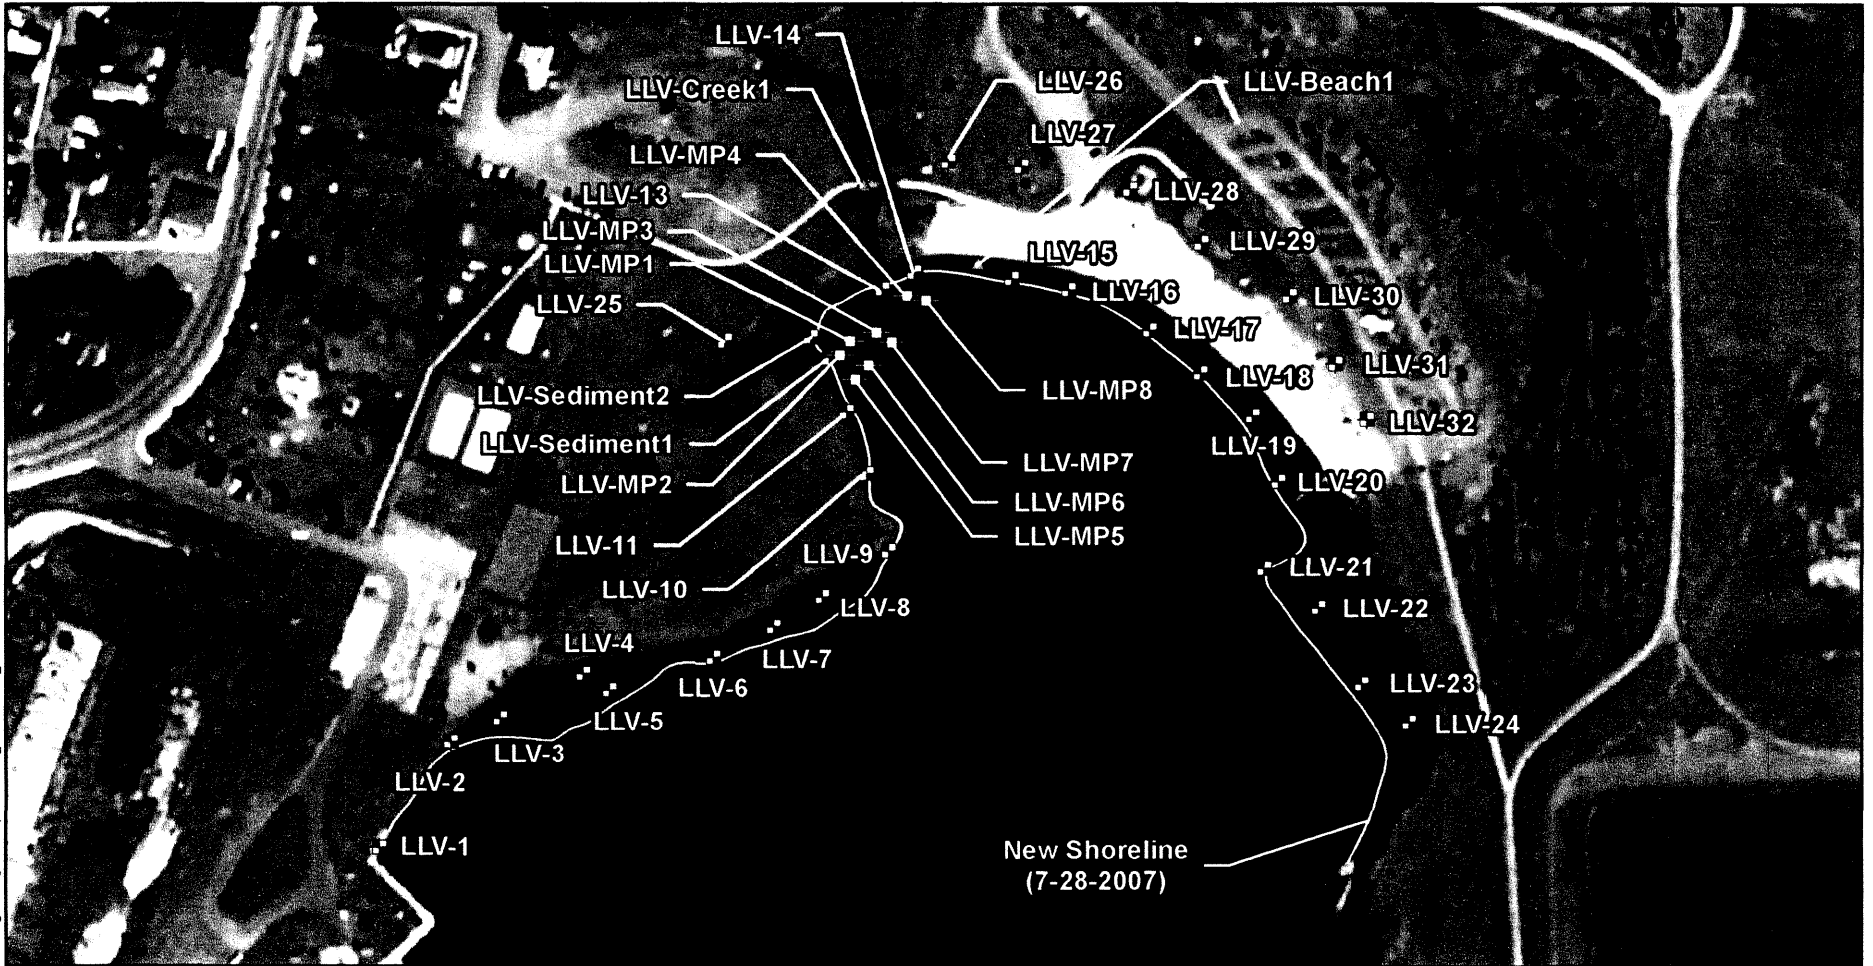
Figure 2

In addition to the yellow stained sediments, yellow stained rocks and pipes persist in the area. WESTON performed XRF screening of many rocks along the shore within 200 feet of the northern end of the marina dock. Arsenic concentrations ranged between 0 and 756 ppm. Thus, not all yellow stained rocks contain elevated levels of arsenic. Rocks and rock piles containing concentrations of arsenic in excess of 20 ppm were flagged. Please see attached photo and **Figure 2**.

- Excavate the exposed stained sediments. The excavation is expected to be approximately 18 feet wide, 75 feet long, and 1 foot deep. WESTON recommends that the excavation continue into the water for an additional 10 feet to ensure removal of the material of concern;
- Cap the entire area that extends from the north edge of the marina dock to the other side of the exposed stained sediments (estimated to be a 275 feet long by 25 feet wide area); and,
- Remove and cap (as necessary) encountered piping.

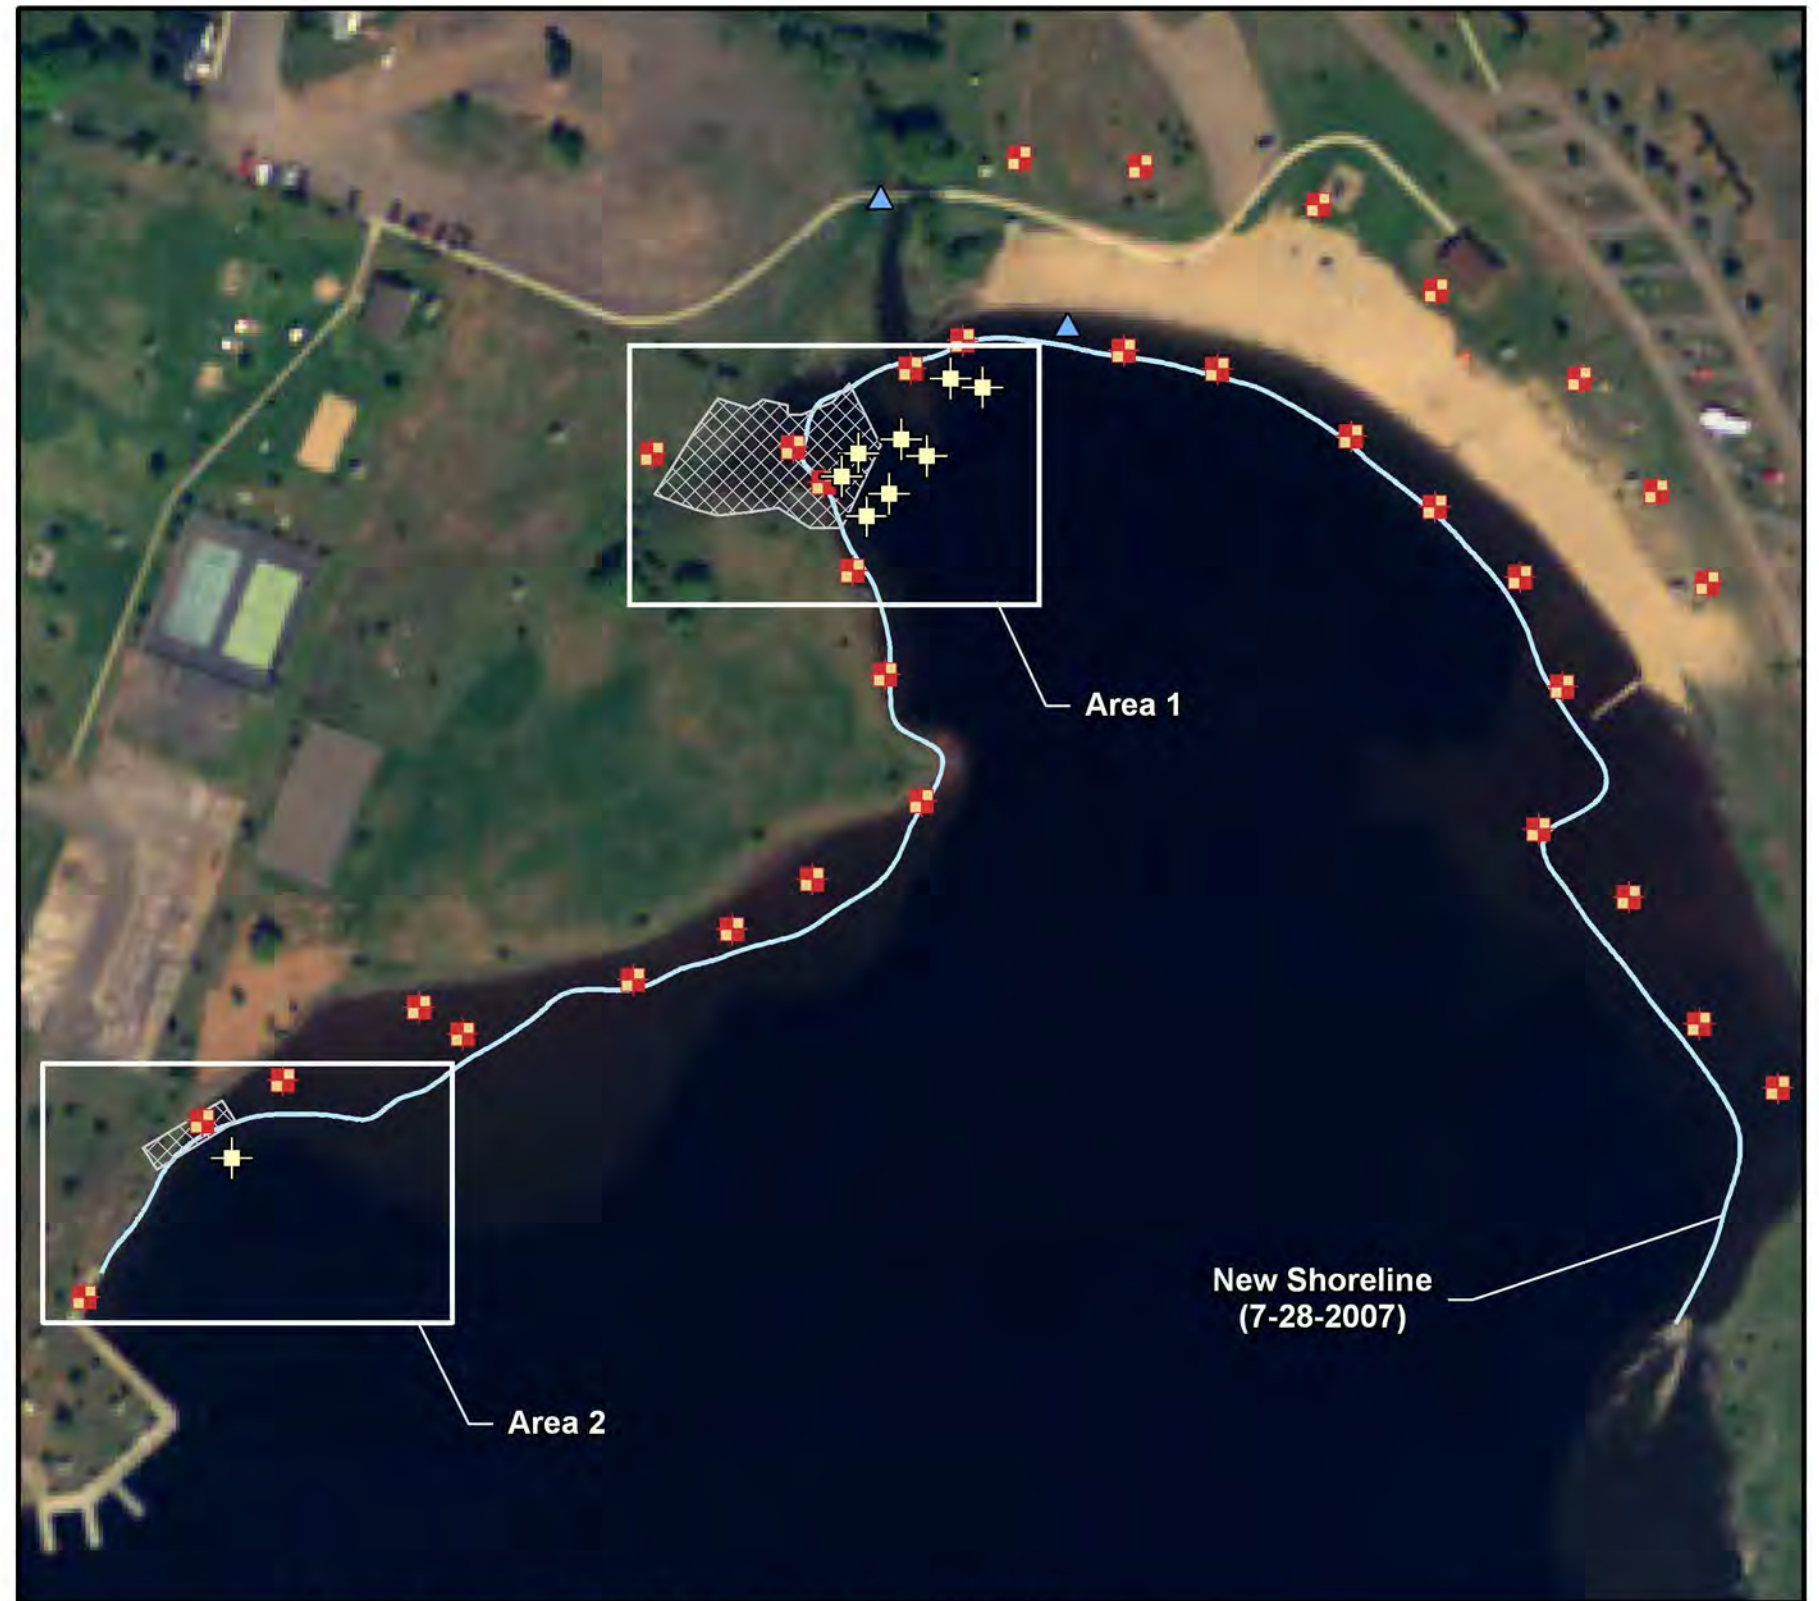
feet wide. Arsenic concentrations ranged between 50 and 180 ppm from the ground surface to 8 inches bgs in this area based on XRF screening results (**Figure 2**). In one location, ERRS excavated to 12 inches bgs where the arsenic concentration was 13 ppm. The typical arsenic concentration of the stamp sands that cover the area in this vicinity is approximately 20 ppm based on recent sampling and XRF screening results.
