Notes from the desk of Amy Keranen

Abandoned Mining Wastes Project– Torch Lake

Remedial Activities Completed

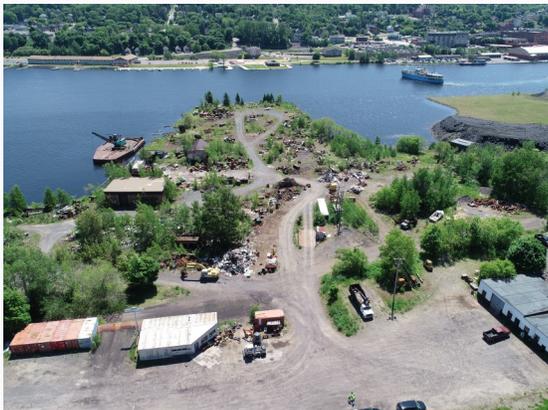
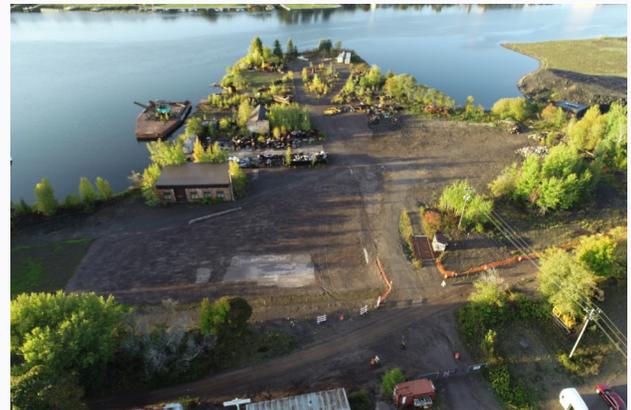
These photos are the before (L) and after (R) images of the scrapyard.

Environmental studies along the Portage Canal and the Michigan Department of Natural Resources (DNR) Recreational Trail on Julio properties in the Ripley area identified old drums, cylinders, tanks, asbestos, PCB and mercury containing wastes and equipment. EGLE, DNR, EPA and the property owner worked together to conduct several removal actions between 2019 and 2021 that included the removal and disposal of mercury contaminated equipment and soil; recycling of abandoned containers, cylinders and scrap metal; and disposal of asbestos, PCB and metals contaminated soil and wastes. After the containers and wastes were removed, the contaminated areas were covered with gravel or topsoil and grass to assist with site drainage and prevent direct contact and erosion by wind or water. Additional site information is available here [Julio Properties Site](#).

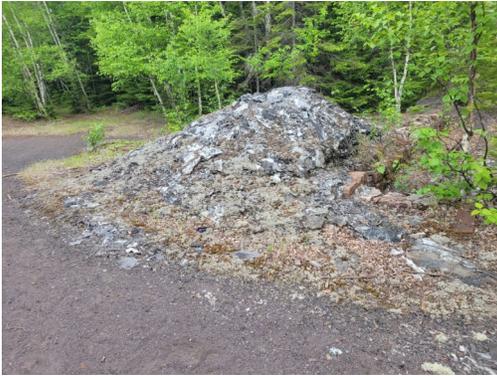
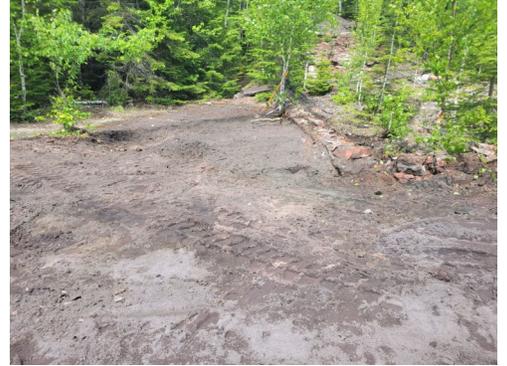
The photo on the left depicts a pile of asbestos containing building materials. The photo on the right shows the same area, post-removal.

EPA ERB conducted an assessment of the Gay Stamp Mill ruins and identified asbestos and metals in the soil. In 2021, EPA ERB addressed these concerns by conducting a removal of the contaminated soil and wastes. Once removal and disposal was complete, the area was graded, topsoiled and seeded to prevent erosion concerns in the future. Additional site information is available here [Gay Stamp Mill](#).

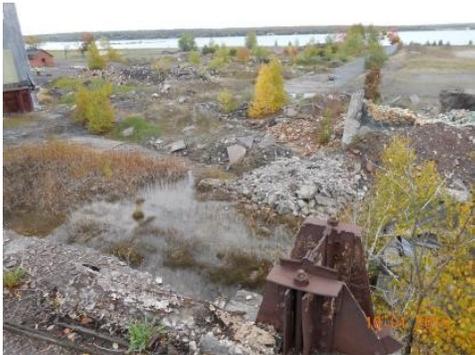
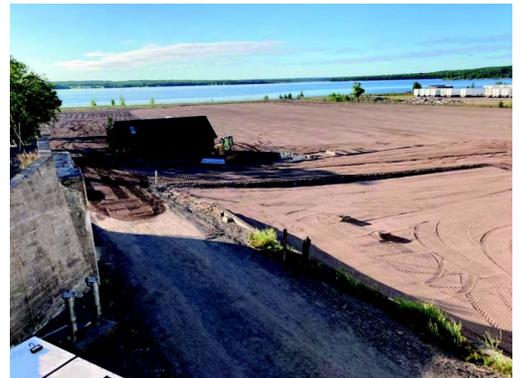
The photo on the left shows the site before the removal action took place. The photo on the right is the view after cleanup.

Environmental investigations at the C&H Mineral Building, located between Lake Linden and Hubbell, identified PCBs and metals contaminated soils, asbestos, piles of mining waste, abandoned containers and smokestack debris. Asbestos roofing material that had blown off the roof of the Mineral Building was present on the ground, including outside of the fenced Site property in the MDOT M-26 right of way (ROW). EGLE notified the property owner of the site conditions and completed a series of investigations and requested assistance from the EPA ERB to help address the concerns at the site. Between 2018 and 2020, the property owner and Honeywell in partnership with EPA’s GLNPO undertook a series of cleanups that included: asbestos removal from the roof of the Mineral Building and surrounding ground surface and removal and disposal of almost 14,000 tons of PCB, metals and asbestos containing wastes. The site was restored by

placement of sand backfill and a gravel cap to promote drainage and prevent direct contact and wind and water erosion concerns. Additional site information is available here [C&H Mineral Building](#).

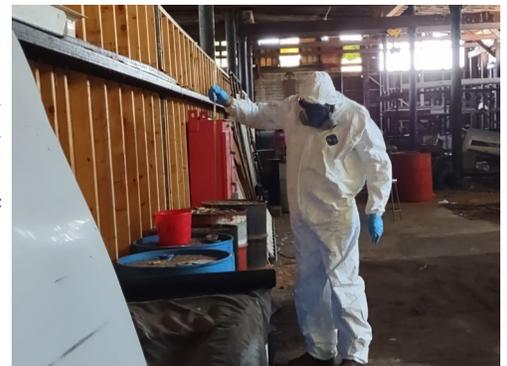
The photo on the right shows a drum in the Calumet warehouse being sampled.

As part of the Centennial Mine Site, EGLE identified 30 abandoned containers in a warehouse near the Calumet Township office, the Calumet Housing complex and the Calumet Public Schools K-12 campus. EPA ERB conducted an emergency removal which included characterizing the drum contents for disposal and placing them in over pack containers for subsequent proper management and disposal. [Calumet Warehouse Drum Site](#). The drums were disposed during the last week of September 2022.

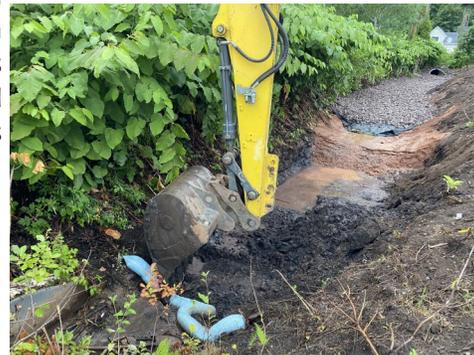
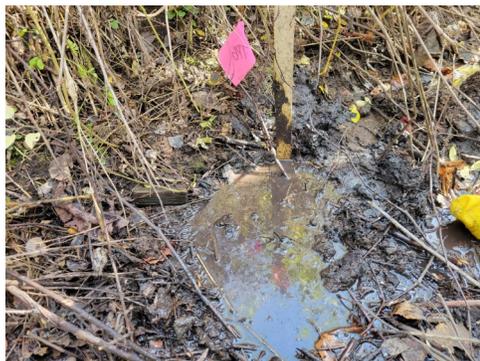
The photo on the left shows the petroleum sheen collecting in the bottom of the ditch in Ripley. The photo on the right shows the ditch as it was excavated, lined with clay and capped with rock.

Environmental studies in the Ripley area identified petroleum contaminated sediments and a sheen within a drainage canal that discharges to the Portage Canal. The EPA ERB undertook an interim response in 2022 that included the removal and disposal of 236 tons of petroleum contaminated sediments from the drainage canal. After the sediment was removed, a clay cap and riprap stone was placed to address direct contact and water erosion concerns in the drainage canal. Additional site information is available here [Standard Oil Site](#).

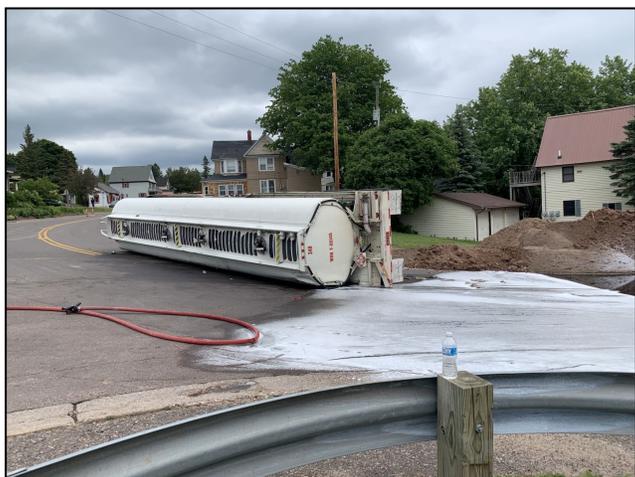
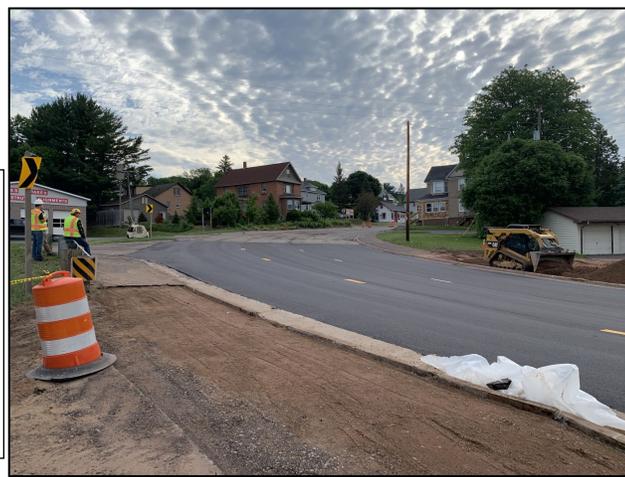
Left photo is of the overturned tanker. The one on the right is of the restored roadway.

In June 2021, a gasoline tanker overturned while driving uphill around the corner at the intersection of US-41 and Ethel Avenue (locally known as “Santori’s Corner”). The overturned tanker spilled approximately 6,500 gallons of a mixture of unleaded gasoline and diesel fuel. The spilled petroleum ran down US-41, entered the storm drain system and was discharged to the Portage Canal. EPA and EGLE personnel mobilized to the site and responded with local agencies to cleanup the spill. Response activities included: spill containment and recovery by constructing a sand berm across US-41 downhill of the overturned tanker; use of a petroleum absorbing boom in the Portage Canal at the storm sewer outlet; removal and replacement of gasoline soaked asphalt pavement; excavation of contaminated soils along the highway shoulder; cleaning the storm sewer network; and follow-up investigation within the spill area to ensure full cleanup was achieved. Additional site information is available here [K and V Transport](#).

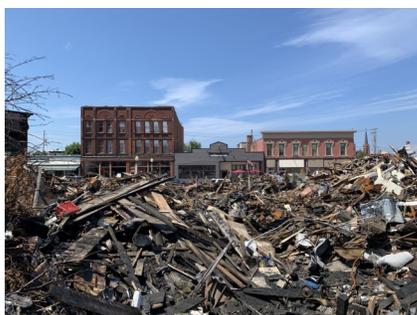
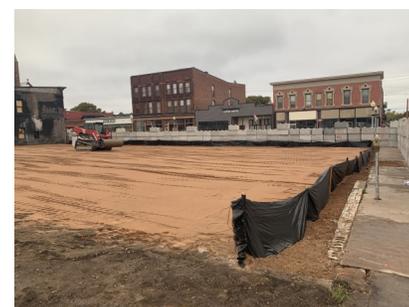
Before and after pictures of the 5th Street Fire site

Three structures on 5th Street in Calumet were destroyed by fire in May 2021. EGLE collected samples of the fire debris confirming that siding, plaster, insulation, flooring and roofing materials contained asbestos which can pose potential health risks. EGLE, EPA ERB, the Village of Calumet, Calumet Township and Houghton County worked together to find a solution. EPA ERB assistance was requested and a removal action was conducted to remove the asbestos containing fire debris. In 2021 and 2022, almost 3,000 tons of demolition waste was removed and disposed from the site which was then backfilled and restored. During the removal of the fire debris, solvent tanks were found buried under a concrete slab. EPA ERB removed the tanks and 152 tons of solvent contaminated soil but contamination still remains in the soil and groundwater. EGLE is in the process of identifying the extent of contamination and will sample the groundwater from wells on site and conduct periodic monitoring of vapors in surrounding buildings. The village is hopeful for redevelopment of the now vacant parcels in the near future. Redevelopment, while taking into consideration existing contamination, is possible with coordination between agencies, property owners and developers. Additional site information is available here [EPA 5th St Calumet Fire Site](#). EGLE will provide additional environmental assistance to local stakeholders to facilitate redevelopment of the property.

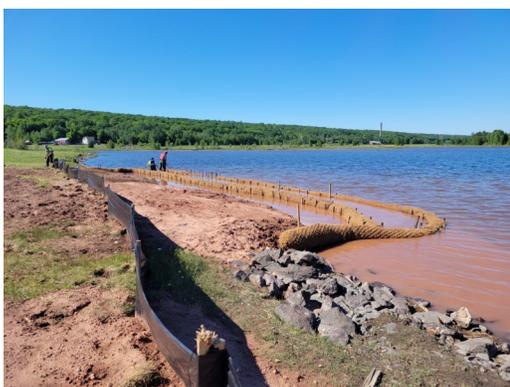
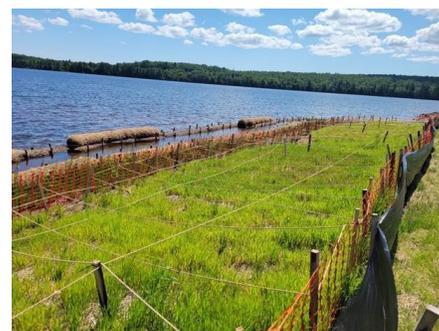
Photos depict test plot construction.

Given that excessive predicted timeframe, in 2019, EGLE's Water Resources Division held a technical summit with scientific experts, policy makers from local, tribal, state and federal agencies, construction experts, and other stakeholders to discuss options to improve the benthos in Torch Lake in a shorter timeframe. One outcome from this meeting included construction and monitoring of test plots to determine which types of capping and habitat restoration may work long term.

Mini test plots were constructed in 2021 and are monitored periodically to determine if these techniques improve the Torch Lake benthic organisms. If the experiment seems to be effective, a larger-scale project will be evaluated.
