<p>Prepared for: U.S. EPA REGION V Contract No: EP-S5-06-04</p> <p>TDD No.: S05-0002-0708-020 DCN: 274-2A-ABDT</p>	  <p>Prepared by: WESTON SOLUTIONS, INC. 2501 Jolly Road, Suite 100 Okemos, Michigan</p>	<p>AOI No. 19 SITE FEATURES AND XRF LOCATIONS TORCH LAKE AREA ASSESSMENT KEWEENAW PENINSULA, MICHIGAN October 2007</p>
--	--	---

AOI Nos. 10 and 18
RDCC EXCEEDANCES IN SOIL
TORCH LAKE AREA ASSESSMENT
KEWEENAW PENINSULA, MICHIGAN
October 2007

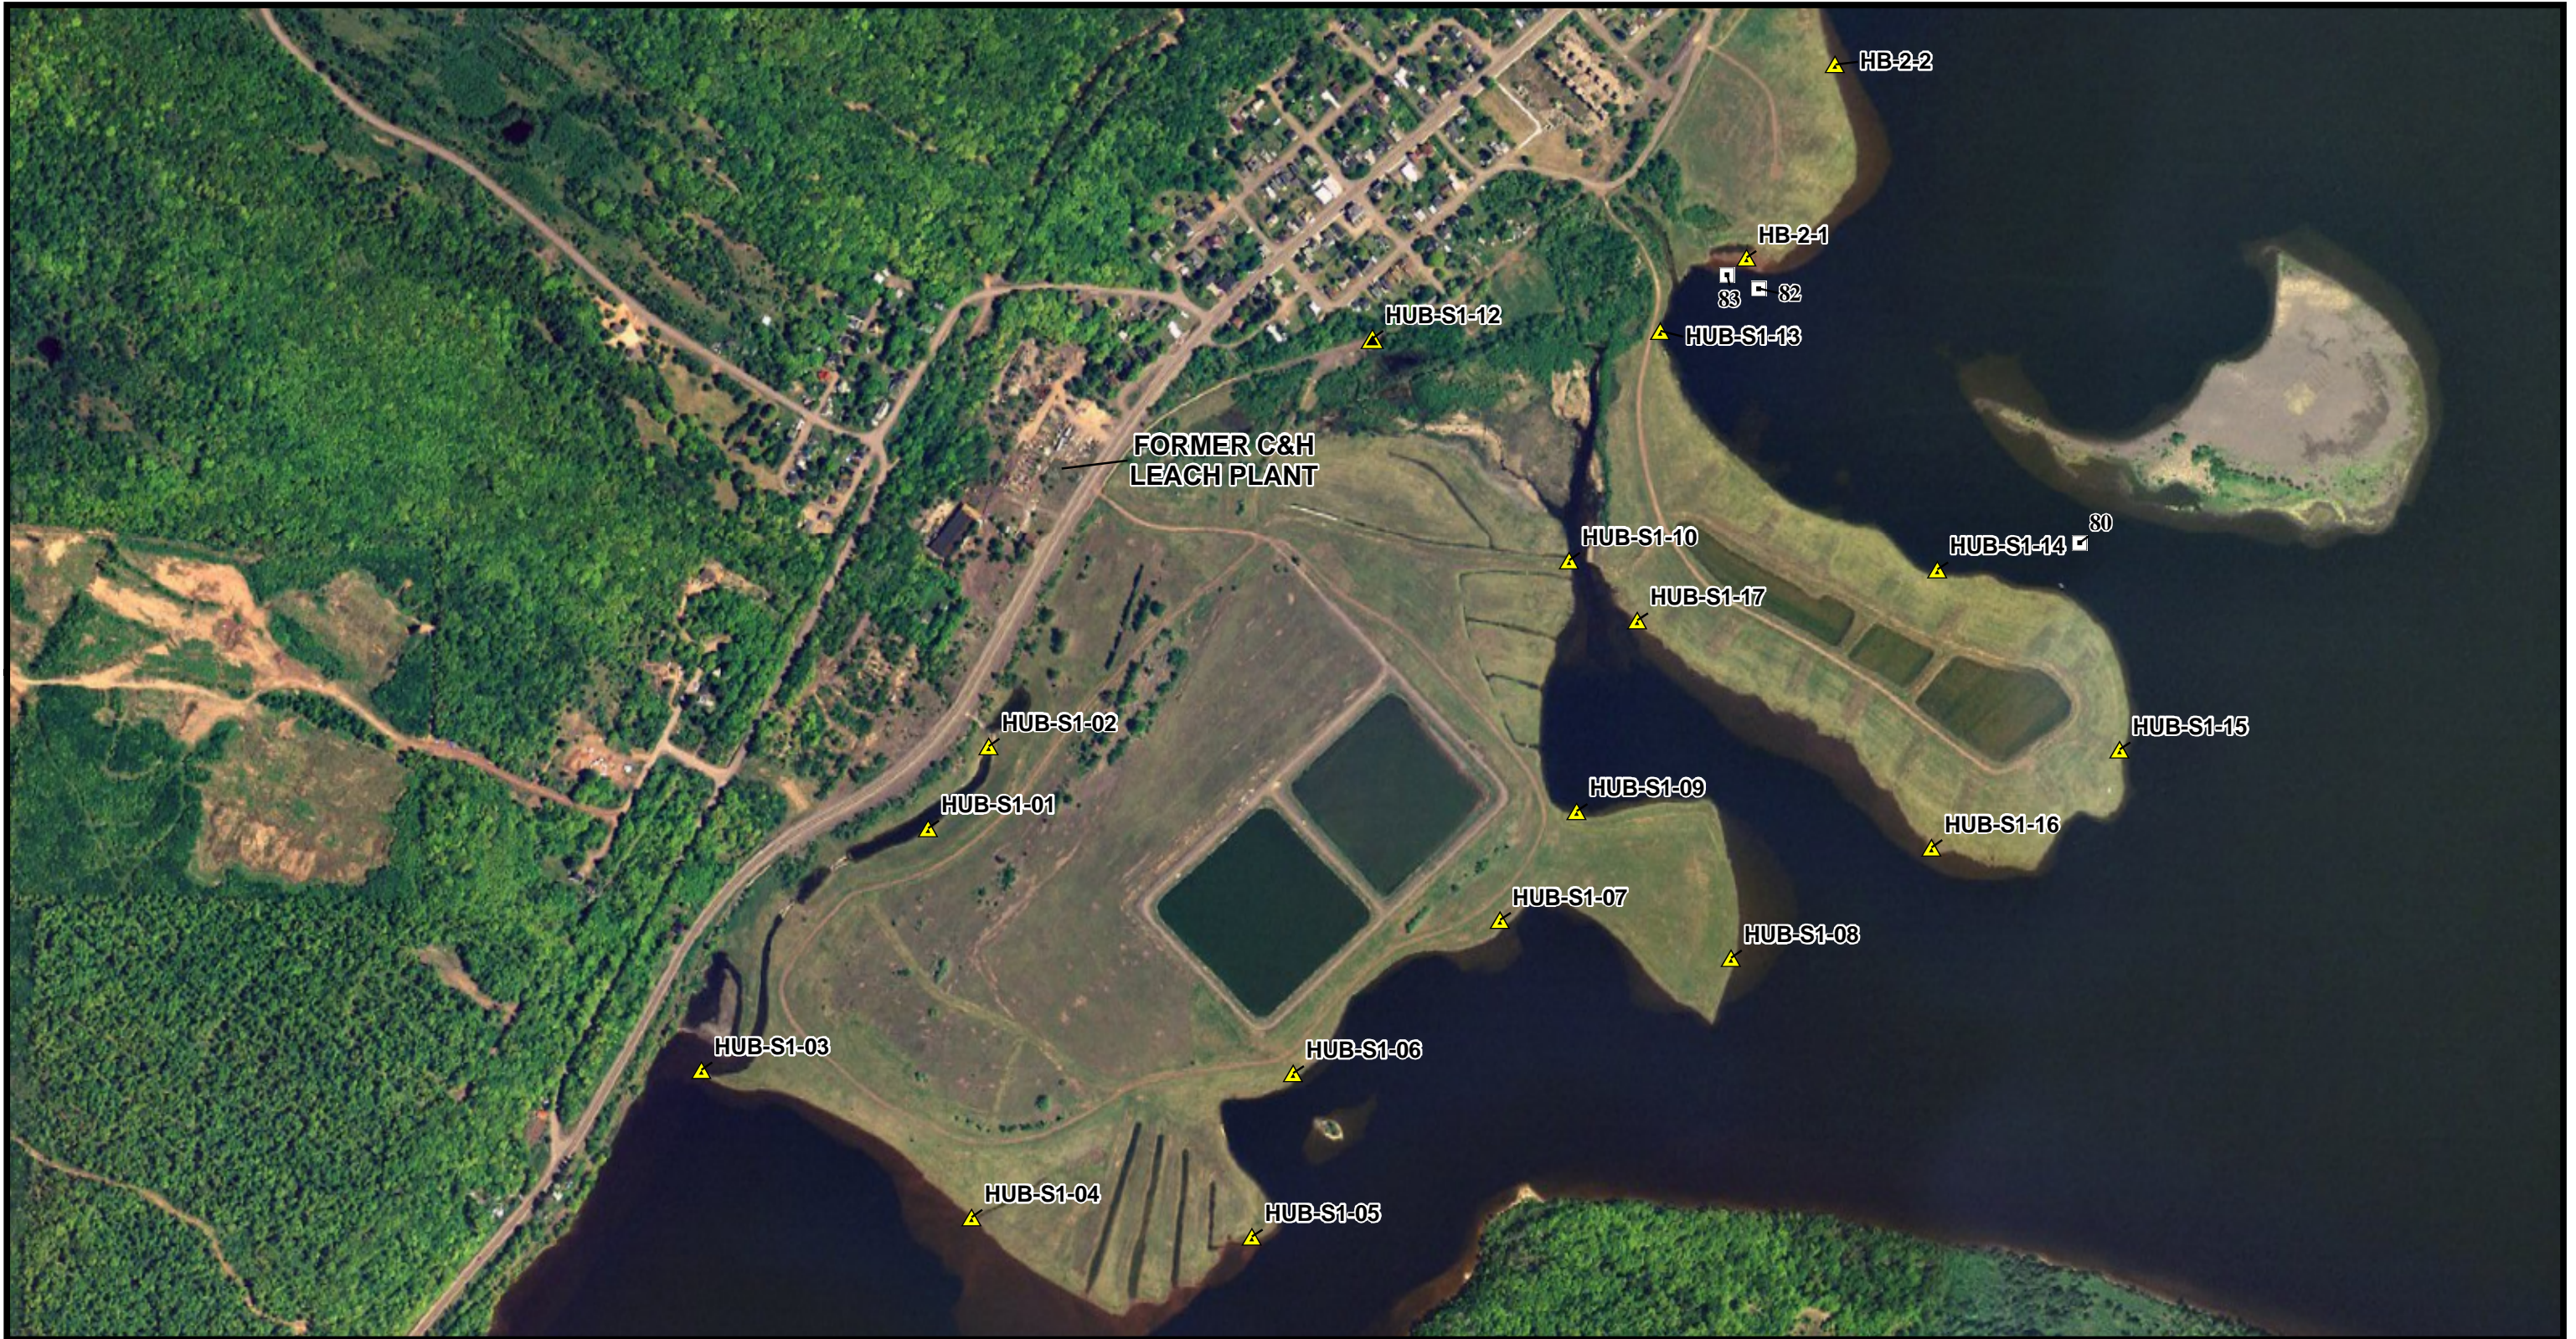
Figure 5a

- FIELDS Team XRF and Laboratory Sample
- FIELDS Team XRF Sample
- MDEQ Identified Drums/Debris

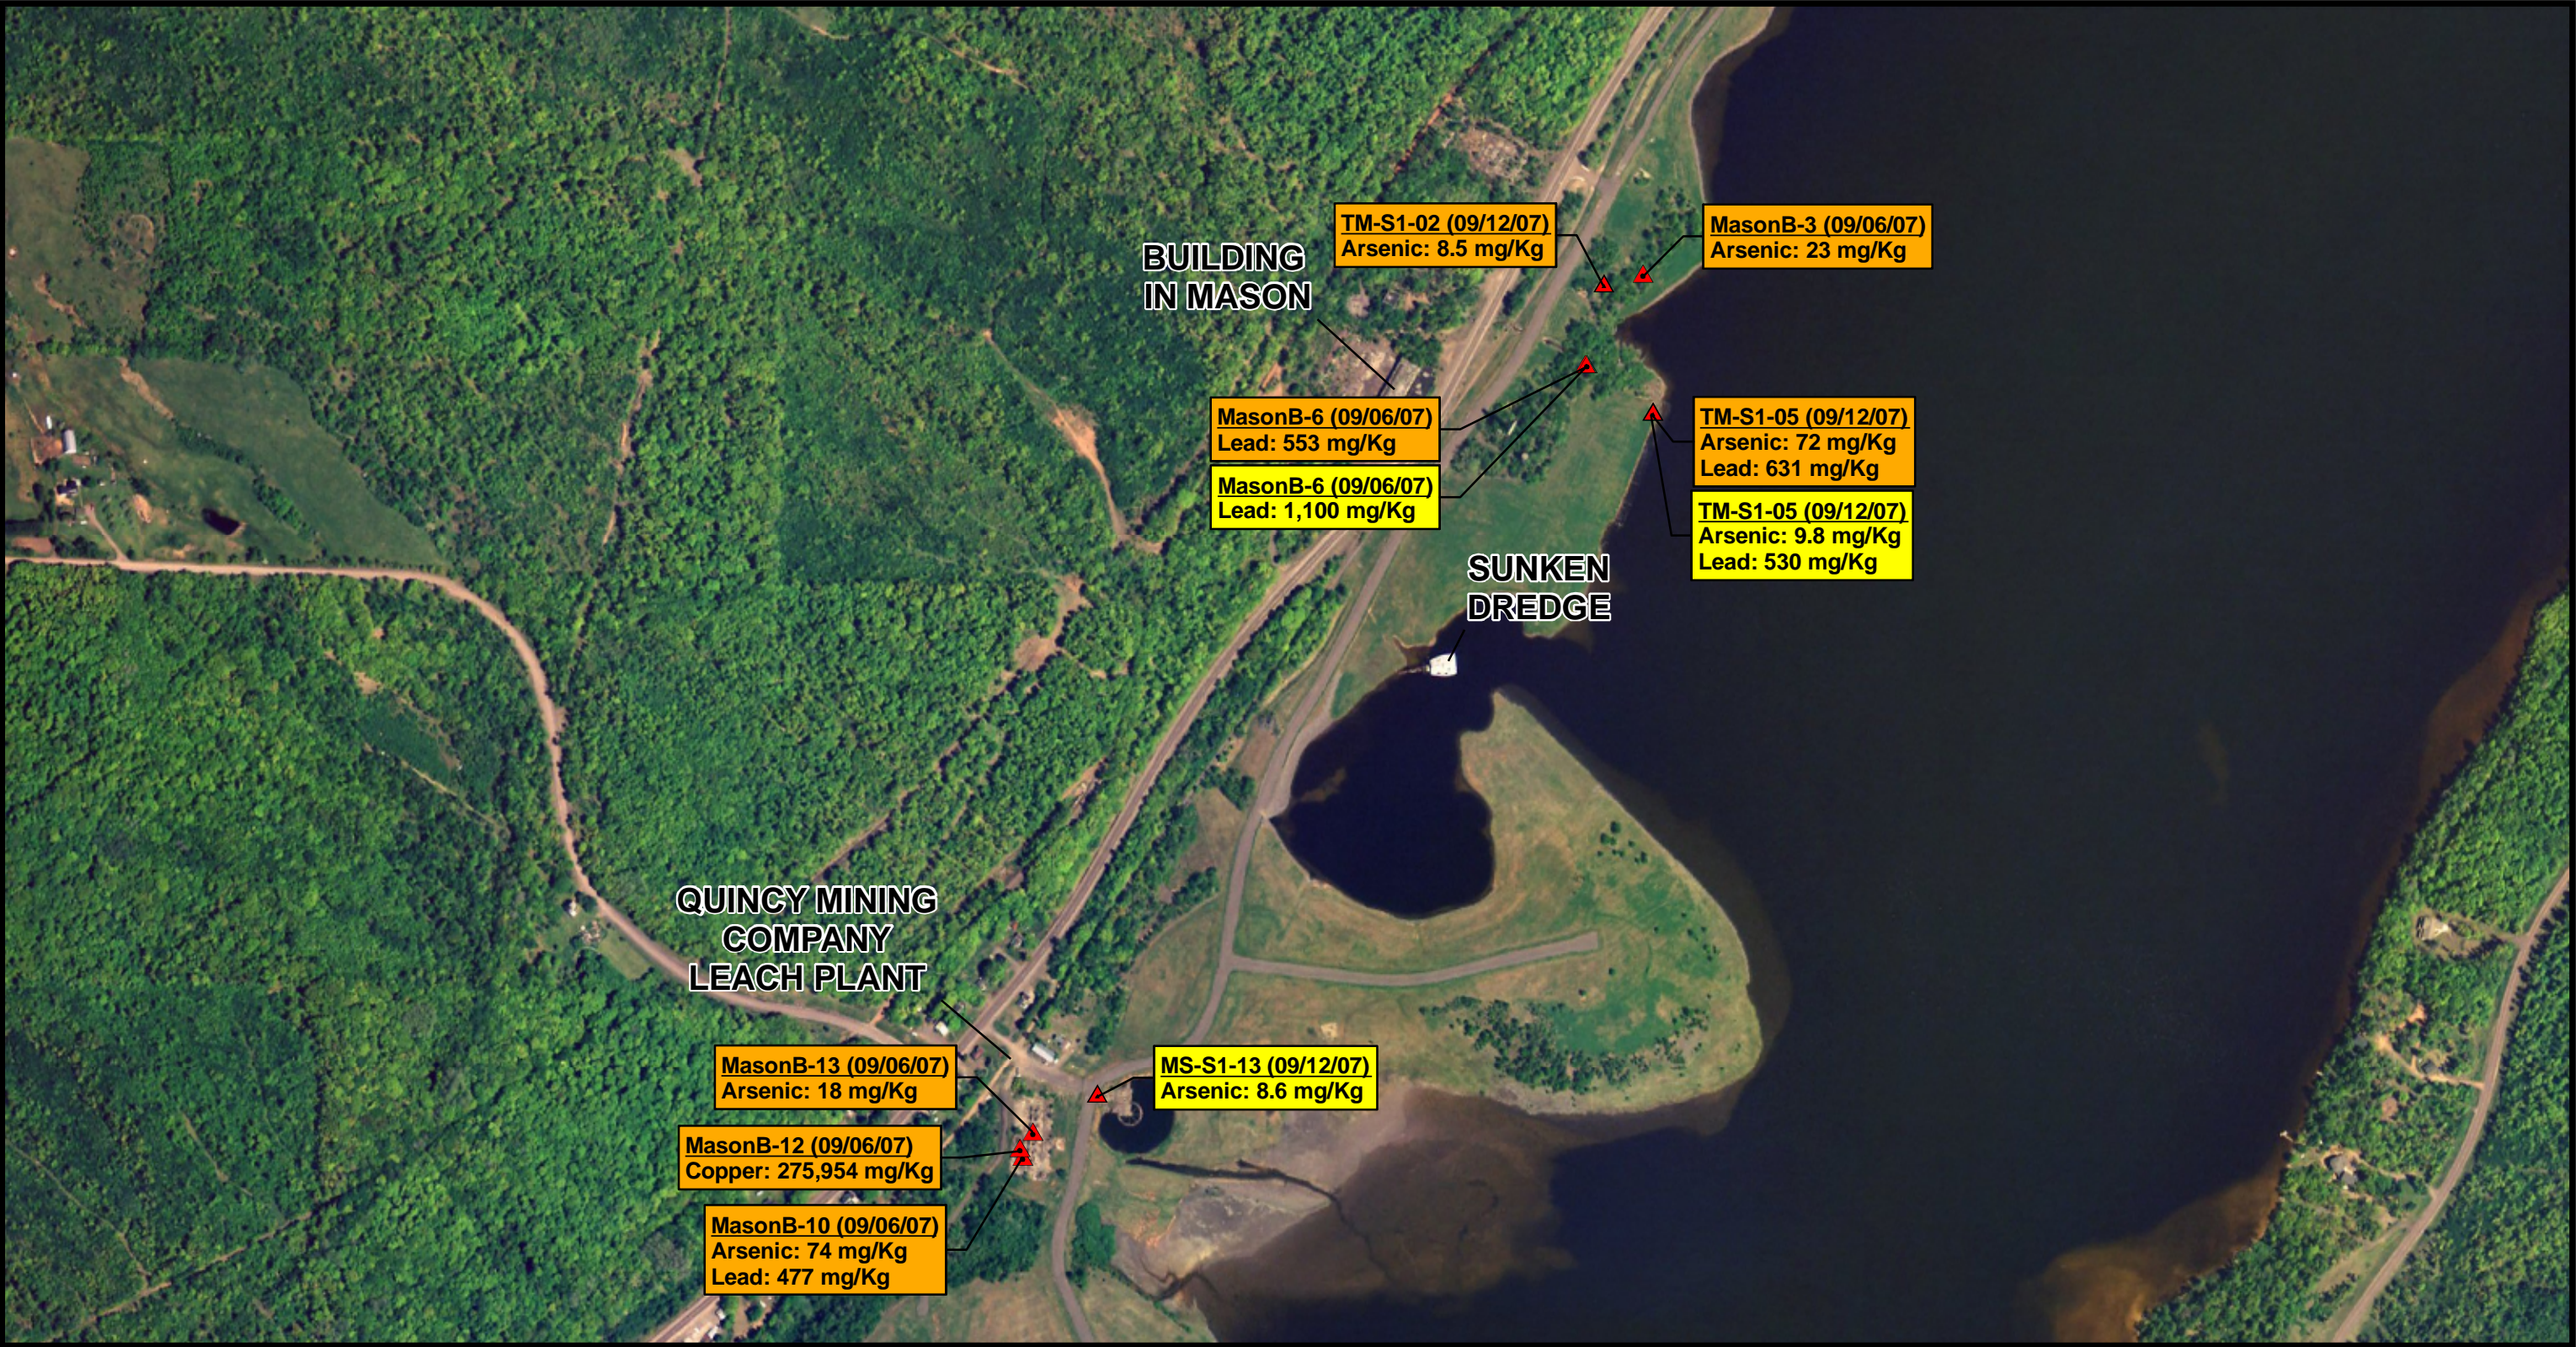
Figure 4b

- ▲ Soil Sample Exceeds Part 201 Residential Direct Contact Criteria (RDCC)
- Orange box: XRF results exceeding RDCC are shown in Orange
- Yellow box: Laboratory results exceeding RDCC are shown in Yellow
- mg/kg -- milligrams per kilogram
