AOI Nos. 12 and 23  
**SITE FEATURES AND XRF LOCATIONS**  
TORCH LAKE AREA ASSESSMENT  
KEWEENAW PENINSULA, MICHIGAN  
October 2007

AOI Nos. 12 and 23  
**RDCC EXCEEDANCES IN SOIL**  
**TORCH LAKE AREA ASSESSMENT**  
**KEWEENAW PENINSULA, MICHIGAN**  
October 2007

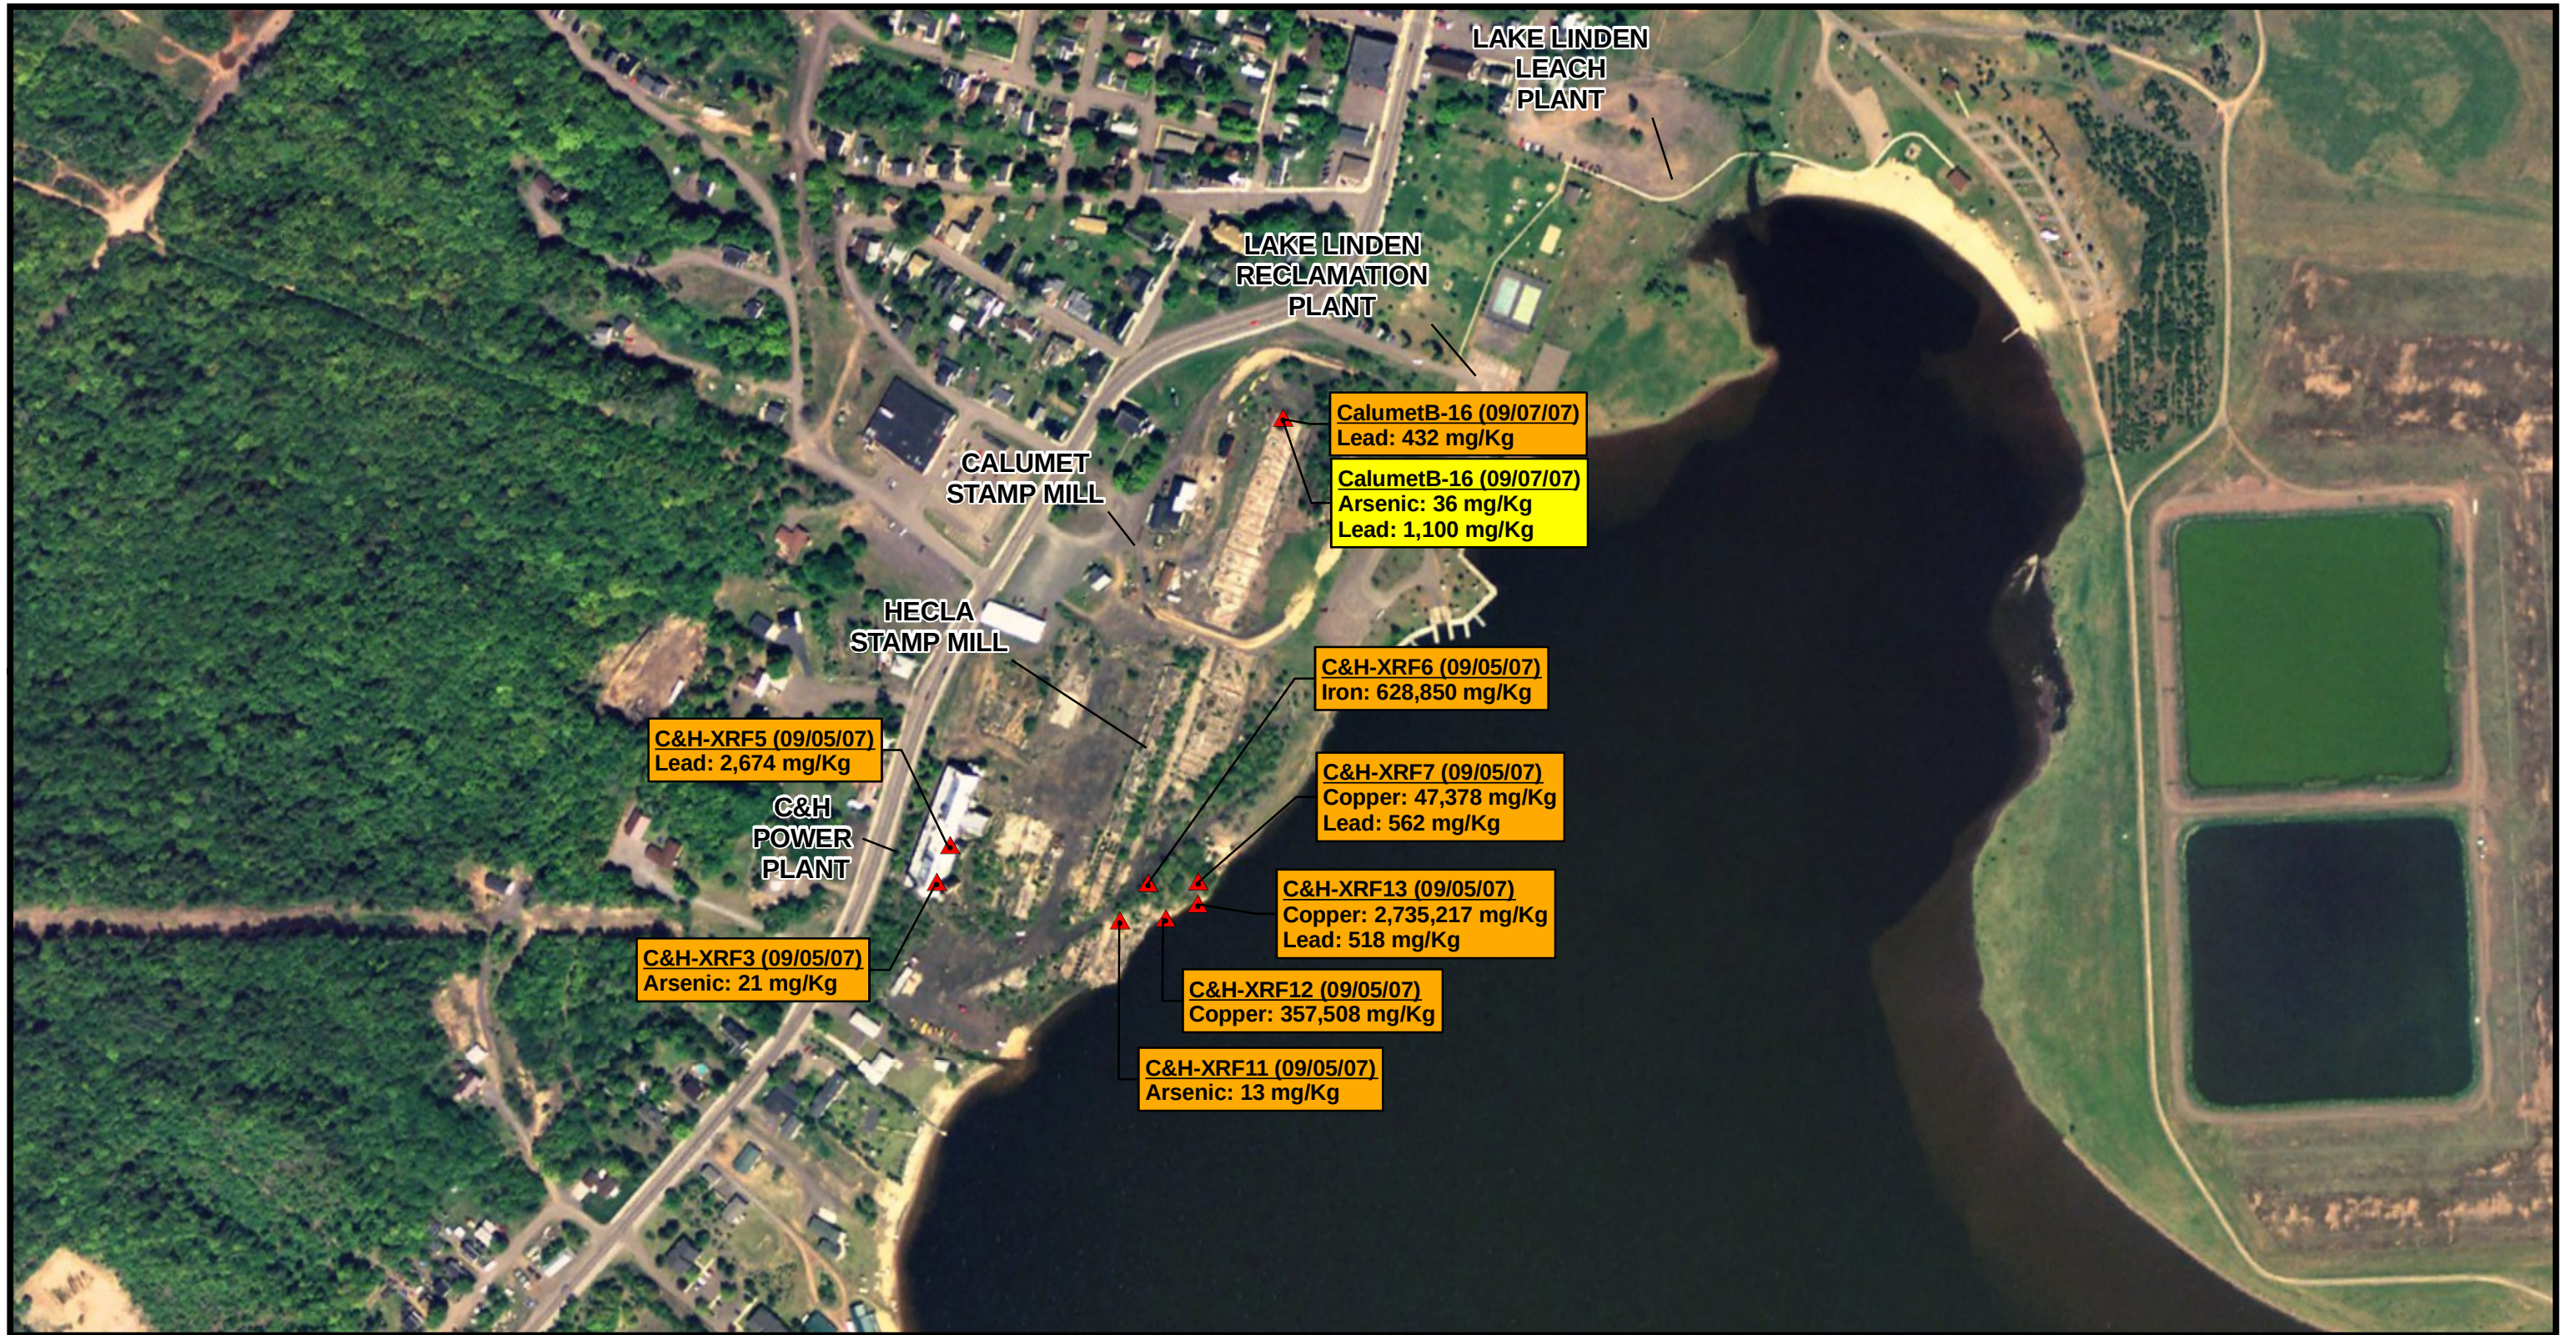
Figure 8b

- ▲ Soil XRF Sample Exceeds Part 201 Residential Direct Contact Criteria (RDCC)
- Orange box: XRF results exceeding RDCC are shown in Orange
- Yellow box: Laboratory results exceeding RDCC are shown in Yellow
- mg/kg -- milligrams per kilogram
