# **Removal Recommendation**

## **Degradation of Aesthetics Beneficial Use Impairment**

### **Clinton River Area of Concern**

### Office of the Great Lakes, Areas of Concern Program Michigan Department of Environmental Quality Statewide Aesthetics Assessment Findings for Impaired AOCs

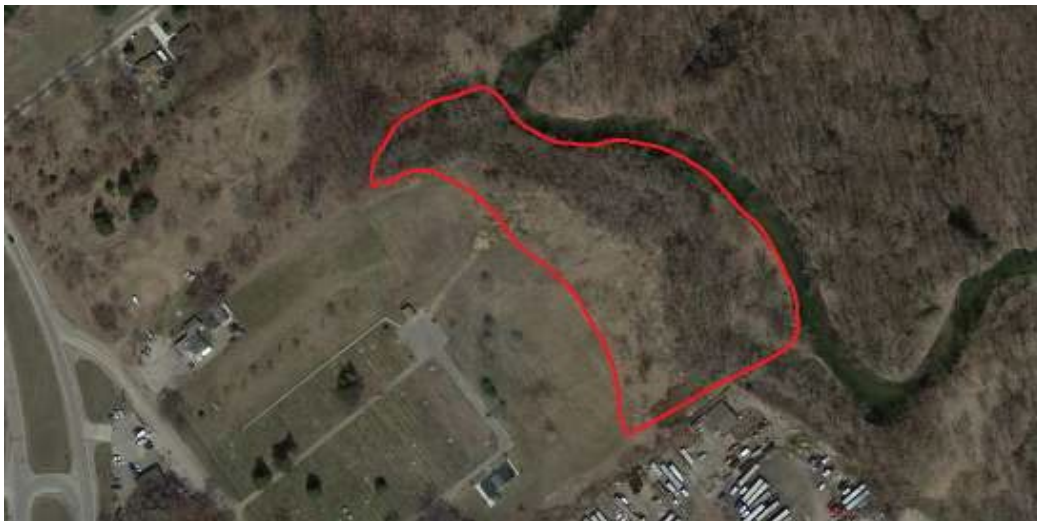
Figure 2: St. Lawrence Cemetery Site Boundary

None of the sites assessed showed evidence of degradation of aesthetics as an impaired use. However, prior to the second round of monitoring the AOC Coordinator was informed of a site of potential issue located at the St. Lawrence Cemetery on the banks of the Clinton River in Shelby Township (Figure 2) and the site was added for assessment.

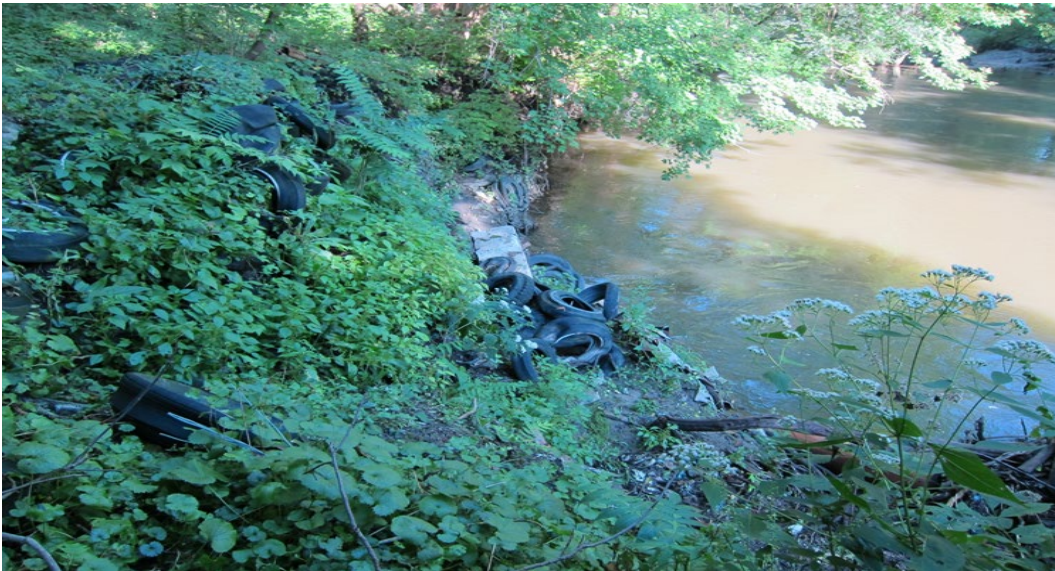
During the second round of monitoring in November 2011 none of the previous ten sites again showed evidence of degradation of aesthetics as an impaired use. However, the St. Lawrence cemetery site revealed the following:

- Excessive erosion of the riverbank cutting into a historical landfill/dump
- Solid waste and trash in the river
- Discolored water seeping from the riverbank

Figure 3: St. Lawrence Cemetery Riverbank Erosion and Trash

In 2015, The U.S. EPA Great Lakes National Program Office entered into an Interagency Agreement with the U. S. Army Corps of Engineers (USACE) to design and construct a project to address the aesthetic impairments at the SLCL. In a collaborative effort between the U.S. EPA, USACE, EGLE and the St. Lawrence Church a project was designed which included removing the exposed landfill debris from the site and in the river, pulling back the failing banks to a more stable grade, properly covering the site with the appropriate soils, and stabilizing the banks with rock and vegetation.

Construction of the project began in Spring of 2017 and was completed in Fall of 2017. Site visits were conducted by EGLE staff throughout the project construction and post construction (Figures 5 and 6). Based on these visits it was determined by EGLE staff that the site had been properly addressed to eliminate the issue of debris falling into the river. EGLE staff were also satisfied that the stabilization of the riverbank had addressed the stormwater runoff that lead to discoloration in the river. The USACE has provided post-construction monitoring for two years. The site will continuously be observed by the Clinton River Watershed Council as part of their regular watershed activities.

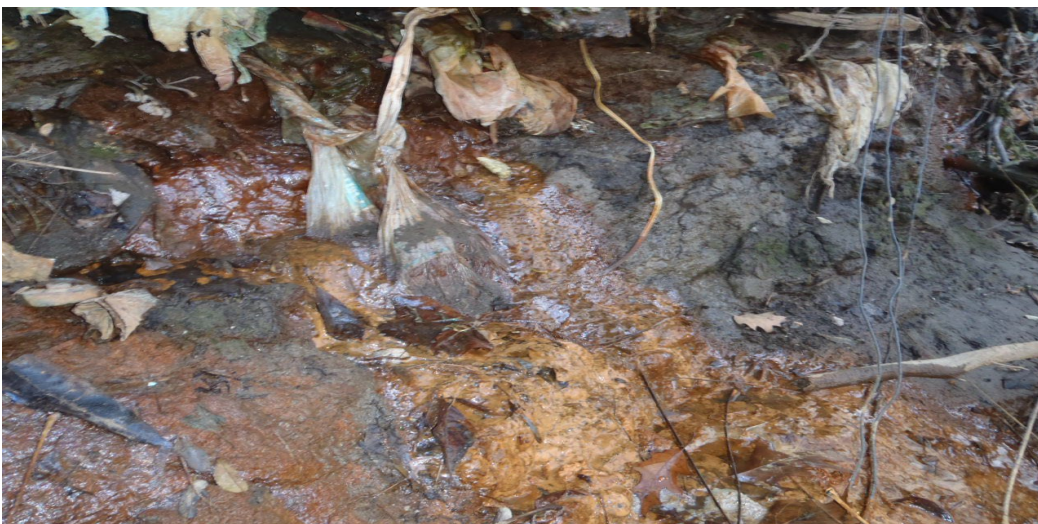
Figure 4: St. Lawrence Cemetery Riverbank Discolored Water Seep

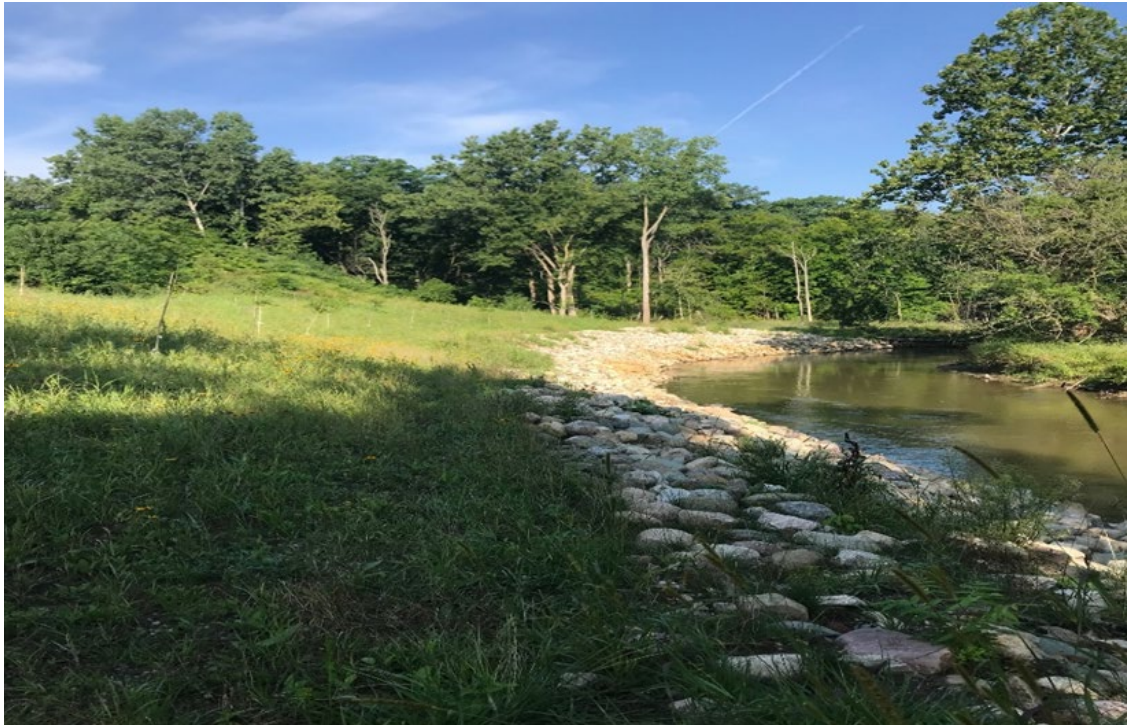
Figure 5: St. Lawrence Cemetery/Landfill Completed Site – Upstream

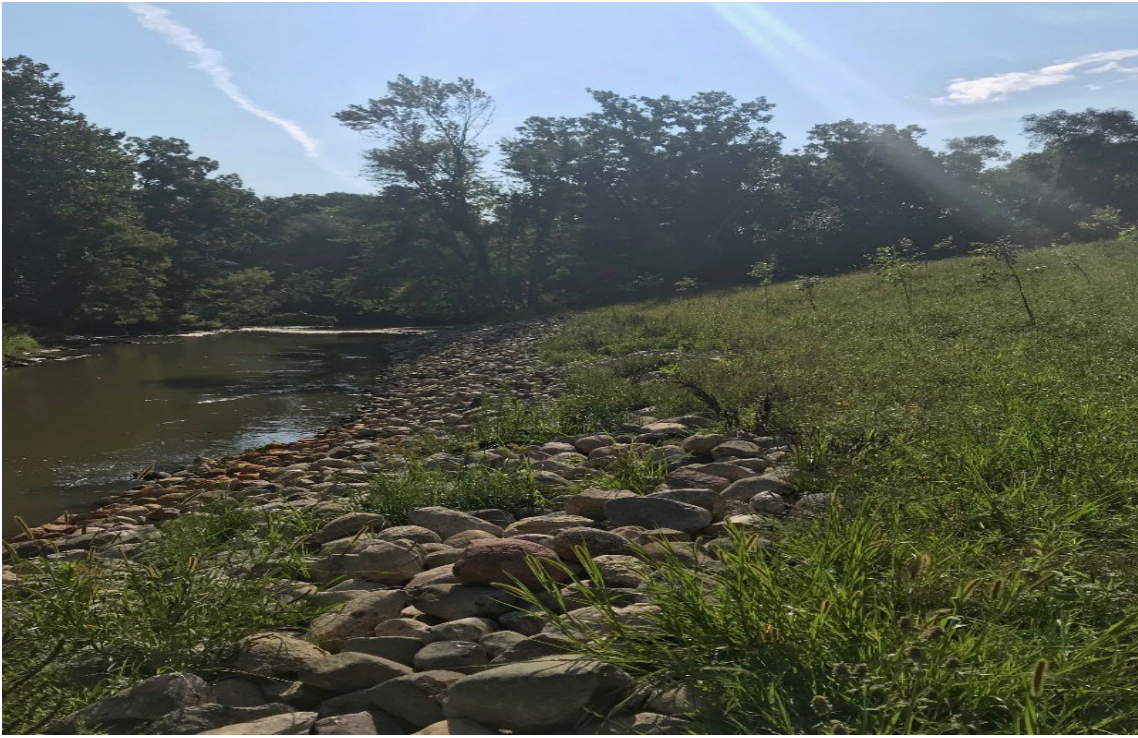
Figure 6: St. Lawrence Cemetery/Landfill Completed Site - Downstream

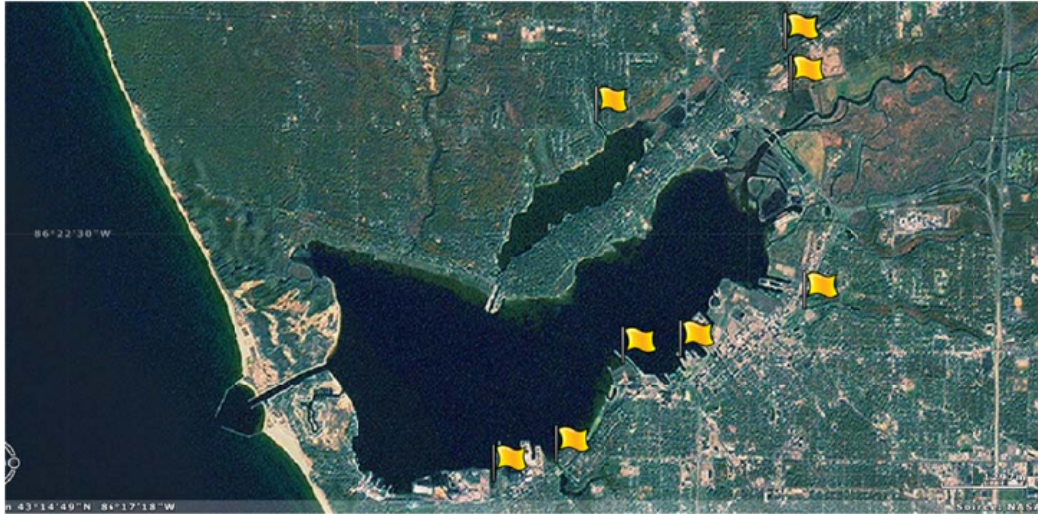
**Figure 1. Muskegon Lake Aesthetics Monitoring Locations.**

**Muskegon Lake** was assessed on July 12 and November 29, 2011, see Figure 1 for locations. Eight sites were assessed around Muskegon Lake. Staff identified the ongoing oil leak in Fenner's Ditch, which feeds Bear Lake, and petroleum odors and oil films near Bear Creek and adjacent to Celery Lane, near the Zephyr site (determined by the DEQ to be a "facility" under Part 201, Environmental Remediation, of the Natural Resources and Environmental Protection Act, 1994 PA 451, as amended) as potentially impairing designated uses. Also noted was abundant trash in a small area of Ryerson Creek, resulting from a backed up culvert near the farmers market. Since the assessments, the Ryerson Creek culvert was replaced and its elevation adjusted to restore stream flow, which also appears to be alleviating the accumulation of trash. DEQ AOC staff conclude the Muskegon Lake AOC continues to be aesthetically impaired, due to petroleum contamination at the Fenner's Ditch and Zephyr sites.

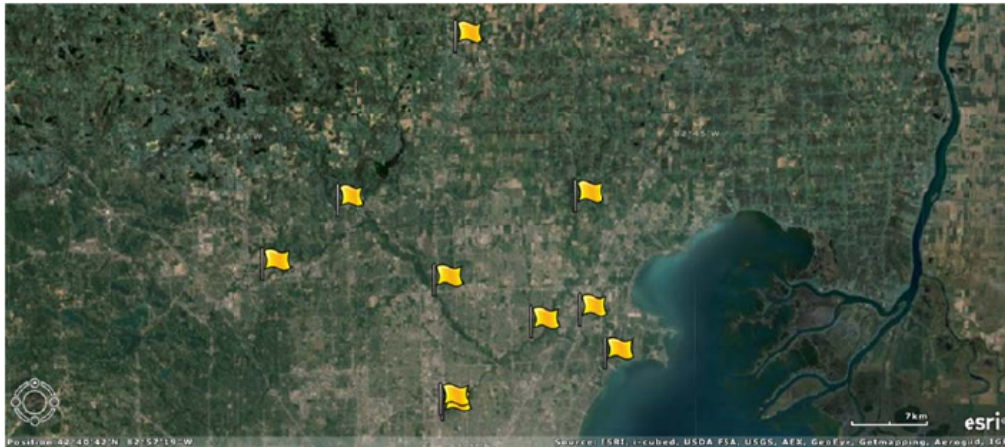
**Figure 2. Clinton River Aesthetics Monitoring Locations.**

The **Clinton River** was assessed on July 27 and November 16, 2011. See Figure 2 for locations. Ten sites were assessed in the Clinton River watershed during the initial round of monitoring. Although there are dissolved oxygen and *E. coli* Total Maximum Daily Loads (TMDLs) in place for specific parts of the Clinton River AOC, there was no evidence of potential aesthetic impairments observed, outside of a small amount of debris in one limited area. Evidence of wildlife habitat was observed, along with minnows, shore birds, aquatic insects, crayfish, etc. One person was observed paddling a kayak in the Clinton River in downtown Mt. Clemons and children were seen playing in Paint Creek, a tributary of the Clinton River, at the City of Rochester municipal park. In the days immediately following the conclusion of the first cycle of monitoring, information came to the attention of AOC staff regarding a potentially aesthetically impaired site in the AOC, of which staff were not previously aware. On September 21, 2011, the DEQ AOC Coordinator visited the St. Lawrence Cemetery on Auburn Road, in Macomb County and took a number of photographs showing an inactive landfill behind the cemetery, on the banks of the Clinton River. Over time, the banks have eroded, exposing landfill debris and leachate seeps. Some of the debris continues to fall into the river, and water of unnatural characteristics had been observed discharging into the Clinton River. This site was added to the list of monitoring locations for the second round of assessments.

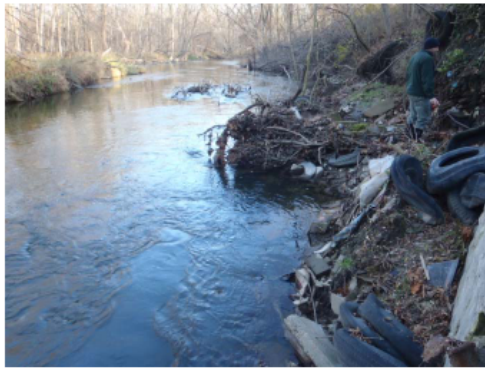
During the November 16, 2011 assessment, additional photographs of the landfill area were taken showing a six to eight foot vertical wall of landfill debris sloughing into the river (Figure 3). The debris found in the immediate area included: car bodies, a transmission, a motorcycle frame, a clothes dryer, scores of tires, glass bottles, plastic toys, bicycle parts, plastic bags, wood debris, and other various forms of trash. In terms of water quality, discolored water was observed seeping out of the exposed river bank and into the river (Figure 4). However, surface samples of river water that were collected adjacent to the site did not exhibit unnatural color, but petroleum odors were present, as were oily sheens and biofilms.

**Figure 3. St. Lawrence Cemetery Property, 11-16-11**

The site was immediately referred to the DEQ's Water Resources Division and Remediation Division for further investigation and follow up. On September 1, 2011, water and sediment samples were collected from the site for analysis. The water samples exceeded aquatic life values developed for both mercury and copper. The sediment samples did not exceed available screening value concentrations. A meeting has been scheduled with the landowners, regulatory authorities and other stakeholders to begin the process of determining how best to proceed with site remediation. It is the professional opinion of AOC program staff that due to ongoing, persistent conditions at the St. Lawrence Cemetery site immediately adjacent to the Clinton River, the aesthetics beneficial use in the Clinton River AOC remains impaired.

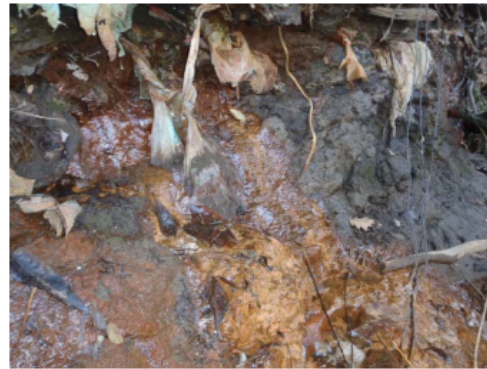
**Figure 4. Landfill Leachate, 11-16-11**

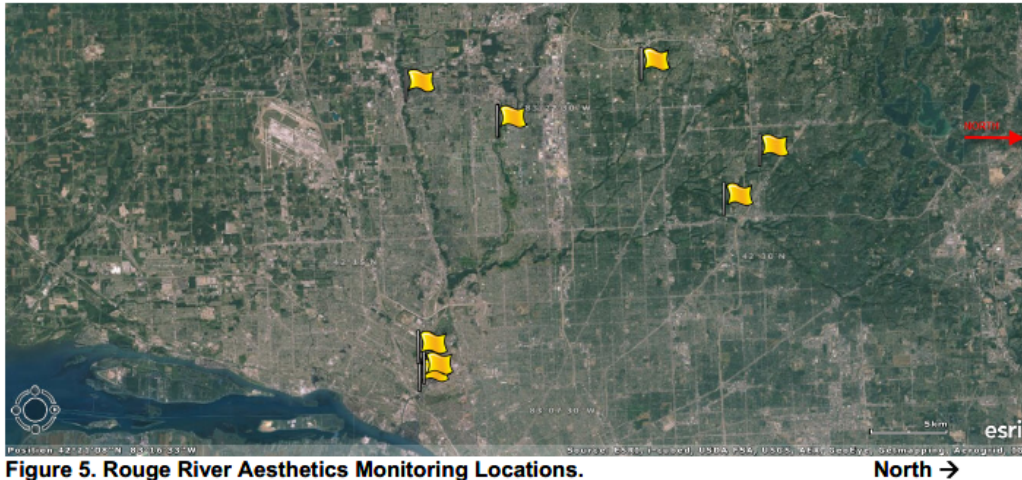
The **Rouge River** was assessed from shoreline locations on July 28 and November 17, 2011. See Figure 5 for locations. Eight sites were assessed in the Rouge River AOC from shore. The mouth of the river was observed from the water on August 9, 2011, as an excursion from the Detroit River assessment, from the river mouth up to Jefferson Avenue. Significant rain fell overnight prior to the July and August dates. A number of aesthetic issues were identified, including frequent oil sheens, chemical odors, debris resulting from apparent Combined Sewer Overflow discharges (floating sanitary trash), and the appearance of the river in some areas was extremely turbid and almost opaque.

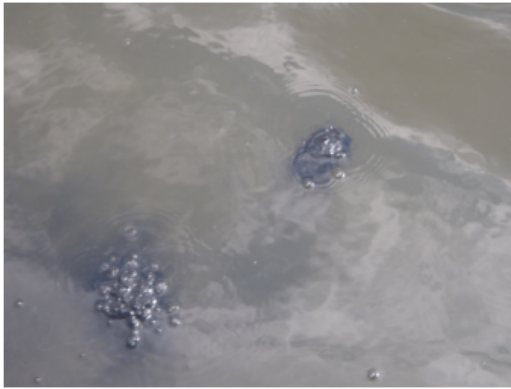
On August 9, for approximately a couple hundred yards downstream of the Detroit Water and Sewerage Department (DWSD) outfall #050, prolific gas bubbling was observed at the surface, which occasionally buoyed globs of fine, black sediment to the surface. At the outfall location, oil sheen was observed and the discharge was extremely dark, coloring the river from the outfall discharge point to the mouth where the Rouge River discharges into the Detroit River (see Figures 6 and 7). Additional photos and video of these phenomena were captured and are available. In July, at the Fordson Island site in Dearborn on the lower main stem of the river, staff disturbed the sediment to observe the release of oily black sediment from the river bottom.

Figure 6. Rouge River Sediment Globs, 8-9-11.

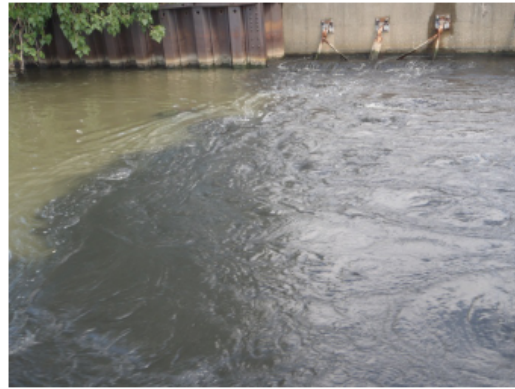
Although a monitoring data sheet was not completed at the DSWD outfall, there is no question that the lower main stem of the river near Jefferson Avenue was the most aesthetically impaired area assessed in the Rouge River AOC. Following these assessments, DEQ staff conclude that the Rouge River remains impaired due to the remaining combined sewer overflows and persistent, high levels of submerged oil and oil sheens.

Figure 7. Rouge River DWSD Outfall #050, 8-9-11.

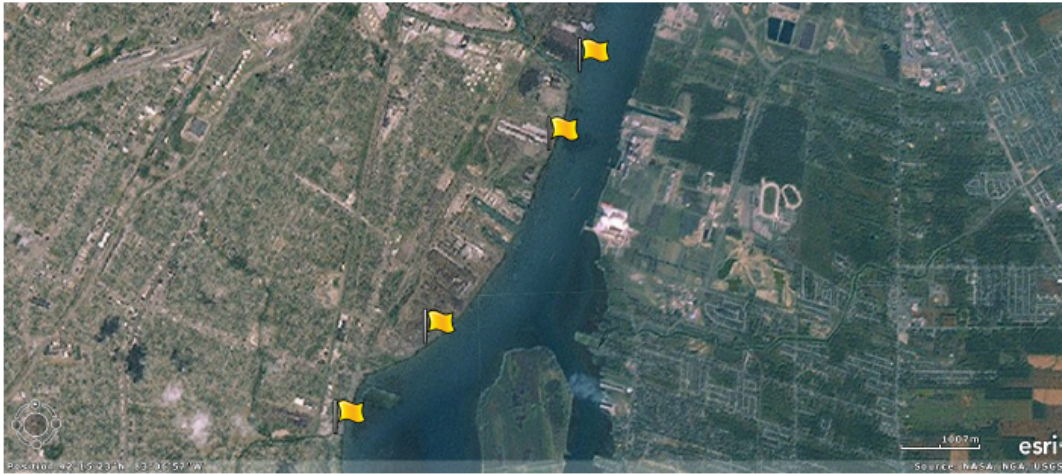
Figure 8. Detroit River Aesthetics Monitoring Locations.

The **Detroit River** was assessed on August 9 and October 31, 2011. See Figure 8 for locations. Four sites were assessed from the water, courtesy of Detroit Riverkeeper, Robert Burns. The DEQ would like to acknowledge and thank Mr. Burns and the Friends of the Detroit River for providing DEQ staff with the opportunity to observe the Detroit River system on board their vessel, and for sharing his personal knowledge of the history and conditions of the Detroit River.

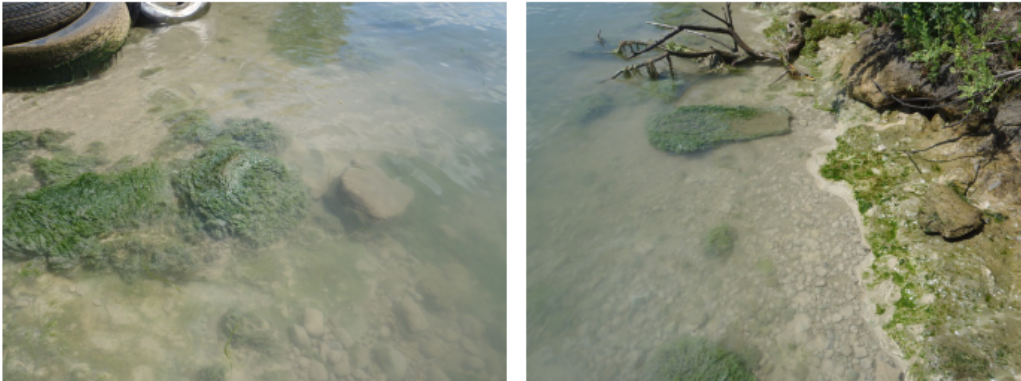
The shoreline adjacent to the US Steel Slag operation, identified by SEMI staff as being operated by Edward C Levy (industrial stormwater general permit holder), appeared to be bleached and has an unnatural grey/light brown color. Slag operation debris appears to have been dumped along the shoreline, perhaps for stabilization. Tires and other debris were noted as well. Closer inspection revealed calcified deposits and stains along the shore. Submerged aquatic vegetation was absent and no aquatic insects or other aquatic life was observed in the area, except discolored algae (see figures 7 and 8). Additional photos are available. During the initial assessment, DEQ staff conducting the aesthetics monitoring at this site did not evaluate any physical or chemical water quality parameters to assess any potential runoff that may be occurring. However, during the October 31 assessment, a pH meter was deployed in the river at this site, and several readings were taken, with the highest reading being 9.5. The pH level gradually fell as the readings were taken farther away from the shore.

Without performing a biosurvey, it is not clear whether the aquatic life designated use may be impaired at this location. However, based on the pH level and calcified deposits observed during the aesthetics assessment, DEQ staff conclude that the aesthetics beneficial use in the Detroit River remains impaired.

**Figures 7 & 8. Detroit River Shoreline Adjacent to US Steel Slag Operation.**
