Septic Systems and Nutrients

STATE OF MICHIGAN, DEPARTMENT OF ENVIRONMENTAL QUALITY

Nutrient Framework to Reduce Phosphorus and Nitrogen Pollution

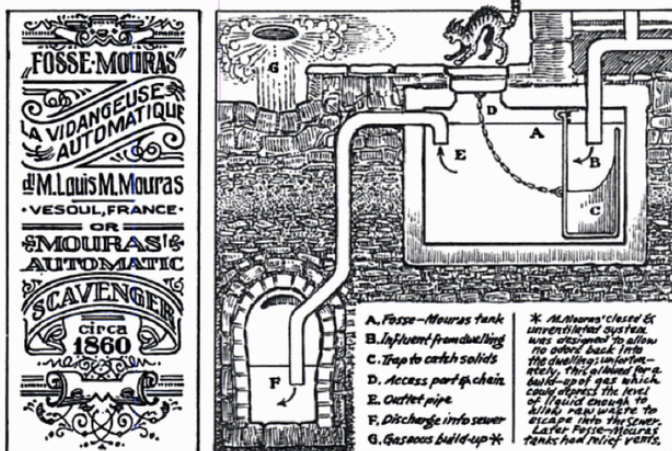
Fig 1. Schematic of an early-design septic tank from 1860. (from <http://djwl.co.uk/blog/brief-history-septic-tanks/>)

The invention of the first septic tank is often credited to a Frenchman by the name of Jean-Louis Mouras in 1860 (Fig. 1). Mouras invented a tank for waste disposal with the idea that storing the solid wastes would be a better disposal method than discharging them straight into the nearest waterway. Which, up until then, had been the preferred method of waste disposal. The first septic tank was later installed in the U.S. in 1883. Some 50-60 years later, drainfields or “soakaways” were recognized as being necessary for the liquid effluent that left the tank. Today, the basic design and concept of the septic tank system has changed little from its earlier prototypes.
