Cass River Watershed Survey (2016)

Cass River Watershed Monitoring 2016
 Water Resources Division

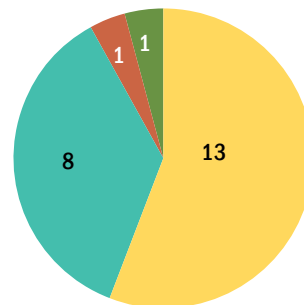
Aquatic Bug Community

In the Cass River watershed most sampling sites were rated acceptable, marginal, or good (see pie charts). The south branch of the Cass River at Kelly Road had a poor macroinvertebrate score due to a lack of stable habitat caused in part by the stream being straightened and cleaned out for efficient water drainage.

Aquatic Bug and Habitat Health at 23 stations in the Cass River watershed (2016)
