MICHIGAN DEPARTMENT OF ENVIRONMENTAL QUALITY  
WATER BUREAU  
MAY 2009

STAFF REPORT

BIOLOGICAL AND WATER CHEMISTRY SURVEYS OF SELECTED STATIONS IN THE  
RABBIT RIVER WATERSHED  
ALLEGAN COUNTY, MICHIGAN  
AUGUST, SEPTEMBER, AND OCTOBER 2008

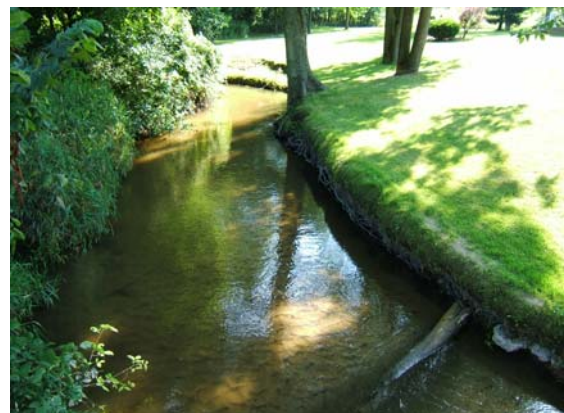
Figure A: Green Lake Creek upstream of 11<sup>th</sup> Street.

The glide/pool habitat at Station 3 in Green Lake Creek scored marginal (66; moderately impaired; Table 2a). The habitat was markedly different from Station 2 located just one mile upstream. There was a large amount of shifting sand that was more than 12 inches deep in places. This large amount of sand was not observed at Station 2 suggesting there may be additional sources of sediment between Stations 2 and 3. Bank scour evidence suggested that the channel flow was somewhat flashy. The riparian area at Station 3 was greatly impacted by residential yards (Figure A) that were mowed to the edge of the stream resulting in a large amount of bank erosion and bank sloughing. The macroinvertebrate community scored acceptable (-1, Tables 2b and 2c).

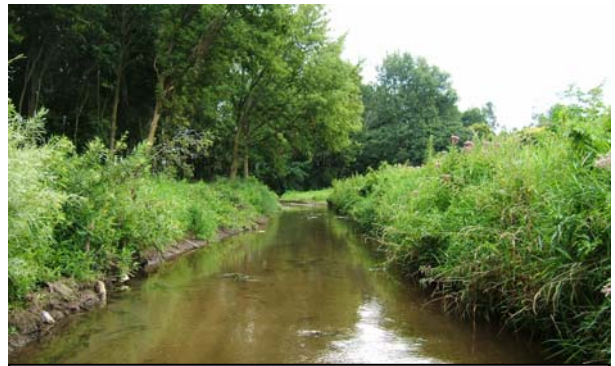
Figure B: Bear Creek at Hopkins Village Park upstream of Godfrey Road.

Bear Creek was sampled at a park in the village of Hopkins (Station 9). The park is just downstream of an agriculture feed supply company that is located directly adjacent to the creek. The glide/pool habitat at Station 9 was rated marginal (70; moderately impaired; Table 4a). Several areas along the stream bank had recently been reinforced with riprap to prevent erosion. The stream channel was very straight and uniform with very little pool variability and was incised approximately 8 feet (Figure B). The riparian area was impacted on both sides by the park. A five-foot wide grassy area was left as a riparian buffer. Bank scour evidence and areas of erosion suggested that the channel flow was somewhat flashy. The macroinvertebrate community scored acceptable (0; Tables 4b and 4c).

Kalamazoo District Office, NPS staff requested assistance in investigating possible nutrient loading from an agriculture feed supply operation that is in close proximity to Bear Creek. The operation is located directly adjacent to the stream in the village of Hopkins. Observations were made near the operation and the macroinvertebrate community was sampled at the Hopkins Village Park, located just downstream of the operation. The macroinvertebrate community at this station indicated the other indigenous aquatic life and wildlife designated use is being met. No nuisance vegetation or bacterial slimes were observed. Although obvious nutrient sources were not observed, the operation and associated parking lots and driveways lie directly adjacent to the stream with no riparian buffer.

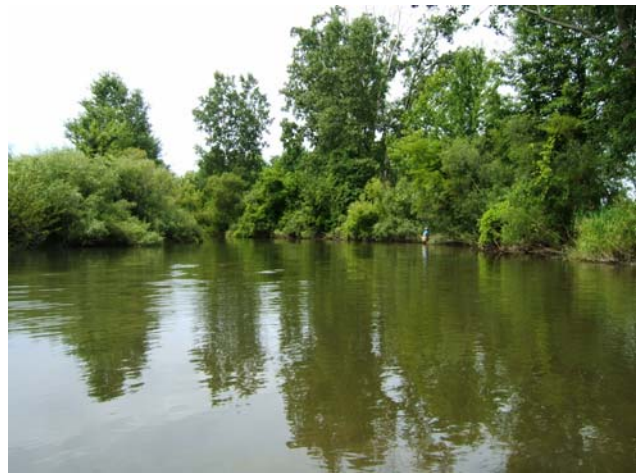
Figure C: Rabbit River downstream of 30<sup>th</sup> Street.

Station 13 was sampled downstream of 30<sup>th</sup> Street. The glide/pool habitat at Station 13 was rated marginal (82; moderately impaired; Table 5a). The river was very wide and slow with pools more than 6-foot deep (Figure C). Sand once again dominated the substrate; however, clay deposits were present and there was a layer of silt on top of the sand. Cobble, gravel, and leaf packs were absent and there was very little woody debris. A portion of the riparian area was impacted by a yard and row crops that had a 10-foot buffer. On the south side of the river, the banks were more than 50-feet high in places and were eroding. The habitat at this station was very different and much less suitable for macroinvertebrate colonization than that at Station 12, which was located just two miles upstream. Station 13 had more sedimentation, less woody debris available for epifaunal substrate, less pool diversity, and a reduced amount of riparian vegetative protection when compared to Station 12. Station 13 was also much wider, slower, deeper, and had more silt and clay. The macroinvertebrate community scored acceptable (0; Tables 5b and 5c).

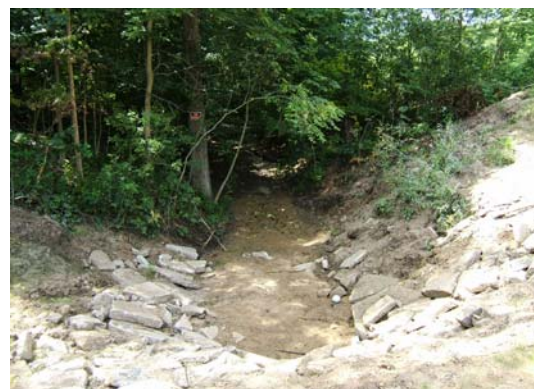
Figure D: Winks Brook at 138<sup>th</sup> Avenue

Winks Brook is a small intermittent tributary to the Rabbit River. Observations of this site indicated that a possible culvert replacement had occurred and no silt fences or other sedimentation control Best Management Practices were implemented. A large amount of sediment from the road and construction was in the dry stream bed (Figure D).
