MICHIGAN DEPARTMENT OF ENVIRONMENTAL QUALITY  
WATER RESOURCES DIVISION  
JUNE 2016

STAFF REPORT

BIOLOGICAL SURVEYS OF SELECTED LOWER GRAND RIVER STREAMS  
IONIA, KENT, MUSKEGON, AND OTTAWA COUNTIES, MICHIGAN  
AUGUST-SEPTEMBER 2014

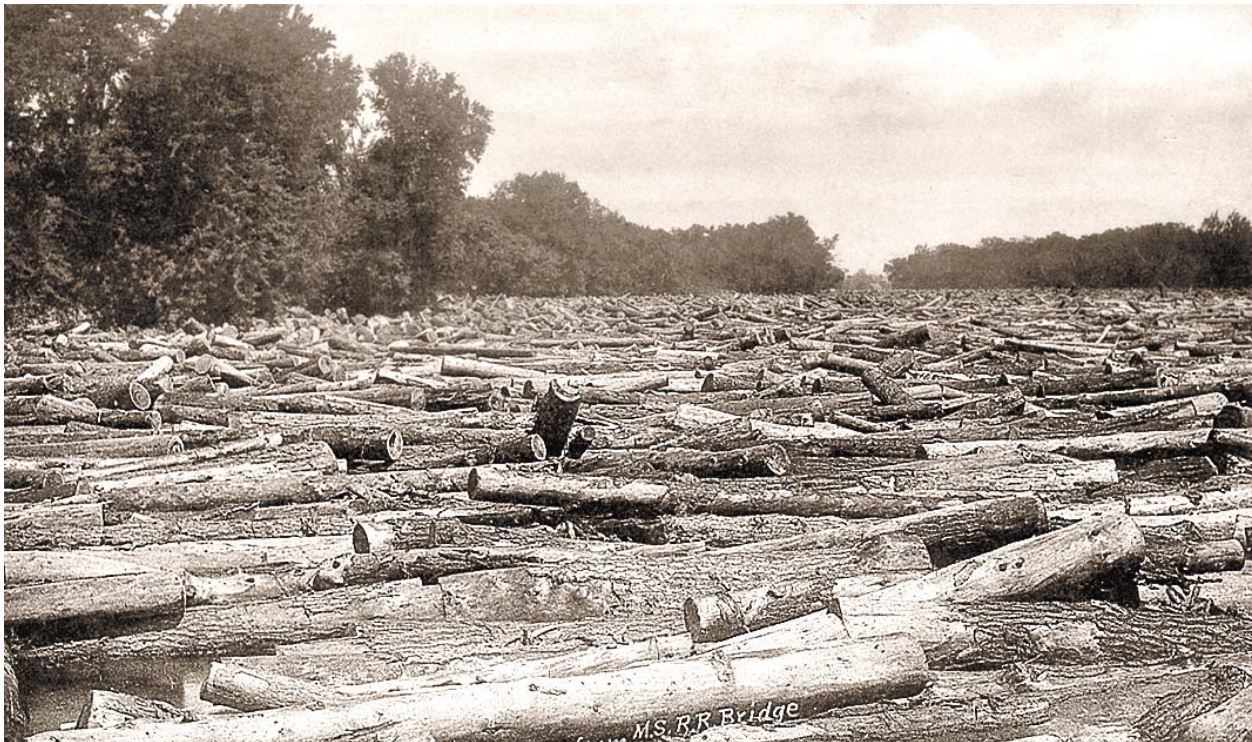
Figure 2. Portion of massive log jam in Grand River that occurred in 1883. Photo from [http://blog.mlive.com/chronicle/2008/07/grand\\_jam\\_of\\_1883.html](http://blog.mlive.com/chronicle/2008/07/grand_jam_of_1883.html).

Beginning in 1881, the Grand River was dredged from Grand Rapids to Grand Haven to make the river much wider and deeper than it naturally was (United States Army Corps of Engineers [USACE], 1919). This dredging allowed for the movement of massive amounts of logs, as well as steamboats, from Grand Rapids to Grand Haven (Figure 2). Today, the Grand River from Grand Rapids downstream remains unnaturally deep and wide, with steep banks. Today, a navigation channel of eight feet is maintained by the USACE from the mouth of the Bass River to Lake Michigan (Hanshue and Harrington, 2011). This deep profile and steep banks often prevents large woody debris retention within the river and is not conducive to macrophyte growth, both of which would provide habitat for fish and macroinvertebrates.

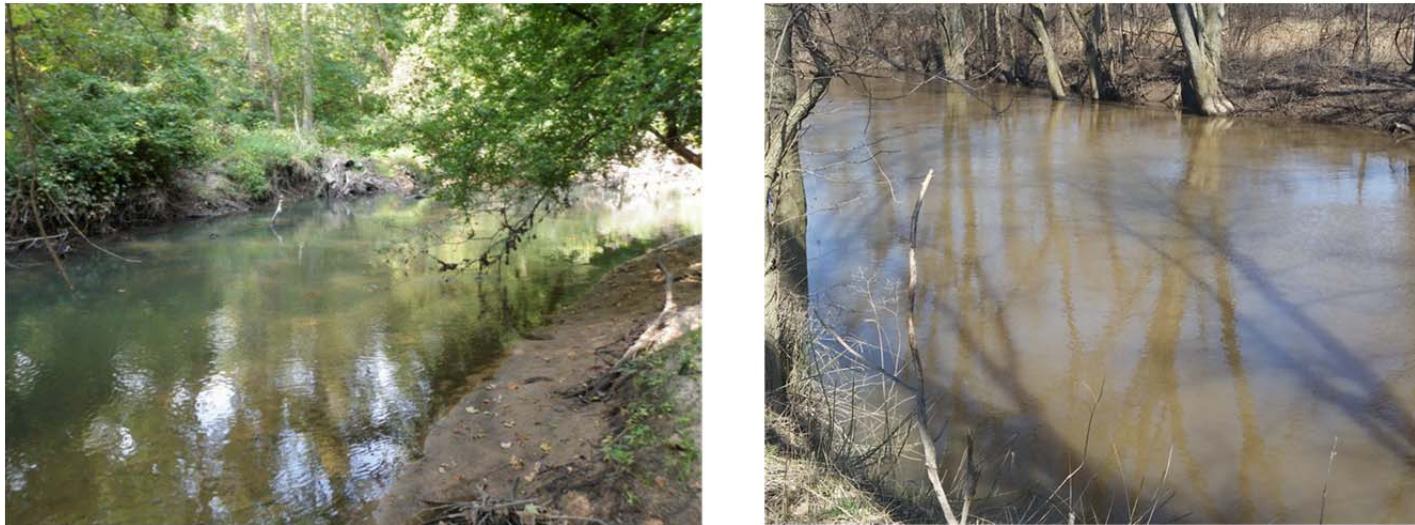
Figure 4. Crockery Creek, Ensley Road site (Station 8). Photo on left is from August 2009 and photo on right is from March 2016.

At Station 8 the macroinvertebrate community scored a high acceptable (3; Table 4), although habitat was marginal (68; Table 6). The macroinvertebrate community was dominated by Amphipoda and Brachycentridae. Three Ephemeroptera and five Trichoptera families were found. While Amphipoda are facultative, Brachycentridae are considered to be very sensitive to disturbance (Voshell, 2002). Although in-stream large woody debris was sparse at this site, Brachycentridae and other Ephemeroptera and Trichoptera taxa were colonizing what little stable habitat was available. The large woody debris that was present was largely out of the water and lying parallel to the stream, indicating flashy flow conditions (Figure 4). The banks were very steep and largely devoid of vegetation with active erosion occurring on both sides. This section of the creek appeared to have been historically dredged and channelized. Along the right bank was Ensley Road, which is a gravel/dirt road and along the left bank was a small row crop field. Crockery Creek runs parallel to Ensley Road for over 0.1 mile. Large trees were growing immediately alongside the stream, which provided good canopy cover. The sediment

type was mostly sand (95% visual estimate). The greater surrounding area contains a mix of forest and agricultural land use. This site was sampled in 2009 with the macroinvertebrate community scoring acceptable (0) and habitat scoring marginal (104; Rippke, 2011).

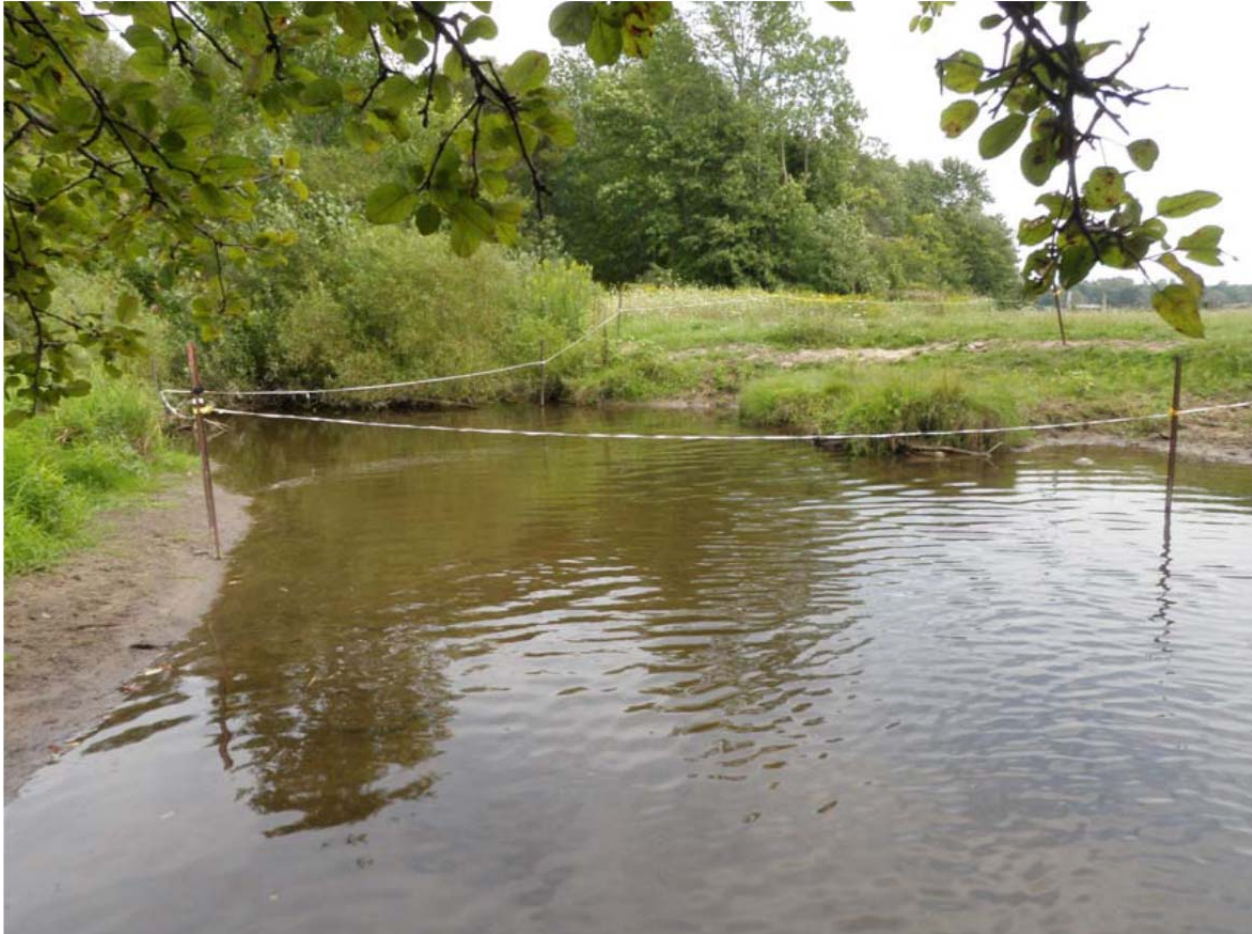
Figure 5. Photo of restricted, but direct access for horses in a section of North Branch Crockery Creek near 24th Avenue during 2009 survey.

At Station 16 the macroinvertebrate community scored acceptable (1; Table 4) and habitat scored good (119; Table 6). This site was sampled in 2009 and macroinvertebrates scored poor (-5) and habitat scored low good (106). In 2009, the macroinvertebrate community was dominated by Amphipoda and only one Ephemeroptera and one Trichoptera family were collected. In 2014, the macroinvertebrate community was still dominated by Amphipoda; however, three Ephemeroptera and three Trichoptera families were collected. The current results indicate moderate disturbance at the site, but the conditions may be improved since the last sampling event. During the 2009 survey, biologists observed that horses were allowed access to a section of the stream (Figure 5; Rippe, 2011).

The restricted, but direct horse access to the stream caused localized bank erosion as well as localized stream bed disturbance. The direct access was reported to Grand Rapids district staff who worked with the Michigan Department of Agriculture and Rural Development to restrict all access to the stream. During the 2014 visit, the fence was set back from the stream and vegetation was starting to regrow in areas along the bank where bare soil was present in 2009. Rootwads were extensive and undercut banks, overhanging vegetation, and large woody debris were moderately available. The stream showed signs of flashiness though, with moderate amounts of sediment deposition and bank scour. Riparian vegetation along the stream is reduced by a crop near one bank and the horse pasture along the other bank. In some areas

- Resample the four trend sites within the watershed.
- Resample sites with noted NPS impacts such as unrestricted cattle access: Station 14, Crockery Creek and Station 20, Plaster Creek.
- Resample sites that did not attain the OIALW designated use in 2014.
- Resample sites within the Plaster Creek subwatershed after restoration work has been completed.
- Collect and analyze sediment samples from Indian Mill Creek for metal, oil, and gas contamination in 2016.
- Collect and analyze ten Common Carp (*Cyprinus carpio*) from the lower Grand River for contaminants.
