MICHIGAN DEPARTMENT OF ENVIRONMENTAL QUALITY
WATER RESOURCES DIVISION
SEPTEMBER 2017
STAFF REPORT

BIOLOGICAL SURVEY OF SELECTED STATIONS IN THE CASS RIVER WATERSHED IN SAGINAW, TUSCOLA, GENESEE, LAPEER, SANILAC, AND HURON COUNTIES, MICHIGAN, JUNE-SEPTEMBER 2016.

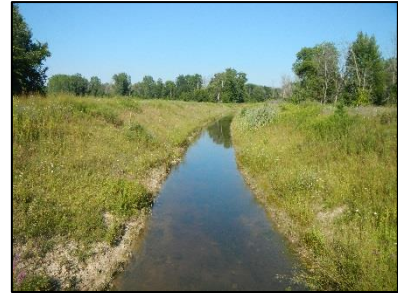
Figure 6. Unnamed Tributary (upstream Plain Road) 2016.

The unnamed tributary upstream of Plain Road is a straightened, channelized, and maintained drain. In 2016, macroinvertebrates scored Acceptable (0), while habitat scored Marginal (61) (Tables 3 and 4). The macroinvertebrate community was made up of 28 taxa, 5 of which were EPT taxa. Riparian vegetation consisted entirely of herbaceous vegetation for approximately 15 meters on each side of the stream and there was an obvious lack of riparian woody shrubs and trees, and consequently, in-stream woody debris.

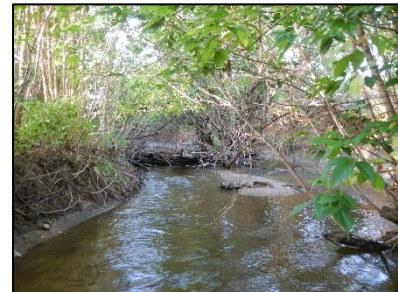
Figure 7. Millington Creek (upstream Ormes Road) 2016.

Millington Creek upstream of Ormes Road is a flashy, warmwater tributary to the lower Cass River. The stream in this reach had a decent amount of stable substrate and abundant in-stream woody debris but sediment covered much of the available habitat and overall habitat scored Marginal in 2016 (100; Table 3). Eroding banks were evident just upstream of the bridge and throughout the reach extending from Ormes Road upstream to Vassar Road. Macroinvertebrates at this site scored Acceptable (0) with Amphipods dominating the community and all EPT taxa combined making up only about ~15 percent of the community (Table 4).

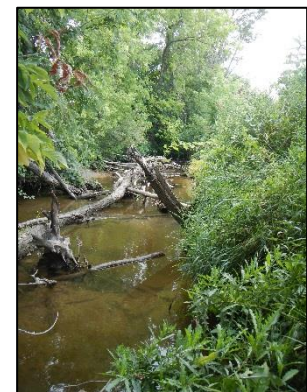
Figure 8. Dead Creek (upstream Sargent Road) 2016.

Dead Creek upstream of Sargent Road is a straightened road-side ditch, but contained a surprising amount of in-stream habitat and complexity. Woody debris was abundant and the stream was well shaded even though riparian width was less than 10 meters on the west bank and was bordered by an agricultural field on the east bank. Concrete slabs stabilized the west bank along the road, but also

provided some in-stream substrate. Overall, habitat for this site scored Good (110) and macroinvertebrates scored Acceptable (3) (Tables 3 and 4).

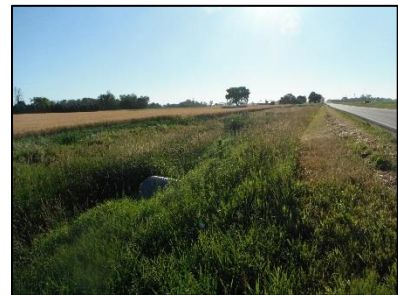
Figure 9. Sanilac Huron Creek (upstream Bay Forestville Road) 2016.

Sanilac Huron Creek is a small tributary to the North Branch Cass River near Sanilac State Game Area. In 2006, Sanilac Huron Creek was sampled downstream of Bay Forestville Road and found to have Acceptable macroinvertebrates (-2) and Marginal habitat (59). In 2011, the stream was sampled upstream of the road-stream crossing, making it difficult to assess trends. The upstream site had Acceptable macroinvertebrates (-4) and Marginal habitat (79). In 2016, it was decided that the upstream site would be sampled and this would become the new trend site. The stream in this reach is a narrow, straightened ditch with grasses and cattails dominating the riparian vegetation and no shrubs or trees present. In-stream substrate was dominated by sand and gravel and some riffles and small pools were evident. Macroinvertebrates scored Acceptable (1) while habitat scored Marginal (90) (Tables 3 and 4).

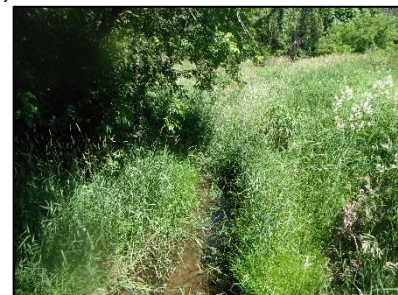
Figure 10. Sanilac Huron Creek (upstream Ritter Road) 2016.

Similar to the Sanilac Huron Creek site at Bay Forestville Road, the site at Ritter Road (~1 mile downstream) was sampled at different locations in 2006 and 2011 making trend analysis difficult. In 2006, Sanilac Huron Creek was sampled downstream of the road-stream crossing and found to have Acceptable macroinvertebrates (1) and Good habitat (105). In 2011, the stream was sampled upstream of the road-stream crossing and found to have Acceptable macroinvertebrates (1) and Good (136) habitat. In 2016, it was decided that the upstream site would be sampled and this would become the new trend site. Substrate at this site consisted of cobble on bedrock with some depositional areas. Most of the stream was bordered by mixed deciduous forest, had abundant overhanging vegetation, and some aquatic macrophytes, but little in-stream woody debris. Macroinvertebrates in this reach scored Acceptable (2) while habitat scored Good (138) (Tables 3 and 4).

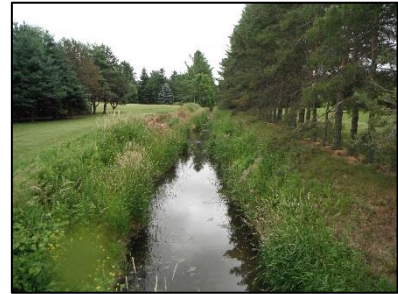
Figure 11. Turtle Creek (upstream Wheeler Road) 2016.

Turtle Creek is currently listed as not supporting the OIALW, Fish Consumption, Total Body Contact Recreation, and Partial Body Contact Recreation Designated Uses. Turtle Creek is a highly modified county drain and several previous surveys have shown its characteristics, along with a history of illicit connections and pollution problems, are not conducive to high quality macroinvertebrate assemblages. A survey in 1989 noted a poor biological community due to low current velocity and stream flow, and poor habitat (Masterson, 1989). In a 2006 survey of the stream, Turtle Creek was described as a “health hazard” due to illicit sewer connections from the community of Snover and observations of sanitary sewers flowing directly into the creek (Cooper, 2007). Macroinvertebrates scored Poor (-7), as did habitat (54) in the 2006 survey.

In 2007, a wastewater sewage lagoon was placed in service addressing at least some of the illicit connections, and likely resulted in an improvement in water quality. However, in 2011, Turtle Creek macroinvertebrates still scored low Acceptable (-2), while habitat was Marginal (78), and presence of algae was again noted indicating problems may still exist. Similar observations were noted in 2016. In 2016, Turtle Creek had very little current velocity. The riparian areas were similar to previous years and abundant dead algae was found. The stream had a borderline Poor macroinvertebrate score of Acceptable (-4), and Marginal habitat (70) (Tables 3 and 4). A 5-week E. coli study was also completed in 2016 and found that there may still be illicit connections or failing septic systems in the area, indicated by high E.coli in dry weather and during low flows (draft MDEQ Report). The creek will be proposed as part of the draft statewide E. coli TMDL (www.Michigan.gov/ecolimtld).

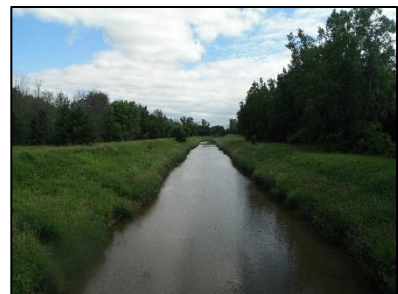
Figure 12. South Branch Cass River (upstream Shabbona Road) 2016.

The South Branch Cass River is a maintained drain and is highly modified throughout most of its length. There was a fair amount of cobble throughout the sampled reach; however, most available habitat was covered in silt. As is the case in most maintained drains, the South Branch Cass River in this area was very uniform in depth and contained little habitat complexity. Macroinvertebrates have scored Acceptable in all years; however, the scores have gotten progressively worse since 2006, moving from high acceptable in 2006 (2) to low acceptable in 2016 (-4). The most notable decline is in number of mayfly taxa (5 to 1 taxa), and percent mayfly composition (22.3 to 1.42 percent). Habitat scores have also declined since 2006 (2006: 107; 2011: 69; and 2016: 69), with lower scores for available habitat, bank stability, and vegetative protection.

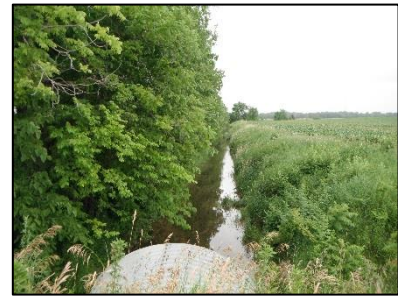
Figure 13. White and Moffatt Drain (upstream Dennis Road)

White and Moffatt Drain is a straightened, channelized, drain that flows into the North Branch White Creek in western Sanilac County. Surrounding landscape has changed little in the past 15 years and macroinvertebrates and habitat have remained similar. In 2006, the macroinvertebrate community scored Acceptable (-1), while habitat scored Marginal (88). In 2011, the macroinvertebrate community scored Poor (-5), while habitat scored Marginal (68). In 2016, the macroinvertebrate community scored Acceptable (-3), while habitat scored Marginal (84). Macroinvertebrates in this reach will likely remain at the lower end of Acceptable pending drastic changes in drain maintenance practices and current land use in the surrounding watershed.

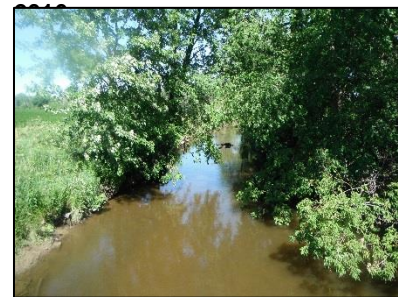
Figure 14. North Branch White Creek (upstream McArthur Road) 2016.

North Branch White Creek is a moderate size, low gradient tributary to the Cass River. Habitat at this site scored higher in 2006 (124), and similar in 2011 (91) and 2016 (94). There was less than desirable available habitat in all years due to siltation. Macroinvertebrates scored Acceptable in all 3 years, although there were fewer mayfly taxa and less percent mayfly and caddisfly composition in 2016, leading to a lower score in 2016 (2006: 0; 2011: 0; 2016: -3). This site also had abundant rusty crayfish and a few dense mussel beds.

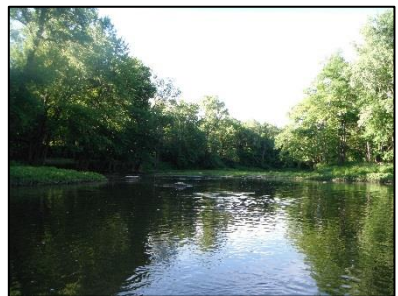
Figure 15. Cass River at Pinkerton Road (looking downstream from top of reach) 2016.

The Cass River at Pinkerton Road is a reach typical of the mainstem Cass River between Caro and Frankenmuth, characterized by wide, shallow reaches with shallow pools, occasional riffles, and a good variety of substrate, and in-stream habitat. Emergent vegetation lines the margin of the river in this section and provides excellent habitat for macroinvertebrates. Habitat scored Good in all years and was very similar in 2006 (136), 2011 (138), and 2016 (145). Macroinvertebrates scored Excellent in 2006 (6), 2011 (6), and 2016 (5).

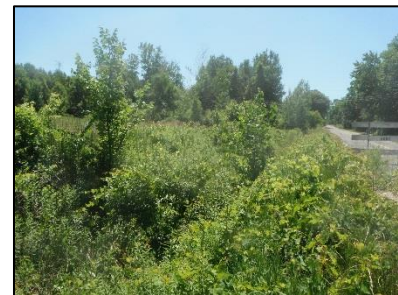
Figure 16. Dead Creek (upstream Center Road) - June 2016.

Dead Creek at Center Road is a maintained drain that has been dredged at least twice in the last 15 years. During the 2006 survey, dredging was occurring during sampling and thought to be the cause of the Poor (-6) macroinvertebrate community and Marginal (69) habitat observed (Cooper, 2007). Macroinvertebrate scores were much higher in

2011 (Macroinvertebrates: Acceptable (1); Habitat: Good (112)) when dredging was not occurring and similar, although slightly lower, in 2016 (Macroinvertebrates: Acceptable (-1); Habitat: Good (71)). Sometime between sampling in June 2016 and February 2017 this reach was again dredged and riparian habitat removed (personal observation, K. Turek) possibly as part of a culvert replacement (new bridge was constructed around this same time at the road-stream crossing). In February 2017, no vegetation remained and the banks were completely covered in rolled straw. This likely influenced the macroinvertebrate community a great deal, as overhanging riparian vegetation accounted for the majority of available macroinvertebrate habitat at this site. The macroinvertebrate community at this site will likely fluctuate with continued dredging, seeing improvements in the community as the stream recovers until the next dredging when it will likely revert back to a Poor community.

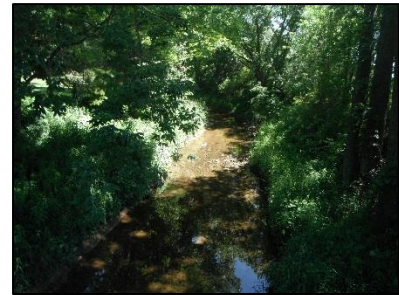
Figure 17. Dead Creek (upstream Townline Road) 2016.

Dead Creek at Townline Road had an Acceptable (-1) macroinvertebrate community and Good (130) habitat in 2016 (Tables 3 and 4). This reach had little in-stream vegetation and some overhanging vegetation and rootwads, the majority of which was unavailable to macroinvertebrates due to low flows. There was a good mix of stable substrate and velocity/depth regimes, but also a fair amount of embeddedness. This site scored similar in 2006 (Macroinvertebrates: Acceptable (0); Habitat: Good (145)), and 2011 (Macroinvertebrates: Acceptable (0); Habitat: Good (140)). The slightly lower score in 2016 was due to a decrease in number of mayfly and caddisfly taxa (Table 4). Habitat was similar among years with slightly more embeddedness and sediment deposition in 2016 than previous years. However, flows were also lower in 2016, which may have resulted in the increased deposition and thus embeddedness.

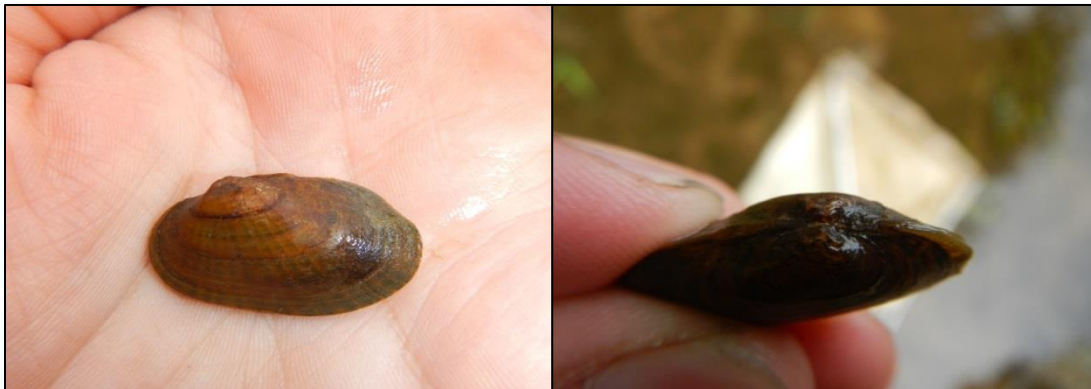
Figure 18. *Venustaconcha ellipsiformis* found in Moore Drain downstream of Spring Street (~30-35 millimeters in size).

One State listed Species of Special Concern freshwater mussel, *Venustaconcha ellipsiformis*, was also found downstream of Spring Street in 2016. It is unknown whether or not the species occurred in the drain prior to the project or at what densities it may have occurred; however, the Cass River contains some of the densest populations of *V. ellipsiformis* in the state so its occurrence is not surprising. One of the largest populations on record with Michigan Natural Features Inventory was found in Goodings Creek in 2003-2004 (Badra, 2004). Goodings Creek is a tributary that flows into the Cass River approximately 1 mile downstream of the mouth of Moore Drain.

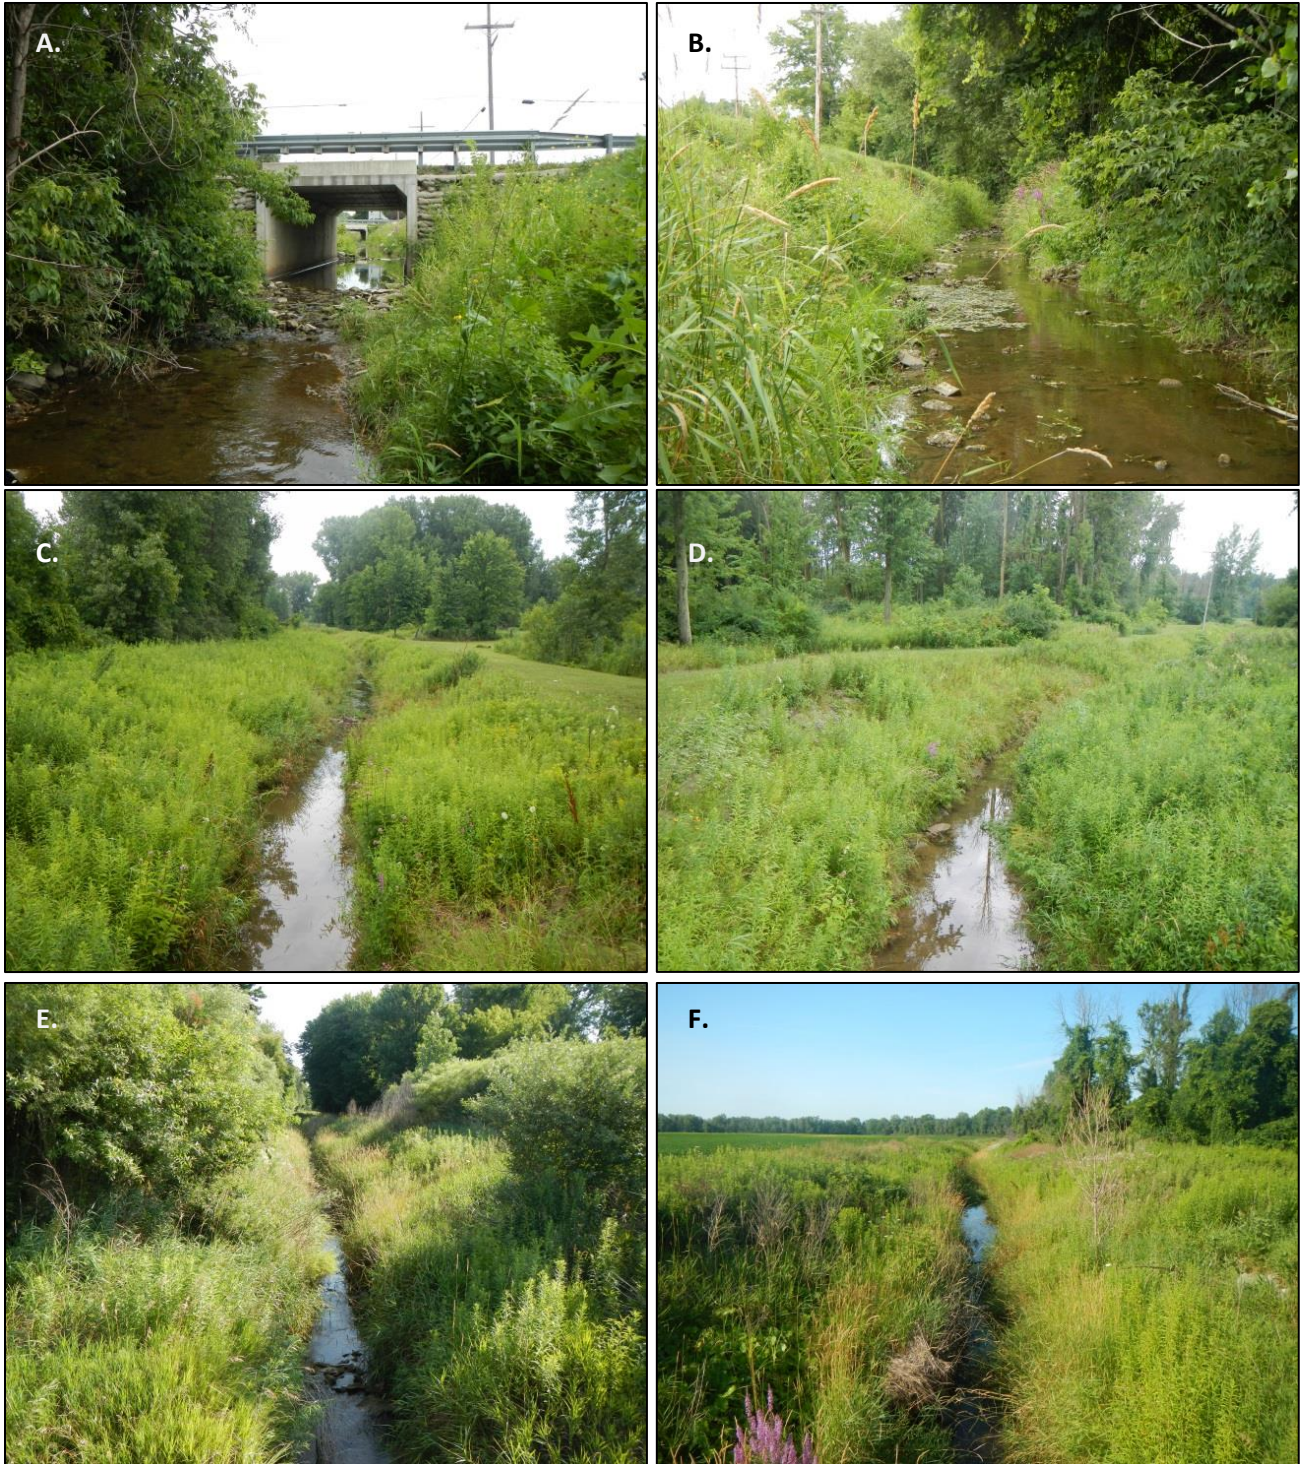
Habitat conditions scored Good (112) at Spring Street, Marginal (66) at Waterman Road, and Good (105) at Sanilac Road in 2016. Macroinvertebrate communities were Acceptable at Spring Street (-2), Acceptable at Waterman Road (-2), and Acceptable (-4) at Sanilac Road. The Waterman Road and Sanilac Road sites had not been previously sampled. As noted previously in 2006 at the Spring Street site, there was some in-stream habitat consisting of rock substrate (bricks and concrete), and vegetation, although most surfaces were covered in

filamentous algae making it non-ideal for colonization. Habitat, in general, scored similar in 2006 and 2016 at Spring Street and no notable improvements in physical habitat were observed. A lack of non-herbaceous riparian vegetation at the stream margins, as well as in-stream woody debris, was evident throughout Moore Drain. Although the project may have improved some aspects of flow, the available habitat for macroinvertebrates likely has not improved since 2006 and it is not recommended that the attainment status be changed at this time.

Figure 19. Moore Drain: (A.) Downstream of Spring Street; (B.) Upstream Spring Street; (C.) Downstream Waterman Road; (D.) Upstream Waterman Road; (E.) Downstream Sanilac Road; (F.) Upstream Sanilac Road.

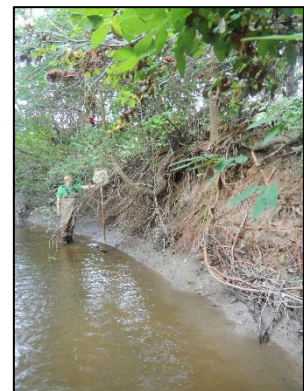
Arguably the greatest NPS concern throughout the Cass River watershed is the lack of riparian protection in headwater tributaries to the Cass River. Improved riparian buffers and farming practices in many areas would result in improved water quality in the Cass River. One particular site observed during the 2016 surveys was on Millington Creek at Ormes Road. Indicators of flashy flows and little riparian vegetation were observed and the majority of outside bends were highly eroded (Figure 21). This erosion is likely contributing large amounts of sediment to Millington Creek and subsequently the lower Cass River. However, this was only one of relatively few sites assessed in 2016, and higher priority areas within the watershed may exist.

Figure 21. Example of Millington Creek Erosion (note: riparian width here was <10 feet).
