Michigan Department of Environment, Great Lakes, and Energy
Water Resources Division
November 2021
Staff Report

Biological surveys and water chemistry sampling of selected stations in the Thornapple River watershed in Barry, Eaton, Ionia, and Kent Counties, Michigan: 2015-2018

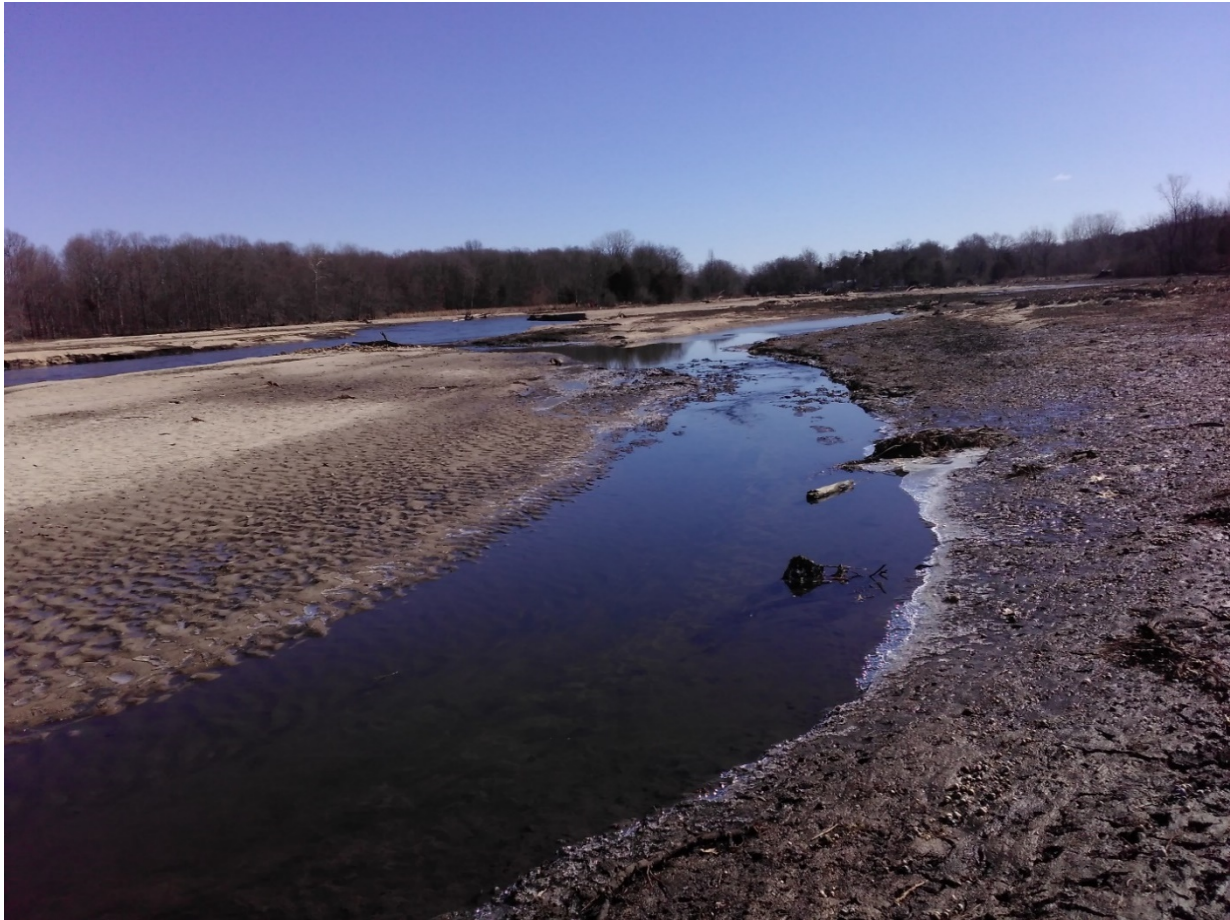
Figure 4. Exposed sediment above Irving Dam, after earthen berm was breached and the impoundment had drained in February 2018.

In 2013 the Thornapple River at Irving Road, below the Irving dam and impoundment, scored excellent (+6) for macroinvertebrate community and good for habitat (122) (Rippke, 2015). In 2018, following the breach of the impoundment, the macroinvertebrate community remained in excellent condition and even increased slightly (+8), while the habitat rating declined to marginal (99). The decline in habitat score was related to increased sediment deposits, resulting in a poor score for the sediment deposition habitat metric in 2018, while prior to the breach and subsequent sediment movement, the site had scored excellent in that metric. This corresponded with a decreased amount of epifaunal substrate (available cover for macroinvertebrates) with scores for that metric falling from good condition in 2013 to the marginal category in 2018. It was also observed that cobble was a dominant substrate of the stream bed in 2013 (approximately 30 percent of the survey area), but in 2018 cobble was only 3 percent of the

survey area. In 2018 the substrate was estimated to be 90 percent sand. The cobble would have provided habitat niches for macroinvertebrates and was likely buried in sediment released during the breach and during heavy precipitation in the following year.

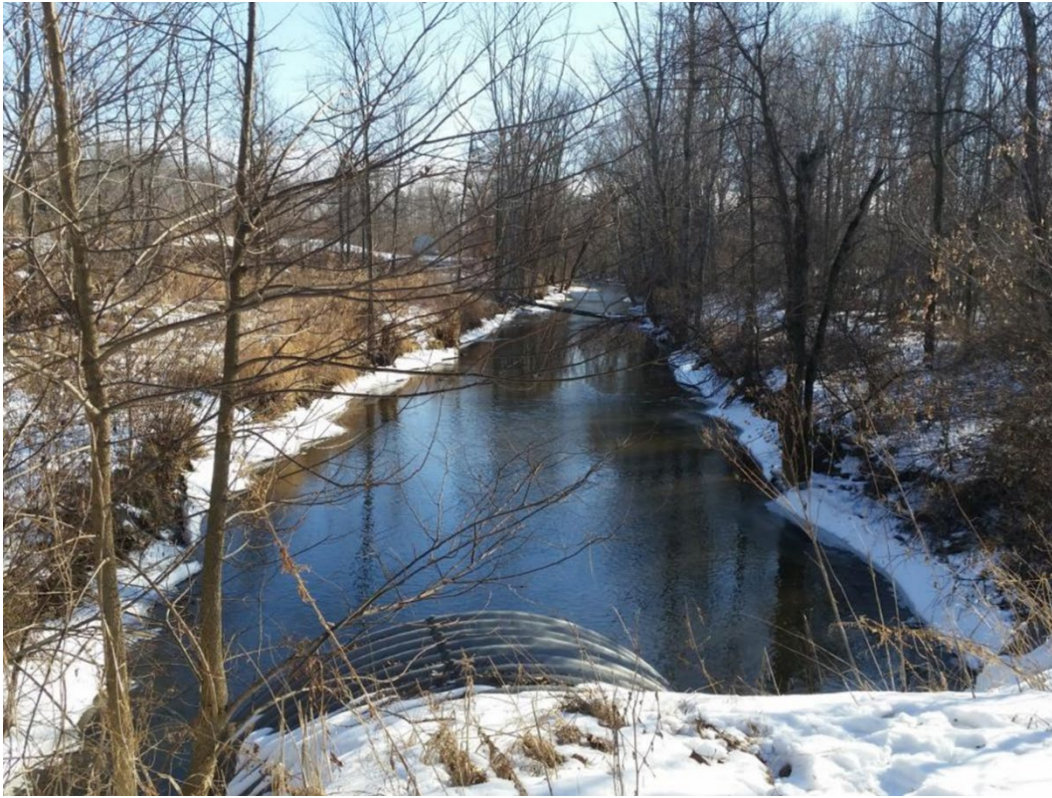
Figure 5. Coldwater River looking east (upstream) from Messer Road in January 2015, before drain work started.

- The macroinvertebrate community at Coldwater River at Messer Road was coincidentally also monitored in 2013 (Rippke, 2015). The macroinvertebrate community at this site scored +6 (excellent) in 2013 and fell to acceptable in 2015 and 2018 (scores of +2 and 0, respectively) following drain maintenance activities (Figure 5). This site was directly impacted by channel dredging activities and as the most downstream impacted site, also received indirect impacts from the in-stream sediment disturbances and bank modifications upstream. In 2013, long cobble and gravel riffles were present at this survey location providing valuable habitat. Likely a direct result of drain activities, in 2018, these riffles were composed of sand and gravel, with cobble no longer present in the center of the stream channel and only at the edges.

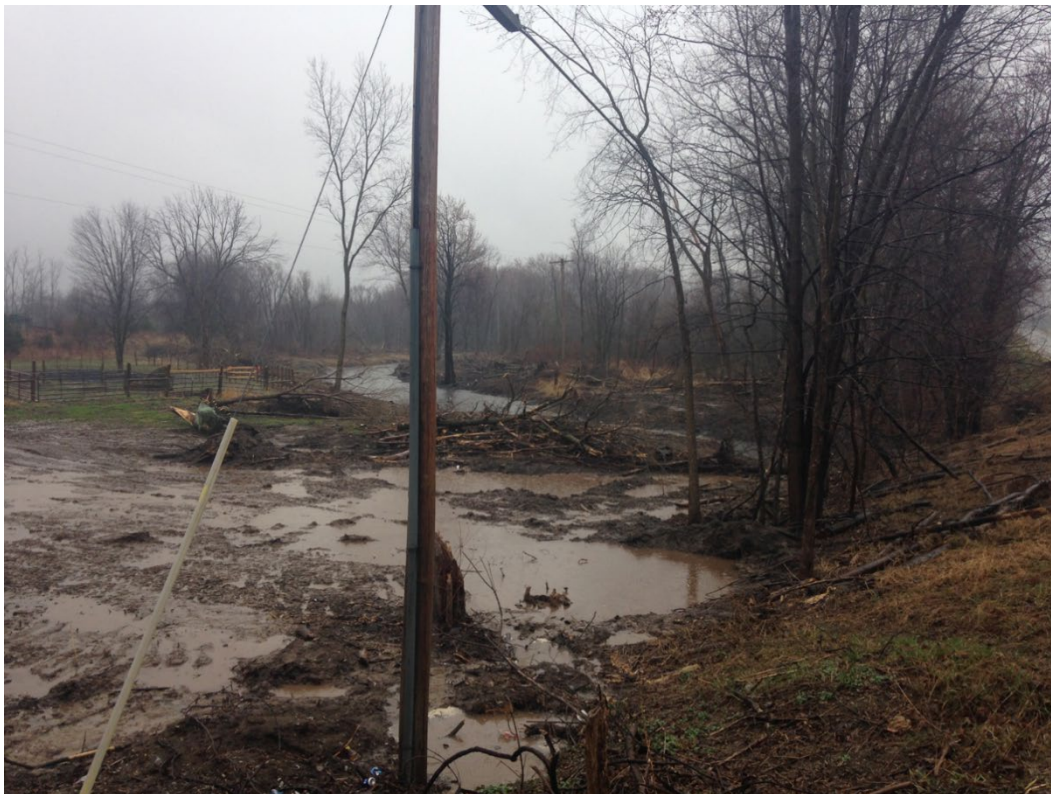
Figure 6. Little Thornapple River mainstem, looking north (upstream) from M-43 in April 2015, after drain work disturbance.

- The Little Thornapple River upstream of M-43 rated low acceptable in 2015 (-3), with the score increasing to 0 in 2018 (Figure 6).
- The macroinvertebrate community scores at the Little Thornapple River upstream of M-43 (080269) and Rush Road (080244) each improved between 2015 and 2018 surveys, indicating some recovery (Figure 7). No 2013 surveys were conducted at either site so no pre-disturbance baseline data exists. In-stream structures to improve habitat were noted at Rush Road, and tree planting had occurred upstream of M-43.

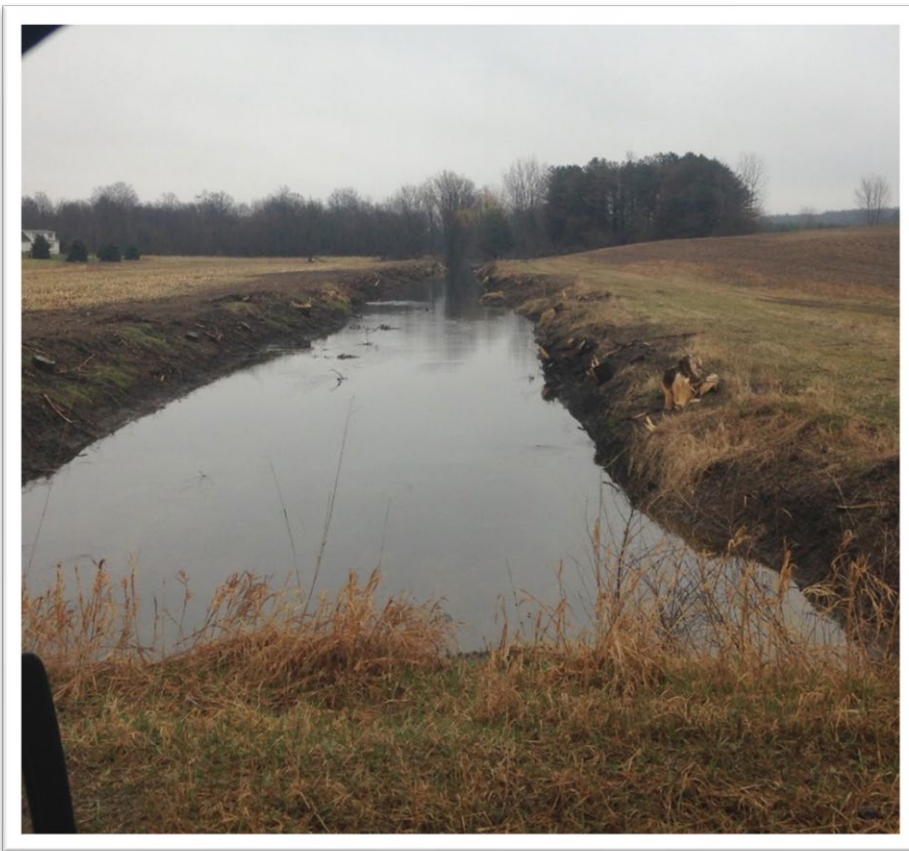
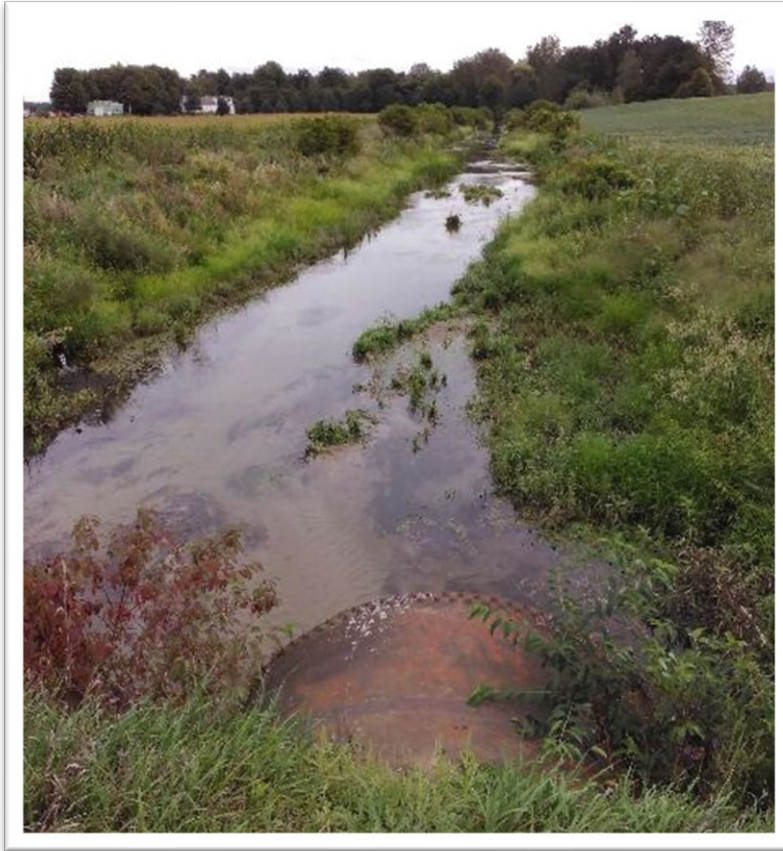
Figure 7. Upstream view of Little Thornapple River from Rush Road in April 2015 after drain work (left) and recovering in 2018 (right).

- Habitat scores at all three sites, which were monitored in both 2015 and 2018, improved slightly during that time, also indicating recovery after the 2015 disturbance. In-stream habitat was largely limited to aquatic macrophytes, with little or no large woody debris, no undercut banks, and little overhanging vegetation.

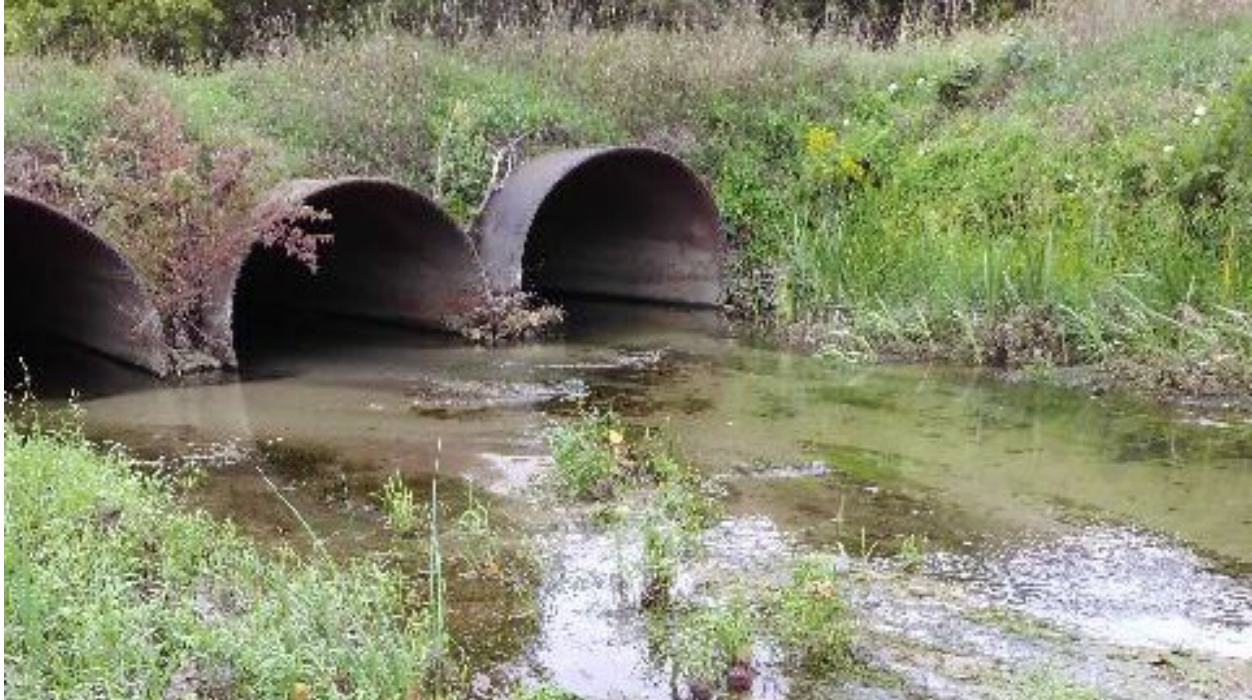
In addition to the issues with sediment movement and accumulation noted in Objective 2 (downstream of Irving Dam) and Objective 3 (Coldwater River drain maintenance), old and undersized culverts continue to be an issue throughout the watershed (**Figure 8**; also see photos contained in Rippke, 2015). Additionally, the following nonpoint source related issues were noted:
