MICHIGAN DEPARTMENT OF ENVIRONMENT, GREAT LAKES, AND ENERGY
WATER RESOURCES DIVISION
JUNE 2022

STAFF REPORT

BIOLOGICAL AND SEDIMENT CHEMISTRY SURVEYS OF SELECTED
LOWER GRAND RIVER WATERSHED STREAMS
IONIA, KENT, MONTCALM, MUSKEGON, AND OTTAWA COUNTIES, MICHIGAN
AUGUST-SEPTEMBER 2019

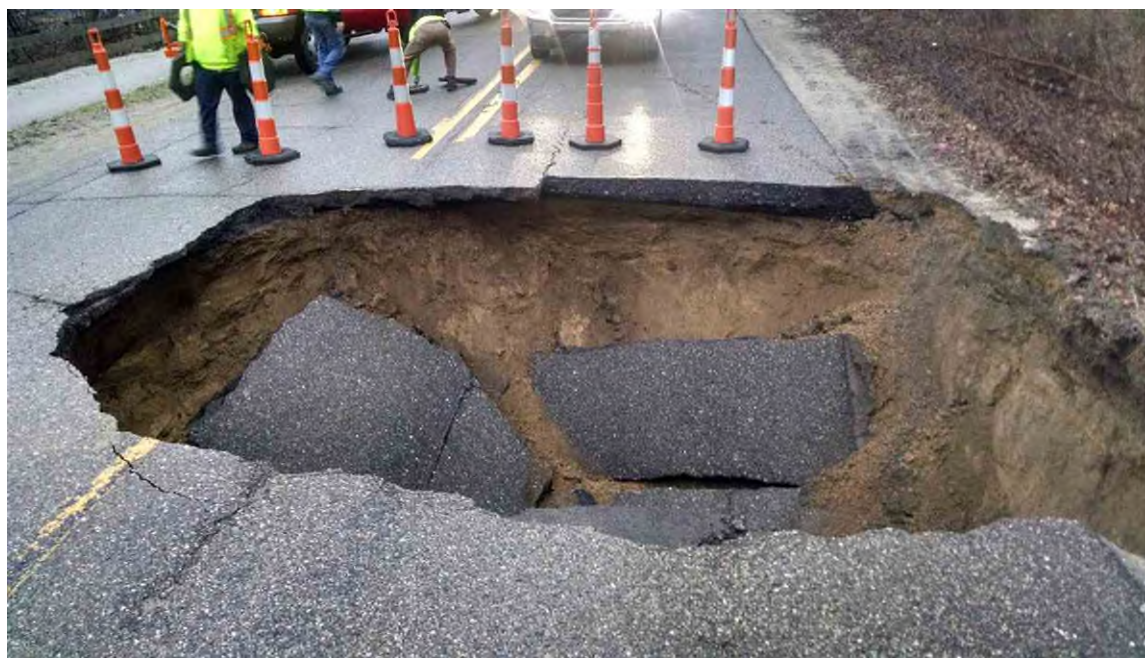
On March 1, 2017, during a heavy rainstorm, a culvert failure occurred on 148th Avenue in Spring Lake Township. The culvert failure occurred when a hole developed in the middle of a 30-inch diameter pipe under about 17-18 feet of soil. Soil from the road berm washed out and eventually caused the pavement to collapse on 148th Avenue (Figure 7), causing large amounts of sediment to enter an unnamed tributary to Lloyds Bayou (Figure 8). A new, 36-inch diameter culvert has since been installed. Every year, culvert failures occur in the state, particularly in the spring, during large rain events. This stream was sampled in 2017 and again in 2019 to evaluate habitat and macroinvertebrate communities immediately after a culvert failure and in subsequent years.

Figure 7. Collapsed section of 148th Avenue in Spring Lake Township after a culvert failure. Image from Grand Haven Tribune online article (link no longer available).

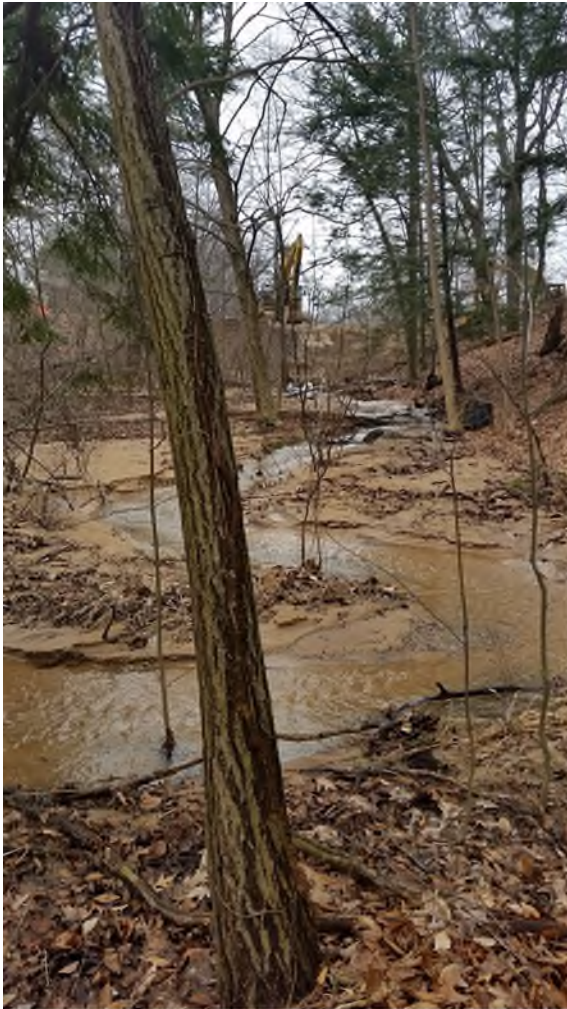
A similar macroinvertebrate community was found at that site in 2017, four months after the culvert failure. In 2017 much of the stream bank was covered with bare sand from the berm, which lowered the habitat score at the time (116 [good]; Figure 8). During the 2019 visit, vegetation was growing along the banks and stabilizing the soils (Figures 8 and 9).

Figure 8. Before and after photos of stream banks below 148th Avenue. Photographs on left were taken in March 2017, shortly after the culvert failure. Photos on the right were taken in May 2020.

The macroinvertebrate communities upstream and downstream of 148th Avenue in Spring Lake Township, remained largely the same two years after the culvert failure. Although, habitat has improved, mostly in the form of revegetation in the riparian areas. Upstream and downstream of Farr Road in Fruitport Charter Township, the macroinvertebrate communities also remained similar one year after the culvert failure.

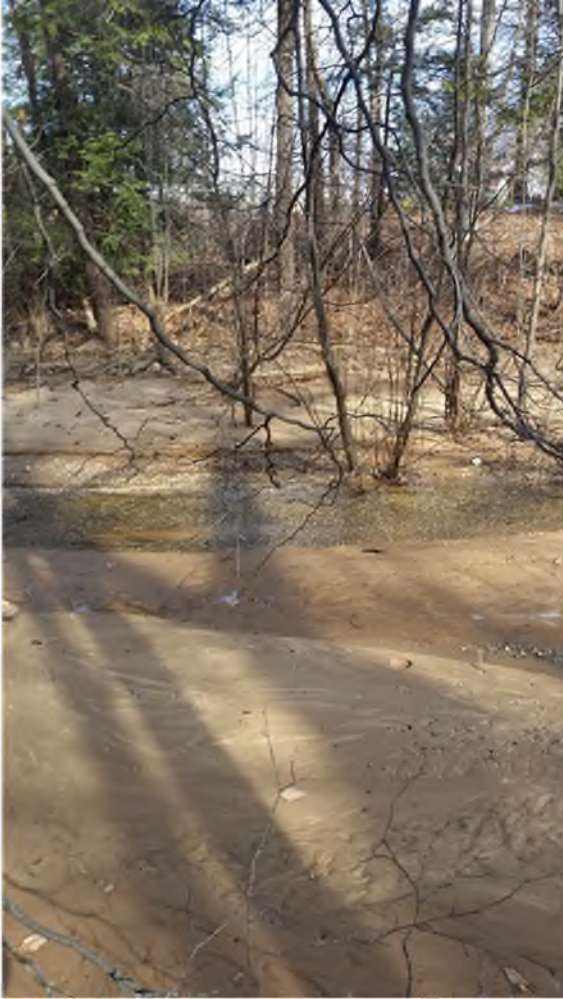
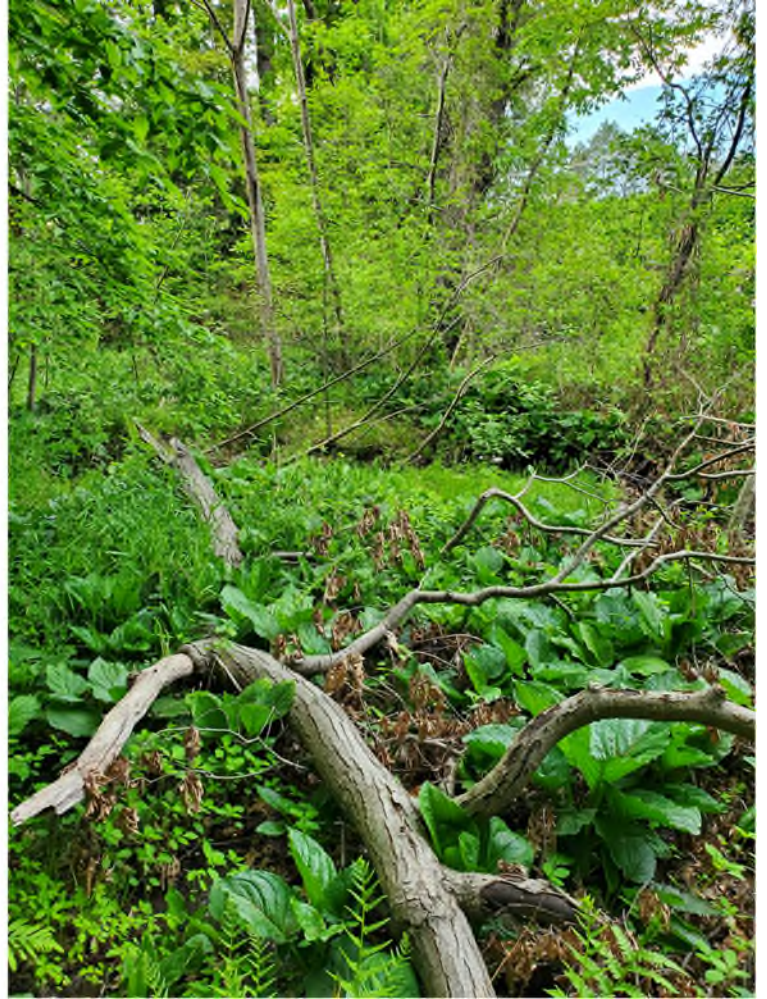
Figure 9. Before and after photos of stream banks below 148th Avenue. Photographs on left were taken in March 2017, shortly after the culvert failure. Photos on the right were taken in May 2020.

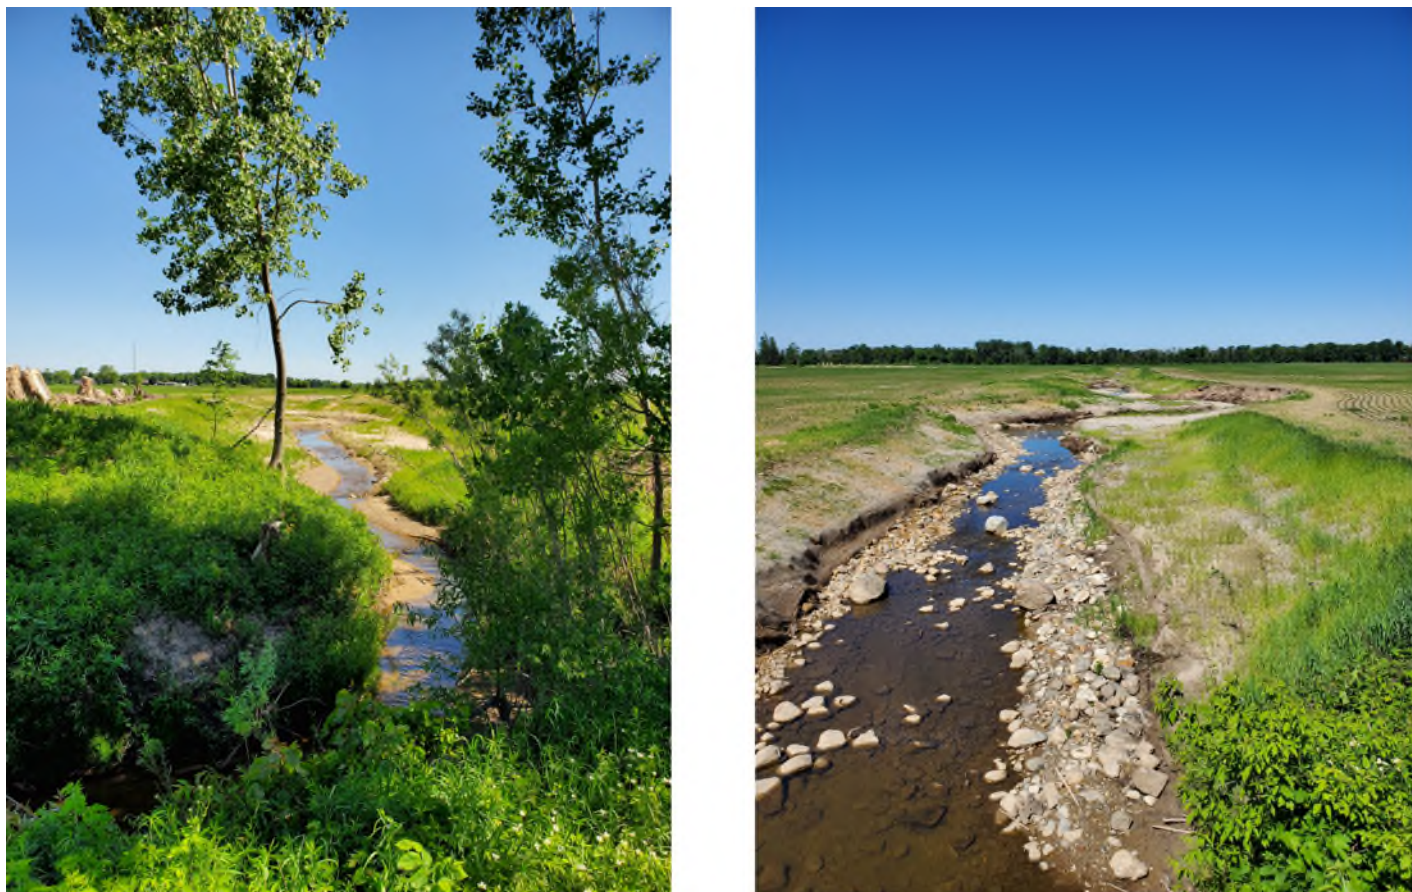
Slightly downstream from 32nd Avenue, Sand Creek was sampled above Wilson Street. This site was sampled prior to the implementation of extensive lengths of two-stage ditches (Figure 10) and upland stabilization. The macroinvertebrate community at Wilson Street scored low acceptable (-2; Appendix 2) and habitat scored marginal (83; Appendix 1). Seventeen taxa were collected, of which, only 3 were EPT, indicating poor habitat and/or water quality. The taxa were dominated by a mix of Chironomidae, Isopoda, and Calopterygidae, all of which tend to dominate in stressed systems (Voshell, 2002). All habitat types such as large woody debris and undercut banks were either sparse or absent. The substrate was an even mixture of clay, silt, sand, and gravel. The stream banks showed signs of flashiness with scour greater than 18 inches above the water surface, storm debris was observed in tree branches about 7 feet above baseflow, and banks were actively eroding. The stream at baseflow was also not

occupying the entire channel and several sediment bars were present. The riparian vegetation was diminished by row crops on both sides of the stream.

Figure 10. Two-stage ditch banks at Wilson Street site (left photo) and slightly upstream (right photo) in June 2020.
