Fish, Macroinvertebrate, and Stream Habitat Surveys in the Manistee River Watershed, Michigan, July-August 2019

Michigan Department of Environment, Great Lakes, and Energy (EGLE)
Water Resources Division (WRD), Surface Water Assessment Section (SWAS)

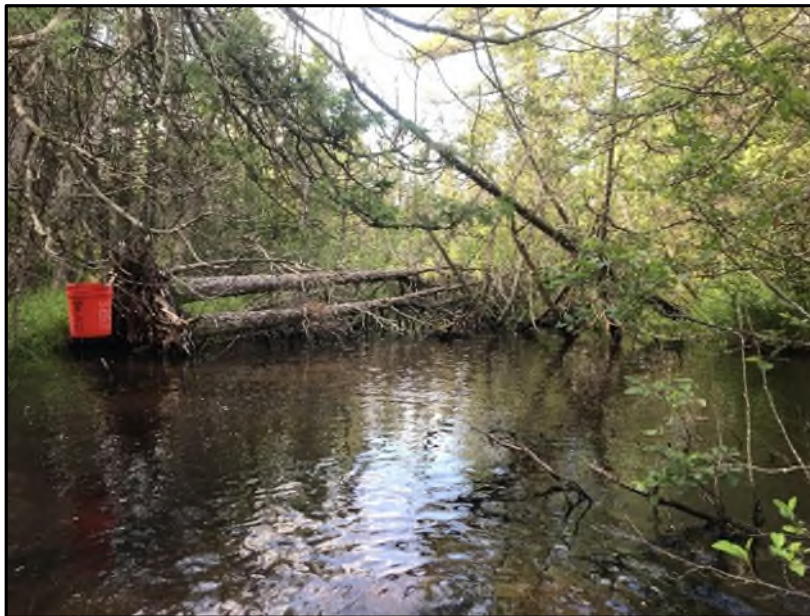
Photo 1. Anderson Creek at County Line Road, Grand Traverse County, 2019.

Anderson Creek was sampled at County Line Road (Station 1; Photo 1). Sand and coarse and fine particulate organic matter was common in this reach. *Vallisneria* plants and undercut banks were available for colonization.

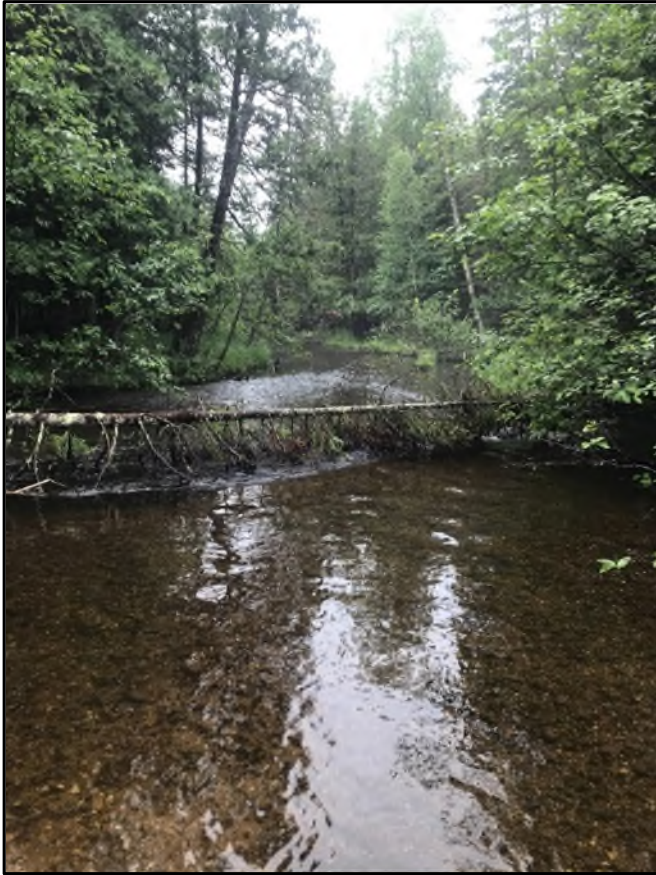
Photo 2. Little Cannon Creek downstream of Dutch John Road, Kalkaska County, 2019.

Little Cannon Creek was sampled downstream of Dutch John Road (Station 2; Photo 2). The riparian zone was fully intact with only a small unpaved driveway running along one side of the stream. Rootwads, overhanging vegetation, large woody debris (LWD), and gravel were all available for epifaunal substrate.

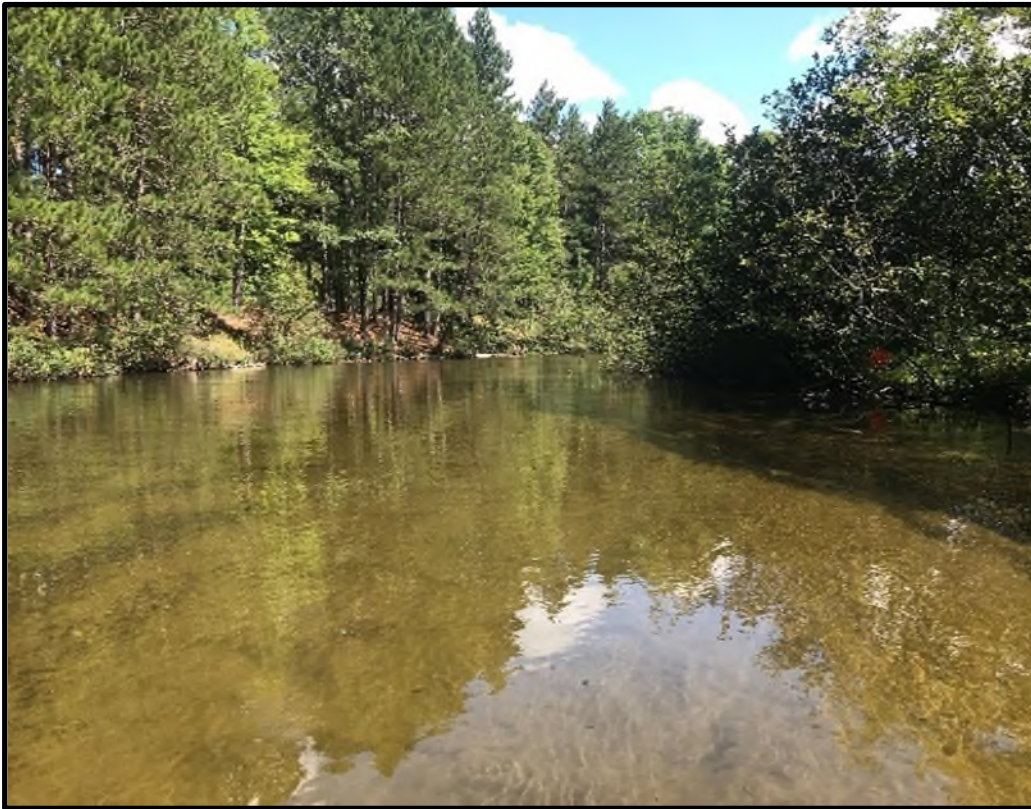
Photo 3. Manistee River off Weber Road. August 2019, Kalksaka County.

The upper portion of the Manistee River (i.e., from headwaters to US-131) was sampled at two stations off Weber Road. The most upstream site (Station 3) had a large amount of aquatic vegetation on the inside bend where the sand and silt had deposited. Except for the remnants of bankside fish habitat best management practices, there was a lack of LWD. The stream flow was fast throughout the reach. Gravel substrate was available on the outside bend and in deeper parts of the stream where flow was highest. Undercut banks were sparse. Station 4 is located just 1.5 miles downstream of Station 3. The flow continued to be fast, but the river was shallower and wider. There was more gravel and cobble available for colonization, and no pools were present. The periphyton growth was more noticeable as well. There continued to be a lack of LWD.

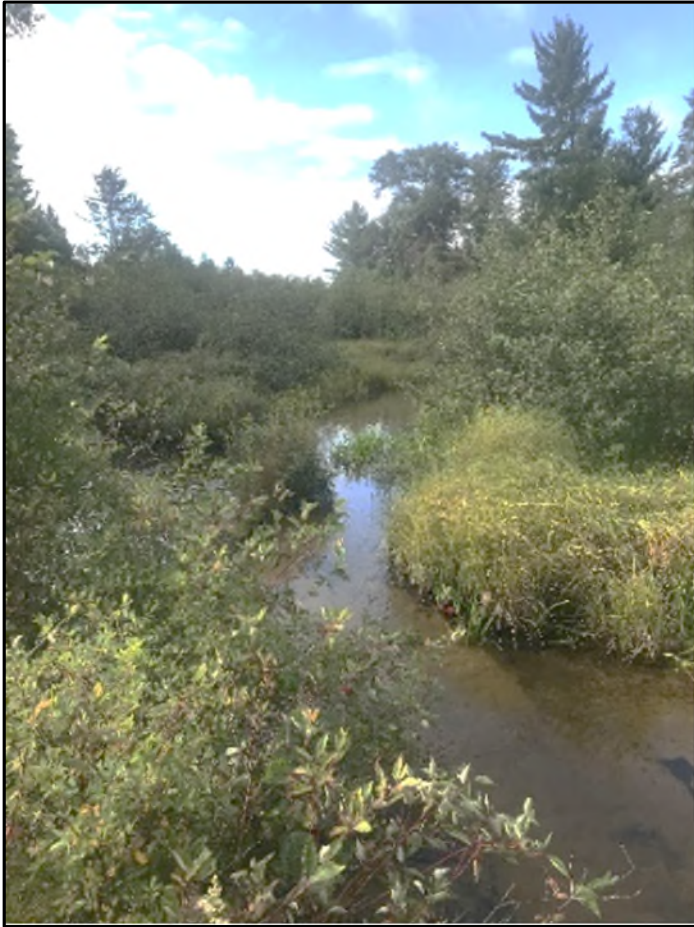
Photo 4. Big Cannon Creek off Naples Road, Kalkaska County, 2019.

The stream habitat and fish community were both sampled at Big Cannon Creek at Naples Road (Station 5; Photo 4). There were deep deposits of shifting sand especially just upstream of the culvert. No gravel or cobble was available. There was a small amount of LWD and macrophytes. Pools were limited to the undercut banks found at the outside of bends. The fish community met the coldwater fish designated use requirement of at least 1 percent Salmonidae species. Five percent of the taxa found were Salmonidae (brown trout). Other species found are noted in Table 5.

Naples Road consists of very loose sand that has been disturbed repeatedly by off road vehicles. Sand is pushed into the creek at the culvert crossing. Shifting sand more than a foot deep in places was observed in the stream. This station would be a good opportunity for a road crossing improvement project and possibly restrictions regarding vehicle use. The stream otherwise has very natural habitat.

4. The Naples Road crossing of Big Cannon Creek consists of very loose sand that has been disturbed repeatedly by off-road vehicles and is being pushed into the stream. This station would be a good opportunity for a road crossing improvement project and possibly restrictions regarding vehicle use.

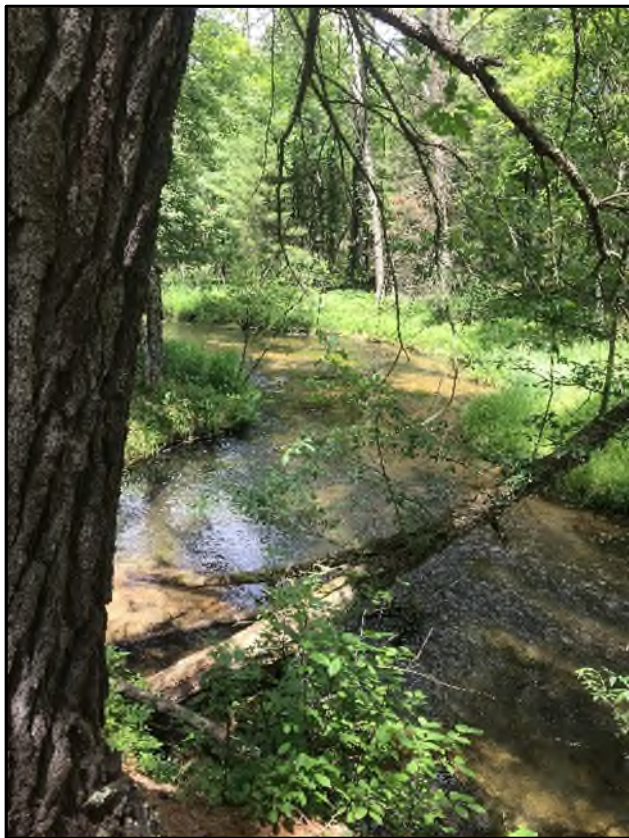
Photo 5. Slagle Creek at S1 Road, Wexford County, 2019.

Slagle Creek was sampled downstream of S1 Road (Station 6; Photo 5). Epifaunal substrate consisted of gravel mixed with sand and some cobble. There was a large amount of habitat diversity with overhanging vegetation, LWD, and in-stream vegetation including periphyton, filamentous algae, and macrophytes throughout the reach. Vegetation was not at nuisance levels but was denser than what is typically found in a stream of this size in the Manistee River watershed. It is an open sunny area until mid-afternoon.

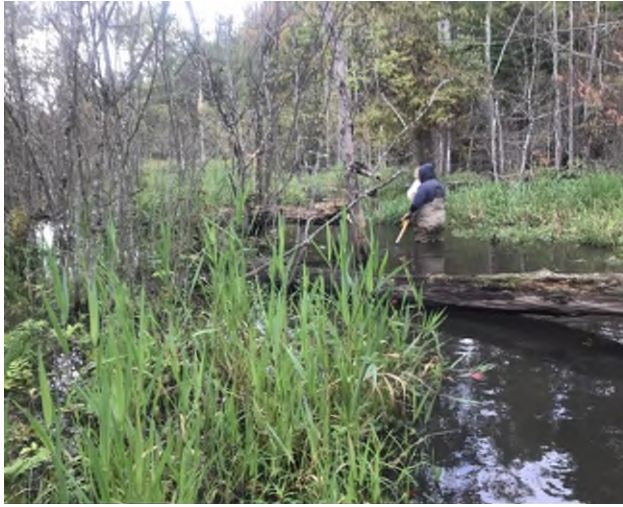
Peterson Creek was sampled downstream of S7 Road (Station 7; Photo 6**Error! Reference source not found.** and Photo 7). The substrate was dominated by sand and silt mixed with clay that made it slippery. LWD was present but was not available due to silt covering it. Grass was growing in the areas that formerly were sand deposits just upstream of the culvert. The culvert only had ten inches or so of clearance because the water was so high. Trees in the floodplain are dying, at least in part, due to high water levels inundating the riparian flood plain.

Photo 6. Peterson Creek at S7 Road, Wexford County, 2019. Note high water levels.

Macroinvertebrates were rated at the lower end of acceptable (-3). Previous years indicated an excellent (7) macroinvertebrate community. Sampling this station was difficult due to the high water levels, but a drop of 8 points is concerning. Sampling should be repeated during a year with lower flows to see if conditions remain. This road crossing should be considered for culvert replacement with an open bottom bridge (Photo 6 and Photo 7).

5. Peterson Creek at S7 Road is experiencing very high water levels compared to past years. Sampling should be repeated during a year with lower flows to see if conditions remain. This road crossing should be considered for culvert replacement with an open bottom bridge.

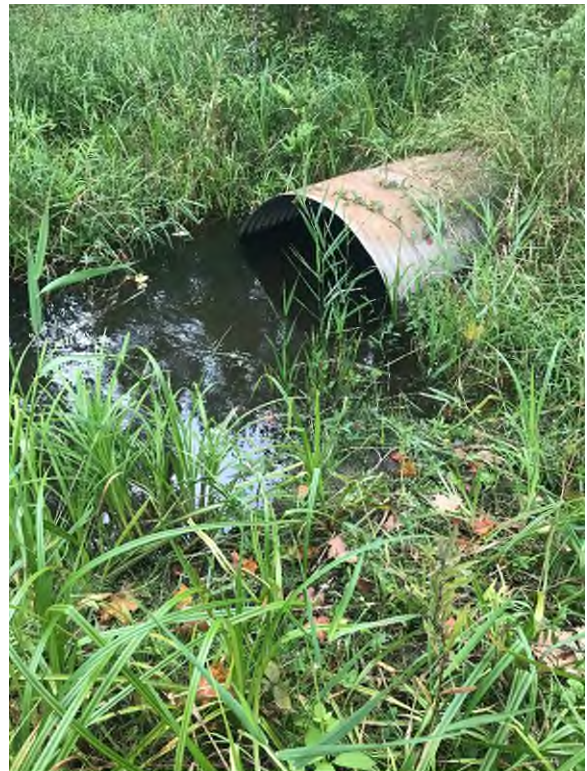
Photo 7. Peterson Creek at S7 Road, note undersized culvert in relation to stream size.

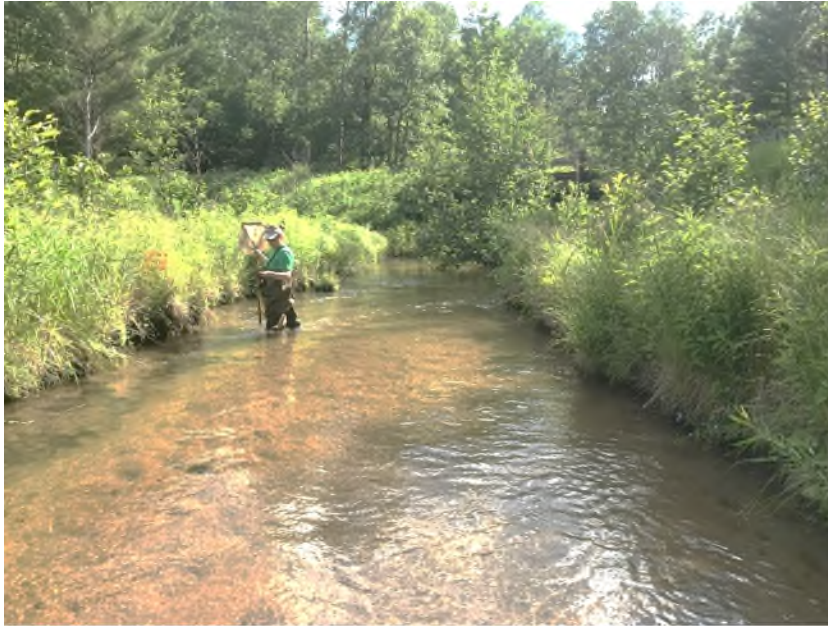
Photo 8. Poplar Creek at S15 Road, Wexford County, 2019.

Poplar Creek is a tributary to the Pine River and was sampled at S15 Road (Station 8; Photo 8). Substrate was entirely sand with an abundance of embedded LWD, half of which was covered by sand. Large globular bunches of algae were growing in and stabilizing the sand. The reach had a lot of pool diversity. Undercut banks with overhanging grasses were available for epifaunal substrate. The riparian area was wetland in nature with the right bank being slightly impacted by the road.

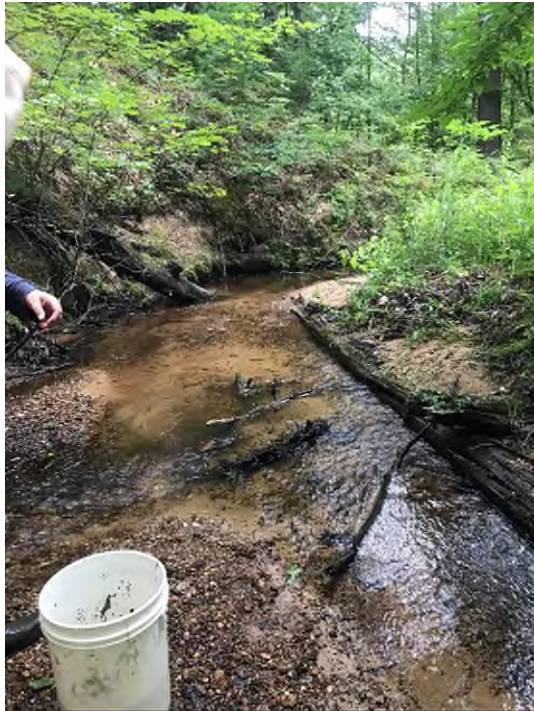
Photo 9. Claybanks Creek upstream of Pine Creek Road, Manistee County, 2019.

Station 9 (Photo 9 and Photo 10) was on Claybanks Creek at Pine Creek Road. The stream is in a deep ravine. It is apparent that the stream is very flashy and eroding the streambed possibly during snow melt or periods of hard rain. The banks were scoured as high as five feet in places. The stream channel was braided in areas due to the large deposits of gravel and sand. LWD was present; however, much of it had been pushed outside of the channel and therefore was not available for colonization.

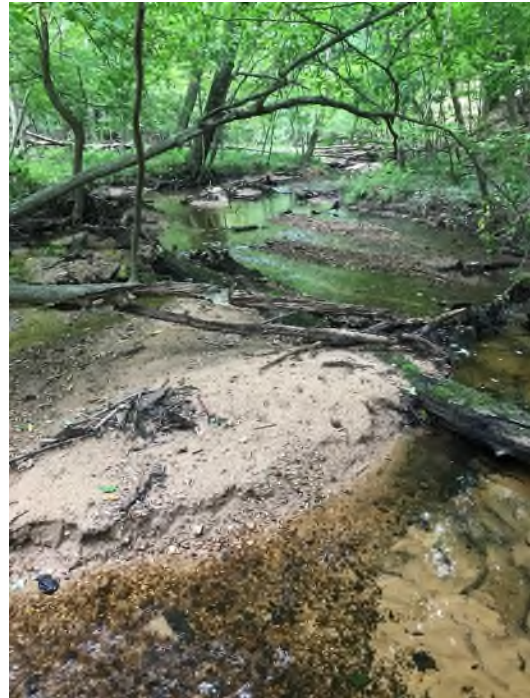
Photo 10. Sediment deposition in Claybanks Creek upstream of Pine Creek Road, Manistee County, 2019.

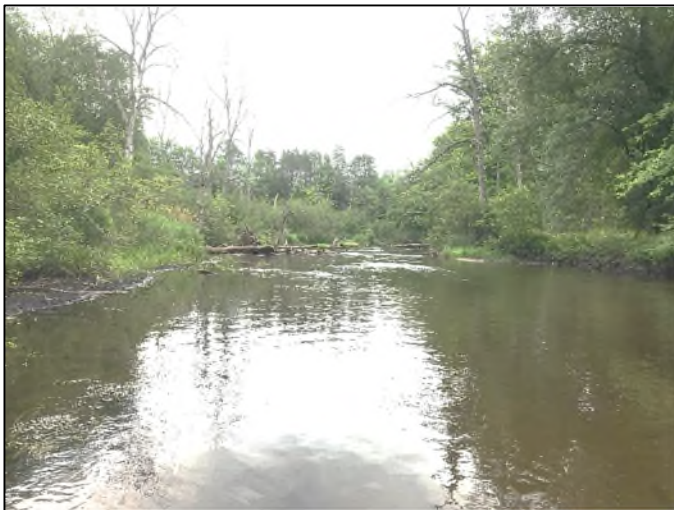
Photo 11. Bear Creek at 13-Mile Road, Manistee County, 2019.

Station 10 was sampled in Bear Creek at 13 Mile Road (Photo 11). Shifting sand and silt dominated the substrate at this site with deposits more than 1.5-feet deep in areas. Islands of sand were visible with vegetation growing on the deposits. Some gravel was present at the bottom of some of the pools but was mostly sand. LWD was plentiful and the river was deep and slow throughout the reach.

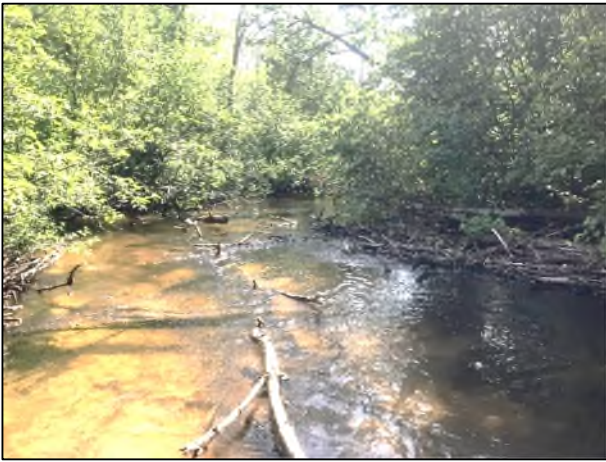
Photo 12. Bear Creek at Leffew Road, Manistee County, 2019.

The most upstream Station 11 (Photo 12) was sampled at Leffew Road where a bridge is no longer in service. Gravel and cobble were available for epifaunal substrate. Some sand deposits from spring and early summer high flows were visible. A large pile of LWD was present. Overhanging alders provided shade for the stream reach. There was good pool variability with LWD, vegetation, and gravel making up the substrate in these pools.

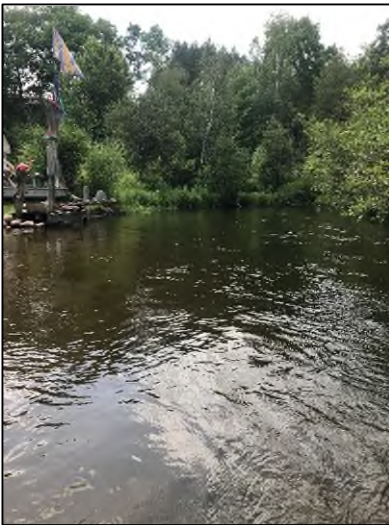
Photo 13. Little Manistee River at 11-Mile Road, Lake County, 2019.

The Little Manistee River was sampled at 11 Mile Road off private property upstream of the confluence of Cool Creek (Station 12; Photo 13). There are many large deep pools with gravel substrates at this station along with a large amount of sand and some silt making up the dominant substrate types.

Elodea sp. and *Vallisneria sp.* aquatic plants were common and globular clumps of algae were also present on the sand bottom.

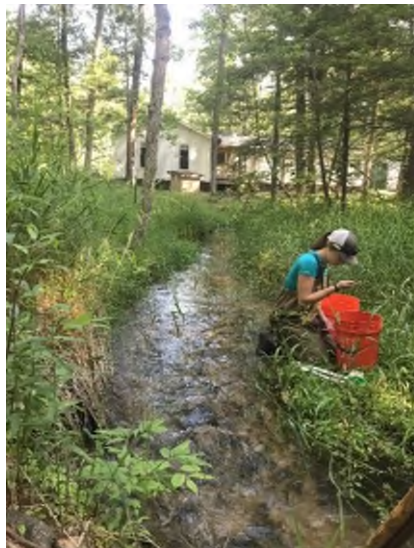
Photo 14. Stronach Creek downstream Java Road, Lake County, 2019.

Station 13 (Photo 14) was sampled on Stronach Creek downstream of Java Road. This is a small stream with good perennial flow and a diversity of epifaunal substrate available for macroinvertebrate colonization. There is not much cobble, and as you reach the downstream end of the reach sand is more dominant.

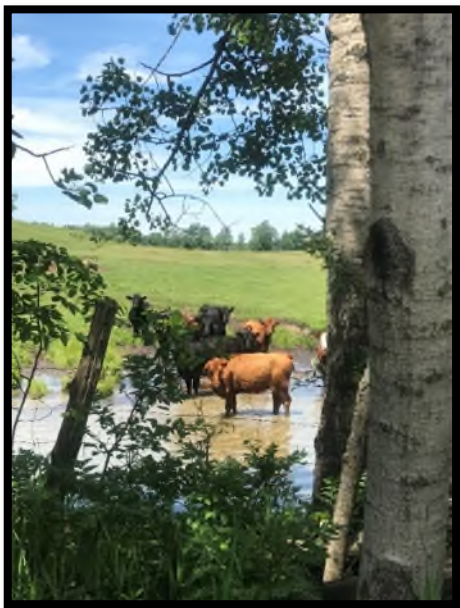
Cattle have direct access to approximately 300 feet of Cool Creek at 12 Mile Road and stream banks are being trampled causing erosion. The stream has two road crossings at 12-Mile Road. One is upstream of the cattle and one is downstream of the cattle. Both crossings have undersized metal culverts that the stream flows through under the road. This has caused sand that is carried in the water during high flows to settle and build up on the stream bottom. The stream is very uniform in width and depth with few pools. The stream lacks the gravel, cobble, and aquatic plants where many macroinvertebrates prefer to live. There were small areas with large pieces of wood, sticks, and roots that could provide habitat. The macroinvertebrate scored excellent (7) upstream of the cows and acceptable (3) downstream. This change is large enough to suggest the water quality may be worse downstream.

Streambanks trampled by cows standing in a stream were photographed (Photo 15 and Photo 16). Upstream and downstream of the cows, the natural stream banks have cedar trees growing with roots holding the soil in place. The trees shade the stream and keep it cooler. [E. coli sampling](#) was also conducted upstream and downstream of the cattle crossing. *E. coli* is an indicator of pathogens in the water caused by waste from warm-blooded animals including cows. Pathogens can make people sick if the contaminated water is ingested. Results show that *E. coli* concentrations were higher downstream of the cattle and were not meeting WQS and thus are not safe for swimming and wading. Cattle were observed in the stream on more than one occasion in 2019. EGLE staff contacted the [State of Michigan Right to Farm](#) staff, who then visited the site and spoke with the owner. As of October 2020 the landowner has constructed some exclusion fencing so the cows no longer stand in the water but can access some water adjacent to the stream channel. The site should be revisited in 2024 to see if the exclusion fencing remains, and if macroinvertebrate scores and *E. coli* concentrations have improved downstream of the cattle.

Photo 15. Cows standing in Cool Creek at 12 Mile Road.

1. *E. coli* concentrations in Cool Creek downstream of 12 Mile Road exceeded WQS, most likely due to cattle having direct access to the stream just upstream of the road crossing. Macroinvertebrates in the same location are acceptable but degraded compared to upstream of the cattle. Cattle exclusion fencing was constructed in October 2020. This site should be revisited in 2024 to see if cattle exclusion fencing remains in place, and if macroinvertebrate scores improve.

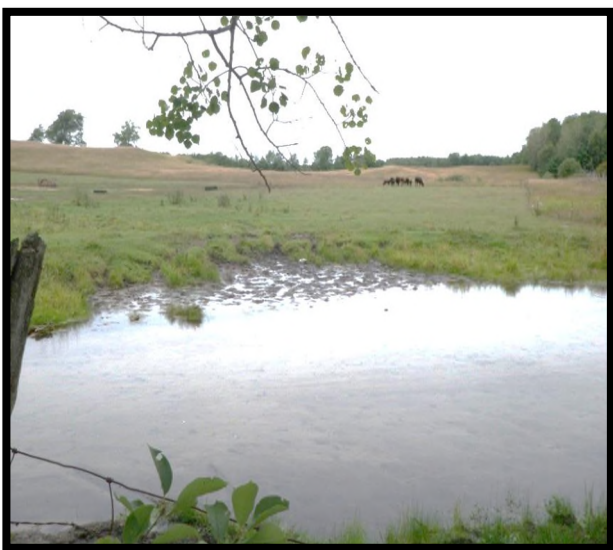
Photo 16. Impacts of cattle having direct access to Cool Creek at 12 Mile Road. Note the lack of trees, the muddy banks, and widening of stream.

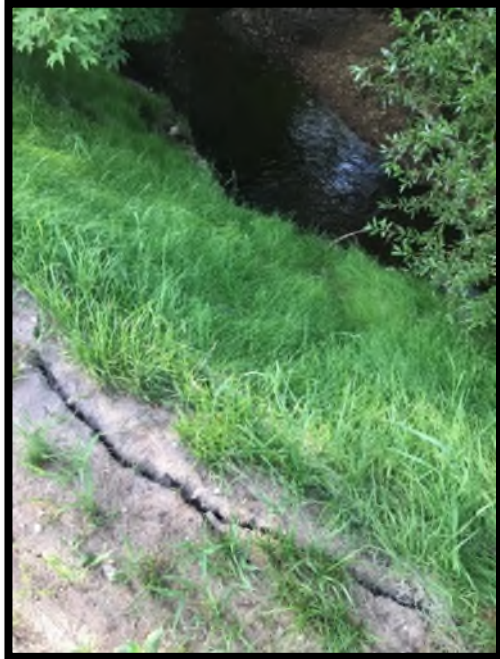
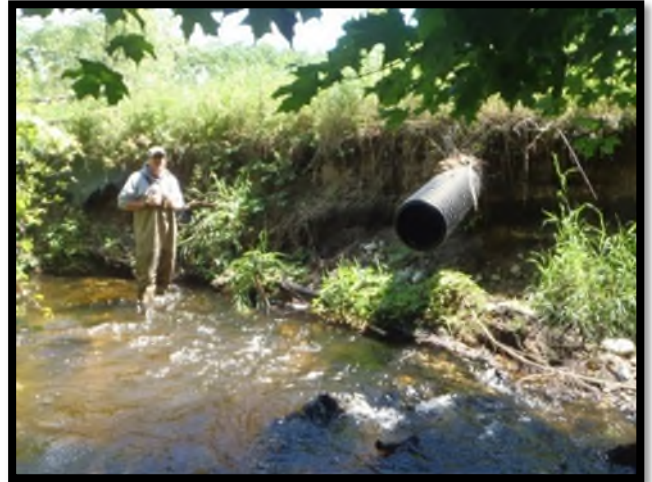
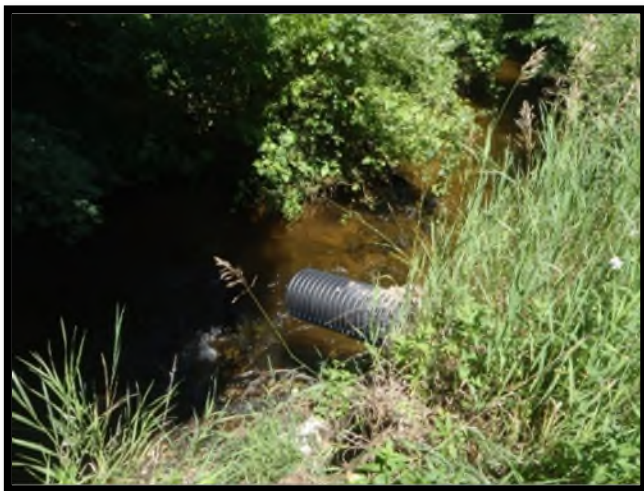
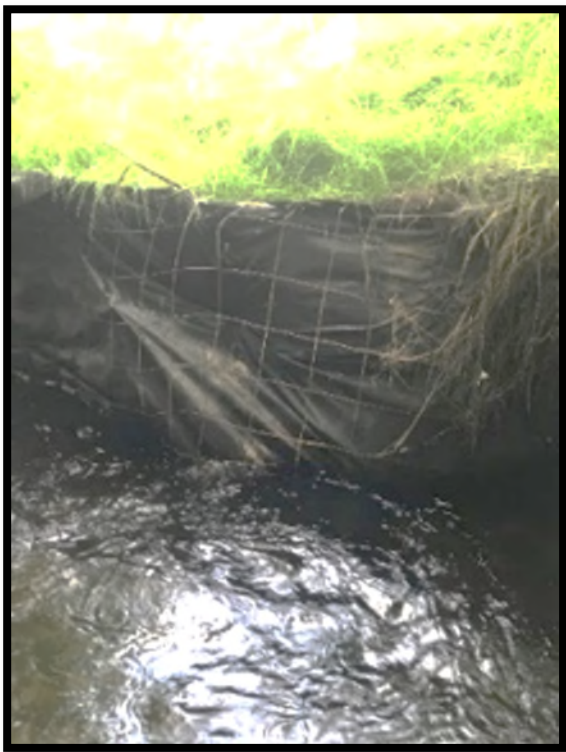
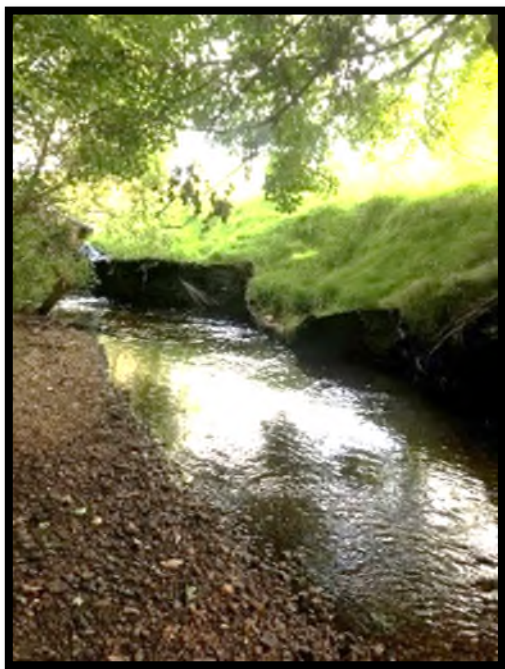
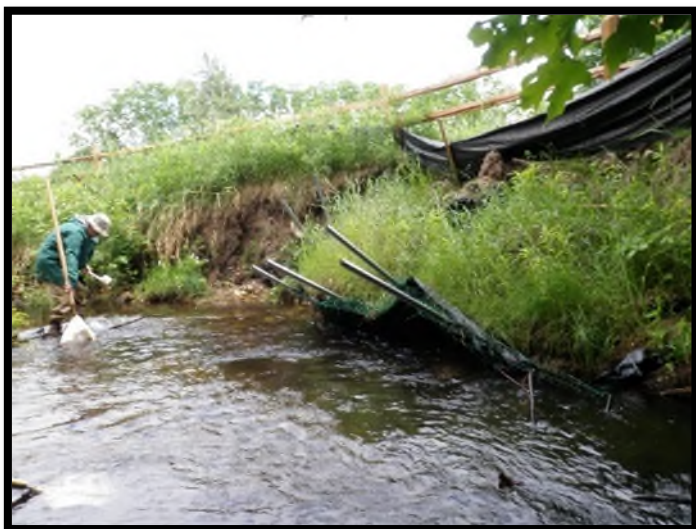
Cedar Creek at Oravainen Road was revisited in 2019 due to observations in 2009 and 2014 of stream bank failure (Photos 17-22). It appears that construction of a pond that discharges to Cedar Creek via an overflow pipe connection has led to this issue that continues at this site. Efforts to work with the landowner to fix the problem would be beneficial to reduce sediment getting into the stream.

Photo 17. 2019 view from berm/stream bank.

Photo 19. 2009 view from stream. Overflow tile from pond.

Photo 18. 2014 view from berm/stream bank.

Photo 20. 2014 view from stream. Berm/streambank failing.

Photo 21. 2019 view of efforts to save berm/stream.

Photo 22. 2019 view from stream. Berm/stream bank is failing.

2. Severe stream bank erosion continues in Cedar Creek off Oravainen Road due to a pond overflow pipe. Efforts to work with the landowner to fix the problem would be beneficial to reduce sediment getting into the stream.

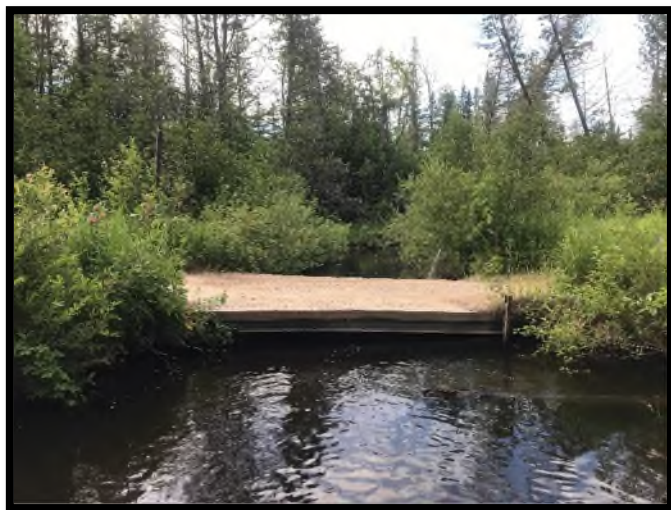
Photo 23. The County Line Road crossing at Anderson Creek, July 2019.

This station has been sampled in 2009, 2014, and 2019. The road crossing seems to be a cement slab that is within inches of the surface of the stream. Lipsey (2010 and 2016) noted that the bridge crossing at this station looks to be extremely old and if there was a flood event, it seems a large amount of sediment could potentially enter the water body (Photo 23). The macroinvertebrate community was rated excellent (7) in 2009, but only acceptable in 2014 and 2019 (0 and 1, respectively). Habitat conditions have remained stable. This location would be a good opportunity for a road crossing improvement project.

3. The road crossing of Anderson Creek at County Line Road should be replaced. The macroinvertebrate community rating, while acceptable, has dropped 6 points since 2009.

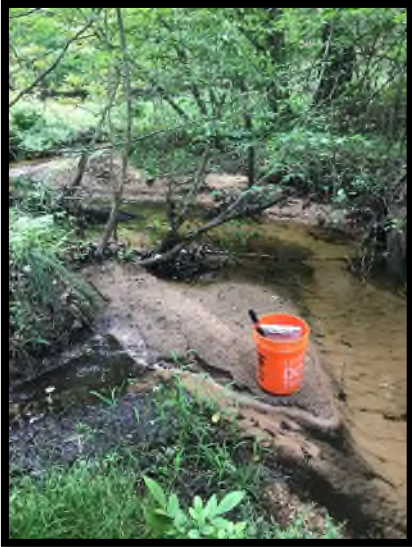
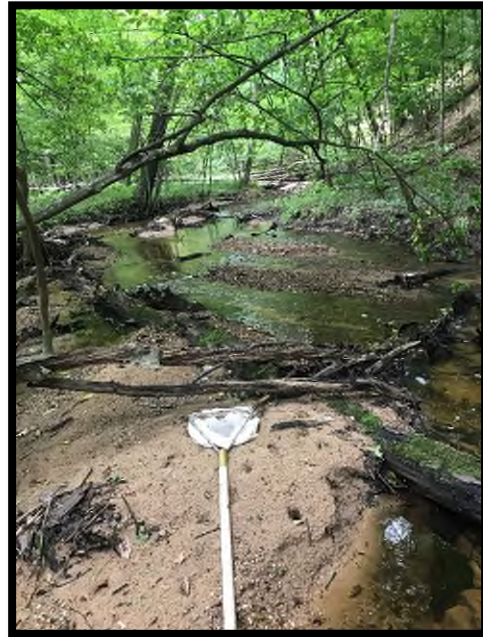
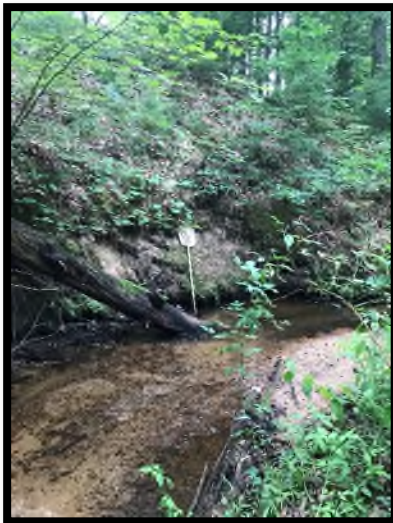
Claybanks Creek at Pine Creek Road flows through a deep ravine. The sediment deposition in the channel was so extensive that the channel becomes braided in places (Photo 24, Photo 25, and Photo 26). Banks are eroded more than 5 feet above the water surface (Photo 27). The bottom substrate was sand and gravel mixed with a small amount of cobble. There was a lot of wood but much of it was not in the water and thus not available to biological communities. The

Photo 24. Claybanks Creek upstream of Pine Creek Road, August 2019.

Photo 26. Claybanks Creek upstream of Pine Creek Road, August 2019.

Photo 25. Claybanks Creek upstream of Pine Creek Road, August 2019.

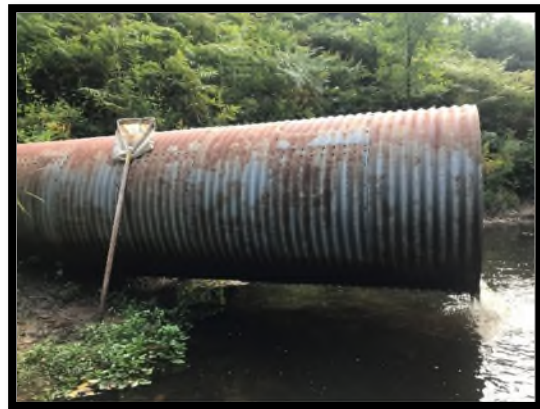
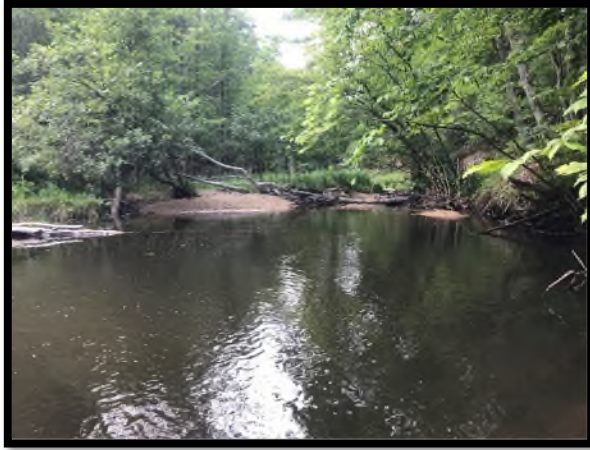
culvert at the road crossing is much too small and is perched several feet above the surface of the water on the downstream side of Pine Creek Road. This prevents fish from being able to swim upstream. Additional sediment deposits could be viewed further downstream of the road crossing (Photo 28) The United States Forest Service has completed some surveys of the site and are working with partners to find money to replace the culvert. The macroinvertebrate community was at the lower end of acceptable (-1).

Photo 27. Claybanks Creek downstream of Pine Creek Road, August 2019. Image is a perched culvert.

Photo 28. Claybanks Creek downstream of Pine Creek Road, August 2019.

6. The culvert for Claybanks Creek at Pine Creek Road is much too small and is perched several feet, preventing fish from being able to swim upstream. The United States Forest Service has completed some surveys of the site and are working with partners to find money to replace the culvert. If a replacement occurs, habitat and macroinvertebrate community surveys could be repeated to see if scores improve.
