MICHIGAN DEPARTMENT OF ENVIRONMENT, GREAT LAKES, AND ENERGY WATER RESOURCES DIVISION AUGUST 2022 STAFF REPORT

Biological Surveys of Selected Stations in the Black River and Belle River Watersheds in Lapeer, Sanilac, and St. Clair Counties, Michigan July-September 2017

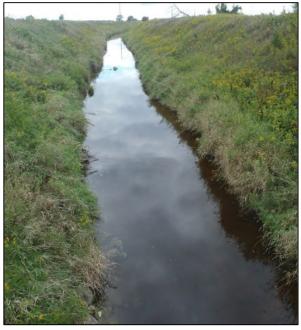
Figure 2. Black River at Shabonna Road (Station 1).

The farthest upstream site sampled on the Black River mainstem was at Shabonna Road (Figure 2), in an intensive agricultural area near the northernmost part of the Black River watershed. The river at this location, and much of the river upstream, was channelized and straightened, with steep banks on both sides and a general lack of natural riparian vegetation conditions. The glide/pool habitat conditions scored Marginal (64) overall, with poor scores for pool substrate characterization, pool variability, channel alteration, channel sinuosity, and riparian vegetation zone width. The epifaunal substrate/available cover metric scored at the low end of good and the sediment deposition metric scored marginal, reflecting how while over half of the stream bottom was impacted by sedimentation/siltation, approximately

40 percent of the substrate was of stable habitat size (cobble and gravel).

The macroinvertebrate community rated Acceptable (+1) with 29 total taxa present, eight of which were mayflies (4) or caddisflies (4). Elmid (riffle) beetles (20 percent) and amphipods (scuds and side-swimmers) (18 percent) were the two most dominant taxa at this station. Mayflies and caddisflies made up 22 and 2 percent of the community, respectively. Despite human impacts (e.g., channelization, agricultural runoff) to this site, the moderate amounts of cobble and gravel likely allowed for some flatheaded mayflies (Heptageniidae) and a snail-case-maker caddisfly (Helicopsychidae) to be present in the samples. These taxa are typically clingers (behaviorally) that are adapted either by shape (flattened) or behaviorally (case), respectively, to live in moving water in erosional habitat areas on stable structures like cobble and logs (Merritt et al., 2019; Bouchard, 2004).

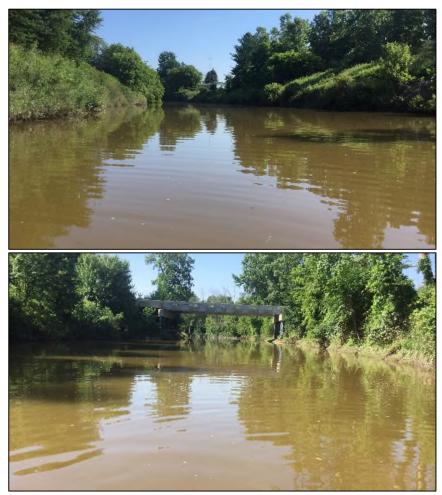
Figure 3. Black River at Aitken Road (Station 3).

Another biosurvey site on the Black River was located approximately 20 river miles downstream at Aitken Road (Figure 3). The reach was slow moving, relatively wide (approximately 80 feet) for a wadeable river, and had turbid water. Like Station 1, the

river here also courses through an area of intensive agriculture, though some occasional, small patches of riparian forest and light residential development also exist upstream of, or adjacent to, this reach. Based upon aerial imagery, portions of the Black River upstream of this reach appear to have been partly relocated and/or channelized historically to accommodate Old M-51 (and other roads) and also expedite drainage. Some old, remnant river bends can be seen where the river used to likely exist prior to channel relocation.

The glide/pool habitat conditions scored low Good (113) overall, with most parameters scoring good or even excellent (i.e., maintained flow volume). A few parameters, however, scored marginal (sediment deposition, flashiness, and channel sinuosity) or poor (pool variability). Approximately 45 percent of the substrate was a sand/silt mixture, with the remainder being a mix of cobble, gravel, and the occasional boulder. Large wood substrate was sparse.

The macroinvertebrate community rated Acceptable (-2), with only 16 total taxa present. Six taxa were mayflies (5) or caddisflies (1), making up 14 and 6 percent of the community, respectively. Hydracarina (water mites) were by far the dominant taxon at 64 percent. While there are over 1,500 species of water mites in North American freshwater environments, and they vary considerably in tolerance to stress and pollution by species, these organisms breathe by absorbing dissolved oxygen (D.O.) all over their body surface, and most kinds can tolerate D.O. oxygen concentrations as low as 1 part per million (Voshell, 2002).

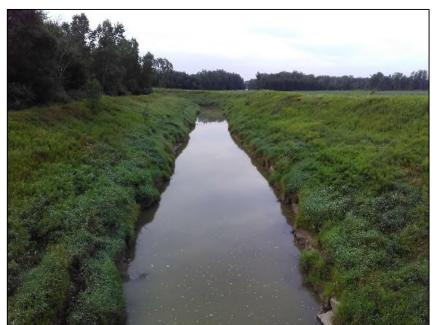
Figure 4. Elk Creek at Washington Road (Station 2). channel sinuosity, and riparian vegetation zone width.

Elk Creek drains into the Black River mainstem between Stations 1 and 3. Station 2 was located on Elk Creek at Washington Road (Figure 4), approximately 1 mile upstream of its confluence with the Black River. Elk Creek at, and upstream of, the sampling station had an occasional curve, but was mostly channelized, straightened,

dredged, and quite uniform. The substrate was predominantly fine sediment (80 percent sand or clay), and large wood was absent. The land use in the watershed upstream of the station was predominantly intensive agriculture, but also included occasional patches of forest. Trees were not present in the riparian zone of the channel, and the banks were fairly steep and grassy. The habitat scored Marginal (74) overall, with poor scores for pool variability,

The macroinvertebrate community here rated Acceptable (-1). Twenty-six total taxa were present, including 4 mayfly and 3 caddisfly taxa. Mayflies and caddisflies comprised 10 and 6 percent of the community, respectively. Elmid (riffle) beetles were the dominant taxon (38 percent), followed by chironomids (midges) (13 percent).

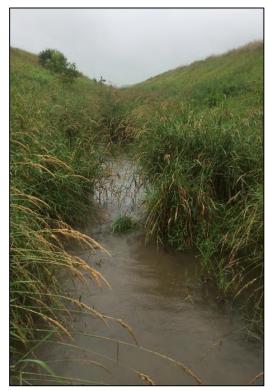
Figure 5. Potts Drain at Hall Road (Station 4).

Potts Drain is a tributary to Elk Creek. It was sampled at Hall Road in 2017 (Figure 5). The stream was channelized, straightened, dredged (historically), and generally lacked riparian trees and shrubs, though overhanging grasses did provide some cover and habitat for macroinvertebrates. While habitat scored low Good (110) overall, many parameters scored marginal (epifaunal substrate/available cover, pool variability, sediment deposition, channel alteration, channel sinuosity, riparian vegetation zone width). The substrate was predominantly fine sediment (85 percent sand or silt), and large wood was absent.

Macroinvertebrates scored Acceptable (0) at this site. The overall number of taxa was 21, including 2 mayfly taxa and 3 caddisfly taxa, which made up 11

and 2 percent, respectively, of the community. The dominant taxon was Chironomidae (29 percent).

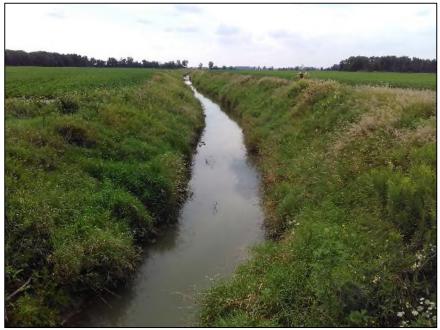
Figure 6. East Branch Speaker and Maple Valley Drain at Harrington Road (Station 5).

The East Branch Speaker and Maple Valley Drain (Figure 6) is another tributary to Elk Creek. This agricultural drain was channelized, dredged, and had little sinuosity. The channel substrate was almost entirely fine sediments (99 percent; mostly clay with some silt and sand). Large wood substrate was absent, and the steep banks lacked riparian trees and shrubs. The habitat conditions scored Marginal (65), overall, and for most of the individual parameters. Pool variability, channel sinuosity, and riparian vegetation zone width scored poor.

The macroinvertebrate community rated Acceptable (-2). Despite what appeared to be low-marginal quality habitat conditions and a low-acceptable community score, the macroinvertebrate community had a surprisingly relatively high taxa richness (32 taxa overall). The most dominant taxon (caenid mayflies), which are tolerant of slow, silty conditions (Bouchard, 2004), only comprised 21 percent of the community. Mayfly taxa (4) and caddisfly taxa (1)

comprised 22 and 1 percent of the community, respectively. The macroinvertebrate community present was what would be expected in a slow-moving "wetland-like" stream with abundant hemipterans (true bugs), odonates (dragonflies and damselflies), coleopterans (beetles), dipterans (flies), amphipods, molluscs, oligochaete worms, and some turbellarians (flatworms).

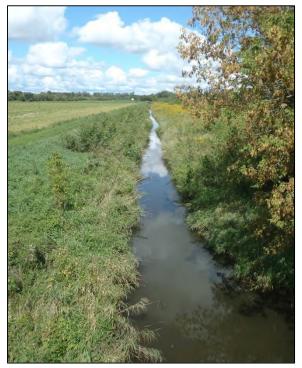
Figure 7. Madison Drain at Bohms Road (Station 6).

Madison Drain (Figure 7) was sampled at Bohms Road. It is a mostly straightened, slow-moving tributary to the North Branch of Mill Creek. Much of the watershed

upstream of this location was agricultural, and the sampling reach had agricultural land on both sides. Aside from immediately at the road crossing, this reach lacked riparian trees and had very sparse shrubs. The channelized habitat scored Marginal (66) overall, with the individual parameters pool variability, sediment deposition, channel sinuosity, and riparian vegetation zone width scoring poor. The reach was 100 percent glide (run) habitat, the substrate was all fine sediment (5 percent sand, 95 percent silt), and large wood substrate was absent.

The macroinvertebrate community in Madison Drain's slow-moving water rated Poor (-6). It had a total richness of 21 taxa. Only one mayfly taxon was present (Caenidae; 1 percent of the community), and no caddisfly taxa were observed. The dominant taxon was coenagrionid damselflies (35 percent), a diverse family

with many species commonly found in or around the vegetation of standing, lentic, or ditch water that are typically moderately to highly tolerant organisms (Voshell, 2002; Bouchard, 2004). Surface air breathers (i.e., surface dependent macroinvertebrates) (MDEQ, 1990), including Culicidae (mosquito) larvae, hemipterans, coleopterans (Dytiscidae, Hydrophilidae, and adult Haliplidae), made up 29 percent of the community.

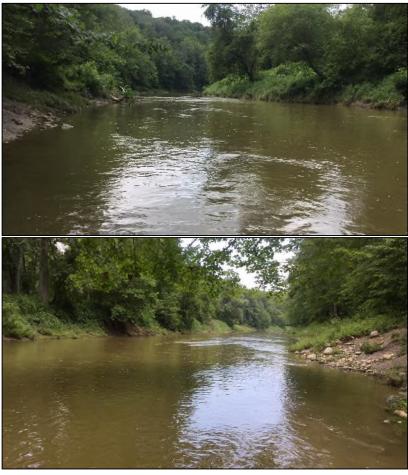
Figure 9. Black River off Abbottsford Road (Station 8).

The Black River was sampled off Abbottsford Road (Figure 9) within the Port Huron State Game Area, an area dedicated for wildlife conservation and management by the MDNR Wildlife Division. The station is roughly 28 river miles downstream from Station 3. and it is also approximately 1.6 and 2.1 river miles downstream of the mouth of Mill Creek and a dam on the Black River, respectively. The Black River here is a sinuous, riffle/run system with a relatively wide and intact forest riparian zone. Habitat at this station rated Excellent (166), with all individual parameters

scoring excellent except for velocity/depth regime and bank stability (good) and flashiness (marginal). Some fine sediments were present (20 percent sand or clay), but

the stream was predominantly gravel (40 percent) and cobble (35 percent), with a small presence of boulders (5 percent).

The macroinvertebrate community rated Excellent (+7) with 31 taxa present, 11 of which were mayflies (7) or caddisflies (4). Mayflies comprised 45 percent of the community and caddisflies made up 16 percent of the community. The dominant taxon (15 percent) was the mayfly family Ephemerellidae.

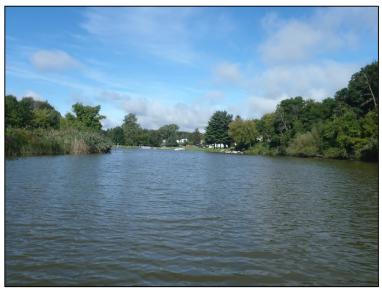
One location on the Black River (Figures 10 and 11) was nonwadeable and was assessed and scored using the SWAS Procedure 22. The thalweg (deepest thread of the channel) was fairly deep and ranged from 10-13 feet over the course of the sampling reach. Boats and docks were a common sight. Flow velocity appeared generally to be slow. The land uses in the watershed region adjacent to, and upstream of, this reach included agriculture, golf courses, patches of forest. several suburban residential developments, and some commercial development. The sampling reach was somewhat

Figure 10. Black River, upstream of boat launch off Strawberry Lane, and upstream of Black River Canal inlet (Station NW-1) (lower end of the sampling reach).

Station NW-1 had a macroinvertebrate community that rated Poor (with a score of 2 out of 100) (Appendix A). Only 7 taxa were observed, with chironomid flies (52 percent) and oligochaete worms (33 percent) dominating the community. Both taxa can be found in just about any habitat but, in general, they can do well in soft sediments. Other taxa that were present in small numbers included Ephemeridae ("common burrowing mayflies," typically found in soft silt or sand), Coenagrionidae damselflies, Gerridae ("water striders;" surface dependent, air

breathers), Elmidae beetles, and Unionidae (mussels). Most of the areas in the river reach randomly sampled for macroinvertebrates generally were not conducive to supporting a diverse macroinvertebrate community. As opposed to wadeable stream sampling using Procedure 51 where one seeks out and samples all available habitats, sampling according to Procedure 22 is limited to randomly selected (left or right side), safely-wadeable (generally <1 meter deep), nearshore areas, at fixed transects that have been evenly spaced. The sampling areas at Station NW-1 transects mostly had minimal amounts of stable substrates and deep, slow water velocities. The stems of the macrophytes (often emergent plants such as cattails having stiff, thick stems as opposed to submergent vegetation with more flexible stems and submerged leaves) and fine sediments that were common in the abundant slow-flowing areas, were difficult to sample. Any available large wood habitats sampled often were tree branches and roots that were partly in the water but not extending deeply into the water. Rapid habitat assessment data collected at macroinvertebrate sampling locations indicated that while overhanging vegetation/undercut banks, plants, and wood were sometimes present, inorganic substrates were primarily fine sediments (silts, sands) while more stable, coarse sediment (i.e., gravel) was sparse. During the survey, there appeared to be infrequent, small patches of shallow, nearshore river waters with some submergent aquatic vegetation (not within random sample locations) that might provide very limited areas of slightly better habitat. Still, overall, habitat available for benthic invertebrate colonization appeared to be very limited, and sedimentation and siltation impacted sampleable habitats.

Macroinvertebrate communities were monitored at 12 stations in 2017 for this report. Communities rated as Acceptable or Excellent at most sites; however, 3 stations (2 wadeable, 1 nonwadeable) rated as Poor. Those stations were Station 6 (Madison Drain at Bohms Road), Station 9 (Howe Drain off M25), and Station NW-1 (Black River upstream of Black River Canal inlet).

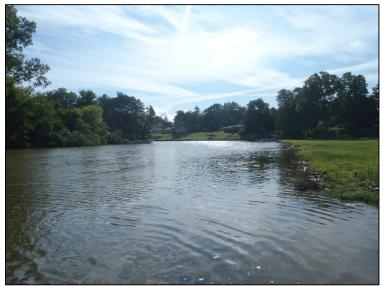
sinuous, although it might have been much more sinuous pre-human settlement since former bends of the river can be seen in aerial imagery and also some sections appear as though they have been somewhat straightened. Sand or other fines were the predominant substrate type observed, with minor amounts of gravel present. Wood, often in the form of shrub or tree roots, and macrophytes were occasionally present along the river margins.

Figure 11. Black River, upstream of boat launch off Strawberry Lane, and upstream of Black River Canal inlet (Station NW-1) (upper end of the sampling reach).

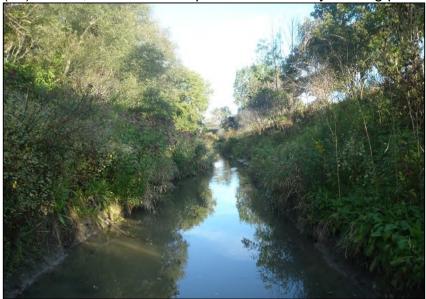
Figure 12. Howe Drain off M25 (Station 9).

Howe Drain off M25 was sampled in a commercial-development, urbanized area of Fort Gratiot, which also had a lot of agricultural and residential land use upstream. Much of the length of this very slow-moving drain has been channelized and straightened; average surface velocity was 0.1 feet per second. Trees were present near the sampling reach and provided some shade to the drain. Banks and riparian areas were quite steep and covered mostly with grasses and forbs (Figure 12). The glide/pool habitat rated Poor (55) overall, with individual parameters mostly scoring poor

or marginal. The substrate was mostly clay (85 percent), with some silt (10 percent) and gravel (5 percent). Overhanging vegetation was moderately abundant, otherwise the presence of other structures available for macroinvertebrate colonization (e.g., aquatic macrophytes, undercut banks, large wood pieces, and rootwads) were sparse or absent.

The macroinvertebrate community rated Poor (-5),

with only 19 taxa identified. The dominant taxon was a "true bug" in the family Corixidae (water boatmen), which are air breathers (i.e., surface dependent) that prefer standing or slow flowing water (Bouchard, 2004). Over half of the taxa collected were water boatmen (51 percent) and, combined with other surface dependent taxa (including mosquitoes [Culicidae]), comprised 59 percent of the community overall (this station had the highest percent surface air breathers in this report). Streams that have high percentages of these organisms may be reflective of stream reaches experiencing conditions such as large diurnal D.O. shifts or other biological or chemical oxygen demanding constraints, elevated temperatures, low flows, and/or erratic flows (MDEQ, 1990). Only one mayfly taxon was observed (Caenidae), and no caddisflies or stoneflies were present. The moderate amounts of overhanging vegetation and slow waters may partly explain why coenagrionid damselflies comprised 24 percent of the community.

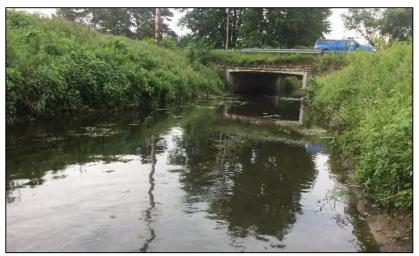
Figure 13. North Branch of the Belle River upstream of Newark Road (Station 10).

The North Branch of the Belle River was sampled upstream of Newark Road (Figure 13) in a watershed that is mostly a mix of agricultural and urban (commercial and residential) land uses along with some forest. Much of the waterway has been channelized and straightened, the streambanks lacked trees, and the water was noted as being slightly turbid. The glide/pool habitat rated as Marginal (90) overall, with a few individual parameters scoring poor (i.e., pool variability, sediment deposition, and channel sinuosity). The substrate was mostly silt (90 percent), along with some sand (5 percent) and gravel (5 percent). Other than dense macrophytes, additional habitat

structures were sparse (overhanging vegetation) or absent (e.g., large wood pieces, rootwads, undercut banks). In 2017, approximately 95 percent of the sampling area of the channel was covered with the macrophytes (including the aquatic invasive plant curly leaf pondweed Potamogeton crispus) and noted as nuisance plant conditions. (Nuisance aquatic plant conditions were not noted in 2012. 2007, 1997, or 1992.)

The station's macroinvertebrate community scored low Acceptable (-4). Only 12 taxa were identified, and the community was dominated by the taxon Chironomidae (41 percent), followed by Amphipoda (36 percent). No mayfly or caddisfly families were observed at this location. The primary reason this station did not rate as Poor likely was because the metrics "percent isopod, snail, leech" and "percent surface air breathers" were low (i.e., each <2 percent of the community).

The aquatic plant community at one station, the North Branch of the Belle River upstream of Newark Road (Station 10), was observed in 2017 as having a dense population of macrophytes including the aquatic invasive plant curly leaf pondweed (*Potamogeton crispus*), and that situation was noted as being nuisance conditions. (The author of this report could not be there in 2017 due to an injury.) Nuisance aquatic plant conditions were *not* noted during surveys at the station in 2012, 2007, 1997, and 1992. Thus, it is recommended that this station be considered as having insufficient information regarding nuisance plant conditions and that further investigations (including more photographs) be considered, as resources allow, at this trend station in the future to help determine whether it truly has nuisance aquatic plant conditions.

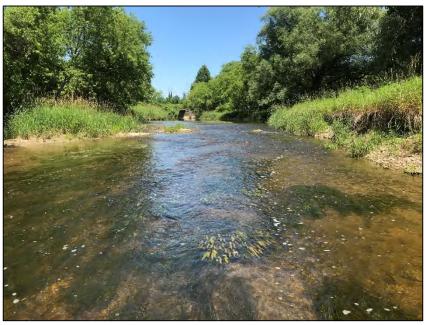
The Belle River at the end of Meskill Road (Figure 14) was sampled southeast of Memphis. While the watershed was dominated by agricultural and some urban residential land use, the riparian zone forest along the mainstem of the river appeared to be relatively wide (>250 feet or more in many places) for the region. This moderately-sinuous, mostly riffle/run reach does not appear to have been channelized in a long time, but may have

Figure 14. Belle River at the end of Meskill Road (Station 11). *Note: a photo was not available for 2017; this photo is from July 2020.*

been historically, given the old river bends visible in aerial imagery. The riffle/run habitat data is not available for 2017, but rated as Excellent in 2012 and Good in 2007 (Varricchione, 2014; Schmitt, 2008). Based upon previous surveys and records, plus surveys for aquatic plant and algae conditions in 2020, cobble and gravel substrate are believed to have been the dominant substrates in the 2017 biosurvey. Aquatic macrophytes are common in parts of this reach (Figure 14).

The macroinvertebrate community rated Excellent (+7) and 27 taxa were observed. There were 8 mayfly (3) and caddisfly (5) taxa, comprising 27 and 29 percent of the community, respectively. The dominant taxon was hydropsychid caddisflies, which comprised 26 percent of the community. Also, this station was second of 2 stations in this report where stoneflies (Plecoptera) taxa were observed in 2017. The presence of these mayfly, caddisfly, and stonefly taxa likely reflected, in part, the diverse stable substrates and flow velocities as well as the relatively healthy riparian zone conditions alongside the river.
