MICHIGAN DEPARTMENT OF ENVIRONMENT, GREAT LAKES, AND ENERGY  
WATER RESOURCES DIVISION  
JULY 2023  
STAFF REPORT

**Biological, Water Chemistry, and Sediment Chemistry Surveys of  
Selected Stations in the River Raisin Watershed in Lenawee, Monroe,  
and Washtenaw Counties, Michigan, June-September 2018**

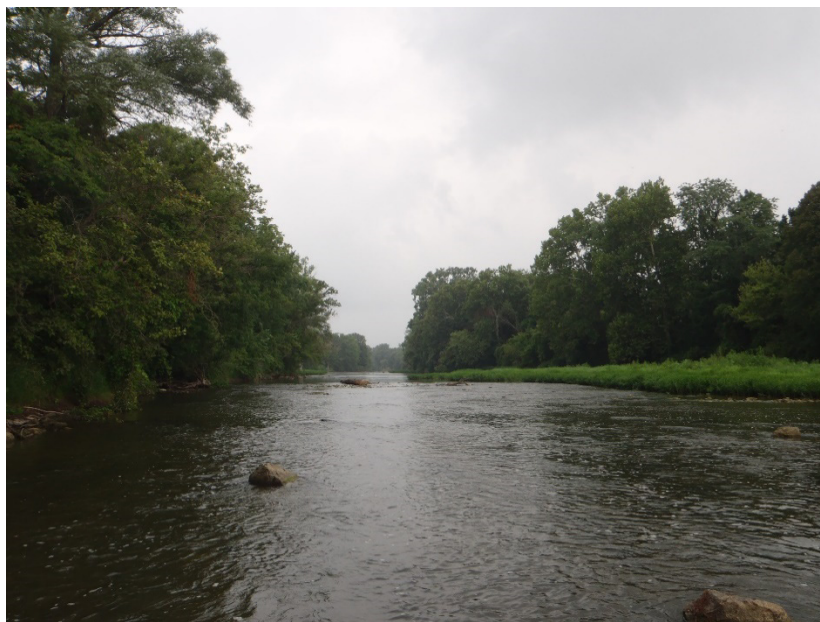
The River Raisin off Dixon Road (Station 2) (Figure 3) was located approximately 1.3 river miles upstream of Station 1. The surrounding land was predominantly agriculture with pockets of light residential areas. No obvious, recent stream modifications (e.g., bank stabilization or channel dredging) were noted. The river corridor adjacent to and upstream of Station 2 also had a thin ribbon of forested riparian buffer with occasional larger patches of forest. While mature trees lined the river's edges, large in-stream wood habitat (e.g., downed logs, tree trunks) was sparse. The southern side of the river channel looked like a typical stretch of rocky riffle, while the northern side was predominantly a large sediment bar covered with annual vegetation (e.g., grasses). Like Station 1, the average width of the sampling reach was relatively wide (140 feet). The inorganic substrate was cobble-dominated (50 percent) but, overall, there was a diverse mix of bedrock, boulder, cobble, gravel, sand, and silt in the wetted part of the channel. Habitat rated good (143) overall in this riffle/run reach, though some individual metrics scored marginal (sediment deposition and flashiness) or poor (frequency of riffles/bends).

**Figure 3. River Raisin off Dixon Road (Station 2). A large, vegetated sediment bar can be seen on the right side of the photo.**

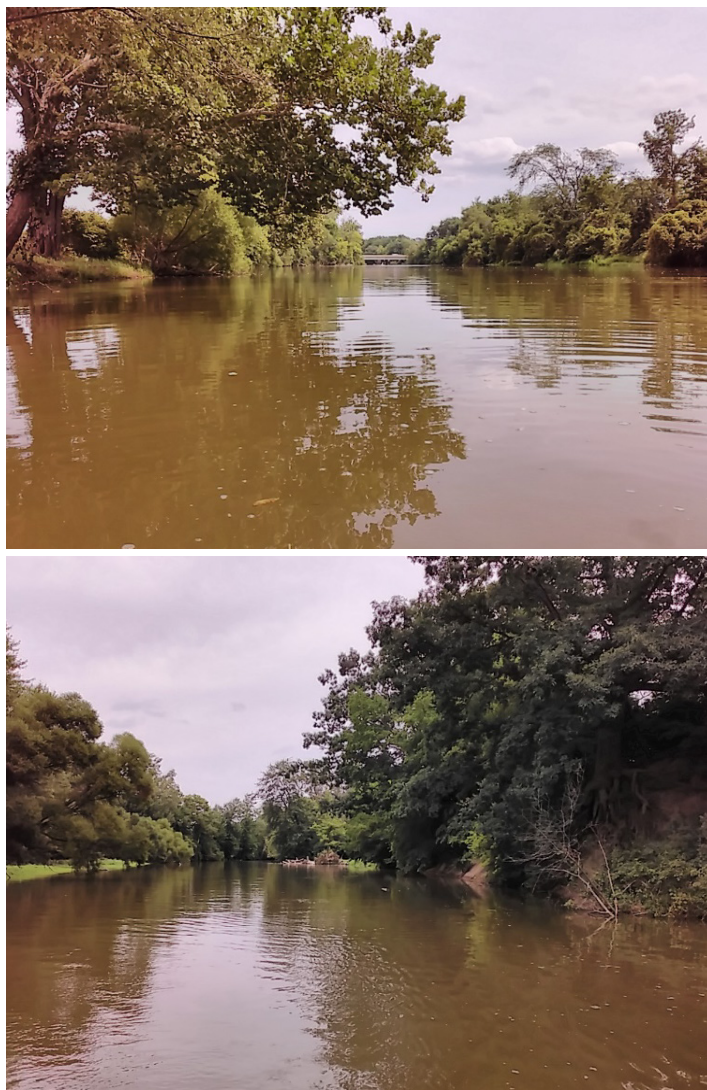
Overall, the biological community rated low fair (25) (Appendix A). Twenty-eight taxa were found, including with 2 mayfly families but no caddisflies or stoneflies. The top 3 taxa found at Station NW-1 were Corixidae (water boatmen) (63 percent), midges (9 percent), and Physidae (lunged snails) (8 percent). These taxa generally are somewhat to very tolerant of stressful environmental conditions (e.g., slow flowing water, low DO, and/or limited stable substrate conditions) (Voshell, 2002; Bouchard, 2004), which was consistent with the habitat conditions observed (slow, silty, and turbid, with limited stable substrate).

**Figure 4. River Raisin near US-23 (Station NW-1).**

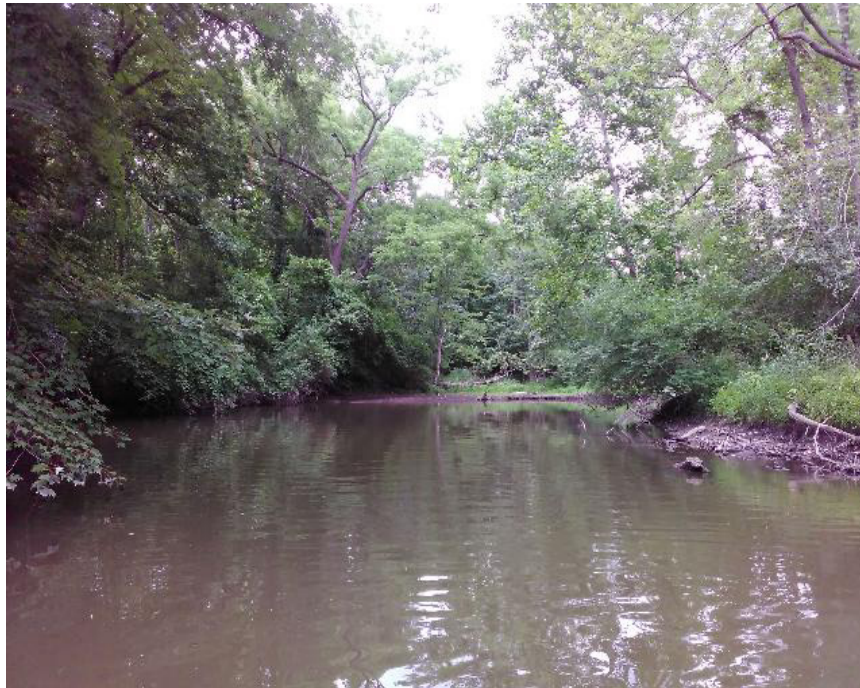
**Figure 6. River Raisin upstream of M-50 and outflow from the Evans Creek impoundment (Globe Mill Pond) (Station 6).**

pond is also connected to Standish Pond (an impoundment of the River Raisin mainstem) via a manmade canal<sup>9</sup>. The low gradient glide/pool habitat at this station (Figure 6) rated excellent (163) overall; all individual metrics scored either good or excellent. The water was turbid on the sampling date (it had rained approximately 0.3 inches 2-4 days before sampling). The inorganic substrate was mostly gravel (60 percent) and sand (25 percent), but also included some silt, cobble, and boulder. Large wood, other coarse organic detritus, and overhanging vegetation were moderately abundant.

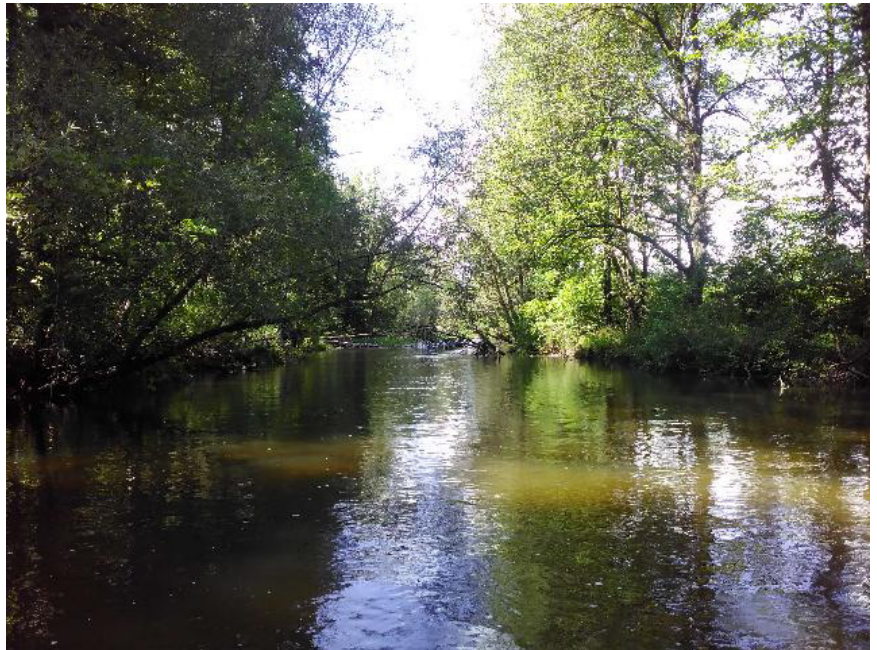
**Figure 7. River Raisin downstream of Wallace Road (Station 9).**

Much of the watershed upstream of Station 9 (River Raisin downstream of Wallace Road) was agricultural, though it was approximately 4.9 river miles downstream an impoundment on the edge of the town of Manchester. Some of the riparian corridor upstream of this station was just a thin ribbon, but there also were some large patches of riparian forest. Habitat here rated good (130) overall (Figure 7) in this low gradient riffle/run reach. All individual metrics scored good or excellent except for velocity/depth regime, flashiness, and riparian vegetation zone width, which scored marginal. The stream bottom here was dominated by sand (50 percent) and gravel (30 percent), but there was also some cobble and silt present. Coarse-sized organic detritus was moderately abundant, and large wood was sparse.

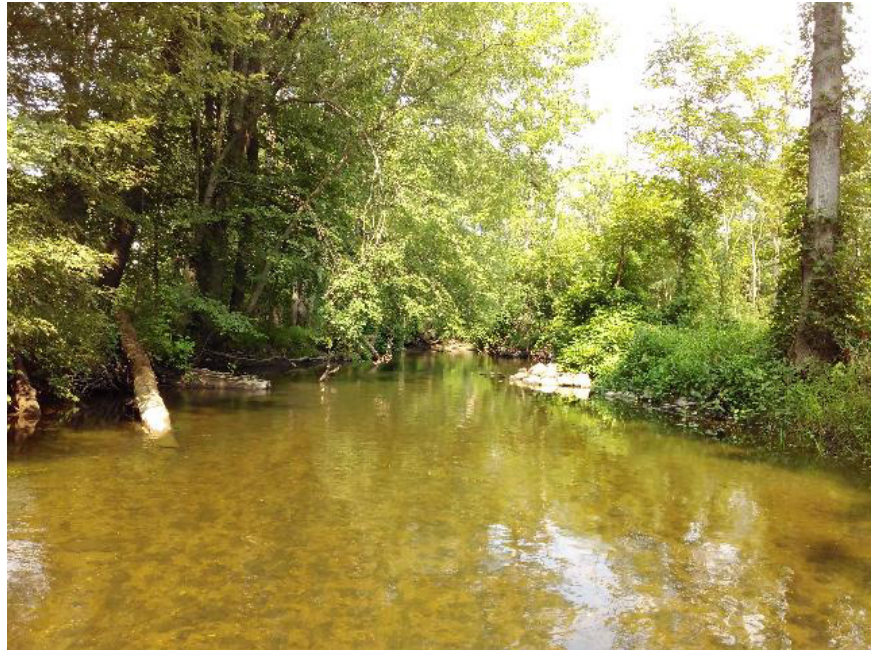
**Figure 8. River Raisin at Sharon Valley Road (Station 10).**

The River Raisin at Sharon Valley Road (Station 10) was a low gradient glide/pool reach with wide forested riparian buffers and/or woody wetlands on both sides of the channel (Figure 8). The upstream watershed was mostly a mix of agriculture and forest and included an impoundment roughly 1.8 river miles upstream of the station. Habitat scored good (139) overall. Every individual habitat scored good or excellent except for pool variability, which scored poor. The inorganic substrate at this location was mostly cobble, gravel, and sand, with a small amount of boulder and silt. Large wood, other coarse organic detritus, overhanging vegetation, and rootwads were present in moderate amounts.

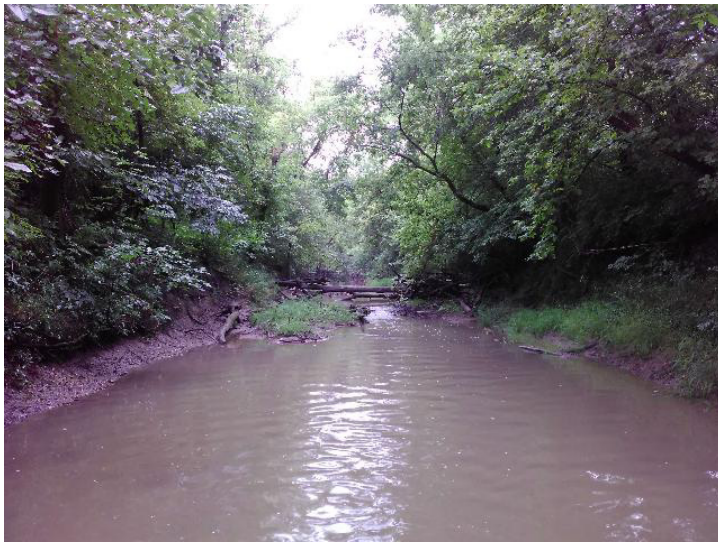
growing back and providing shade to the stream, the immediate stream banks were mostly grasses and bare soil (Figure 9). Although sampled on a different day, Station 13 was like Station 12 in that the water was turbid and fairly slow (0.3 feet/sec) on the day of sampling. (It had rained heavily [approximately 2 inches] the night before the sampling occurred.) There were many downed trees, but they were mostly sticking out of the water and unavailable for colonization by stream macroinvertebrates. The low gradient riffle/run habitat here was marginal (84) overall. While 4 of the individual metrics were good or excellent, most were marginal or poor. Metrics that were poor included: epifaunal substrate/available cover, sediment deposition, flashiness, and bank stability. Cobble was very sparse, and gravel was only moderately present. Sand (40 percent) and silt (40 percent) dominated the channel bottom.

**Figure 9. Macon Creek at Wilcox Road (Station 13).**

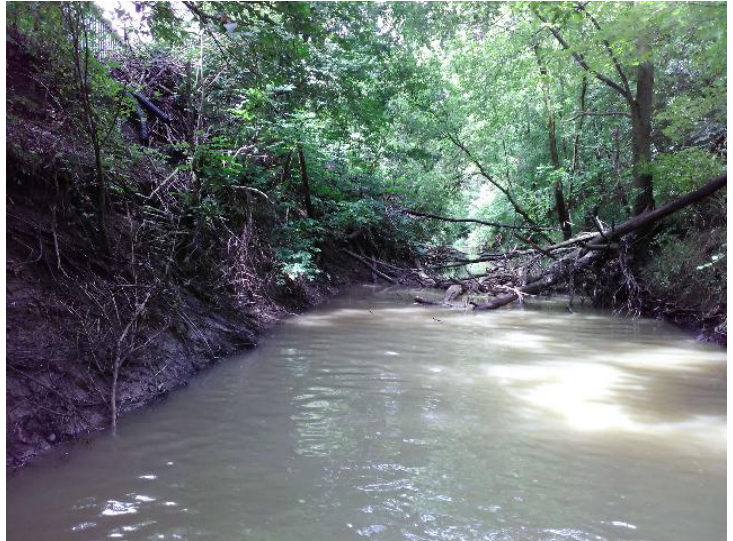
Aerial imagery showed that Station 14, and the reaches upstream of it, were very channelized and straightened. No other obvious stream modifications were noted during the survey. While there were some streamside trees that provided shade for the surveyed reach, the riparian zone was narrow or nonexistent for about two miles upstream. The water here was turbid (it had rained heavily [approximately 2 inches] the night before the sampling occurred). Sand was the dominant inorganic substrate type (60 percent), followed by gravel (30 percent). Some silt and cobble were also present.

**Figure 10. Macon Creek at Hiser Road (Station 14).**

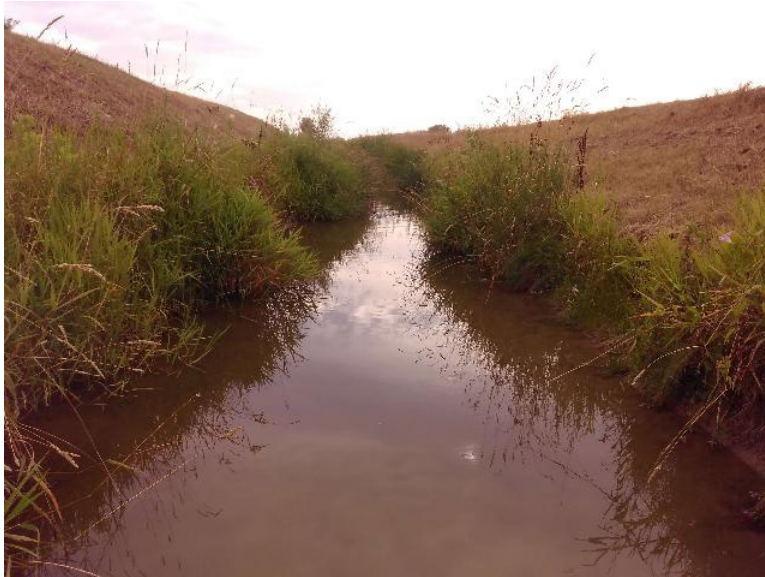
**Figure 11. Bear Swamp Creek at Dennison Road (Station 15).**

Station 15 was located on Bear Swamp Creek at Dennison Road. Bear Swamp Creek is a tributary to the north branch of Macon Creek. The watershed of this station is nearly all agricultural land. This location appeared to have been recently dredged (i.e., 2017 or 2018), as had been similarly noted in Noffke (2015), and the channel has been mostly straightened, to facilitate drainage. The trees have all been removed at this station and, for the most part, reaches upstream only had a thin ribbon of streamside trees (Figure 11). The low gradient habitat, which

Bear Swamp Creek (Station 15), which rated acceptable (-2), required a full bucket count because it only had 175 individuals in the entire sample, suggesting a somewhat sparse population of macroinvertebrates. The recent dredging appeared to have scraped away most of any channel substrate complexity, which likely was a major cause of the sparse population. The five most common taxa at this station were Chironomidae, Decapoda (crayfish), and Pisidiidae (fingernail clams) (each approximately 23 percent of the community), followed by water boatmen (15 percent) and oligochaete worms (4 percent), indicating a community tolerant of disturbance. No caddisfly taxa were present. Only 1 mayfly taxa, the generally tolerant family Caenidae, was present, comprising only 2 percent of the overall community. Surface air breathers made up 17 percent of the community.

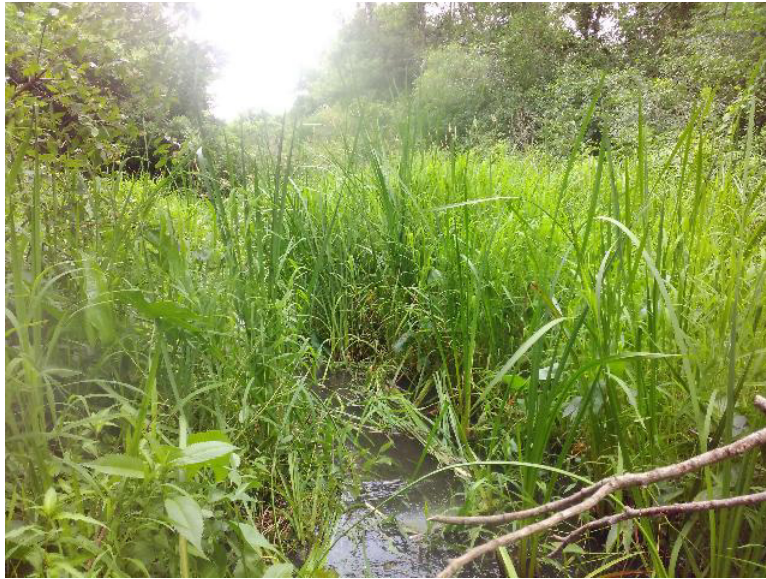
**Figure 13. Koch-Warner Drain at Warner Road (Station 17).**

The watershed upstream of Koch-Warner Drain at Warner Road (Station 17) was a mix of suburban residential neighborhoods, agriculture, and patches of woods. The station had a low gradient, flowing channel, but it also was very wetland-like in its wide floodplain area. Most of the station had low banks and thick, herbaceous wetland vegetation on both sides (Figure 13). The upper part of the survey reach had braided channel with some woody riparian shrubs and the downstream end was near an intersection of two roads.

Aquatic plants were abundant in the channel, with about 75 percent of the survey reach having rooted emergent and rooted submergent plants and/or duckweed, though it did not appear to be nuisance conditions. The water was clear and cool (65 °F) at the time of the survey. This glide/pool habitat rated good (135) overall. Nearly all individual metrics scored good or excellent, with pool variability (poor) being the exception. The inorganic substrate was very soft and nearly 100 percent silt. While large wood was sparse, overhanging vegetation,

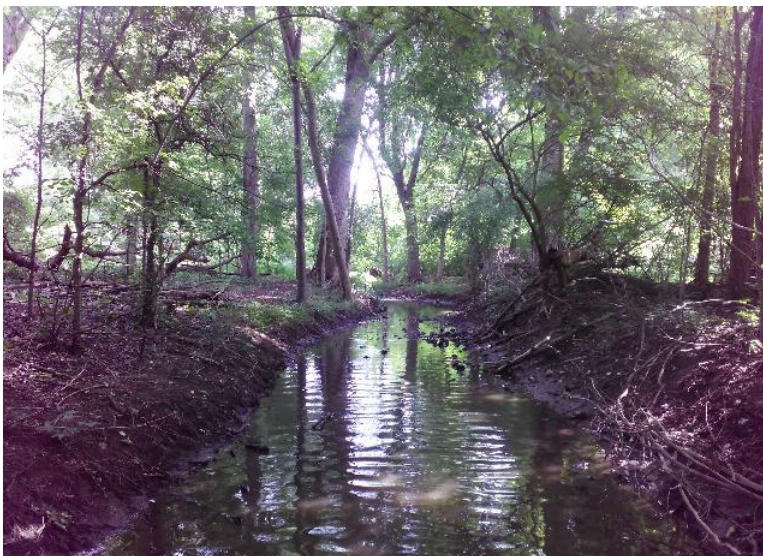
**Figure 14. Wood Outlet Drain downstream of Maple Road (Station 18).**

Wood Outlet Drain downstream of Maple Road (Station 18, Figure 14), was also located in an area that was a mix of suburban residential neighborhoods, agriculture, and patches of woods. There also are several industrial facilities scattered throughout the watershed, and the Ann Arbor Municipal Airport is near the headwaters. While the station is within a forest patch, much of the channel upstream is straightened, with reaches alternating between those lacking streamside trees and others having small patches of forest. Water here was clear and cool (64 °F) at the time of the survey. Average water velocity was slow (0.2 feet/sec). The low gradient riffle/run habitat rated good (128) overall, with most individual metrics scoring good or excellent. Two metrics were marginal (epifaunal substrate/available cover and velocity/depth regime), and one was poor (frequency of riffles/bends), reflecting how the habitat was not very diverse in this location. The channel was 90 percent run, with the remaining habitat being riffle or depositional. Cobble and gravel comprised approximately 20 percent of the inorganic substrate, while fine sediments dominated the stream bottom (sand [20 percent], silt

[60 percent]). Other than the limited riffle habitat, there was little other structure available for macroinvertebrate colonization.

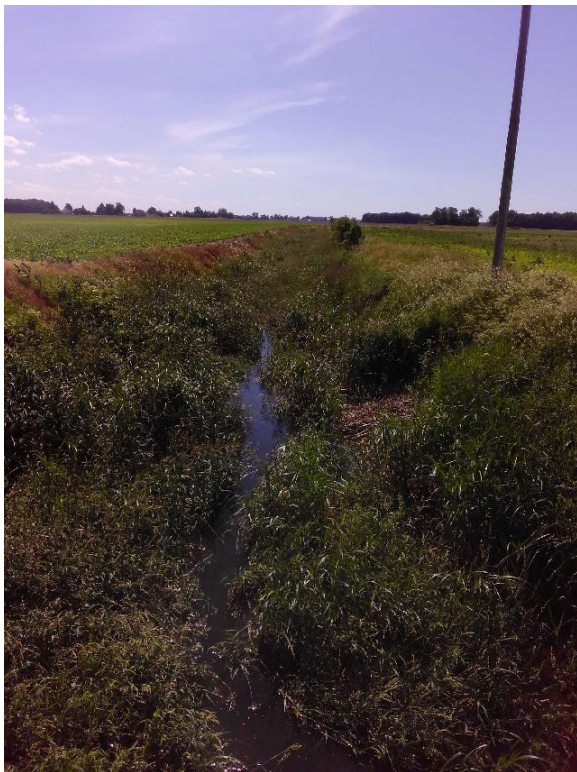
**Figure 16. Little River Raisin at Sisson Highway (Station 23).**

The habitat at this station rated marginal (70) with the following individual metrics scoring poor: pool variability, flashiness, channel alteration, channel sinuosity, and riparian vegetation zone width. There was virtually no riparian forest buffer alongside the channel near, or upstream of, this station and the channel was lined with grasses (Figure 16). The channel bottom was primarily silt (75 percent), but it also had minor amounts ( $\leq 10$  percent each) of gravel, sand, and clay. Average surface velocity was a

little faster (0.4 feet/sec) than at Station 22. Approximately 40 percent of the channel had rooted emergent vegetation; duckweed was also present. Other than emergent vegetation, macroinvertebrate colonization structures were generally sparse.

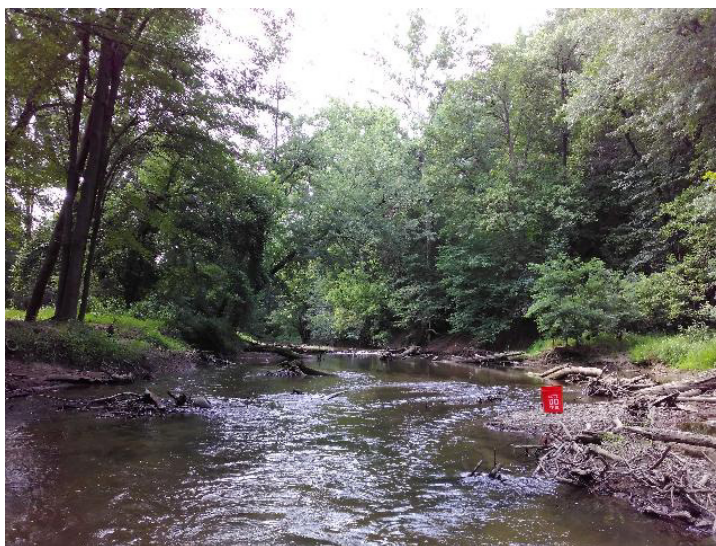
The South Branch River Raisin at Howell Highway (Station 24; Figure 17) is located downstream of the Adrian WWTP. Further upstream are a cemetery and Island Park. Much of the riparian corridor is forest except for some occasional lawn areas near the WWTP and park and treeless areas near a powerline. Habitat at this station rated good (143) overall in this riffle/run reach, with almost all individual metrics scoring good or excellent except for frequency of riffles/bends and vegetative protection, which rated marginal. Most of the inorganic substrate was either gravel (40 percent) or sand (40 percent), with the remainder being cobble (2 percent) or silt (18 percent). Large wood and other organic detritus were present in moderate abundance, which may partially explain why there was a good mix of riffle, run, and pool habitats (plus some depositional areas), and fast and slow water areas.

**Figure 17. South Branch River Raisin upstream of Howell Highway (Station 24).**

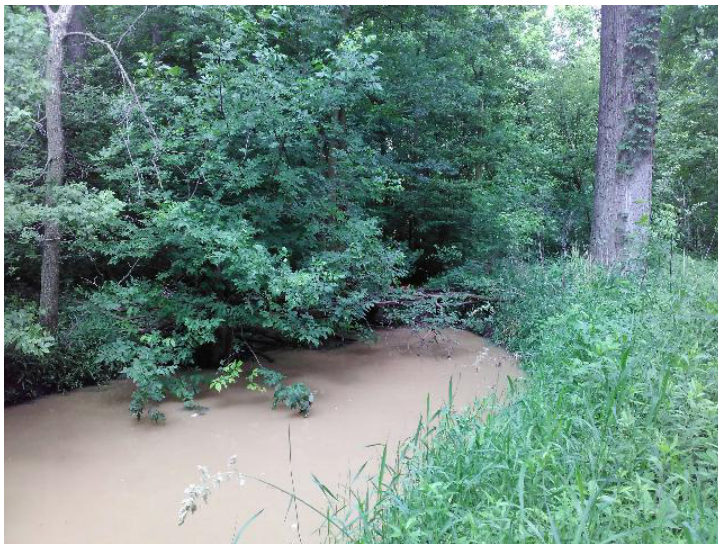
**Figure 18. South Branch River Raisin at Wheeler Highway (Station 27).**

Station 27 was within a patch of woods downstream of mostly agricultural land plus the town of Clayton. Additionally, a wastewater stabilization lagoon was located approximately 1.3 river miles upstream. The riffle/run habitat rated good (125) overall, with most individual metrics scoring good. A few metrics scored marginal (epifaunal substrate/available cover, velocity/depth regime, frequency of riffles/bends). While there were some mature trees and shrubs adjacent to the river and no obvious channel modifications were observed, parts of one side of the channel had been mowed recently. Only about 7 percent of the channel bottom was gravel; the remaining

93 percent was fine sediments (31 percent sand, 31 percent silt, 31 percent clay). Approximately 90 percent of the reach was run, with riffles and pools only representing about 5 percent each. Large wood and other organic detritus were moderately abundant in the channel. Note: Approximately 0.4 inches of rain had fallen in the area between June 9-10, 2018, and the station had very turbid and muddy water on the day it was sampled (June 13, 2018) (Figure 18).

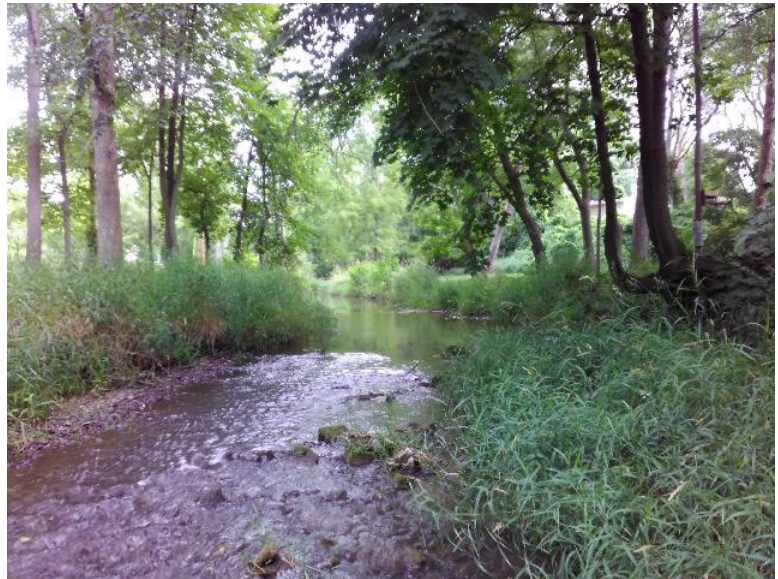
**Figure 19. Beaver Creek at Carson Highway (Station 28).**

Station 28, Beaver Creek at Carson Highway, was located approximately 2.3 river miles upstream of where the creek empties into the South Branch River Raisin. The watershed land uses upstream of this station were mixed, dominated by agricultural lands, but also with some residential developments and riparian forest lands present. The riffle/run habitat rated good (139) overall. All the individual metrics scored good or excellent except for vegetative protection (marginal) and riparian vegetation zone width (poor). Some occasional trees, shrubs, and tall grasses (e.g., reed canary grass) lined the stream

(Figure 19), but there also was a significant amount of lawn along the channel. The inorganic substrate was mostly cobble and gravel (70 percent), but there was still a significant amount of fine sediment (15 percent sand, 12 percent silt, 3 percent clay).

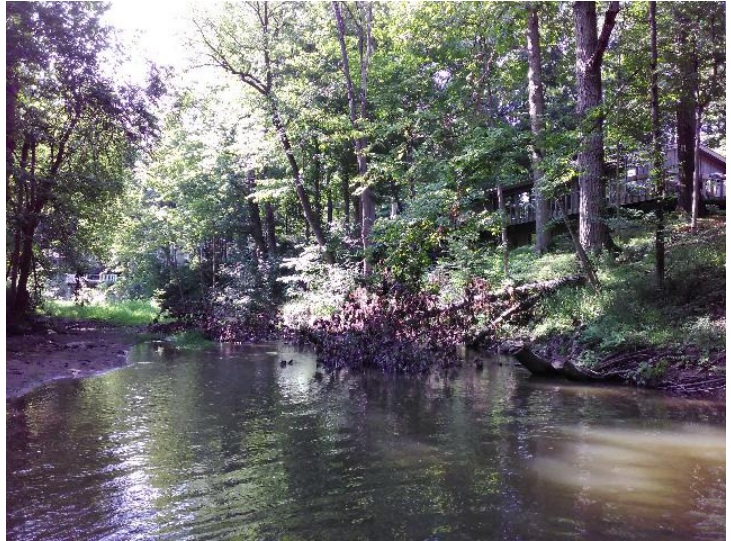
The reach was 90 percent run, 4 percent riffle, and 6 percent depositional. Cobble was the most common inorganic substrate size, with the remainder being a mix of gravel (15 percent), sand (25 percent), and silt (5 percent). Lots of silt covered the rocks. Other macroinvertebrate colonization structures were sparse or absent. Houses and lawns were near the river on the left bank (Figure 20). Sparse moss was observed on some rock in riffles.

**Figure 20. Wolf Creek at Birnwick Drive (Station 29).**

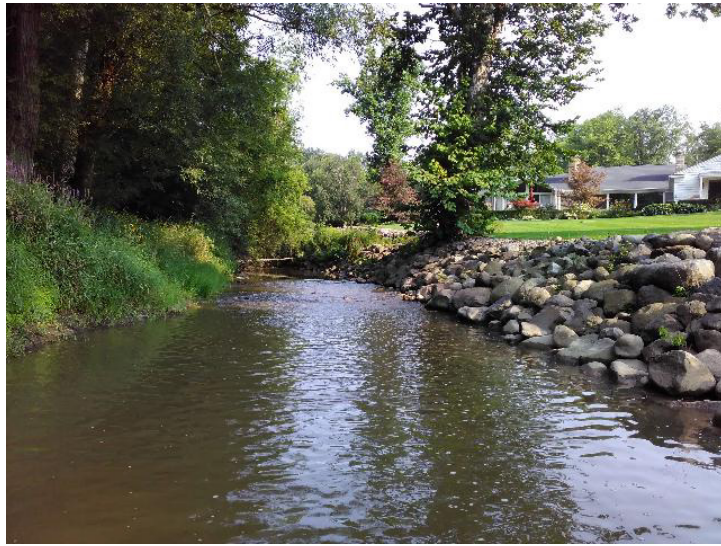
**Figure 21. Wolf Creek at Wolf Creek Highway (Station 30).**

The land uses near Wolf Creek at Wolf Creek Highway (Station 30, Figure 21) included some offices, light residential development, a school complex, and patches of woods,

otherwise the watershed was predominantly agriculture. The riffle/run habitat rated good (110) overall. Most individual metrics rated good or excellent, but a few rated marginal (channel alteration, frequency of riffles/bends, vegetative protection), or poor (riparian vegetation zone width). Bank stabilization and canopy removal were noted at the station, especially on the left bank. This was a residential and small business area with lawn and riprap right up to the edge of the stream in many places. A lot of sunlight could reach the stream, especially on the left side. Sand was the dominant inorganic substrate type

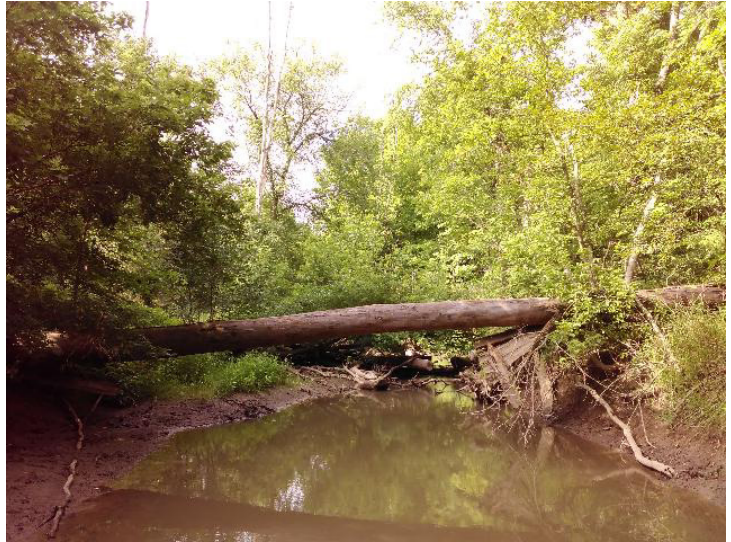
**Figure 22. Wolf Creek off Wolf Creek Highway (Station 31).**

Though still in a mostly agricultural watershed, much of Station 31 and the reaches immediately upstream of it, had relatively wide riparian forest buffers on either side of the channel. Habitat rated good (133) overall in this pool/glide reach (Figure 22). About half of the individual metrics scored as good or excellent, while the other half scored marginal (epifaunal substrate/available cover, pool substrate characterization, flashiness) or poor (pool variability, vegetative protection). Average water velocity was very slow (approximately 0.1 feet/sec). The inorganic substrate was dominated by silt (90 percent), with the remainder being a small amount of sand (8 percent), gravel (1 percent), and cobble (1 percent). Large wood and other organic detritus were abundant.

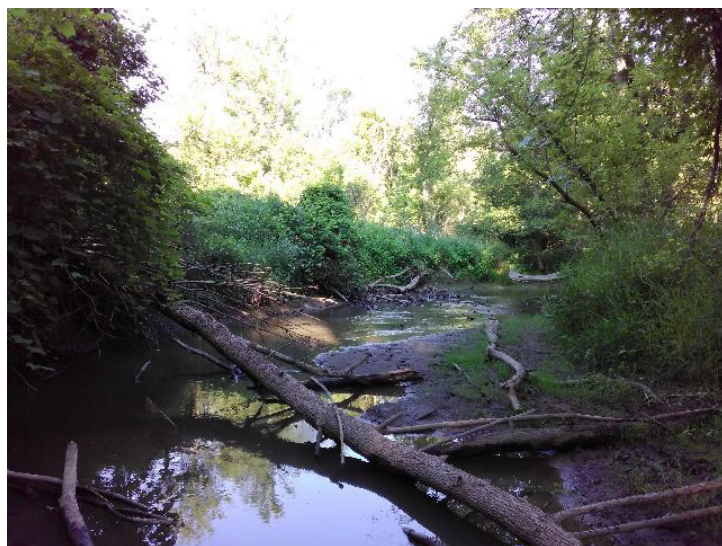
**Figure 23. Wolf Creek at Townline Highway (Station 32).**

Like Station 31, Wolf Creek at Townline Highway (Station 32; Figure 23), and continuing upstream for approximately 1 mile, had relatively wide riparian forest buffers on either side of the channel. Habitat rated good (140) overall in this riffle/run reach. All individual metrics scored good or excellent except for embeddedness, which scored marginal. The water was slightly turbid on the sampling day. The stream bottom was predominantly

sand (70 percent) and silt (20 percent), with some gravel (10 percent). Large wood and other organic detritus were abundant. The riffles present were mostly created by the presence of pea gravel and/or fallen pieces of wood. Riffles only comprised about 10 percent of the sampling reach, with the remaining parts of the channel being slow runs, pools, or depositional areas.

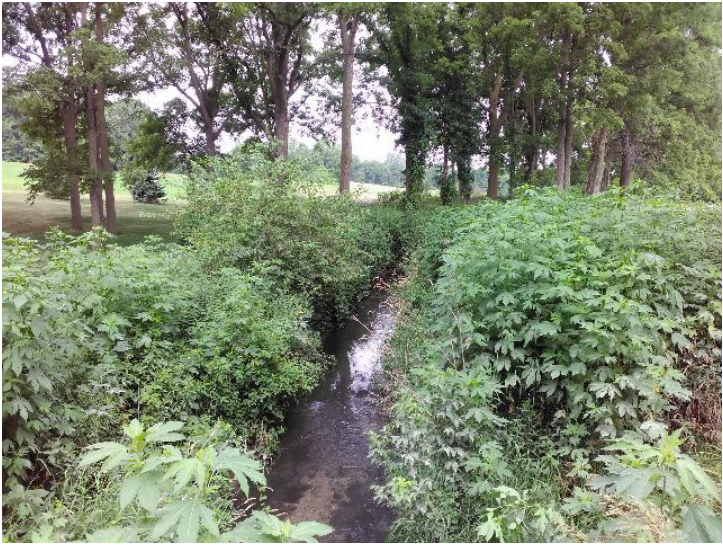
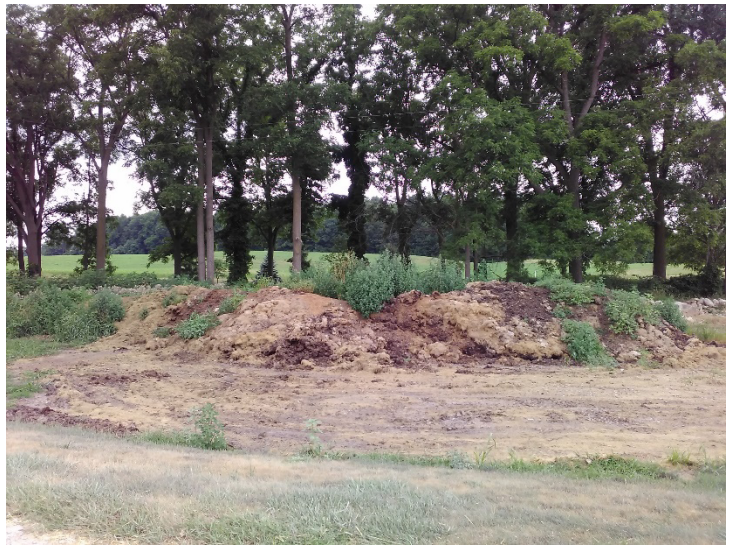
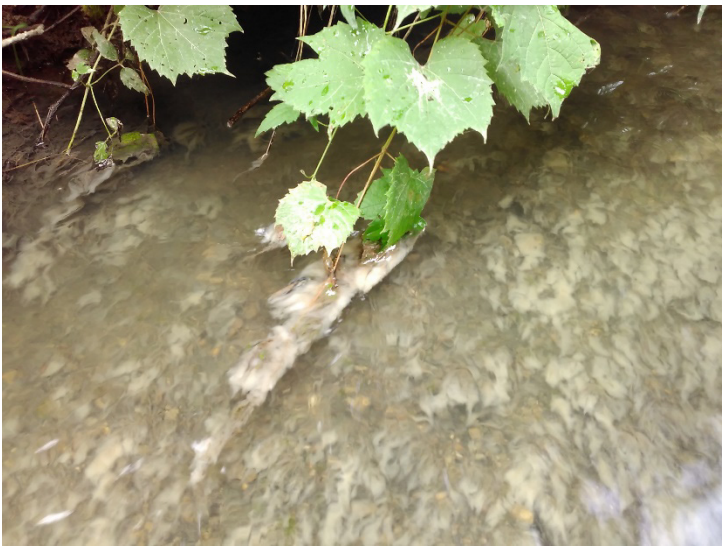
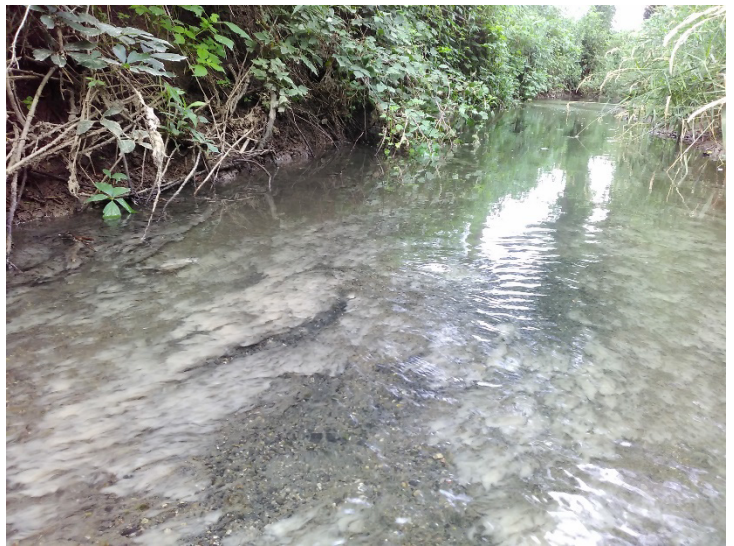
The macroinvertebrate community rated low acceptable (-4; trending towards poor). Not all of the reach (i.e., the upstream 25 percent portion) appeared to be (potentially) impacted by the manure pile, which may have kept the community from rating poor overall. No mayfly, caddisfly, or stonefly taxa were observed. Surface air breathers was, surprisingly, 2 percent. The four most dominant taxa were tolerant including: midges (68 percent), oligochaete worms (21 percent), Physidae (7 percent), and Turbellaria (flatworms) (1 percent). The dominance of chironomids, oligochaetes, and physids appears to be reflecting organic pollution and signaling that oxygen conditions here may be low (even though a DO meter was not on hand that day). Many species of oligochaete worms and midges can tolerate low oxygen concentrations and/or organic pollution such as sewage (Hilsenhoff, 2001; Rosa et al., 2014; Welch and Jacoby, 2004). In fact, some species of Chironomidae are referred to as “blood worms,” are red and contain a hemoglobin-like pigment that retains oxygen, and can tolerate extremely low oxygen concentrations (Hilsenhoff, 2001).

**Figure 24. Evans Creek at Wisner Highway (Station 34). *Top left:* A representative photo of the stream reach with some shrubs and trees. *Top right:* A manure pile adjacent to the stream. *Bottom left and right:* What appears to be possible whitish bacterial or “sewage fungus” slimes on the stream bottom.**

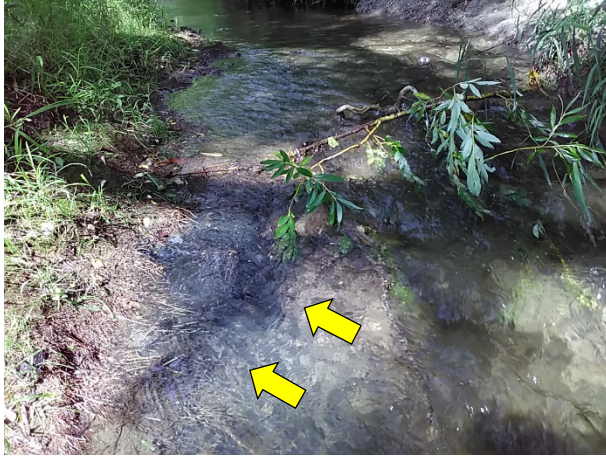
**Figure B-1. Black sediment/substrate color can be seen on left bottom quadrant of the bottom photo (see arrows) at Station 16 (South Branch Macon Creek, upstream of Ridge Highway) on August 1, 2018, though there are also tree shadows in the middle and top parts of the photo.**

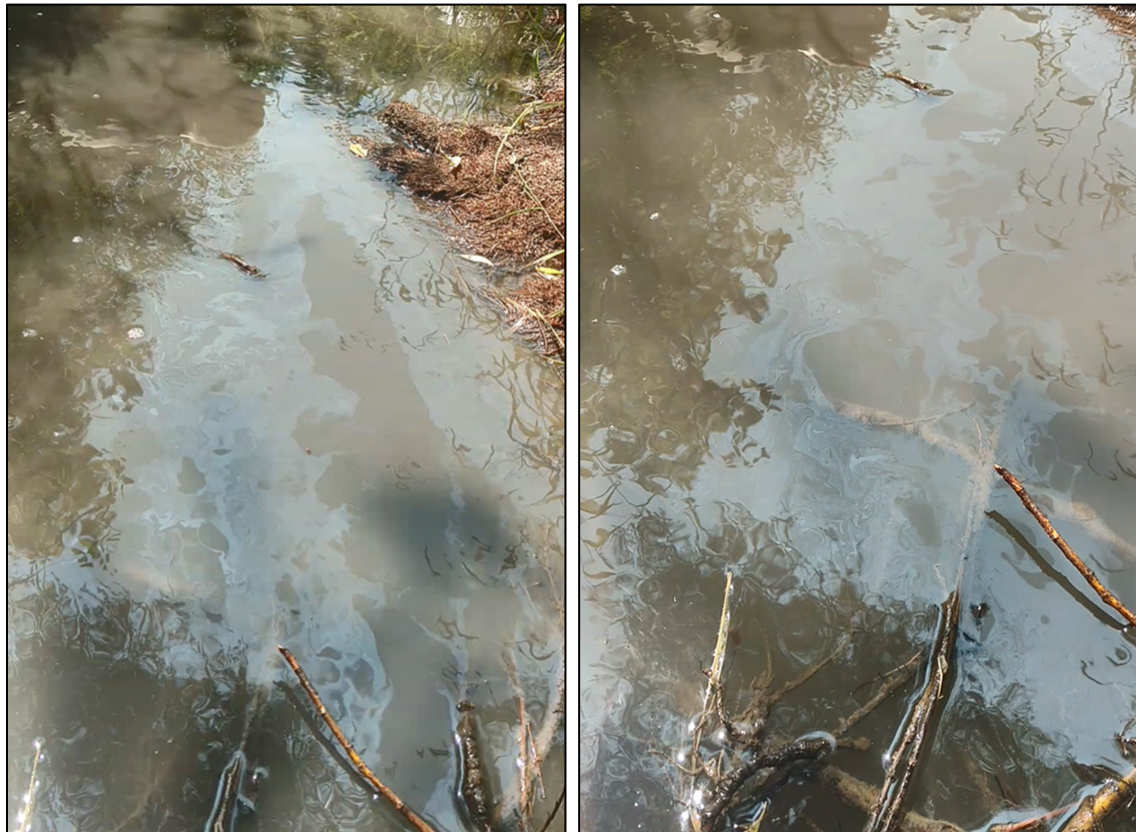
At one location (i.e., approximately 350 feet upstream of Ridge Highway, near Station 16 [South Branch Macon Creek at Ridge Highway]), sediment chemistry samples were collected. Samples of the upper 3 to 5 inches of stream sediment were collected using a stainless-steel spoon, taking care to avoid losing any organic matter that had settled on the sediment surface. Samples were taken from a 4- to 5-inch-wide representative portion of a depositional area in the margin of the stream. Additionally, some tree roots submerged in the stream were disturbed and shaken to try to release

contaminants that had become attached to them. Sheens observed during this sampling process were noted and photographed or recorded on video. Each sample was placed into a stainless-steel bowl, composited, and homogenized with the spoon, and then subsampled to fill up a wide-mouth, 250 mL glass container. During volatile organics sediment sampling, a methanol trip blank was transported to the site in a 40 mL glass vial.

**Figure B-2. Sheens observed after disturbing tree roots at Station 16 (South Branch Macon Creek, upstream of Ridge Highway) on August 14, 2018.**

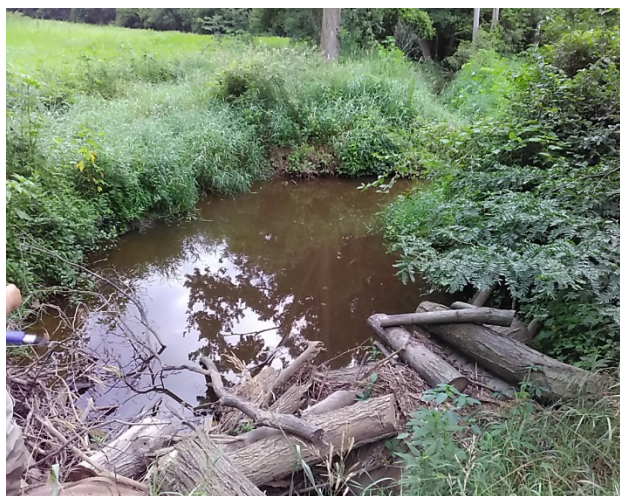
**Figure C-1. S Br River Raisin at W Cadmus Road (Station F).**

It may be warranted that staff of the Surface Water Assessment Section (SWAS) request Jackson District staff to visit this site before summer 2023, when the next River Raisin biosurveys will be conducted, to see if the blockage has been cleared and the river is flowing. If the blockage is cleared and the river is flowing, SWAS staff should revisit the site and check summertime morning DO concentrations again to see whether they are below 5 mg/L.

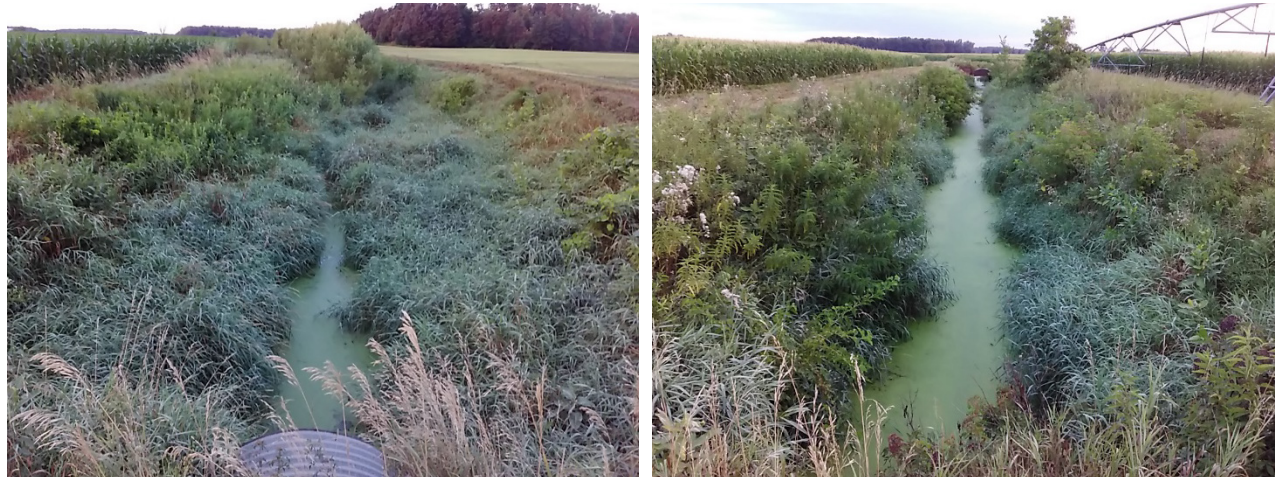
**Figure C-2. Rice Lake Drain at Haley Road (Station I).**

Given the very short stretch of surface water channel, stagnant water conditions, thick density of duckweed, and black water and sediment underneath, it was not unexpected that the drain here had low DO concentrations.

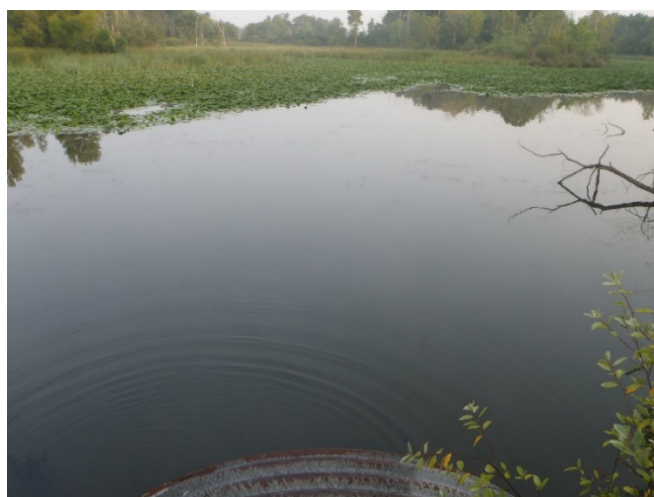
Water at this location was observed to be flowing slowly in a “reverse” direction through the culvert (i.e., downstream to upstream, from the lake back up into the open-wetland area upstream of Stephenson Road) – at least on the August 14, 2018, visit. While the weather was not breezy at this location on this date, one possible explanation for this situation could be, but is not limited to, a small [seiche effect](#) may have been created by wind on the lake. Note that the Wolf Creek inlet to Loch Erin (immediately downstream of Station H and Stephenson Road [i.e., at the bottom end of the culvert]) appeared to be more influenced by Loch Erin than Wolf Creek since it had DO concentration values that were nearly double (4.57, 4.50, and 4.77 mg/L) than just upstream of the road.

**Figure C-3. Wolf Creek upstream of Stephenson Rd (and inlet to Loch Erin) (Station H).**

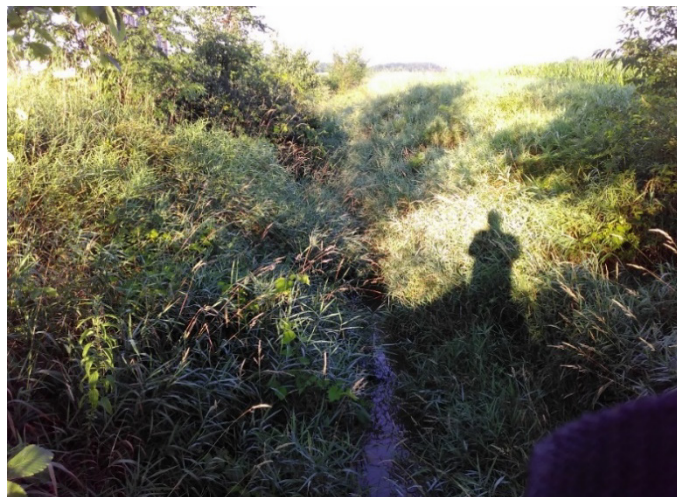
**Figure C-4. Fisk Drain upstream of Knight Hwy (Station D).**

There are no field notes on whether the drain was flowing (i.e., had some downstream velocity) at the time DO measurements were made. If other sites are revisited on a future date (e.g., 2023), this site could be revisited too (and flow conditions noted in addition to DO concentrations).

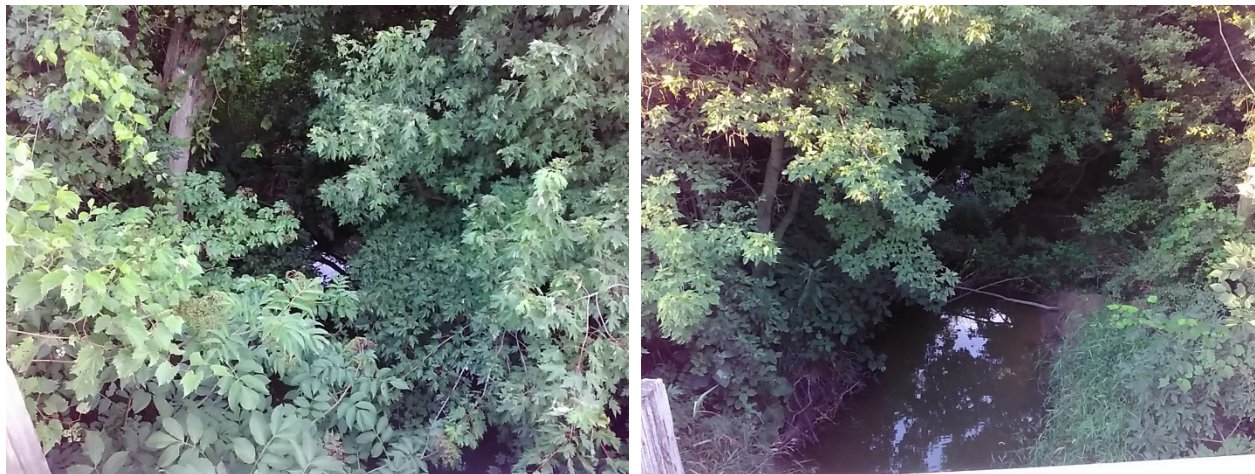
This station (Figure C-5) had an early morning value of 4.78 mg/L (6:39 a.m.). This station location on Bear Creek is approximately 0.17 miles (898 feet) downstream of where Rice Lake Drain flows into Bear Creek. Flow field notes are lacking, though the photo (Figure C-5) indicates that it was likely slow or stagnant.

**Figure C-5. Bear Creek at Medina Road (Station A).**

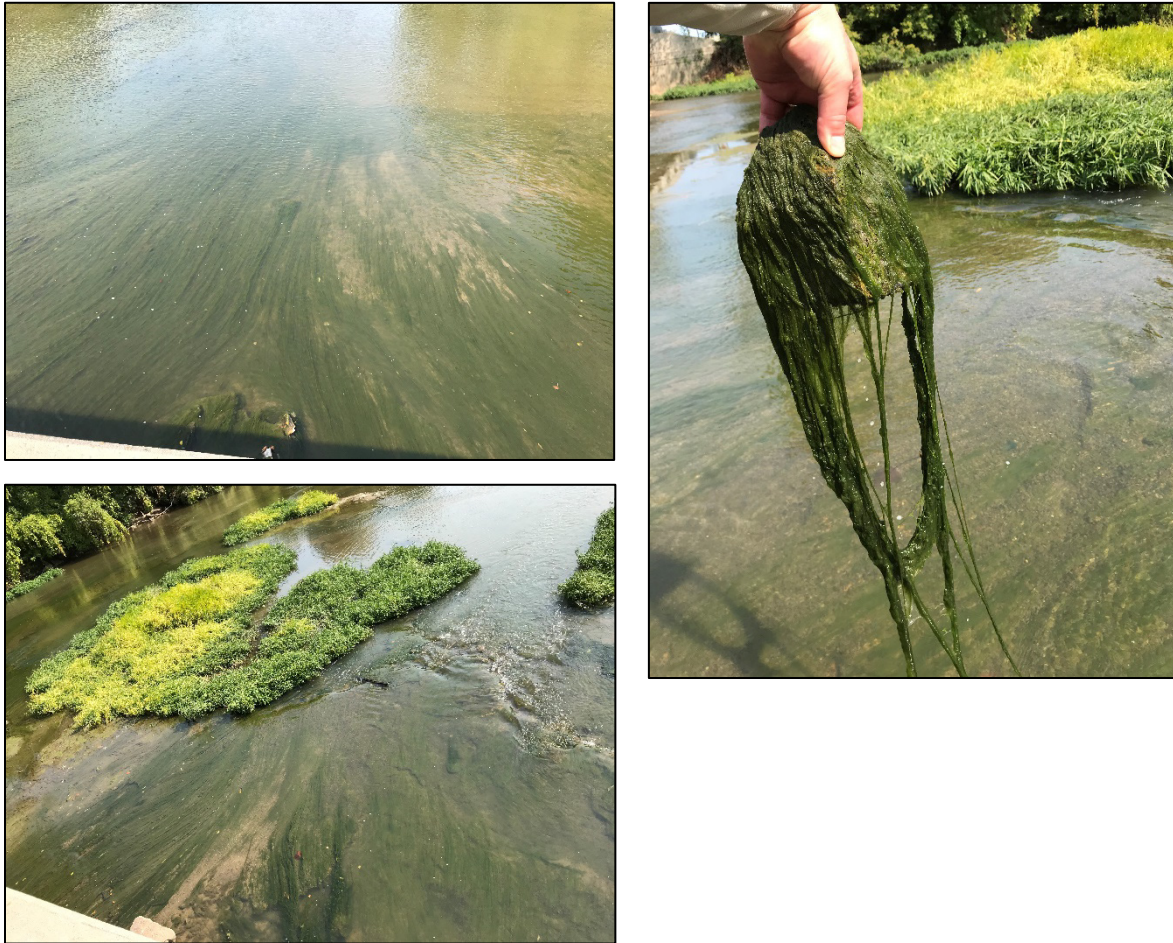
Long strands of filamentous algae can sometimes be found in the River Raisin watershed, seemingly when the habitat (e.g., substrate conditions, open canopy) and water chemistry conditions are present. For example, on September 22, 2020, abundant strands of long filamentous algae were observed at a shallow, wide section of the River Raisin mainstem at Ida Maybee Road (Figure C-6).

**Figure C-6. Filamentous algae growing in the River Raisin mainstem at Ida Maybee Road on September 22, 2020.**

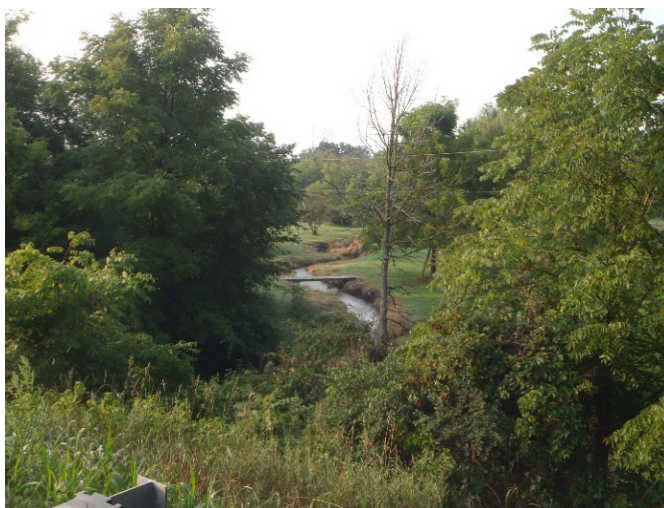
**Figure C-7. Wolf Creek upstream of Springville Hwy (Station G).**

Some phosphorus (water) samples, DO measurements, and observations were collected or made at Station G (Wolf Creek at Springville Highway; Figure C-7) and Station H (Wolf Creek upstream of Stephenson Road [Figure C-3], near/at the inlet into Loch Erin) on the early morning of August 14, 2018 (Table C-2). Some observations were also made in between these stations. Early morning DO was 7.62 mg/L at the upstream location (Station G) and, as mentioned earlier, 2.35 mg/L at the downstream, more pond-like and wetland area location (Station H [Wolf Creek inlet culvert to Loch Erin]). Ortho phosphate concentration was slightly higher (0.015 mg/L) at the downstream station (H) than the upstream station (G) (0.011 mg/L). Conversely, total phosphorus was slightly higher 0.065 (mg/L) at the upstream station (G) than at the downstream station (H) (0.063 mg/L).

Land use activities between the two locations may potentially (at least partly) explain the decrease in DO concentrations; however, the physical characteristics of the two stations were very different (i.e., small stream [G] vs. pond-like and wetland [H] type habitats). While no cattle were observed in the stream between Stations G and H on August 14, cattle did appear to have unrestricted access to parts of the stream (see Figure C-8). The unrestricted cattle access issue downstream of Springville Highway was referred to EGLE's Jackson District Office and then eventually referred to the Michigan Department of Agriculture and Rural Development's Right-to-Farm program for follow-up.
