MICHIGAN DEPARTMENT OF ENVIRONMENT, GREAT LAKES, AND ENERGY  
WATER RESOURCES DIVISION  
JULY 2023  
STAFF REPORT

**Biological, Water Chemistry, and Sediment Chemistry Surveys of  
Selected Stations in the River Raisin Watershed in Lenawee, Monroe,  
and Washtenaw Counties, Michigan, June-September 2018**

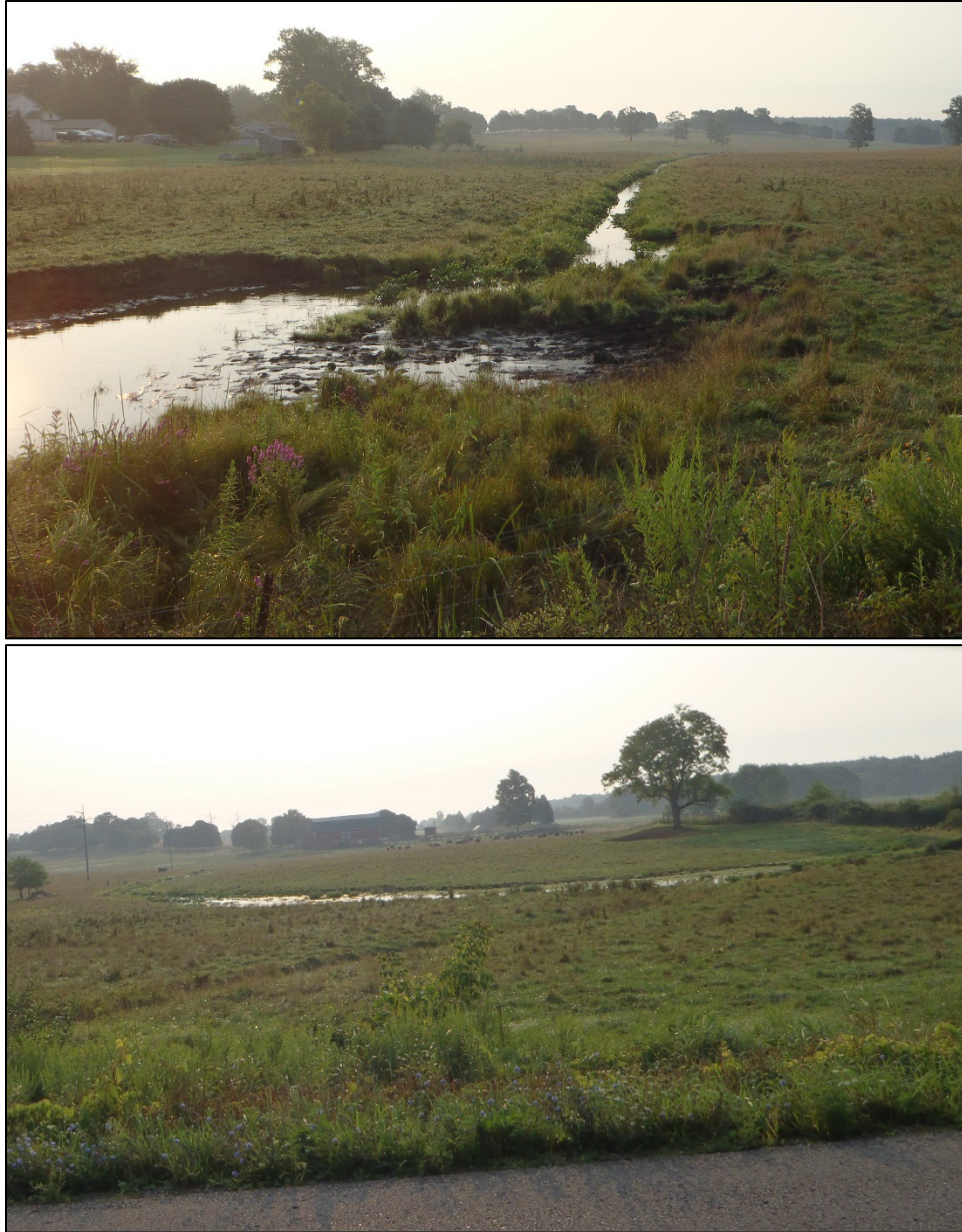
**Figure C-8. Wolf Creek between Stations G and H. Eroding streambanks and streambed (top and bottom); cattle can be viewed off in the distance, with no fencing to restrict access (bottom).**

Land use activities between the two locations may potentially (at least partly) explain the decrease in DO concentrations; however, the physical characteristics of the two stations were very different (i.e., small stream [G] vs. pond-like and wetland [H] type habitats). While no cattle were observed in the stream between Stations G and H on August 14, cattle did appear to have unrestricted access to parts of the stream (see Figure C-8). The unrestricted cattle access issue downstream of Springville Highway was referred to EGLE's Jackson District Office and then eventually referred to the Michigan Department of Agriculture and Rural Development's Right-to-Farm program for follow-up.
