**Clean Michigan Initiative
Nonpoint Source Grant**
1999-0063

Partnership for the Jewel of the Midwest

August 15th 2000 - September 30th 2003

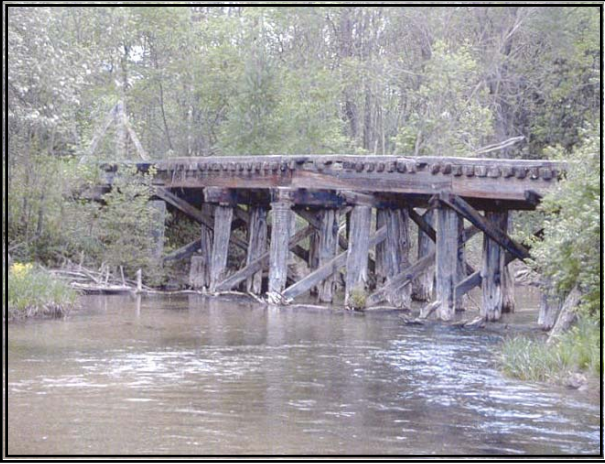
Cedar River "Railroad" Bridge Before:
Deteriorated railroad bridge causing erosion and sedimentation.

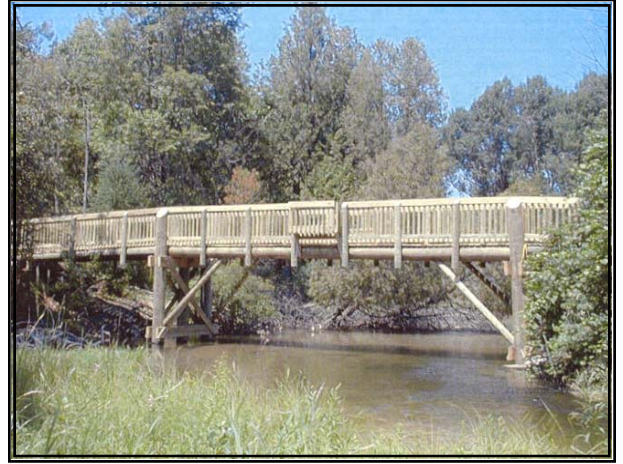
Cedar River "Nature" Bridge After:
Here, the old bridge has been removed, allowing for the construction of this new clear span bridge. Rock rip rap and critical area treatment were placed along the river bank.

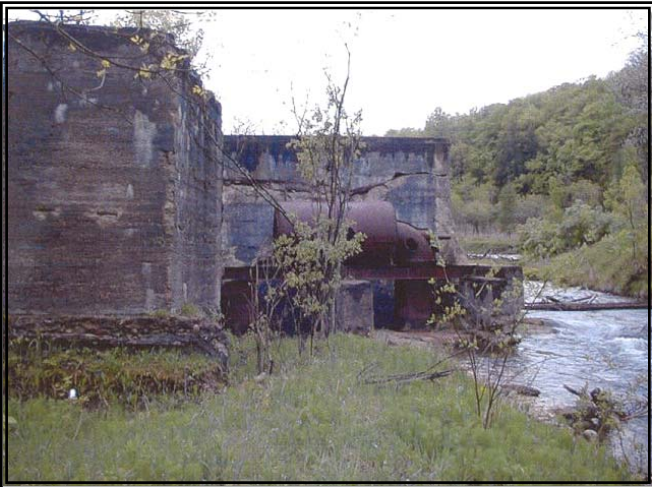
Stover Dam (Cedar River) Before:
The remains of Stover Dam after it broke during a series of heavy storms. The failure caused extensive damage downriver

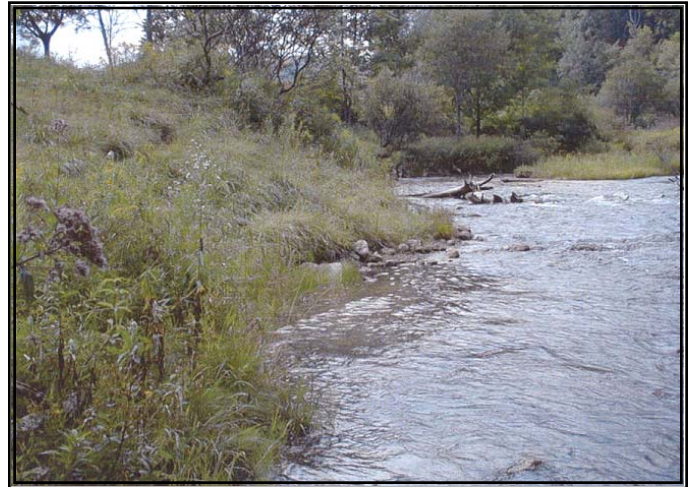
Stover Dam (Cedar River) After:
The Stover Dam site after the removal of the dam. Bioengineering erosion techniques were applied to the stream banks, including fascine bundles, which are long bundles of vegetation (most often willow) placed in the ground to sprout new vegetation.
