**Clean Michigan Initiative
Nonpoint Source Grant**
Tracking Code: 2000-0139

Lake Charlevoix Watershed Project

December 2001 through December 2004

Restoration Projects

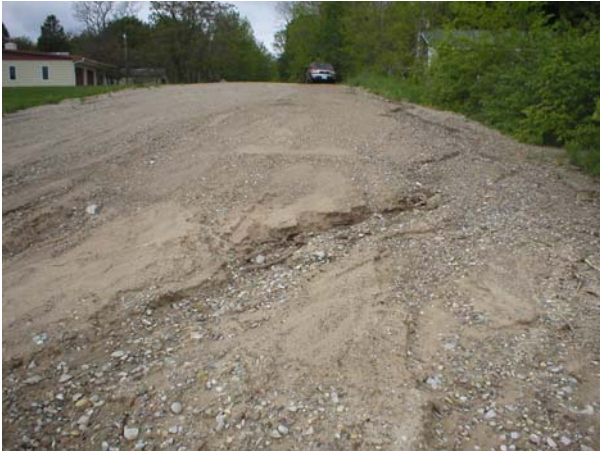
BEFORE

Description: Photo taken spring 2004. Note severe gullying and rilling, both signs of accelerated erosion.

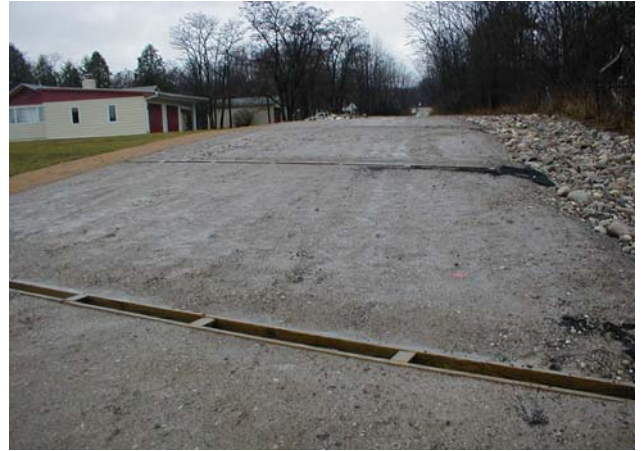
AFTER

Description: Photo taken November 2004. Note fieldstone-lined stormwater conveyance channel (right), water bars (center), and seeded vegetation buffer temporarily stabilized with coir mulch blanket (left). Gully and sheetflow erosion will both be greatly reduced at this site as a result of these 3 BMPs.

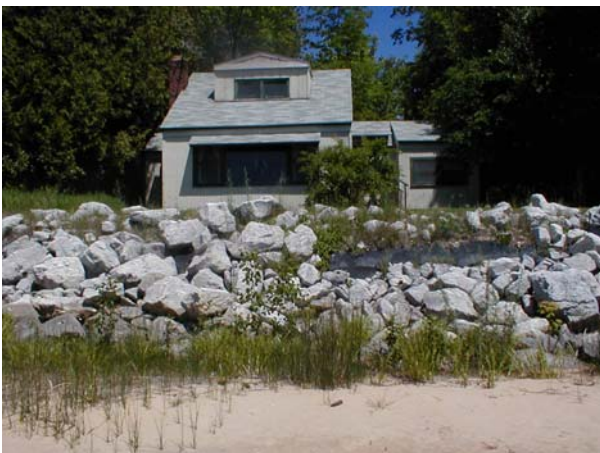
BEFORE

Description: Photo taken fall 2003. Note large areas of exposed filter fabric, and large angular riprap. Almost no buffer exists with maintained turf extending to the edge of the riprap.

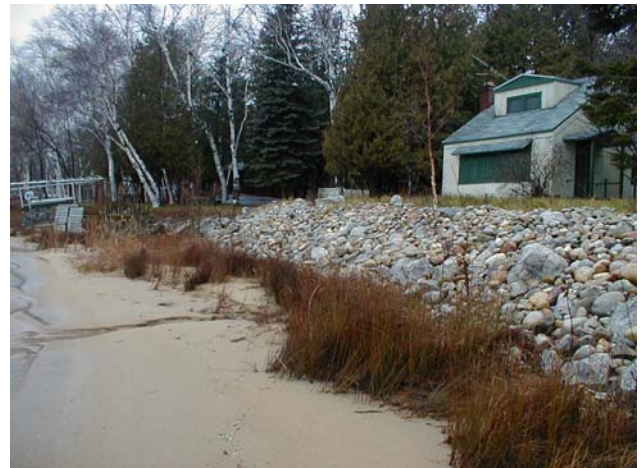
AFTER

Description: Photo taken October 2004. Angular riprap has been top dressed with rounded gravel and fieldstone. After one growing season, a substantial 10' wide buffer zone is taking shape behind the riprap.

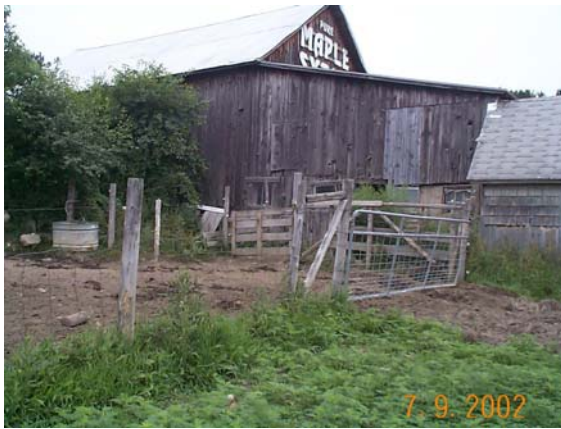
BEFORE

Description: Several seeps from a hillside caused this area around the barn to become extremely muddy.

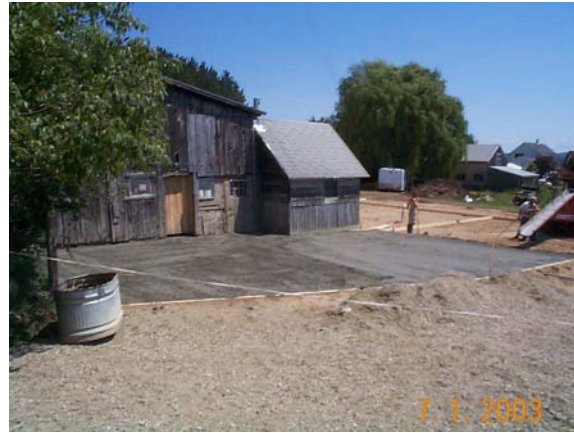
AFTER

Description: Water seeping from hillside is now collected and used in the barn. Material excavated to install the cement pad, was used to stabilize the eroding hillside.

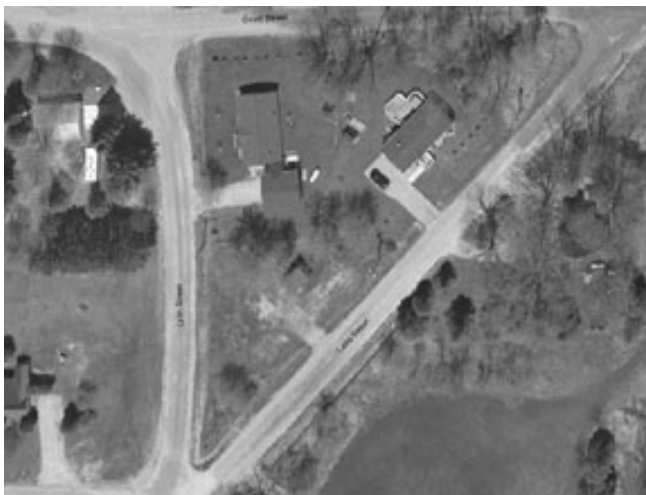
BEFORE

Description: Photo taken Spring 2004. Detention basin location at the corner of Lynn Street, Court Street and North Lake Streets in Boyne City.

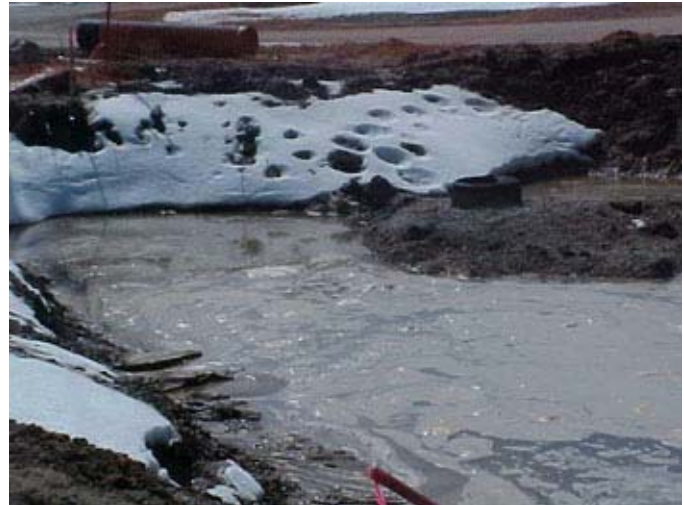
AFTER

Description: Photo taken Spring 2005. This project was started very late in the year. At the time of this photo it wasn't completely finished, but was still working!

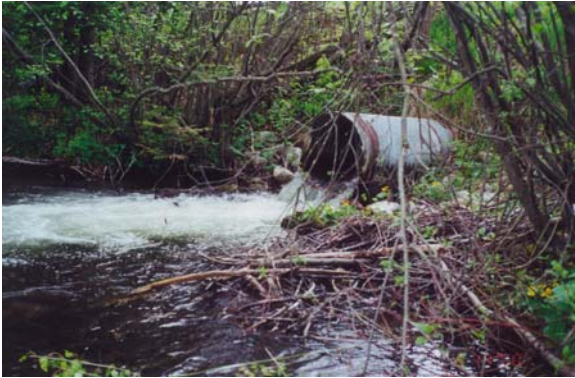
BEFORE

Description: The severely undersized, perched 36" culvert caused ponding upstream.

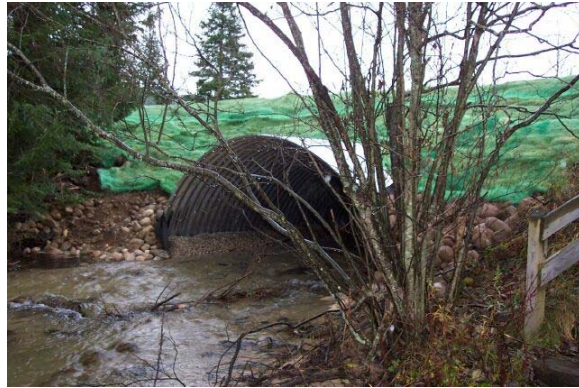
AFTER

Description: A properly aligned 16' wide steel bottomless arch culvert was installed to better accommodate water capacity and velocity of the Jordan River, provide a natural stream bottom, and improve fish passage.

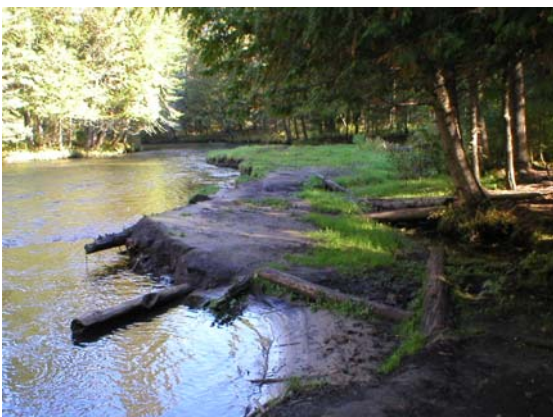
BEFORE

Description: Photo taken in the fall of 2003. Note large areas of exposed soil. Vegetation appears to have been mowed or trampled through extensive use. Other features include scattered litter, accelerated erosion, and lack of woody vegetation.

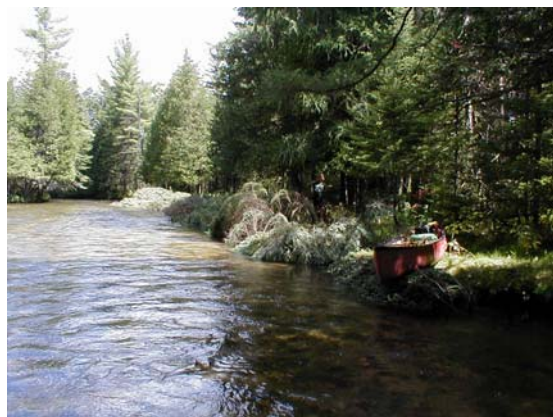
AFTER

Description: Photo taken in August 2004. Whole tree revetments and brush obstacles have been installed in front of and on top of eroding banks. Native woody vegetation installed on banks.
