**Clean Michigan Initiative
Nonpoint Source Grant**
1999-0044

Nottawa Creek Athens Bank Stabilization Project

August 1, 2000, through July 31, 2001

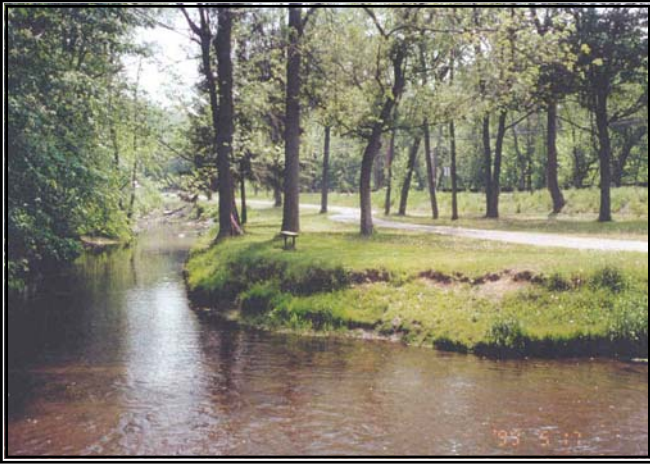
1999:
Sediment from this eroding stream bank was being washed into the river, which covered potential habitat for organisms requiring a rocky stream bottom.

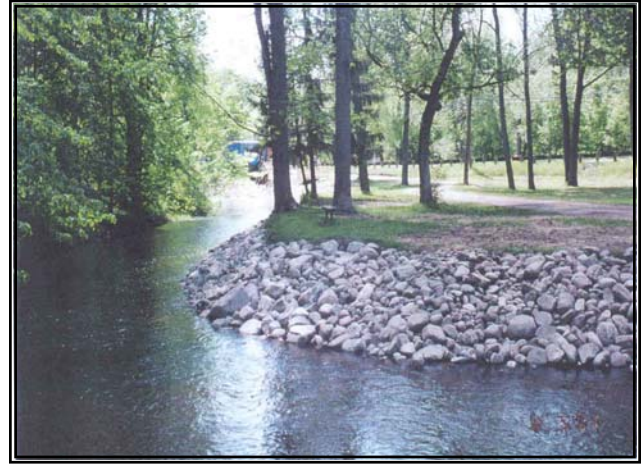
2001:
The bank was stabilized with bank shaping, geotextile fabric, and rock riprap.

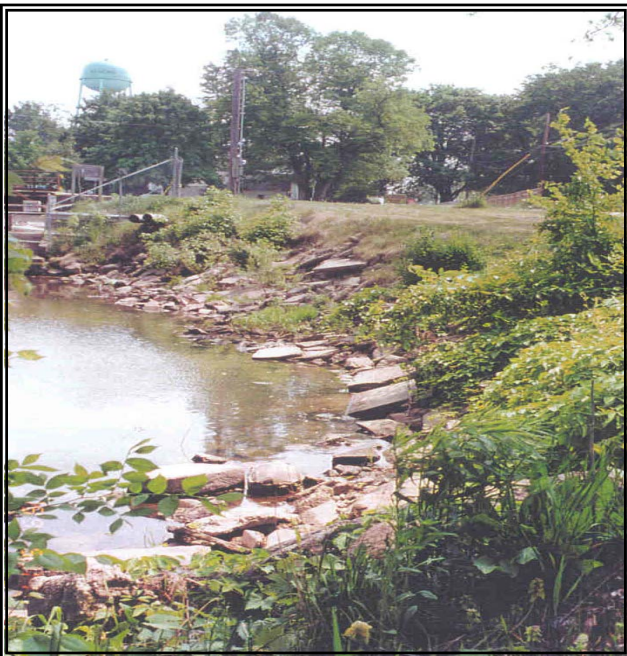
1999:
Water below the spillway had been eroding this stream bank.

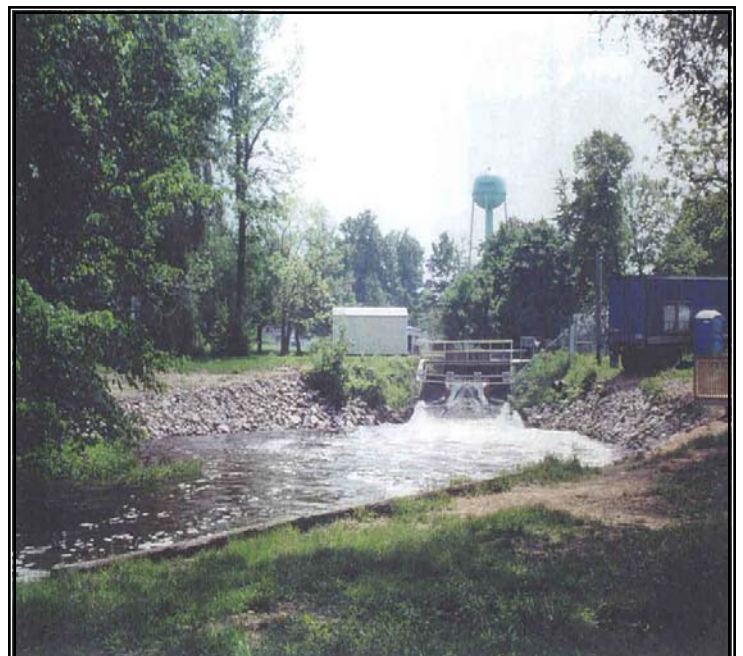
2001:
Erosion was eliminated by bank shaping, geotextile placement, rock riprap, and establishment of native plant species.
