**Clean Michigan Initiative
Nonpoint Source Grant**

Rogue River Watershed Physical Improvements

July 17, 2001 - December 31, 2004

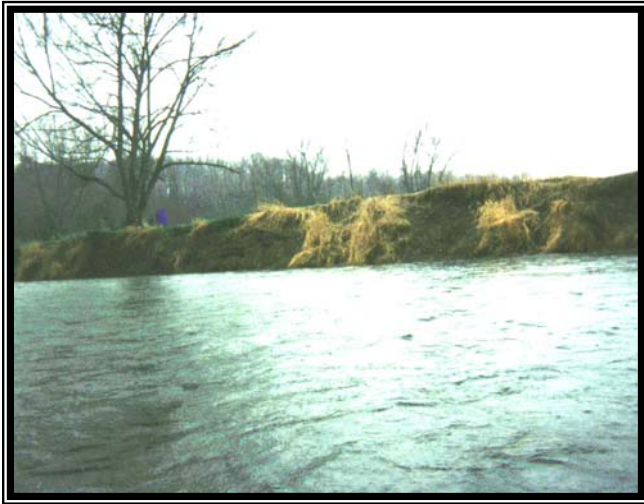
Stream Bank Before

Description: Before and after photos above of a streambank that is heavily used by fisherman along the Rouge River in Kent County. As a consequence, seven hundred feet of streambank were eroding and contributing sediment into this section of the river, which is prime spawning area for fish. To control the sediment input, the bank was graded and stabilized with riprap and vegetation. Partners on this project were the Schrems West Michigan Trout Unlimited.

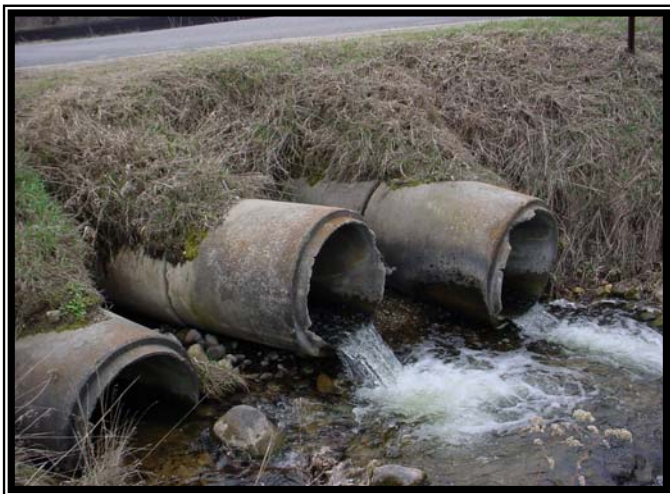
Road Stream Crossing Before

Description: Before and after photos above of failing culverts at 128th Street in Newaygo County. The failing culverts at this crossing have resulted in sediment input into Kosten Drain, which is a tributary at the headwaters for the Rogue River. The failing culverts were replaced with a box culvert. Our partner on this project was the Newaygo County Road Commission.
