**Clean Michigan Initiative
Nonpoint Source Grant**
Tracking Code 2002-0059

Calhoun Conservation District
13464 Preston Drive
Marshall, MI 49068
Telephone: 269-781-4867 ext 5

Nottawa Creek BMP Implementation Project

January 1, 2004 through September 30, 2006

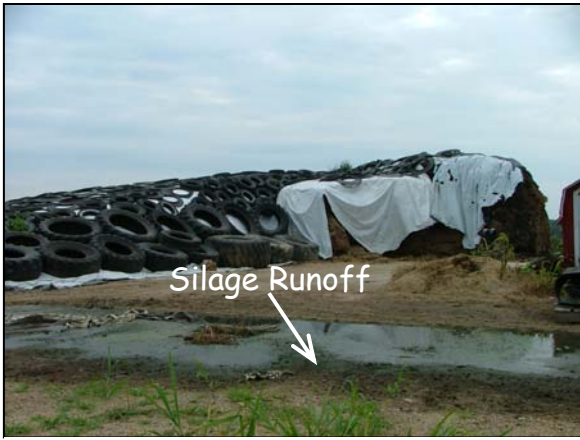
MarGro Farm - before construction, Silage is fermented vegetation which is used as cattle feed. Silage runoff poses a risk to groundwater due to increased nutrient runoff.

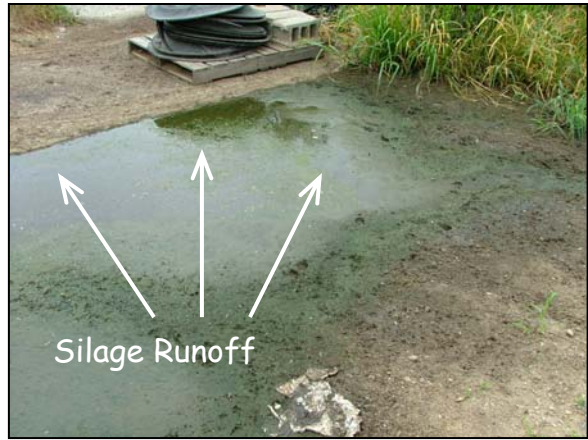
MarGro Farm - before construction, silage pile lacks containment for silage runoff which has high levels of nutrients causing ground water pollution.

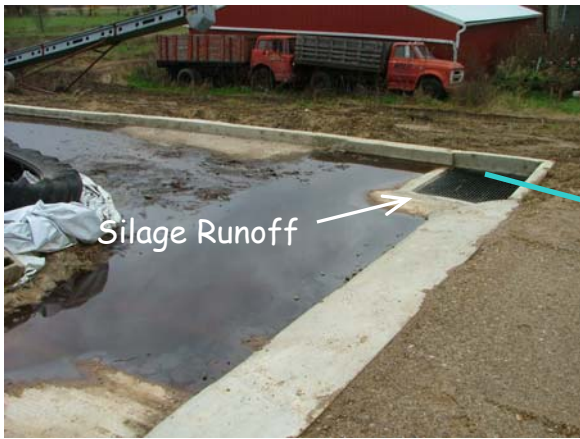
MarGro Farm - after construction, runoff containment prevents groundwater pollution by collecting runoff and discharging it to the waste storage facility.

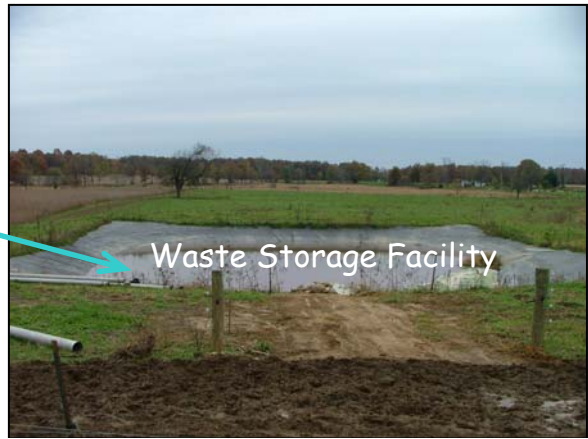
MarGro Farm - after construction, existing waste storage facility was connected to silage runoff collection basin.

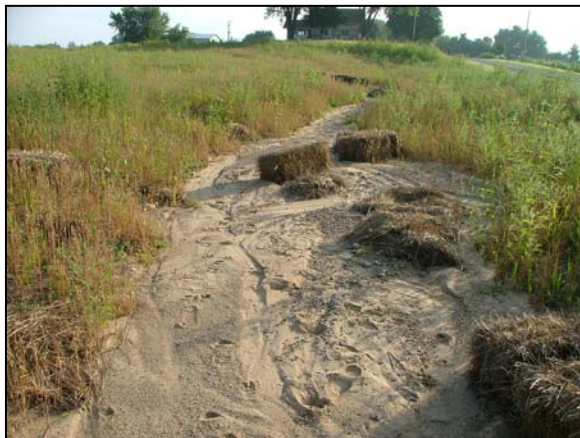
Devenney Farm - before construction, of grassed waterway. Active erosion occurring.

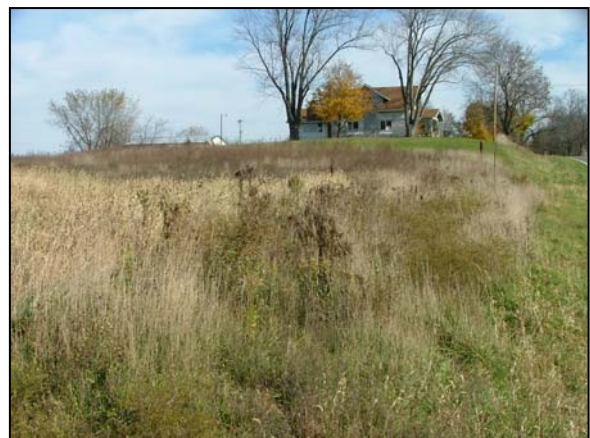
Devenney Farm - after construction, grassed waterway after implementation.
