## Clean Michigan Initiative Nonpoint Source Grant

## Betsie River Watershed Restoration Project - Phase I

September 1, 2001 through September 30, 2005

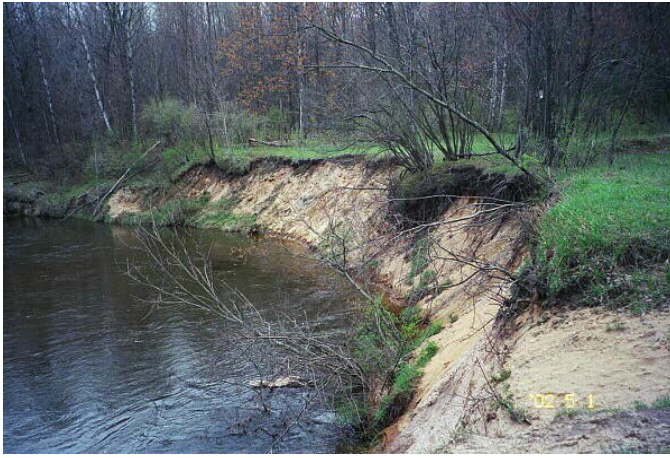
**Streambank Site #146 Before:** This severely eroding streambank was dumping tons of sand into the Betsie River every year. The steep, sandy conditions prevented the bank from revegetating on its own.

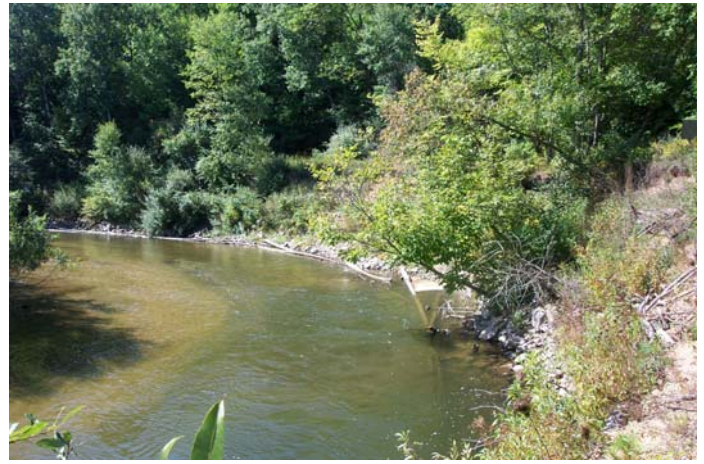
**Site #146 After 3 Years:** Over 200 cu. yds. of fieldstone were placed along the toe of the bank, log terraces were installed along the upper slope, seedlings were planted, and woody debris was placed in the stream in front of the rock for fish cover.

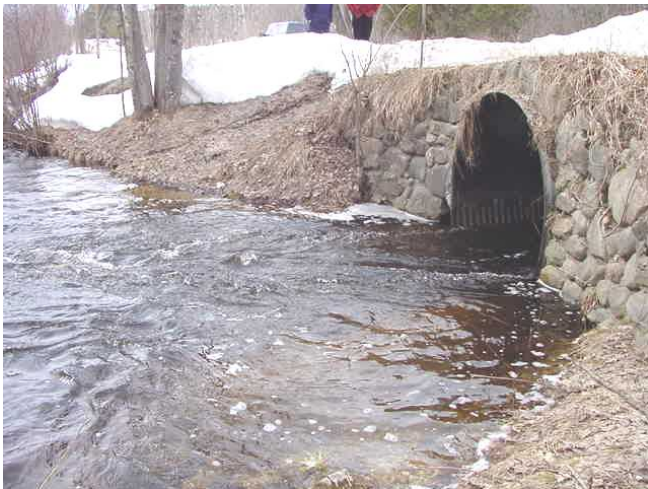
**Site #B-18 Before:** Both road crossing sites, #B-18 and #B-17, had 5' diameter culverts on a 20' wide stream, the Little Betsie. The sites were even on the same road. Pool formation, scouring and embankment erosion were major problems.

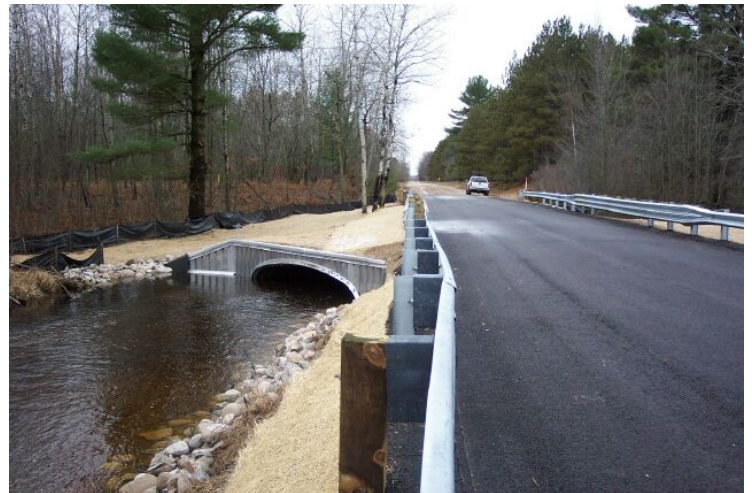
**Site #B-17 After:** CRA worked with Benzie County Road Commission to replace the 5' diameter culverts with 16' wide bottomless, aluminum arches. The roadbed was paved and diversion outlets installed. Fieldstone and revegetation was incorporated. Now we have a natural stream bottom and the large, unnatural pools at the outlets are filling in and narrowing up.
