**Federal Section 319
Nonpoint Source Grant**
Tracking code: 2002-0056

Pine River Hydrology and Geomorphology Project

February 14, 2003 through June 30, 2006

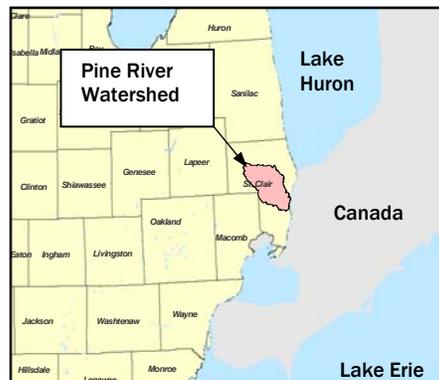
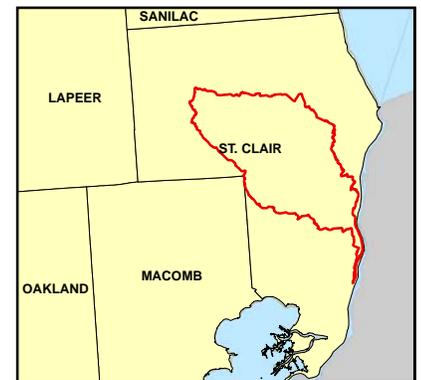
Severe Erosion Problems

- The natural portions of the watershed are geomorphically stable, but in tributaries like the Holland Drain where artificial drainage has been constructed, stream morphology was found to be unstable with some severe erosion problems.

- Approximately 58% of the Holland Drain reaches studied are in an incised state (disconnected from the floodplain).
- Using Rosgen Level II Classifications, the existing drain reaches are primarily of "E", "F", and "G" stream types.

- The erosion analysis showed that many of the reaches are rated at fair to poor erosion ratings. The poorest ratings were correlated to "G" stream types.

• Many of the recommendations for creating a stable watercourse from the severely eroded Holland Drain will be implemented in a petitioned county drain improvement project.
