Clean Michigan Initiative
Nonpoint Source
 Tracking code 2005-0003

Water Tower Park Shoreline Stabilization Project

October 2005 through May 2007

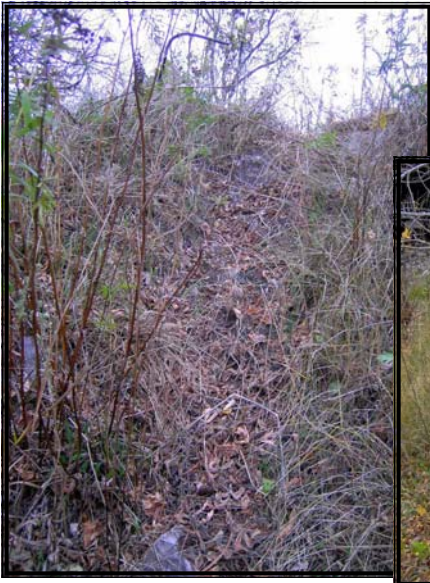
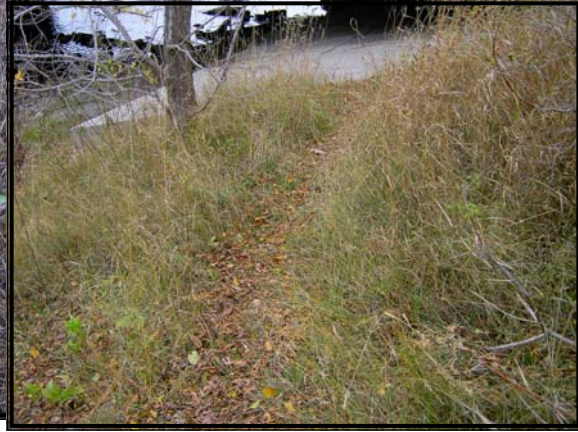
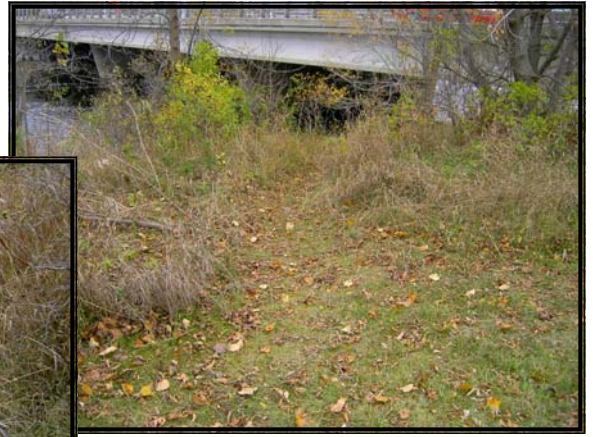
Before: River access for fishermen was through brush down steep banks. This caused the ground cover to be disturbed and erosion to occur over time.

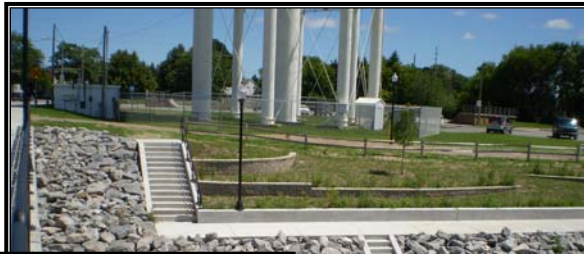
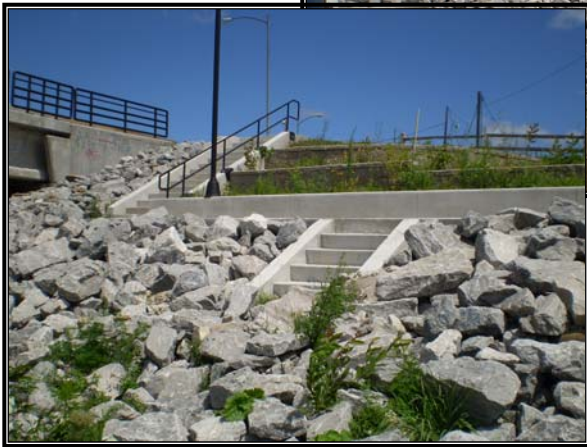
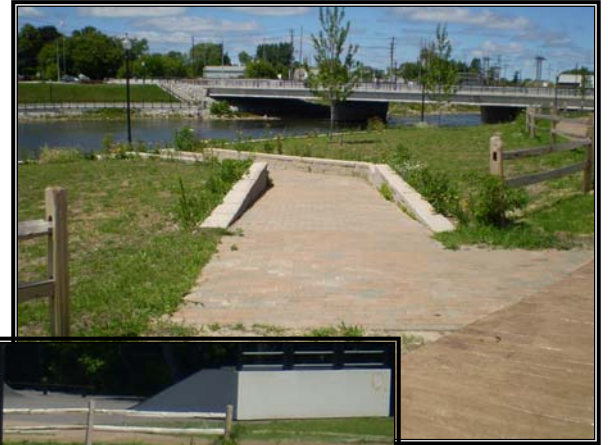
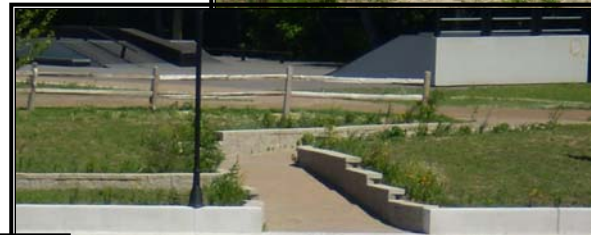
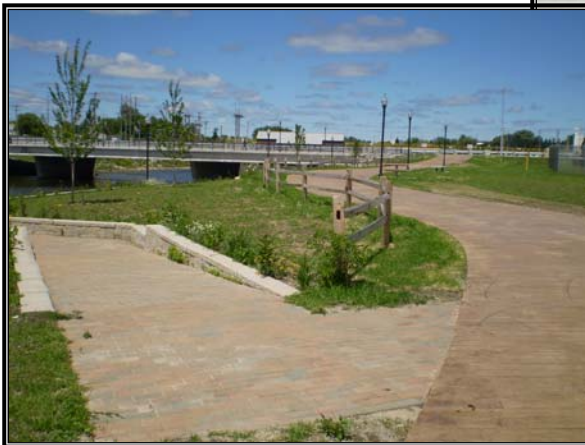
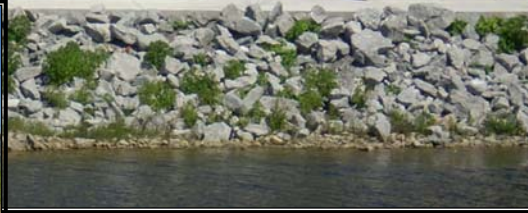
After: Through the installation of porous, barrier-free walkways and concrete steps, fishermen have safe access to the river from parking areas. Access has been guided toward these access points through the use of split rail fence and illuminated walkways.

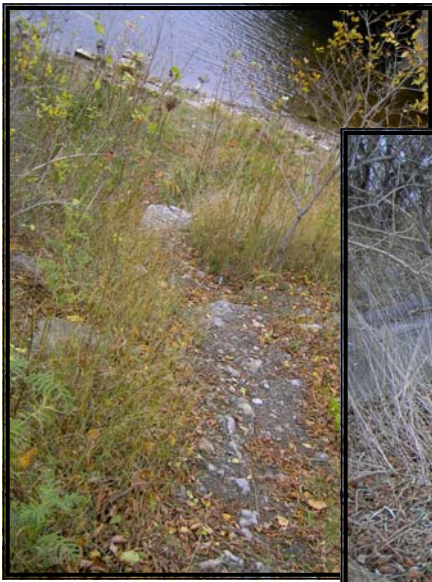
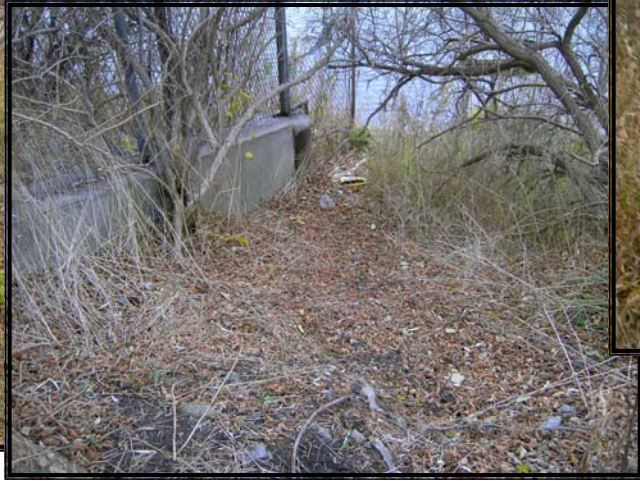
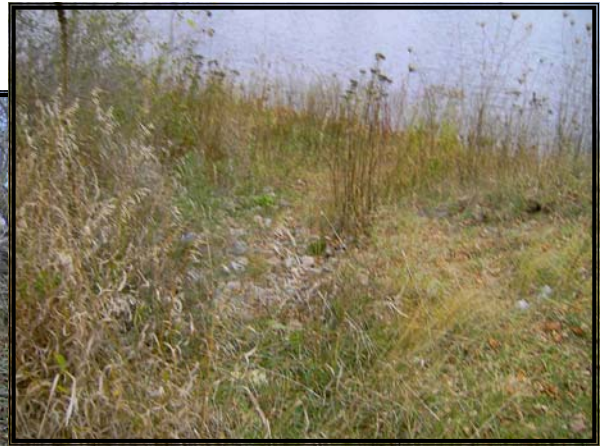
Before: The steep banks adjacent to the river caused soil erosion. In addition, sheet flow from the adjacent park contributed phosphorus and nitrogen due to park maintenance operations.

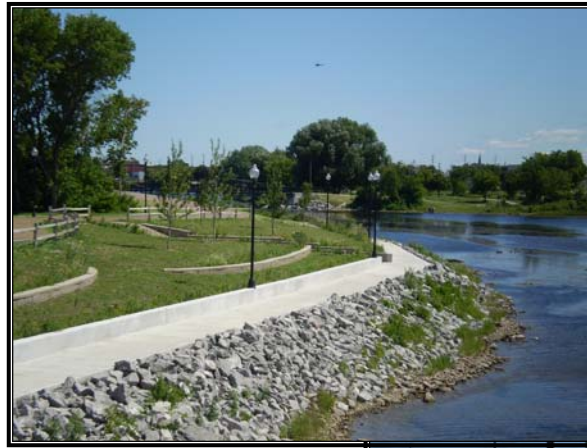
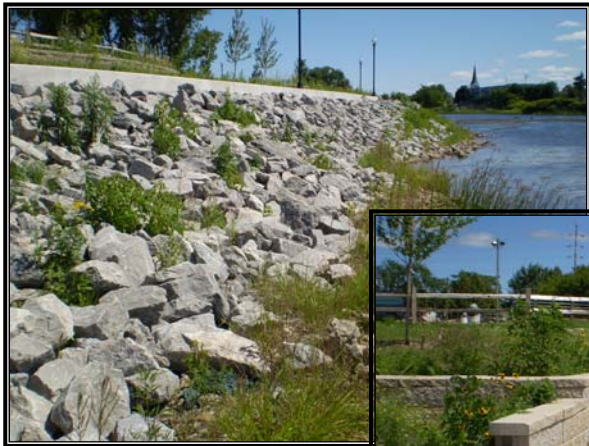
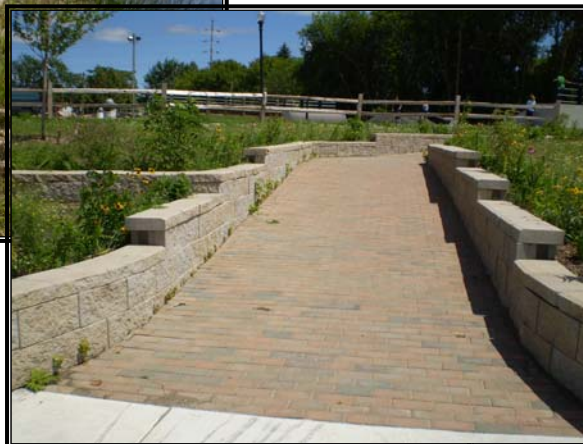
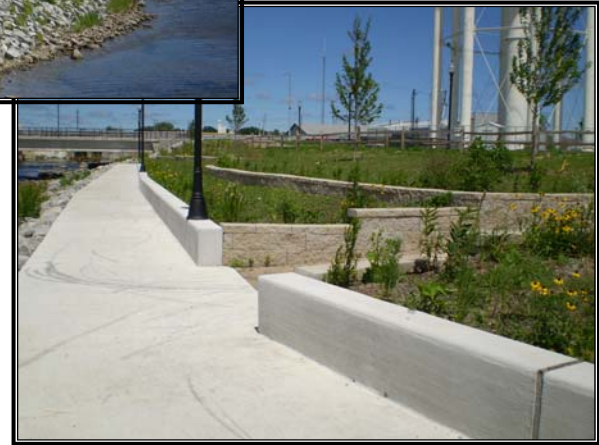
After: The installation of rain gardens on the slope helps filter storm water; grassed swales on the slope help direct storm water to stabilized areas; porous pavement in the parking lot promotes infiltration; tiered retaining walls reduce the slope of the bank. Collectively, these practices reduce harmful runoff from reaching the river. River bank scour was also eliminated by installing stone riprap along the shoreline.
