Phosphorus Reduction in the Macatawa Watershed

February 2018 - December 2020

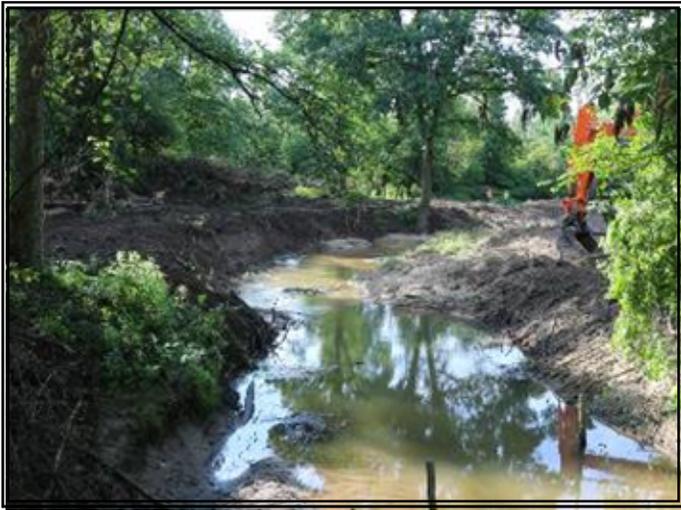
Peters Creek Stream Restoration (before): At the start of construction, vegetation and falling trees were removed before the streambanks were shaped to their new contours. Several of the trees were then used as in-stream structures.

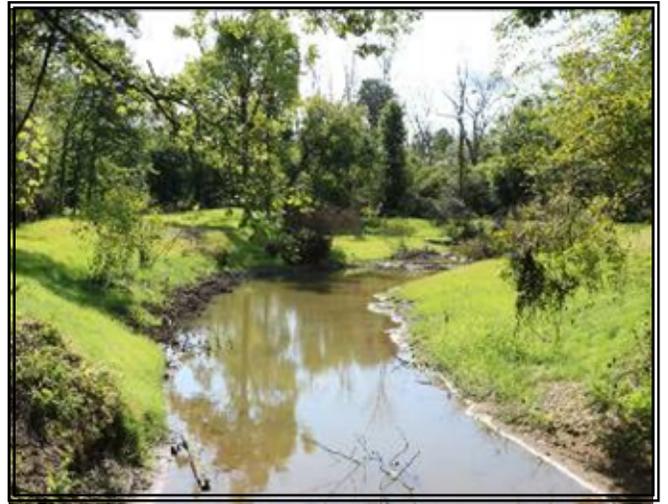
The Peters Creek Restoration following construction. Sod mats and erosion blanket were installed for erosion protection, providing immediate cover for late summer storms.

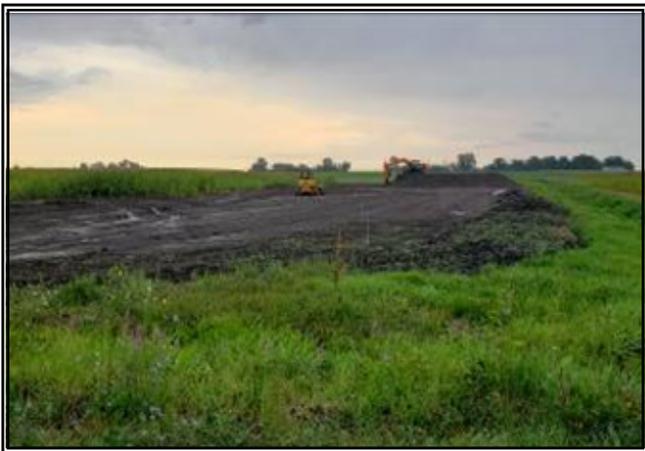
The wetland restoration project took place on the edge of a row crop field near the headwaters of the North Branch of the Macatawa River. The farmer was interested in creating wildlife habitat and storing water during heavy rain events.

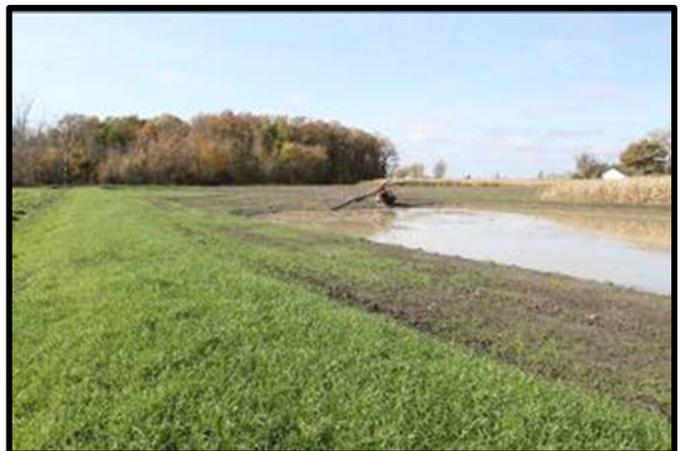
Following construction, several logs were placed in the wetland as habitat structures. Additional water storage will help the farmer with his organic operation, pairing with other conservation practices such as a two-stage ditch and cover crops.
