Two *E. coli* Sources Cleaned up in Stony Creek

Success Story

Stony Creek (AUID number 040500050403-01) is in the Maple River sub-watershed within the Grand River watershed located in Clinton County, Michigan. Stony Creek is listed on the federal Clean Water Act Section 303(d) list of impaired waters for Total and Partial Body Contact Recreation Designated Use Impairments due to *E. coli*.

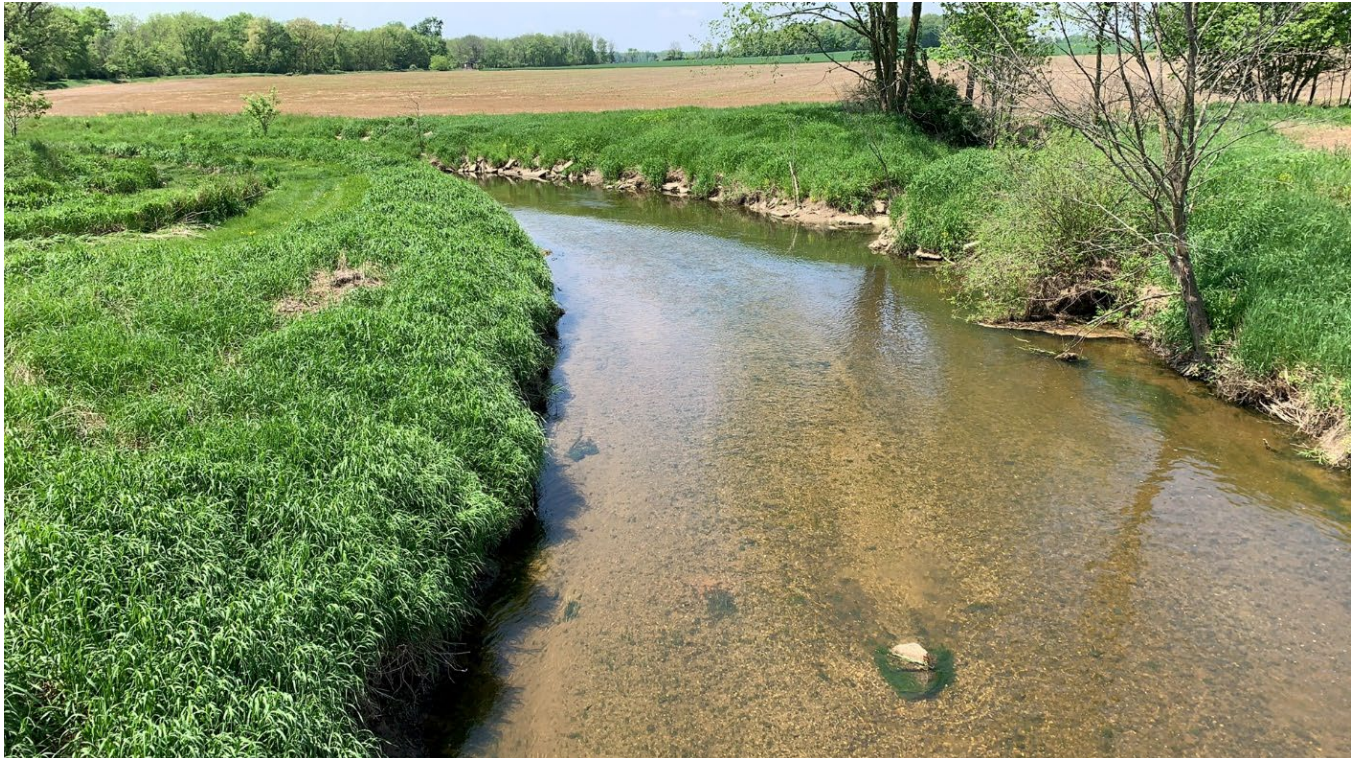
Figure 1. Stony Creek runs through agriculture fields before entering the Maple River.

Stony Creek flows through mid-Michigan in rural Clinton County and drains an area of more than 25,000 acres. According to the 2019 National Land Cover Database, agricultural land use makes up 75 percent of the watershed. The creek is part of the Grand River watershed and flows 20 miles to the Maple River (Figure 1).

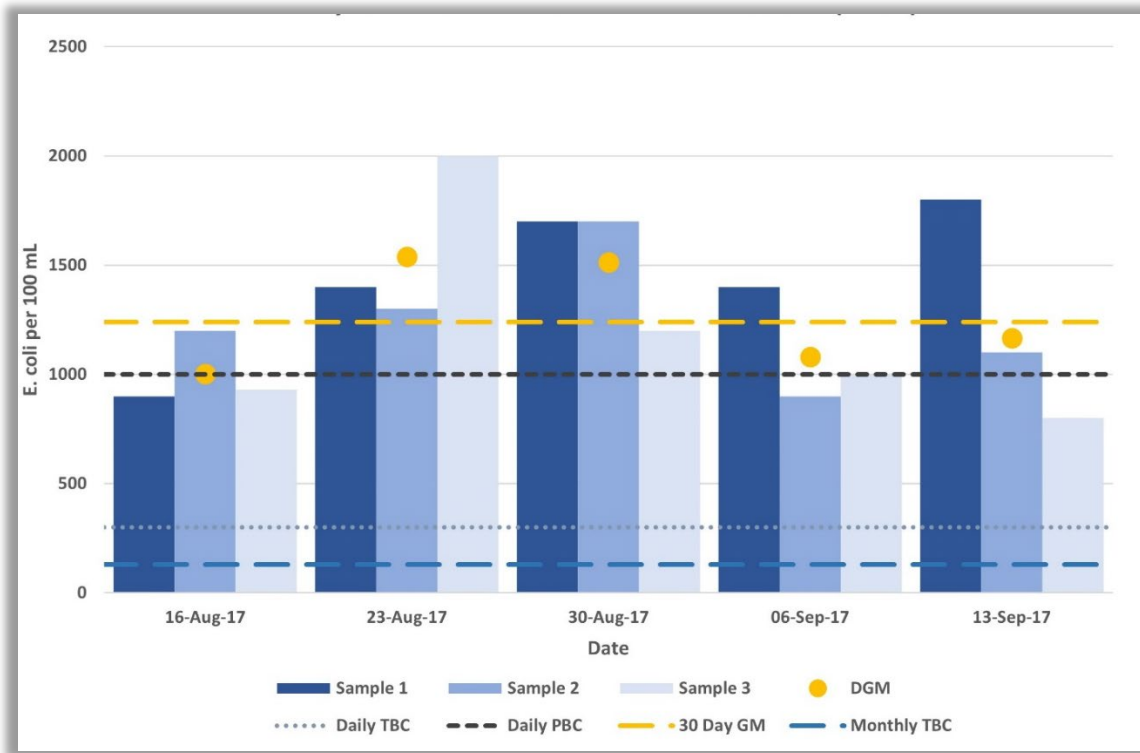
The graph in Figure 3 indicates that the daily geometric mean (DGM, yellow dots) at each sampling event on Stony Creek exceeded safe levels for both TBC (blue dotted line) and PBC (black dashed line) recreation uses. The 30-day geometric mean for the site (yellow dashed line) exceeded the 30-day geometric mean for the TBC standard (blue dashed line), indicating that water was unsafe for recreation.

Figure 3. Stony Creek at Lowell Rd., 2017 *E. coli* Results (Site 1)

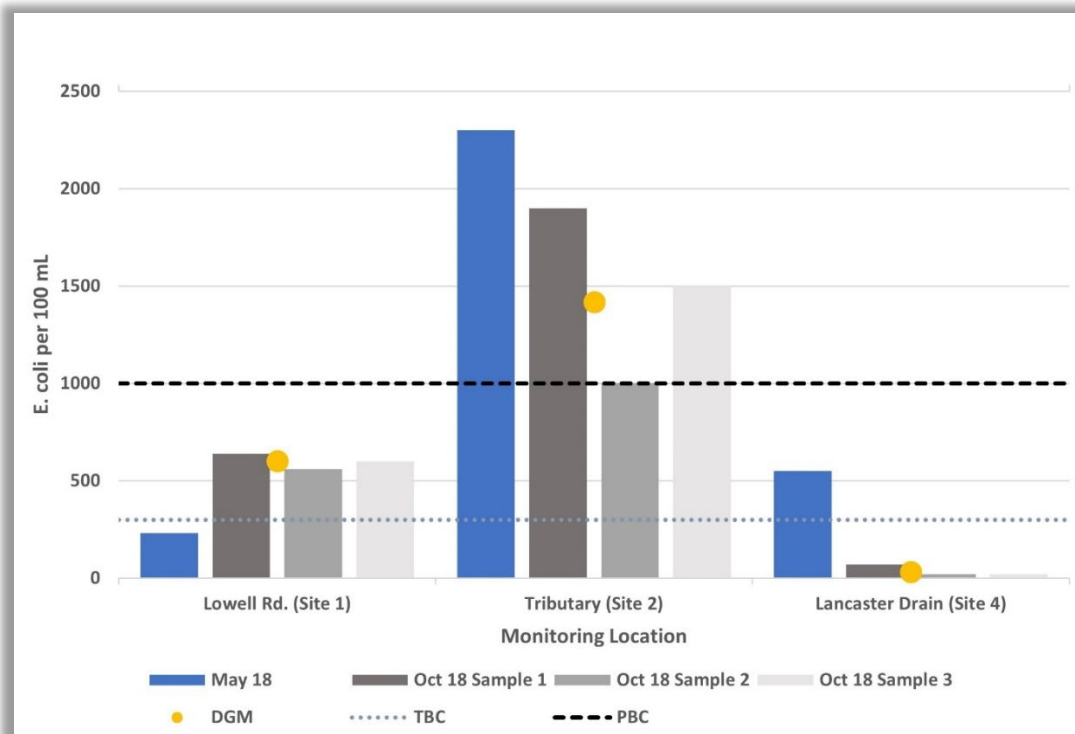
As shown in Figure 4, 2018 sampling occurring in May and October at three sites on Stony Creek exceeded water quality standards. The daily geometric mean for October 18 (DGM, yellow dots) at site 1 exceeded safe levels for total body contact. The DGM for site 2 exceeded both TBC (dotted line) and PBC levels (dashed line). Site 4 had the lowest amount of *E. coli*. Only one sample was collected in May, rather than the required triplicates needed for a daily geometric mean. While the May samples cannot be compared to water quality standards, they are displayed for reference.

Figure 4. 2018 Stony Creek Tributary Monitoring

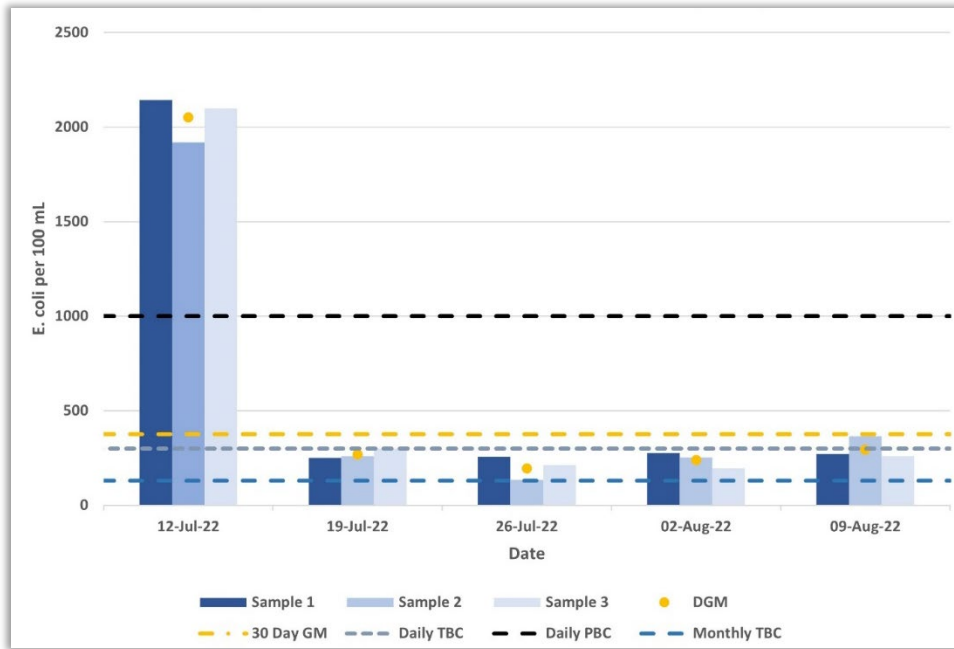
Figure 5 shows that monitoring conducted after the known *E. coli* sources were removed from Stony Creek met water quality standards for all recreational uses, except for the monthly total body contact standard (lowest dashed blue line). High *E. coli* results at the first monitoring event occurred after 0.44” of rain and were likely due to runoff sources.

Figure 5. Stony Creek at Lowell Rd., 2022 *E. coli* Results (Site 1)

Follow-up water quality sampling was conducted in 2022 after the removal of the two sources of *E. coli* in Stony Creek. A rain event occurred on the first monitoring event, likely causing surface runoff to carry *E. coli* into Stony Creek. The result was *E. coli* levels that did not meet TBC or PBC recreational requirements. However, all other monitoring events in Stony Creek met the daily recreational standards. *E. coli* levels in Stony Creek decreased from a high 30-day geometric mean of 1,240 *E. coli* per 100 mL in 2017 to 376 *E. coli* per 100 mL in 2022. The 60% reduction in *E. coli* resulted in Stony Creek supporting recreational uses during dry weather, showing significant progress toward safer recreation (**Figures 5, 6 and 7**).

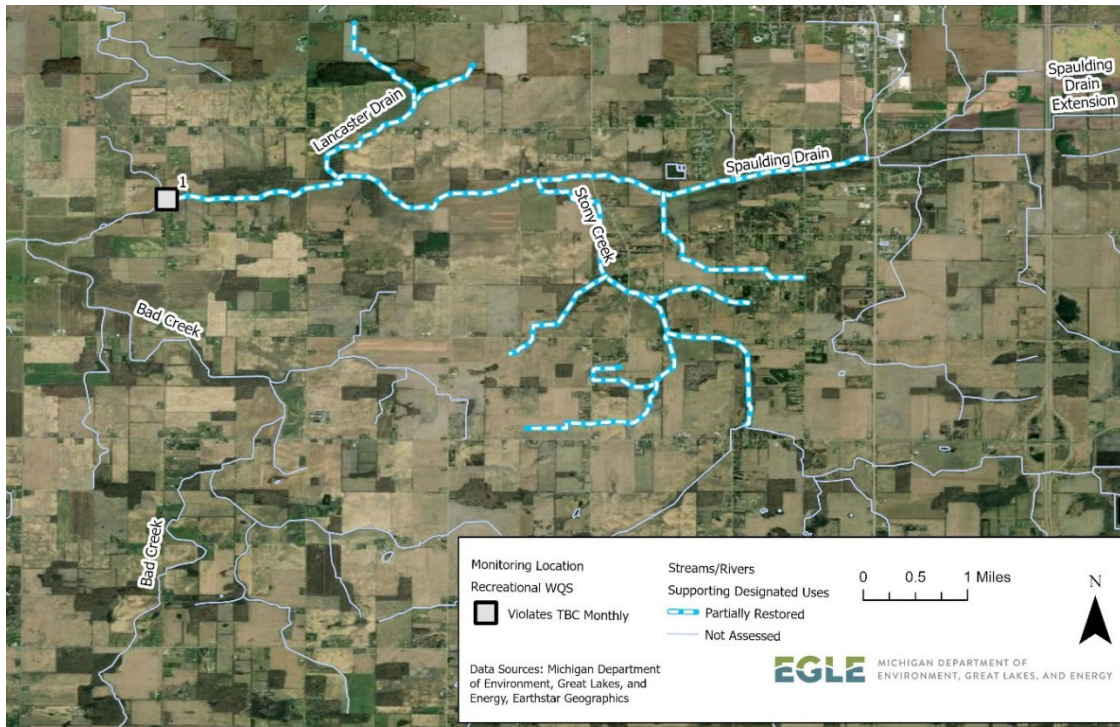
Figure 6 shows that the monitoring conducted after the known *E. coli* sources were removed showed daily PBC and TBC water quality standards were met, increasing recreational uses to a section of Stony Creek.

Figure 6. Results of *E. coli* Monitoring in Stony Creek after removal of pollution Source 2022

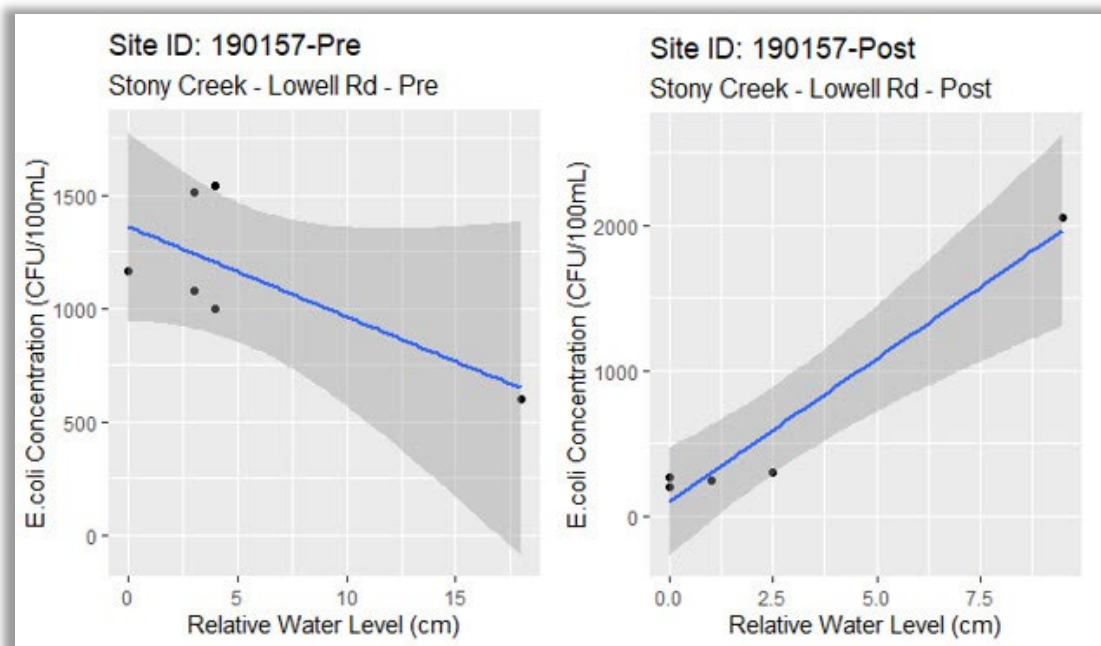
Figure 7. When compared to relative water level, *E. coli* results increased during low water (indicative of dry weather, or constant sources) in 2017 and increased during high water in 2022 (indicative of wet weather sources). The blue line indicates the relationship between both parameters.

E. coli results were compared to relative water levels to discern any correlation between surface runoff from rainfall and *E. coli* levels. *E. coli* levels during low water levels were high in 2017, likely due to the continuous sources of the failing septic system and confined animal feeding operation. After removing the sources, monitoring in 2022 showed that *E. coli* increased during high water levels. This correlation shows that the remaining sources of *E. coli* are related to contaminated surface runoff and continue to make the creek unsafe for recreation during rain events.
