## Iosco County Shoreline Recession Study 2023-2024

Field Operations Support Section, Water Resources Division,  
Michigan Department of Environment, Great Lakes, and Energy  
Lansing, Michigan

March 4, 2024

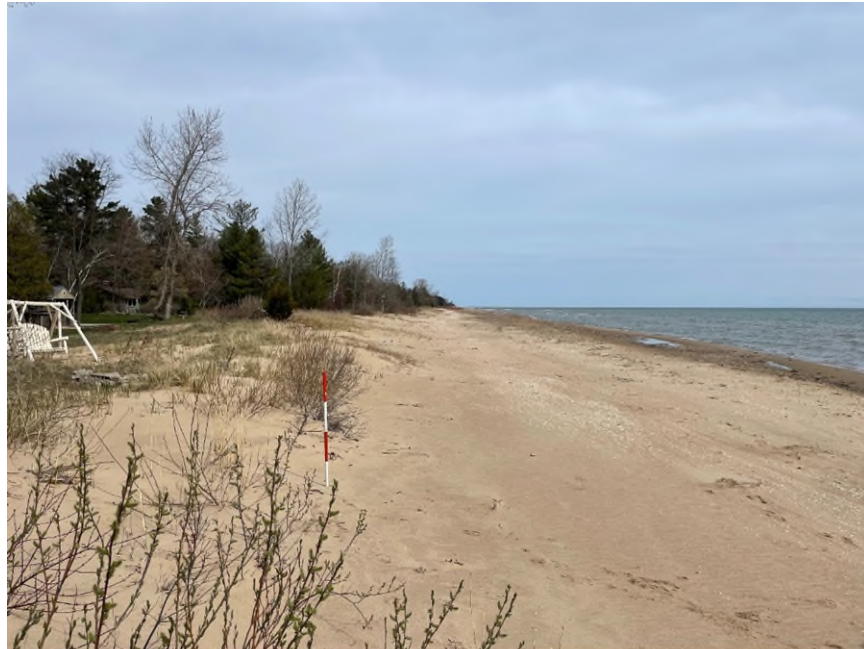
Photo 1: Looking north along vegetation line in Oscoda Township, HREA B – South of 3 Mile Park. Note the inflating beach and expanding vegetation.

The Township had 52 parcels designated in 1986 across three HREAs: Area A (South of 3 Mile Park), Area B (South of 3 Mile Park; contiguous with Area A), and Area C (Bachman Rd). All three areas were reviewed in the field. In general, the shoreline was densely developed with homes and cottages. The shoreline was generally flat with no bluff along the majority of the study area. In all three areas, beaches were observed to be inflating, vegetation was expanding lakeward, and coastal wetlands were forming. No active erosion was observed in Oscoda Township during the April 2023 field work. A comparison of the historic and modern EHLs showed an average annual recession rate of less than 1 foot per year throughout the entire study area. The designations should be removed. It is worth noting that unlike much of the county, shoreline armoring was not prevalent in Oscoda Township and the shoreline appeared to be highly functioning with growing foredunes, wide beaches, and sand bars.

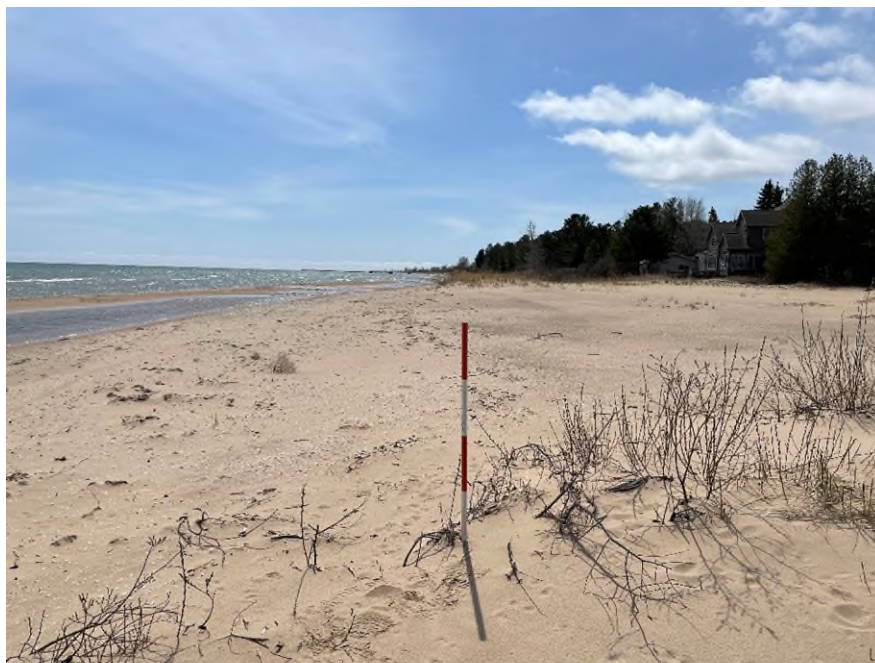
Photo 2: Looking south along vegetation line in Oscoda Township, HREA C – Bachman Rd. Note the inflating beach and growing coastal wetland.

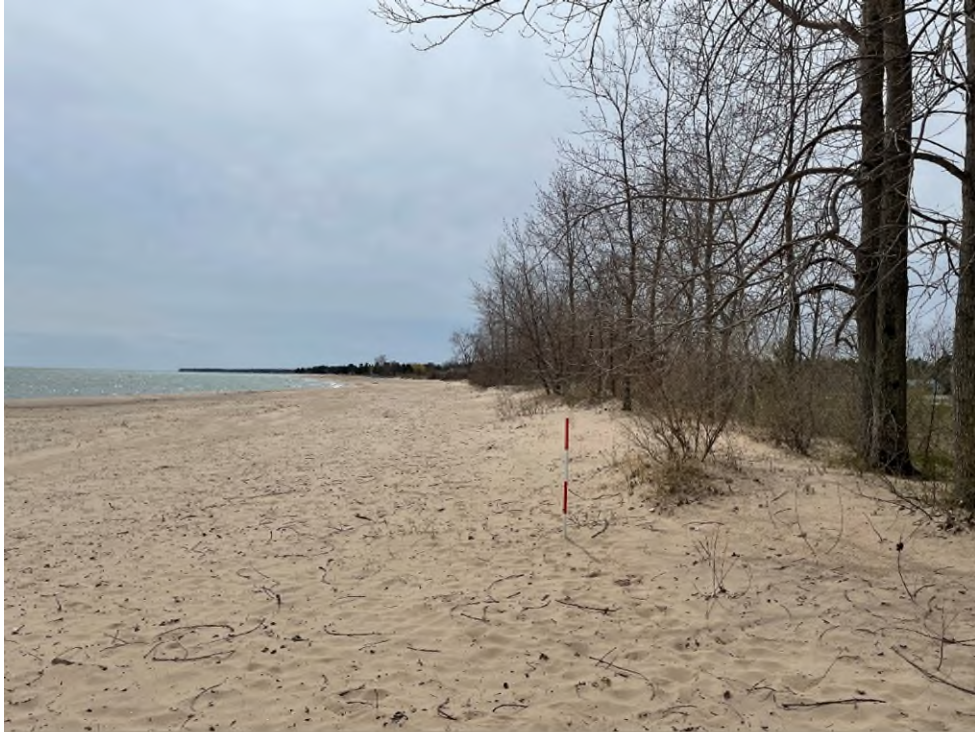
Photo 3: Looking south along the vegetation line in Au Sable Township, HREA A – South of River. Note the growing beach.

aerial photography and obliques prior to the field work. In general, the shoreline across the entirety of the township is flat with little to no bluff. Areas in northern part of the township nearer the mouth of the Au Sable River had more beach compared to areas to the south, much of which had little to no beach. Many of the township's private properties are armored with seawalls and revetments. Active erosion was observed in a few properties near and south of HREA B. No other active erosion was observed in the township. The EHL was observed at the top of shoreline armoring structures across much of the study area. A comparison of the historic and modern EHLs showed an average annual recession rate of less than 1 foot per year throughout the entire study area. The designations should be removed. No new designations are proposed in Au Sable Township as a result of this study.

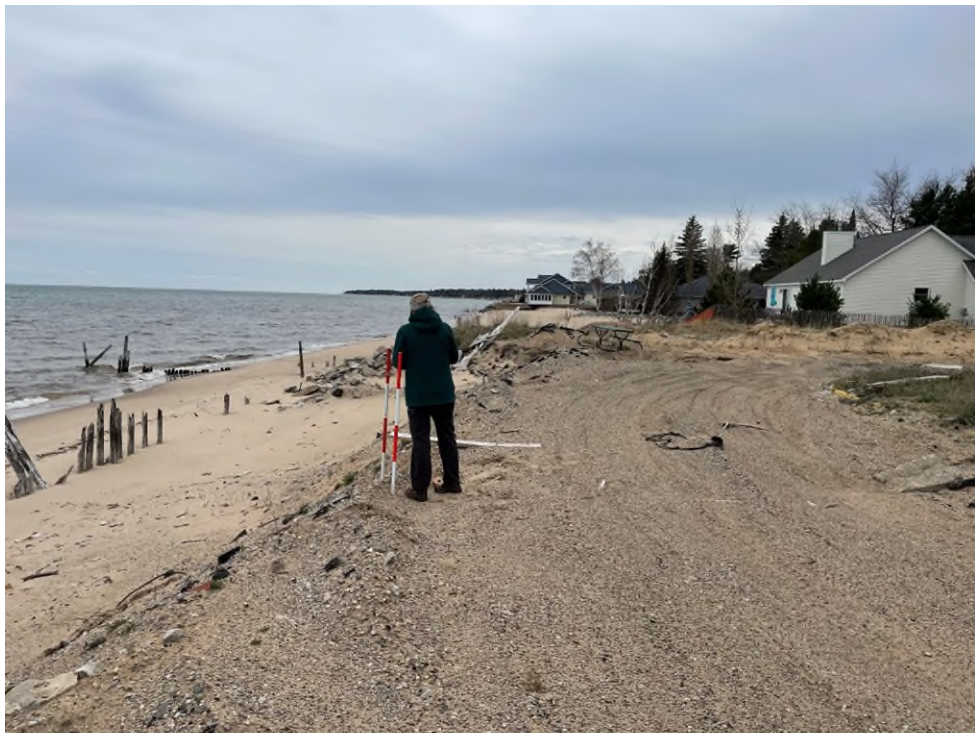
Photo 4: Eroding parcel between armored parcels in Au Sable Township between HREA B and C – Along US-23.

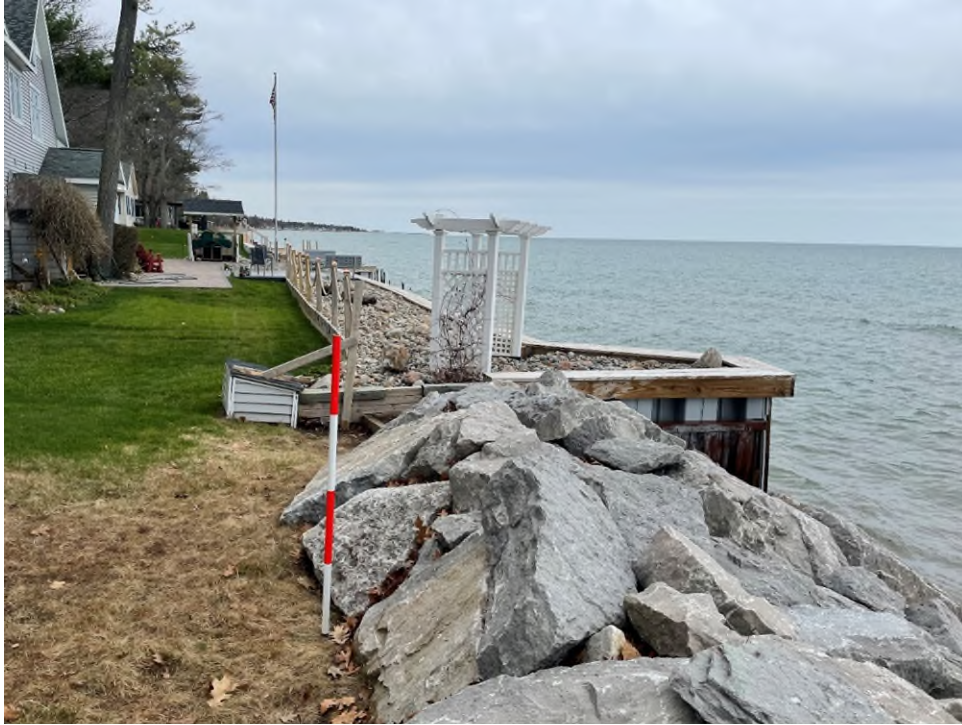
Photo 5: Armored shoreline in Au Sable Township, HREA D – Along US-23.

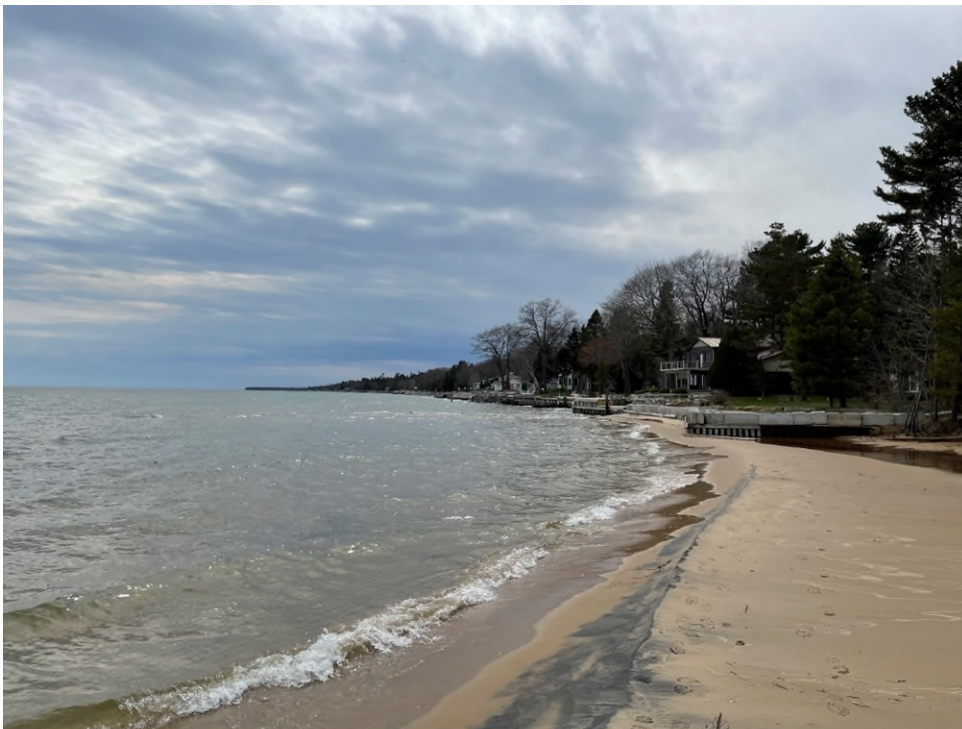
Photo 6: Looking south from the north end of HREA A – Iris Drive in Baldwin Township. Note the significant armoring to the south.

The Township had 400 parcels designated in 1986 across two HREA's: Area A and Area B. The 1986 study noted that the township had "recession rates as high as any found on the US side of Lake Huron." During the current study, the shoreline of Baldwin Township was observed to be heavily armored with only a few areas containing natural beach and coastal wetlands. In areas of significant shoreline armoring, there is little natural shoreline function, and the reflection of wave energy was observed. A comparison of the historic and modern EHLs showed an average annual recession rate of less than 1 foot per year in the majority of the study area. 393 of the originally designated parcels no longer meet the HREA designation requirements and the designations should be removed from these properties.

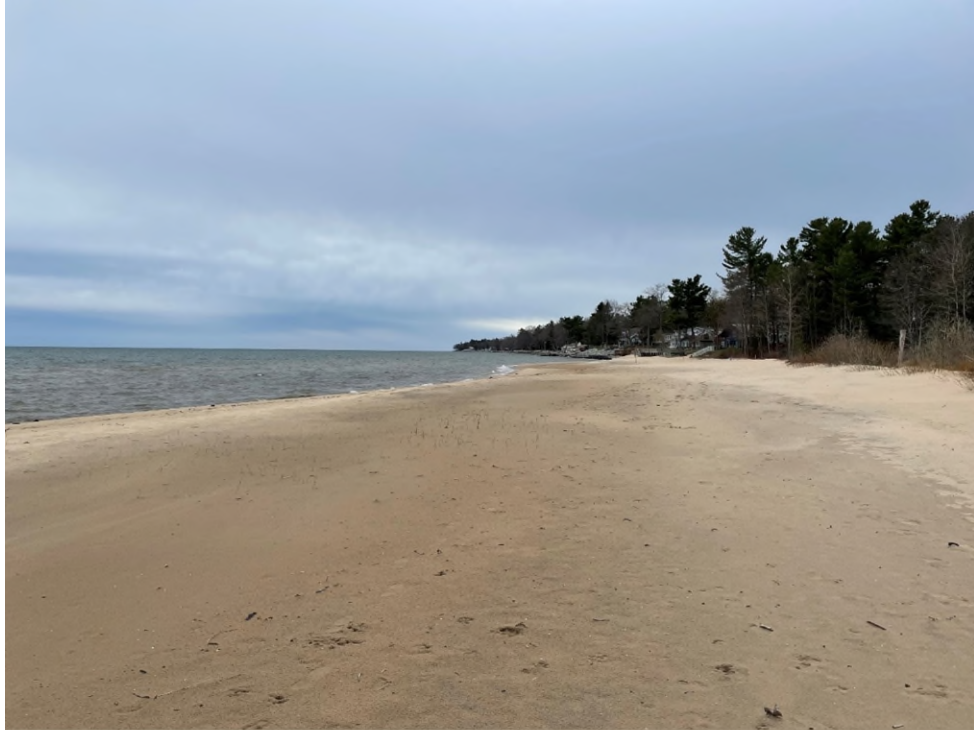
Photo 7: Looking south from the north end of HREA B – Arbutus Drive, Baldwin Township. Note the significant armoring to south.

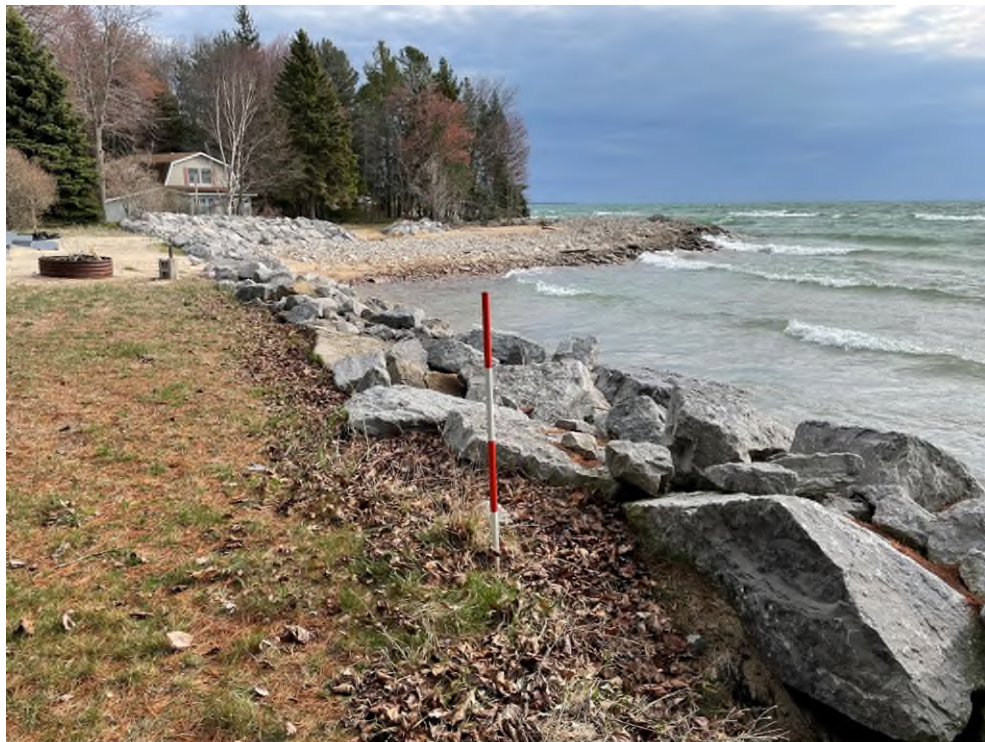
HREA C (East Birch Drive) contains four parcels. During field review, a flat shoreline with little beach was observed. In 1986, the parcels were found to have an average annual rate of recession of 4.5 feet per year with a 30-year PRD of 150 feet and a 60-year PRD of 230 feet. A portion of one of the parcels was located in a different sub-HREA in 1986 had an average annual rate of erosion of 1.1 feet per year. The recent comparison of the modern and historic EHL found an average annual rate of erosion of 1.5 feet per year. The proposed new 30-year PRD for readily moveable structures is 60 feet. The proposed new 60-year PRD for permanent structures is 105 feet. This result is a *lower setback* (L) with the exception of the portion of the one parcel mentioned in which it is an *increase setback* (IS).

Photo 8: Armored, unarmored, and failed armor in background at HREA C – East Birch Road, Baldwin Township.

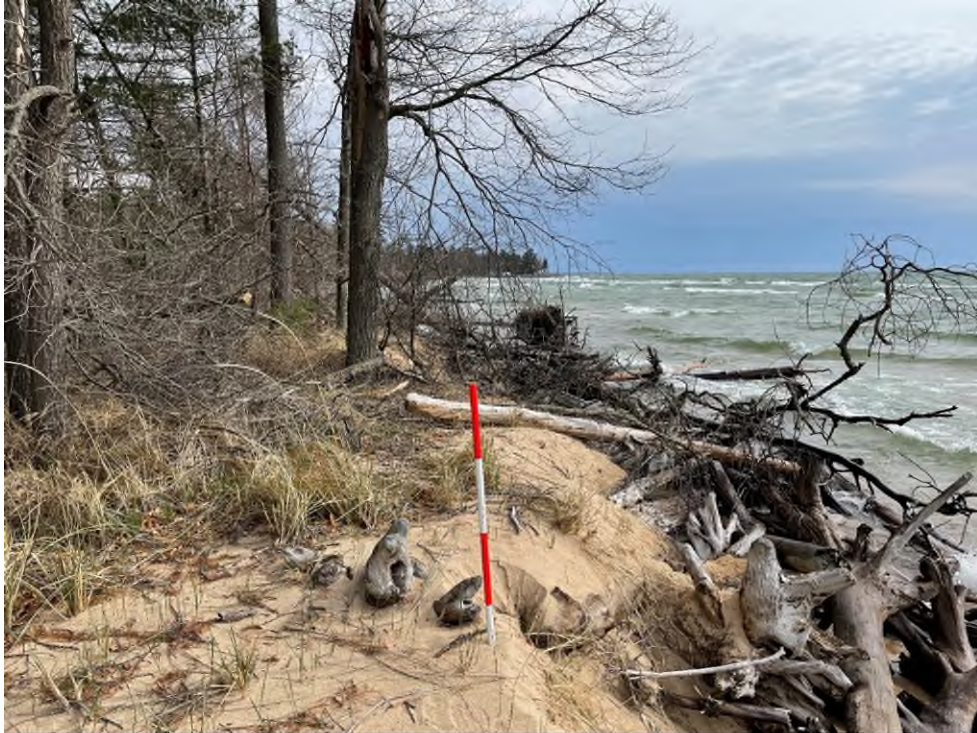
HREA D (Baldwin Resort) contains one parcel that was designated in 1986. The parcel is large and was split between two sub-HREA's in 1986: the northern portion of the parcel had a previous recession rate of 3.8 feet per year; the southern portion of the parcel had a previous recession rate of 1.6 feet per year. During field review, active erosion was observed along much of the parcel. The EHL was observed to be along the top of a low (approximately 5 feet high) bluff with a wave cut face. Many fallen trees and other evidence of erosion typical of a HREA were observed along this shoreline. The recent comparison of the modern and historic EHL found an average annual rate of recession of 2.5 feet per year. The parcel continues to meet the definition of a HREA and should remain designated. The proposed 30-year PRD for readily

moveable structures is 90 feet. The proposed 60-year PRD is 165 feet. This is a *lower setback* (L) for the northern portion of the parcel and an *increase setback* (IS) for the southern portion of the parcel. It should be noted that this parcel contains shoreline on both Tawas Bay and the open coast of Lake Huron. The HREA designation applies only to the open coast of Lake Huron shoreline of the parcel.

Photo 9: Looking north along EHL in HREA D – Balwin Resort, Baldwin Township. Note the wave cut face and fallen trees.

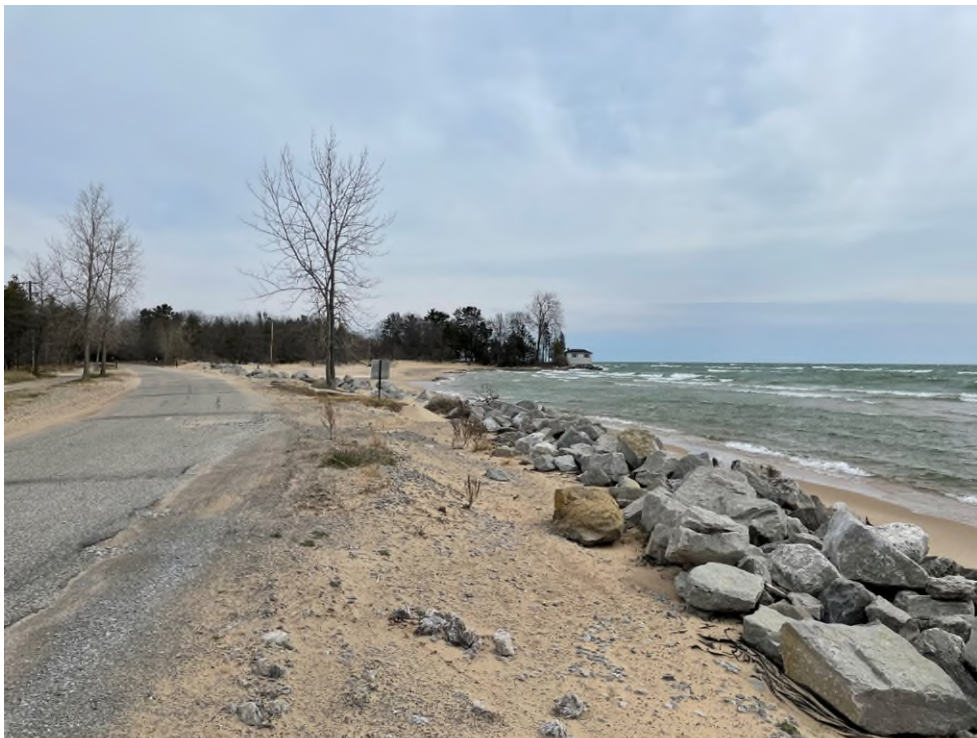
HREA E (Tawas Point) contains two parcels that were designated in 1986. Both parcels are owned by the Michigan Department of Natural Resources as part of Tawas Point State Park. In 1986, the shoreline of these parcels was found to have a recession rate of 1.6 feet per year. Field review of this area indicated recent active erosion and recession of the shoreline as did review of aerial imagery/oblique photographs. The recent comparison of the modern and historic EHL found an average annual recession rate of 2.5 feet per year. The parcels continue to meet the definition of a HREA and should remain designated. The proposed 30-year PRD for readily moveable structures is 90 feet. The proposed 60-year PRD for permanent structures is 165 feet. This is an *increase setback* (IS) for the parcels. It should be noted that one of the parcels contains shoreline on both Tawas Bay and the open coast of Lake Huron. The HREA designation applies only to the open coast of Lake Huron shoreline of the parcel.

Photo 10: Looking north along EHL in HREA E – Tawas Point State Park, Baldwin Township. Note the recently installed revetment and evidence of erosion damage to road.

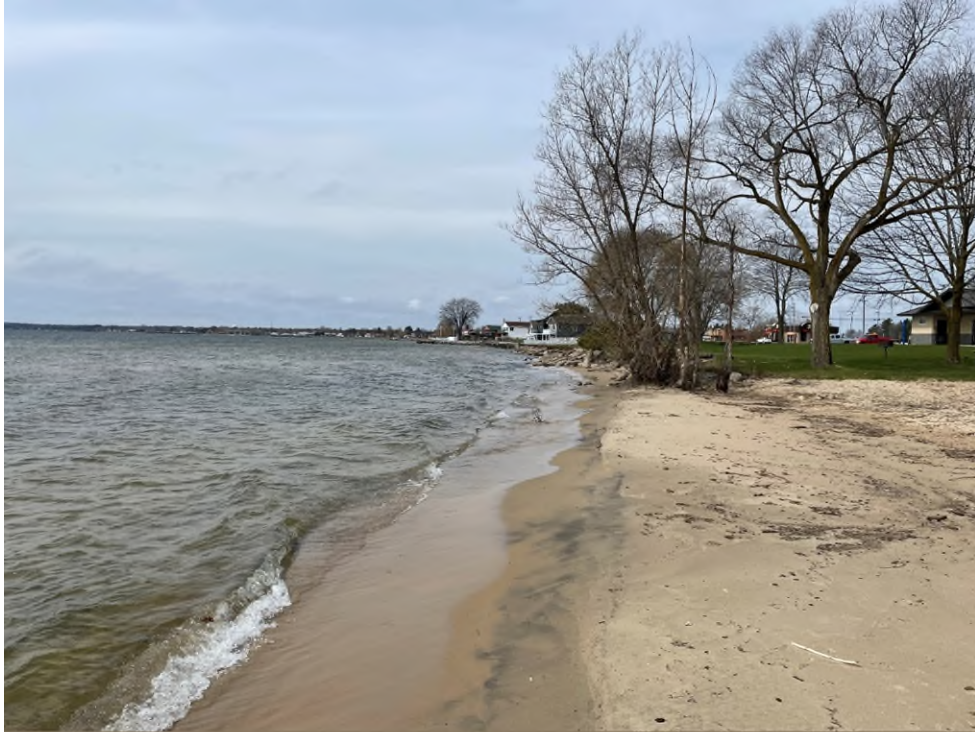
Photo 11: Looking west along the beach toward armored shoreline in HREA C – East Tawas City Park, City of East Tawas.

The city had 57 parcels designated in 1986 across three HREA's: Area A, Area B, and Area C. Due to access, only Area C was reviewed in the field. Observations from aerial photography and obliques combined with the field observations at Area C indicate that the shoreline of the city is heavily armored with seawalls and revetments. Little natural shoreline remains. No active erosion was observed during the field review; however, armoring is indicative of past erosion. A comparison of the historic and modern EHLs showed an average annual recession rate of less than 1 foot per year throughout the entire study area. The designations should be removed.

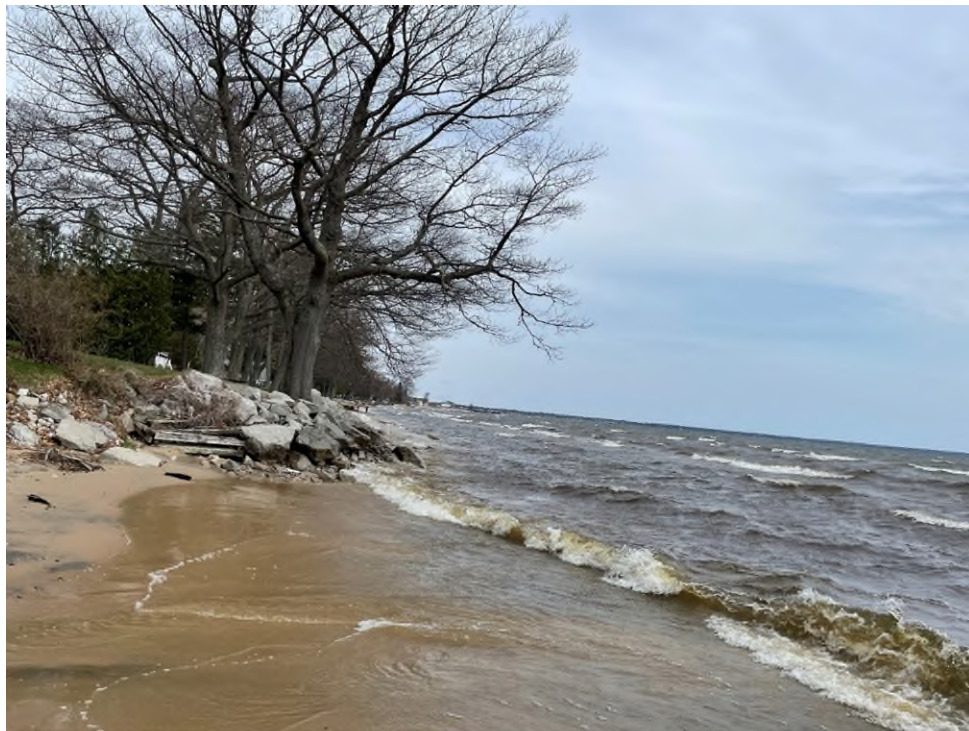
Photo 12: Looking north along heavily armored shoreline in HREA D – Townline Road, Tawas City

The city had 54 parcels designated in 1986 across four HREA's: Area A, Area B, Area C, and Area D. Due to access, only Areas B and D were reviewed in the field. At Area B, a beach was present within the City Park and it appeared to be inflating. A large, filled pier structure exists at the City Park and it is likely that the structure interferes with longshore drift processes. Observations from the pier end confirm observations from aerial imagery and obliques that the majority of the City's shoreline is armored with little to no natural shoreline or beach. At Area D, a heavily armored shoreline of seawalls and revetments was observed. There was no beach along the visible shoreline and no active erosion was present given the armoring structures; however, armoring is indicative of past erosion. A comparison of the historic and modern EHLs showed an average annual recession rate of less than 1 foot per year throughout the entire study area. The designations should be removed.

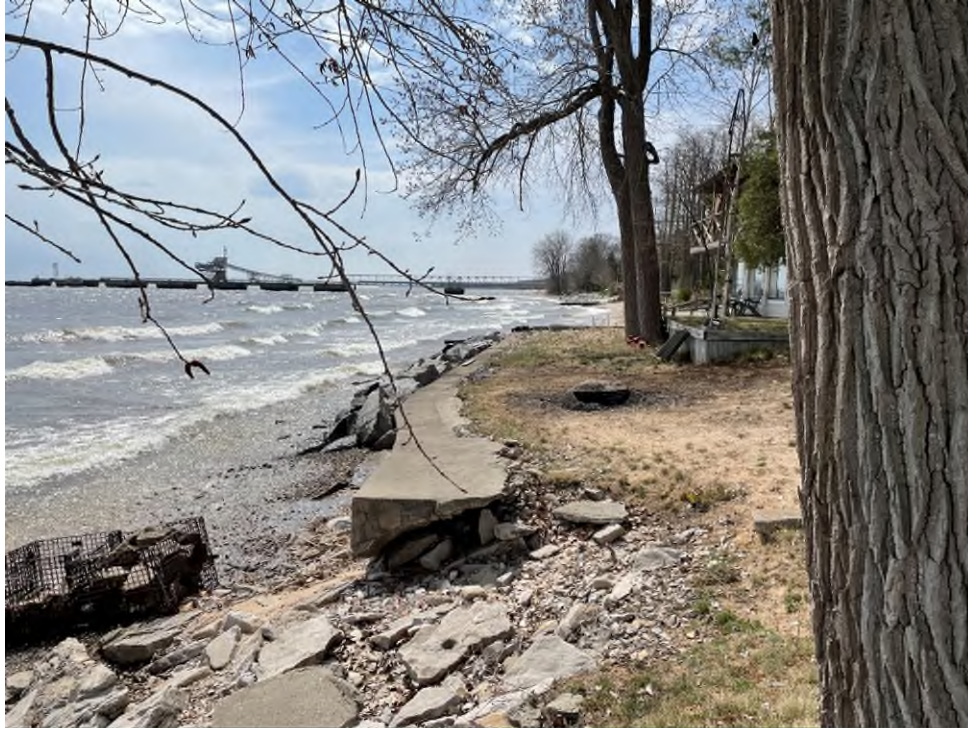
Photo 13: Looking south along armored shoreline in HREA B – Townline Road to Douglas Road, Alabaster Township

In HREA A, the area between HREA A and B, HREA B, the area between HREA B and C, HREA C, HREA D, and the area between HREA D and E, a comparison of the modern and historic EHLs showed an average annual recession rate of less than 1 foot per year. The designations should be removed. No new designations are proposed in these areas as a result of this study.

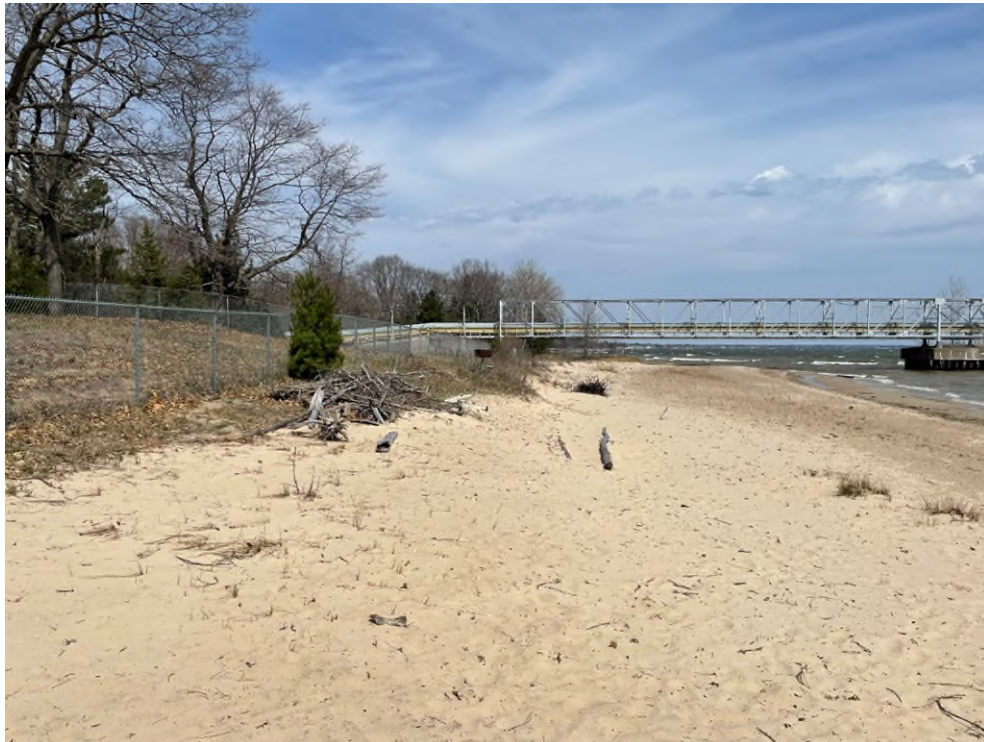
Photo 14: Looking north along beach in previously undesignated shoreline between HREA B and C, Alabaster Township. Note the expanding vegetation and inflating beach.

In addition to the four previously designated HREA's, several of the previously undesignated areas were studied. The area between HREA A and B was included in the study area as it is a relatively short stretch of shoreline that in 1986 almost met the designation criteria. The area between HREA B and C was included in the study. This area was reviewed in the field and was observed to have less armoring than other areas of the Township and an inflating beach and growing coastal wetland was observed. The area between HREA D and E was included in the study. This area was reviewed in the field and found to be heavily armored. The shoreline south of Area E was also included in the study and reviewed in the field. The shoreline was found to be a natural sand and cobble beach backed by forest with evidence of active erosion such as fallen trees.

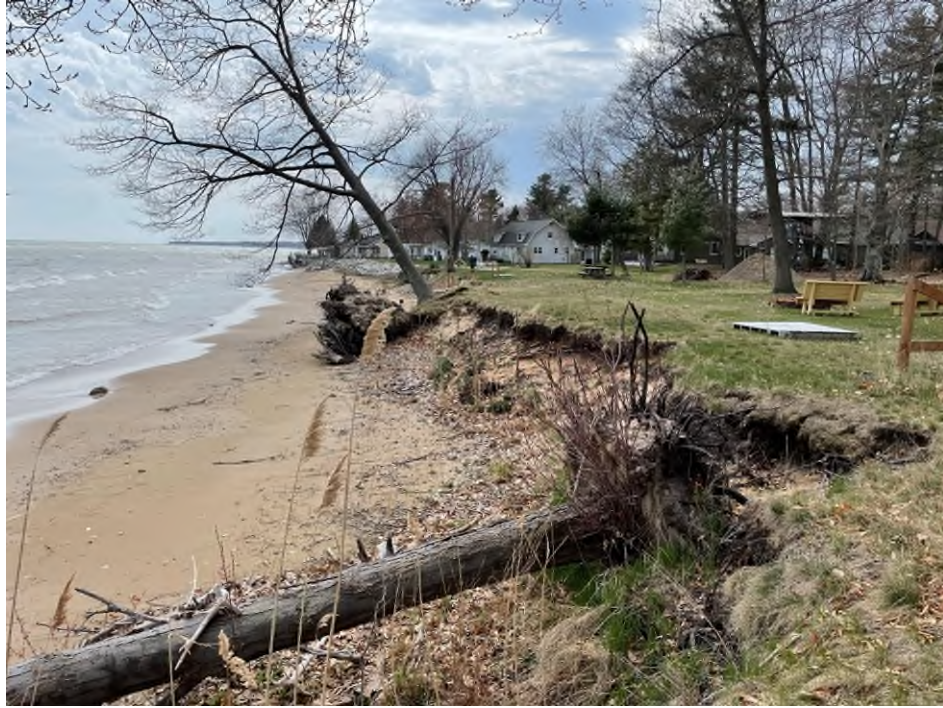
HREA F (Keystone Road) contains 6 parcels, two of which were designated in 1986 with an average annual recession rate of 1.8 feet per year. Four parcels are proposed to be a *new designation* (N). These parcels are along the previously designated shoreline but were not designated in 1986 as they are second tier parcels from the shoreline. Since the 1986 designation, the shoreline in this location has receded sufficiently such that the proposed PRD's extend onto these four parcels. The recent comparison of the modern and historic EHL at this location showed an average annual rate of recession of 1.3 feet per year. The first analysis using 150 feet spaced transects showed some uncertainty in this area. Given the observations of active erosion typical of a HREA, this area was further analyzed with 50 feet spaced transects, which confirmed that the recession rate on these parcels meets the definition of a HREA and should remain designated. The proposed 30-year PRD for readily moveable structures is 55 feet. The proposed 60-year PRD for permanent structures is 95 feet. This is a *lower setback* (L) for the previously designated parcels.

Photo 15: Looking south along EHL in HREA F – Keystone Road, Alabaster Township. Note the actively eroding shoreline and fallen trees.

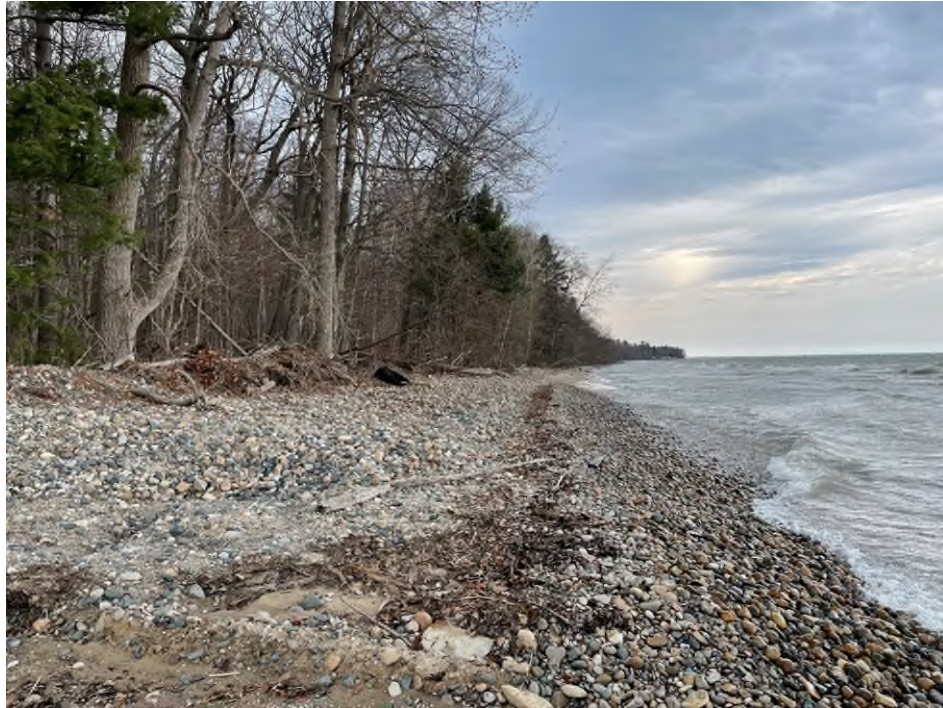
HREA G (South County Line) contains the Township owned parcel described above. Portions of this parcel were designated in 1986 with an average annual rate of recession of 1.8 feet per year. The recent comparison of the modern and historic EHL at this location showed an average annual rate of recession of 1.3 feet per year. The parcel meets the definition of a HREA and should remain designated. The proposed 30-year PRD for readily moveable structures is 55 feet. The proposed 60-year PRD for permanent structures is 95 feet. This is a *lower setback* (L) for the northern portion of the parcel. It is a *new designation* (N) for the southern portion of the parcel.

Photo 16: Looking north in HREA G – South County Line, Alabaster Township. Note the ridge of rocks that appear to be shoved by ice or waves and the fallen trees.

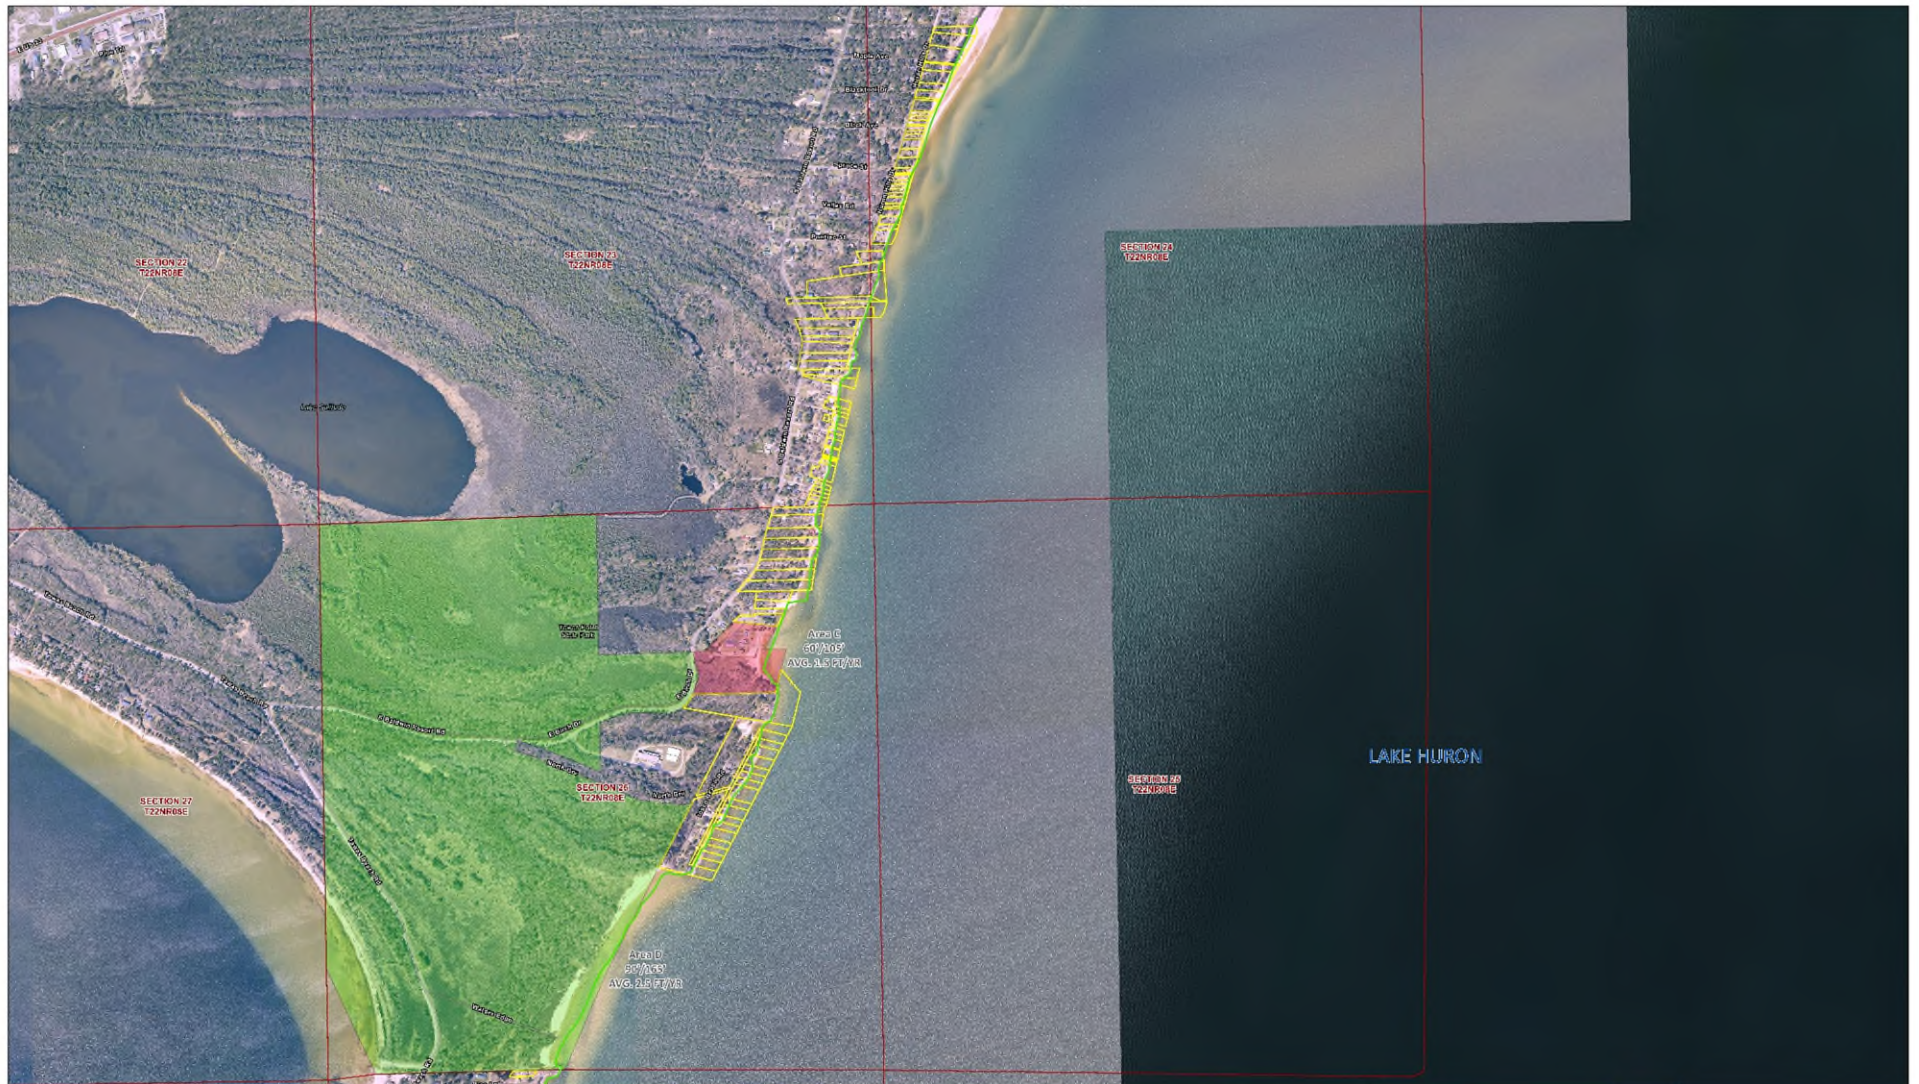
Map 3b. Baldwin Township HREA B Dedesignation Parcels and Proposed HREA C and D Designation Parcels

Baldwin Township, Iosco County  
T22N, R08E Sections 24, 23 and 26

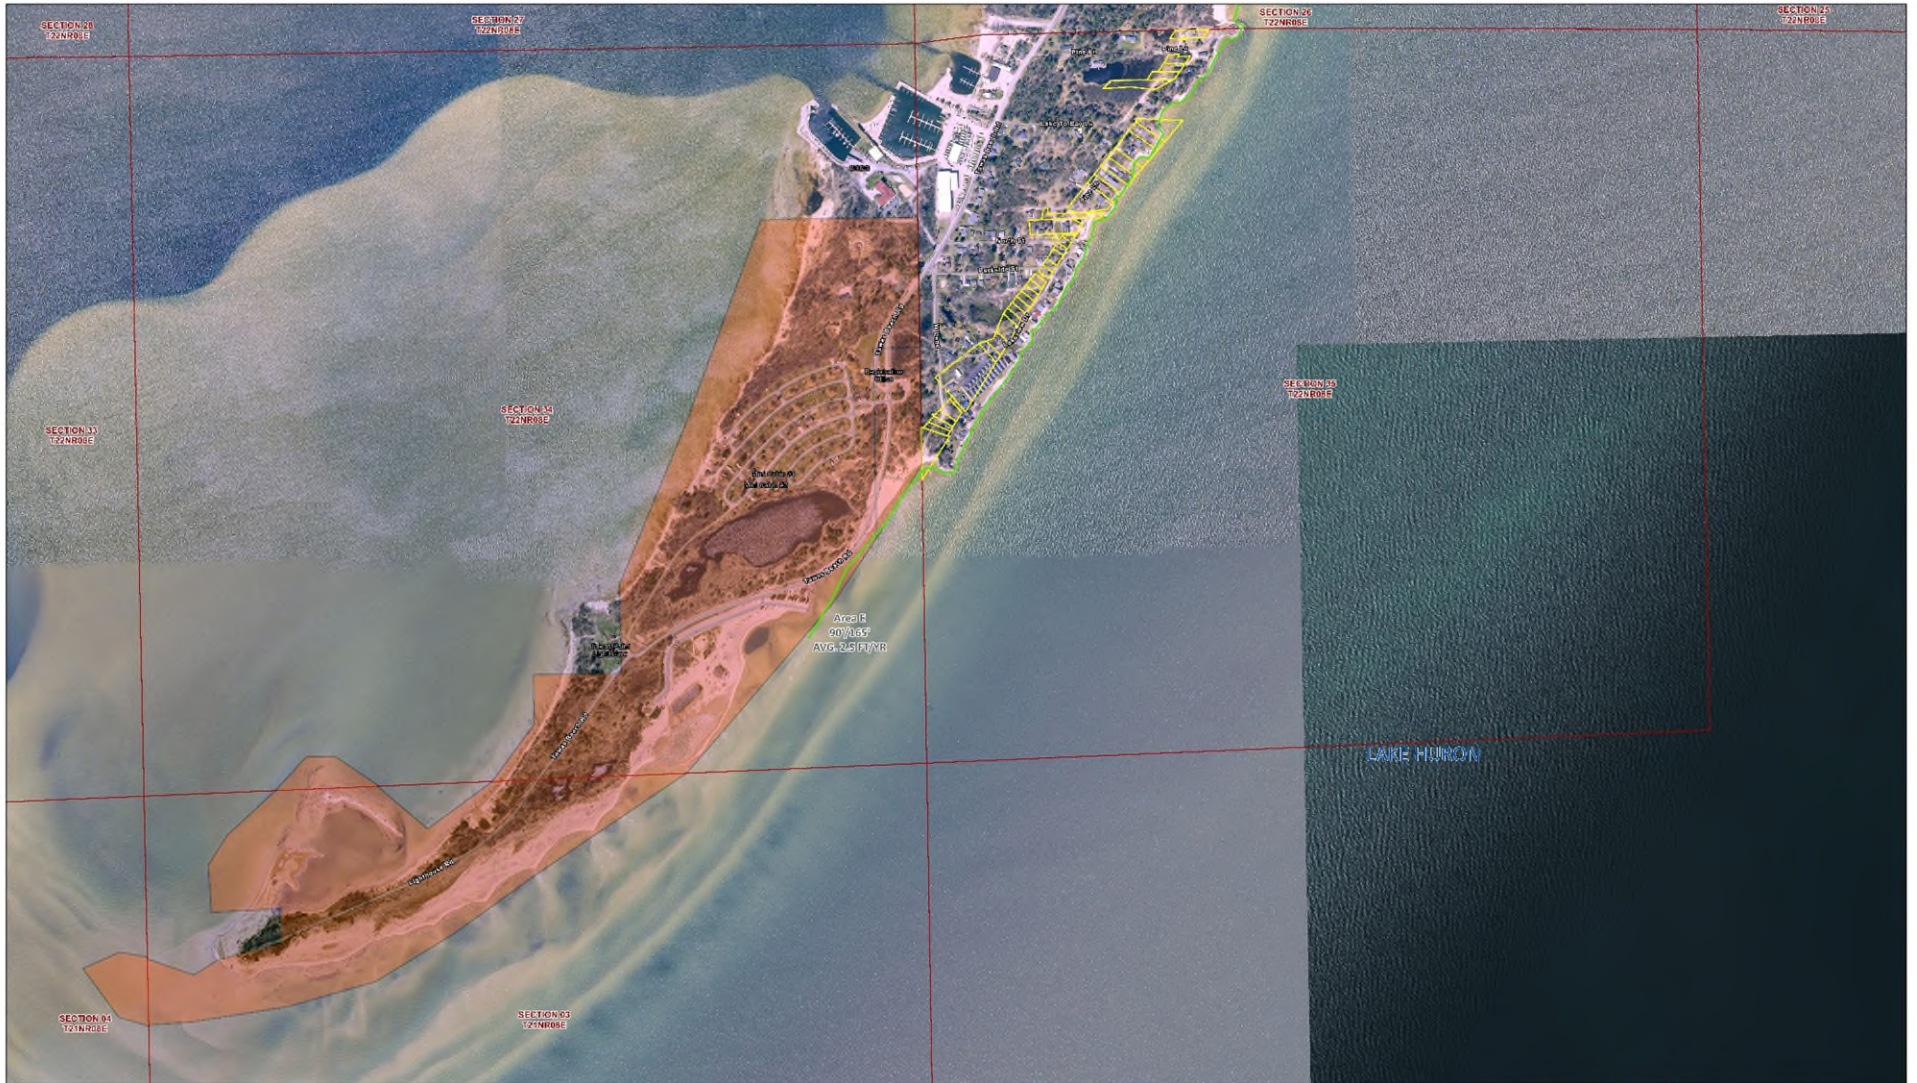
Map 3c. Baldwin Township HREA B Dedesignation Parcels and Proposed HREA E Designation Parcels

Baldwin Township, Iosco County  
T22N, R08E Sections 35, 34 and 3

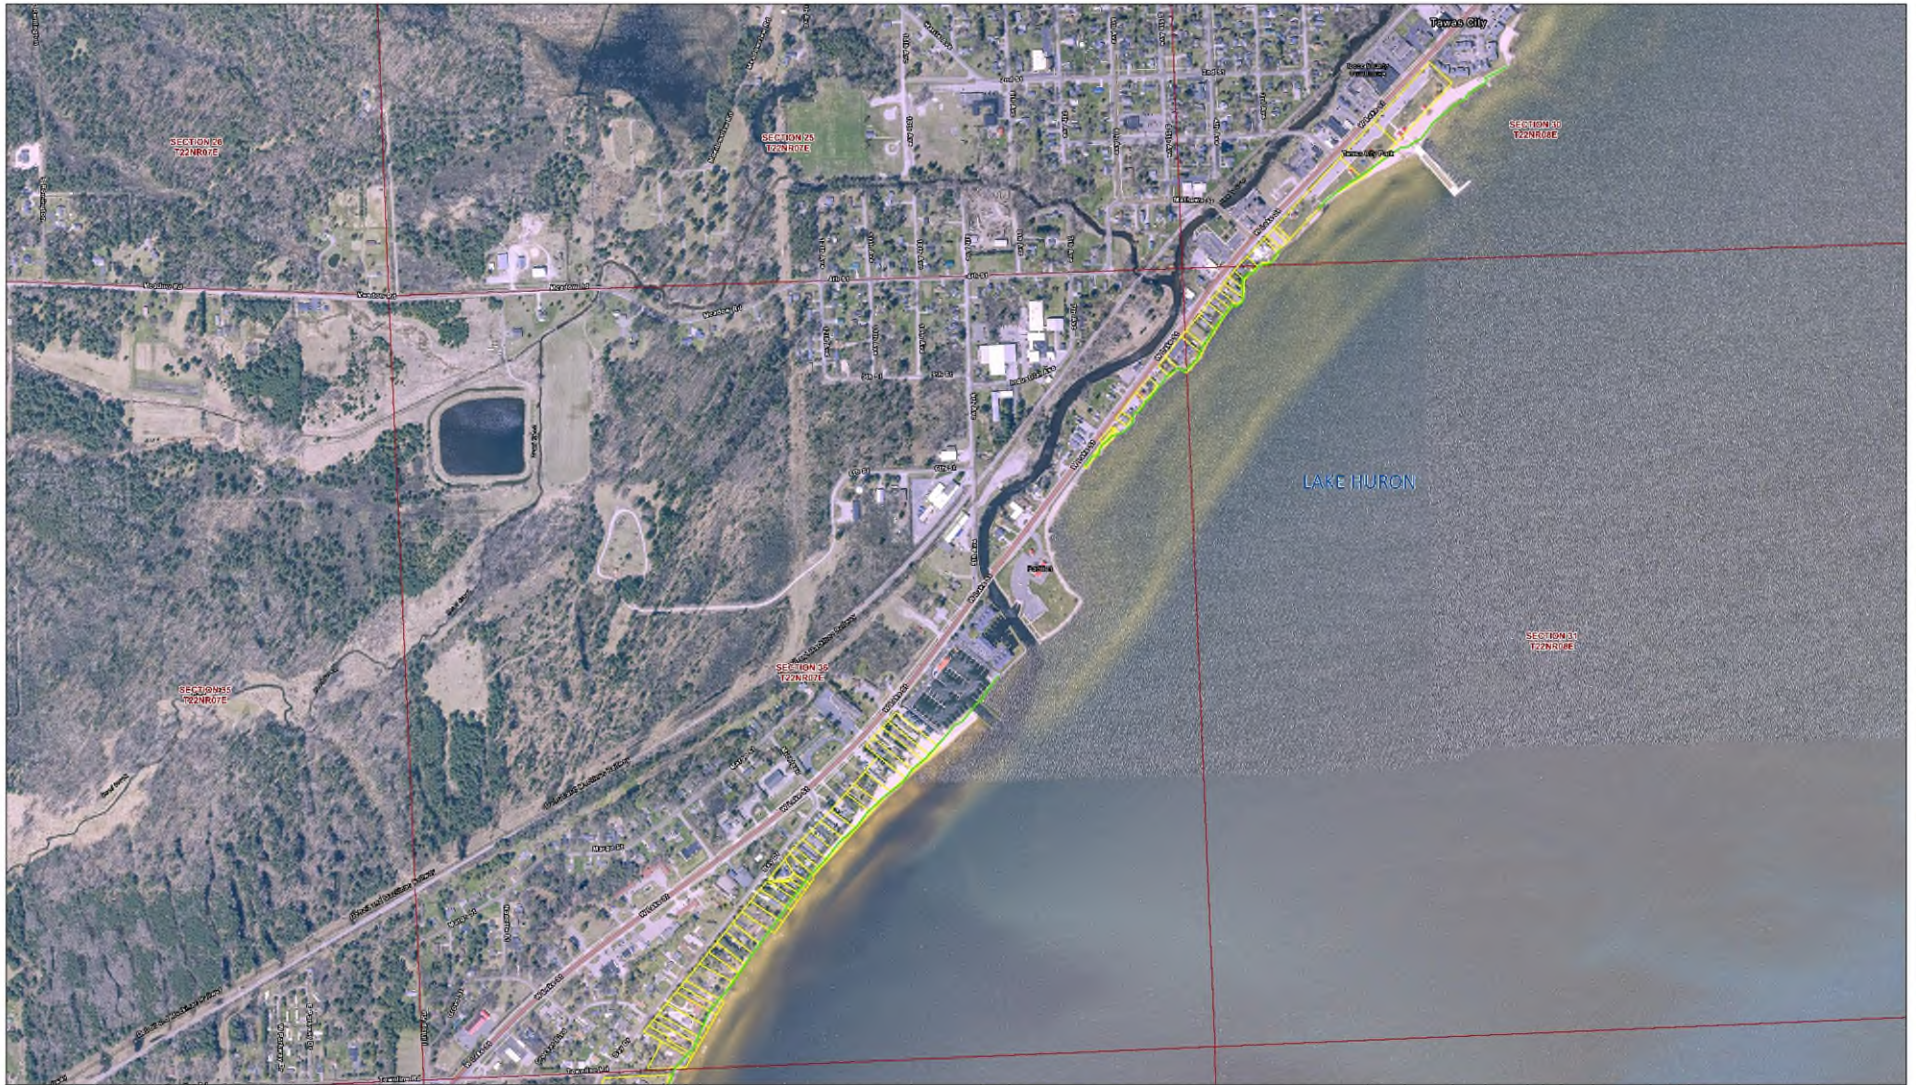
# Map 5a. City of Tawas HREA B, C, and D Dedesignation Parcels

City of Tawas, Iosco County  
T22N, R07E Sections 36, 31 and 30
