## Iosco County Shoreline Recession Study 2023-2024

Field Operations Support Section, Water Resources Division,  
Michigan Department of Environment, Great Lakes, and Energy  
Lansing, Michigan

March 4, 2024

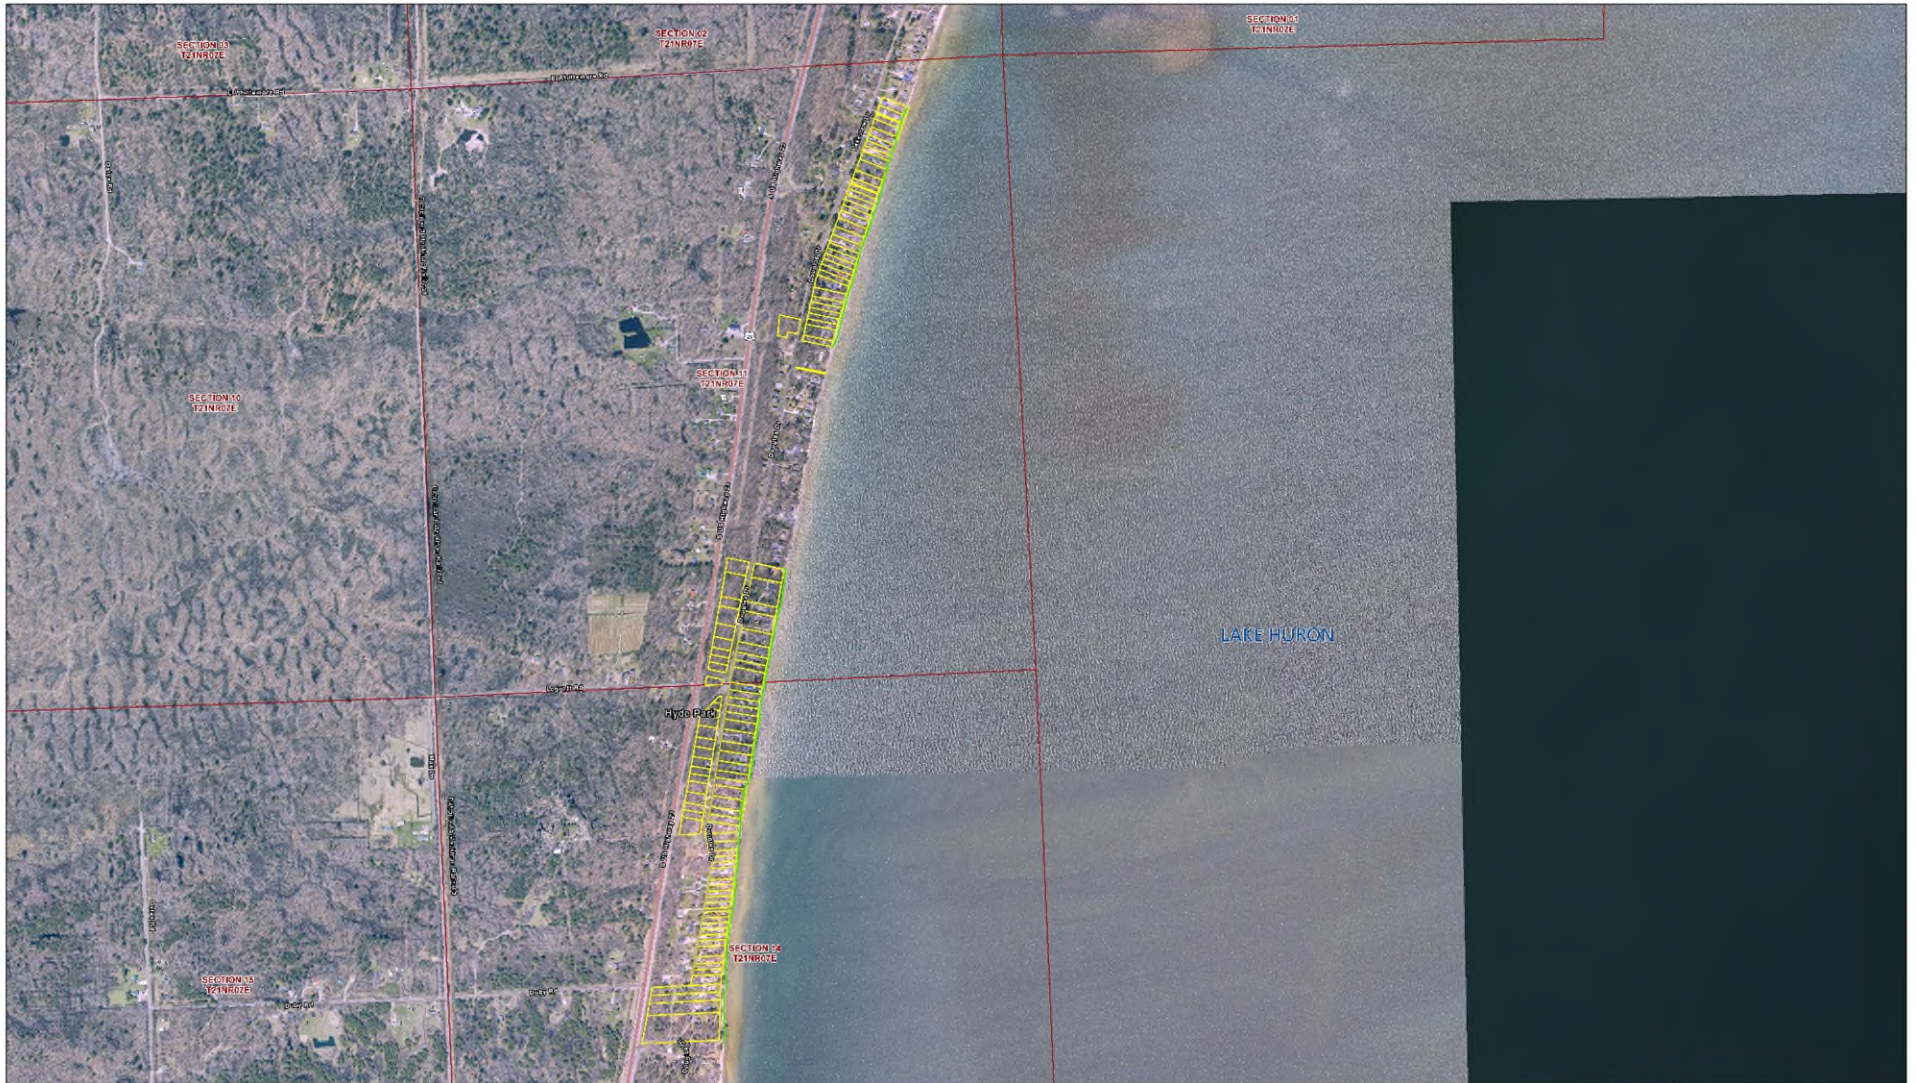
Map 6b. Alabaster Township HREA C and D Dedesignation Parcels

Alabaster Township, Iosco County  
T21N, R07E Sections 11 and 14

The Township had 136 parcels designated in 1986 across five HREA's: Area A, Area B, Area C, Area D, and Area E. In general, the Township was heavily armored with seawalls and revetments. Little to no beaches were observed along the armored shorelines and the natural shoreline function appears to be diminished in these areas. The major exceptions to this were

beaches and growing coastal wetlands observed at unarmored shorelines found generally where US Gypsum Company owned large parcels as well as a large township owned parcel along the County line. The shorelines at Areas A, B, and E were reviewed in the field. The shoreline at Areas C and D were not reviewed in the field due to access. In areas A and B, a heavily armored shoreline with no active erosion was observed. Aerial imagery and obliques indicate that the shorelines in Areas C and D are also heavily armored with little beach. The comparison of the EHL was much more variable in Area E. At the north of Area E, an inflating beach and dune was observed with no active erosion. Further south, along Keystone Road, significant active erosion was observed with a wave cut face along a low (~5 feet in height) bluff and many fallen trees. Further south on a large Township owned parcel a natural sand and cobble beach backed by forest with evidence of active erosion such as fallen trees was observed.

In addition to the four previously designated HREA's, several of the previously undesignated areas were studied. The area between HREA A and B was included in the study area as it is a relatively short stretch of shoreline that in 1986 almost met the designation criteria. The area between HREA B and C was included in the study. This area was reviewed in the field and was observed to have less armoring than other areas of the Township and an inflating beach and growing coastal wetland was observed. The area between HREA D and E was included in the study. This area was reviewed in the field and found to be heavily armored. The shoreline south of Area E was also included in the study and reviewed in the field. The shoreline was found to be a natural sand and cobble beach backed by forest with evidence of active erosion such as fallen trees.
